Thornborough Henges
Northern Henge
North Yorkshire
Monument No. 36
SE 2828 7950

Archaeological Watching Brief

May 2005

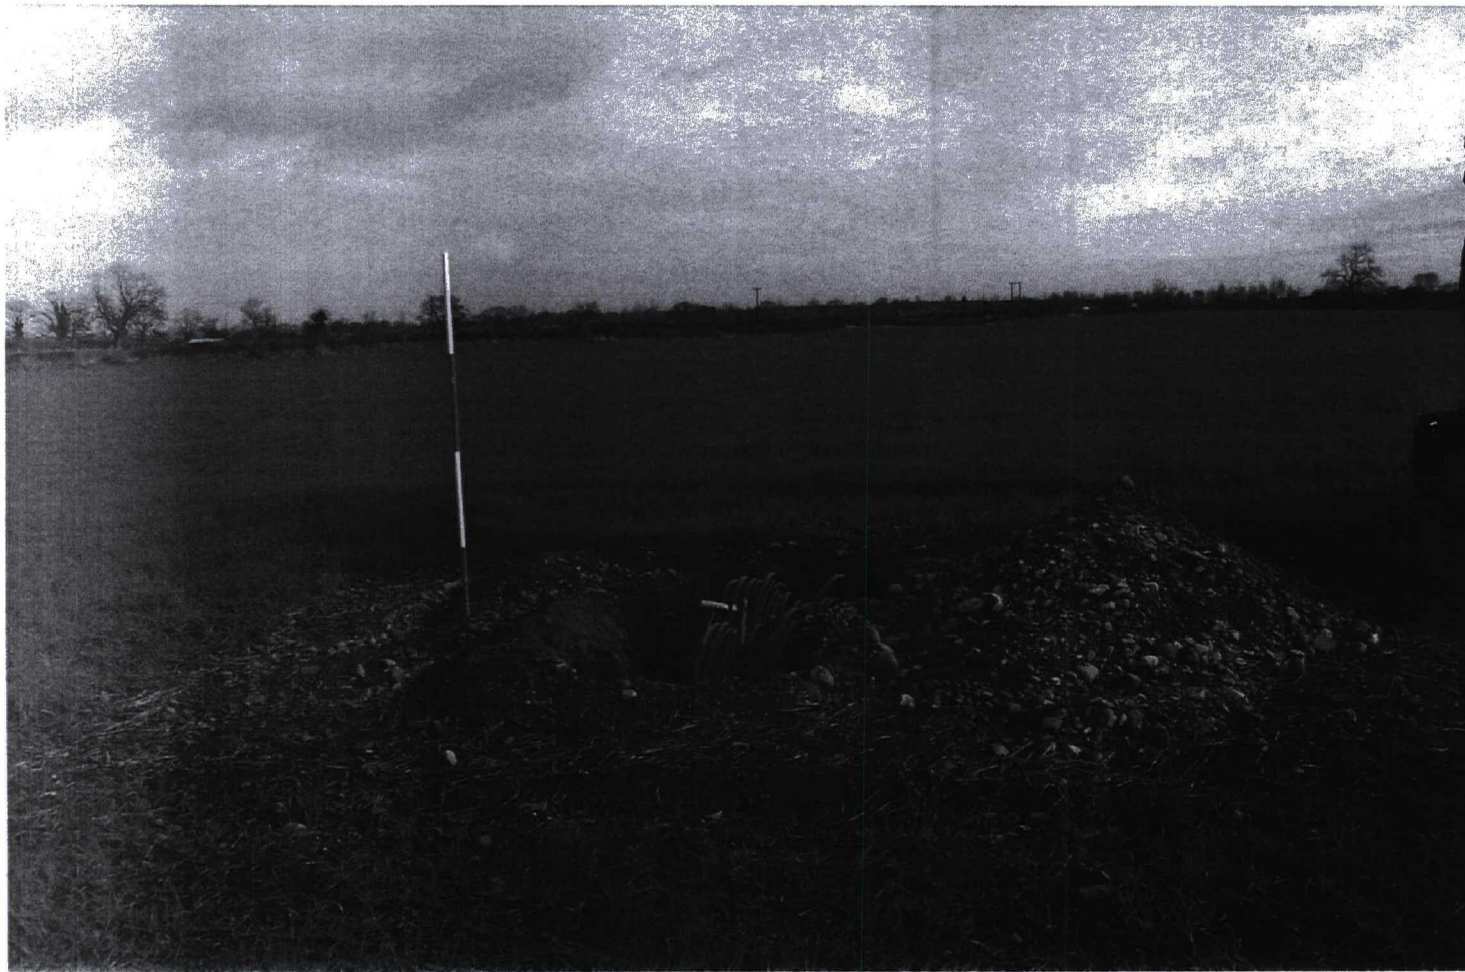
Plate 1. Location of junction with previous pipe trench excavation. Facing north-east.

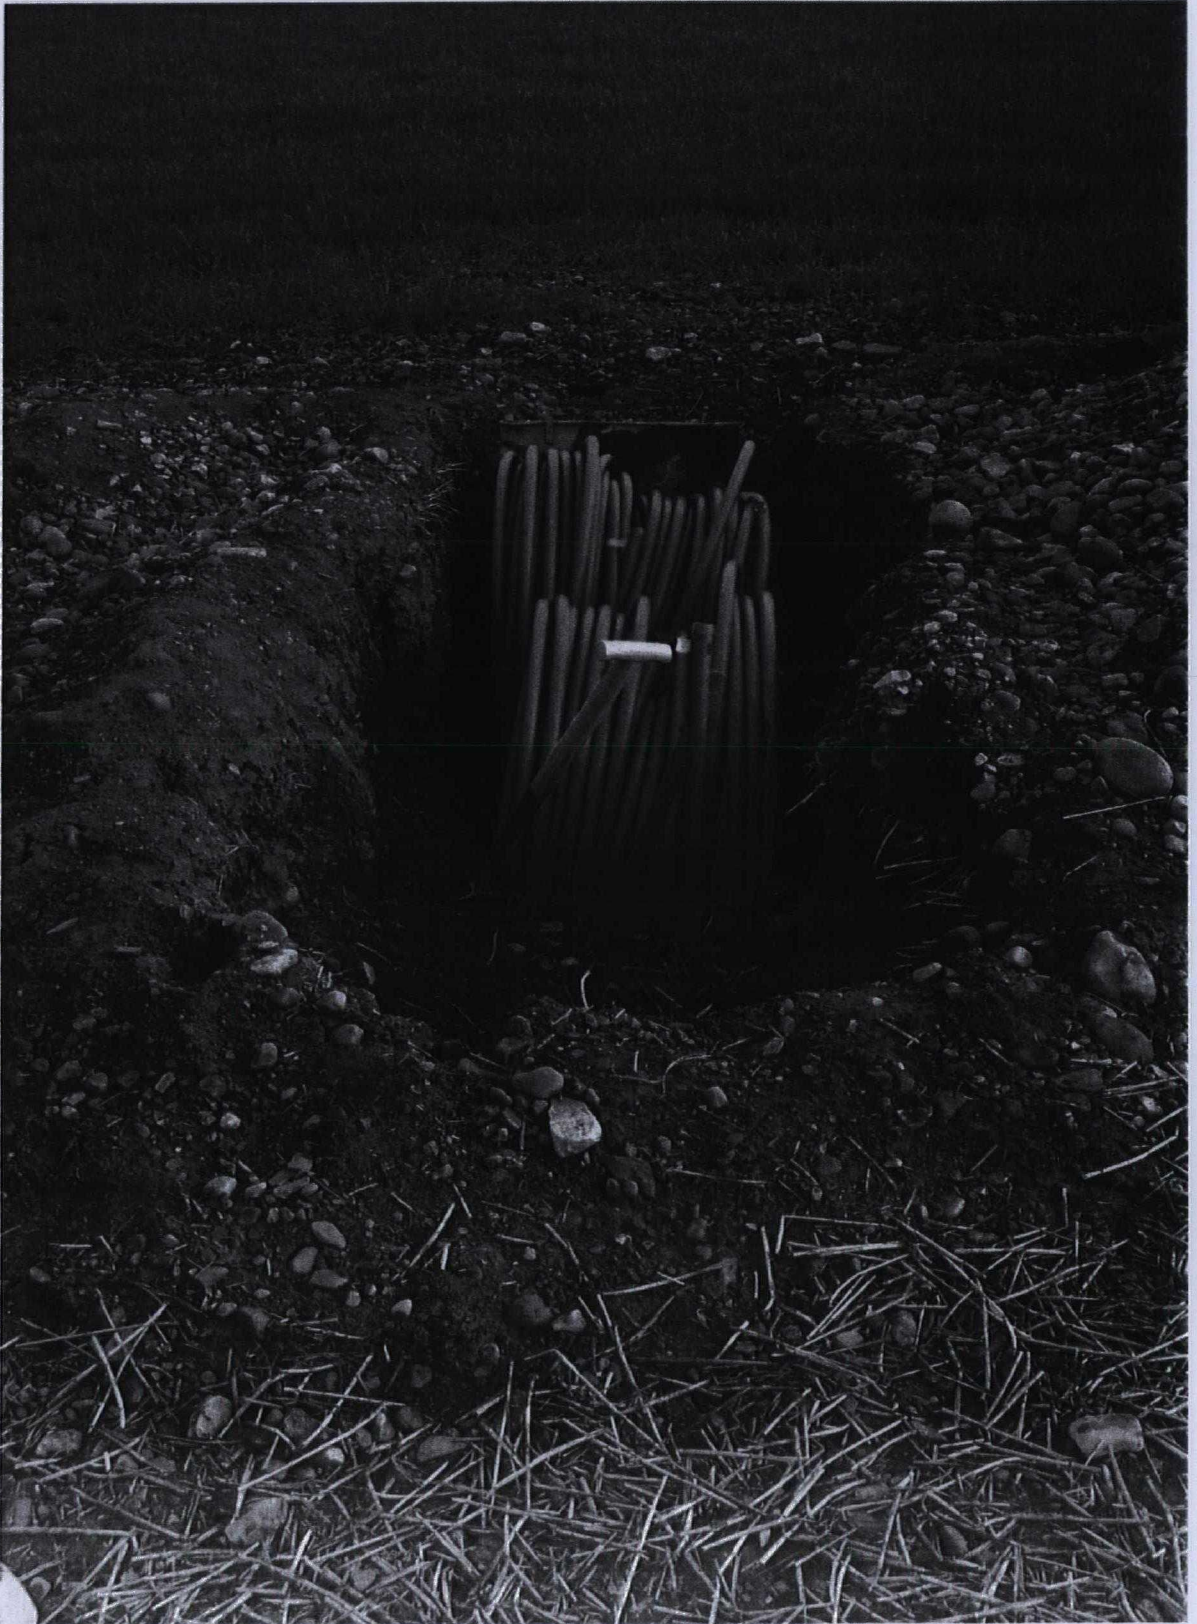
Plate 2. Open junction trench with water pipes in situ. Facing north-east.

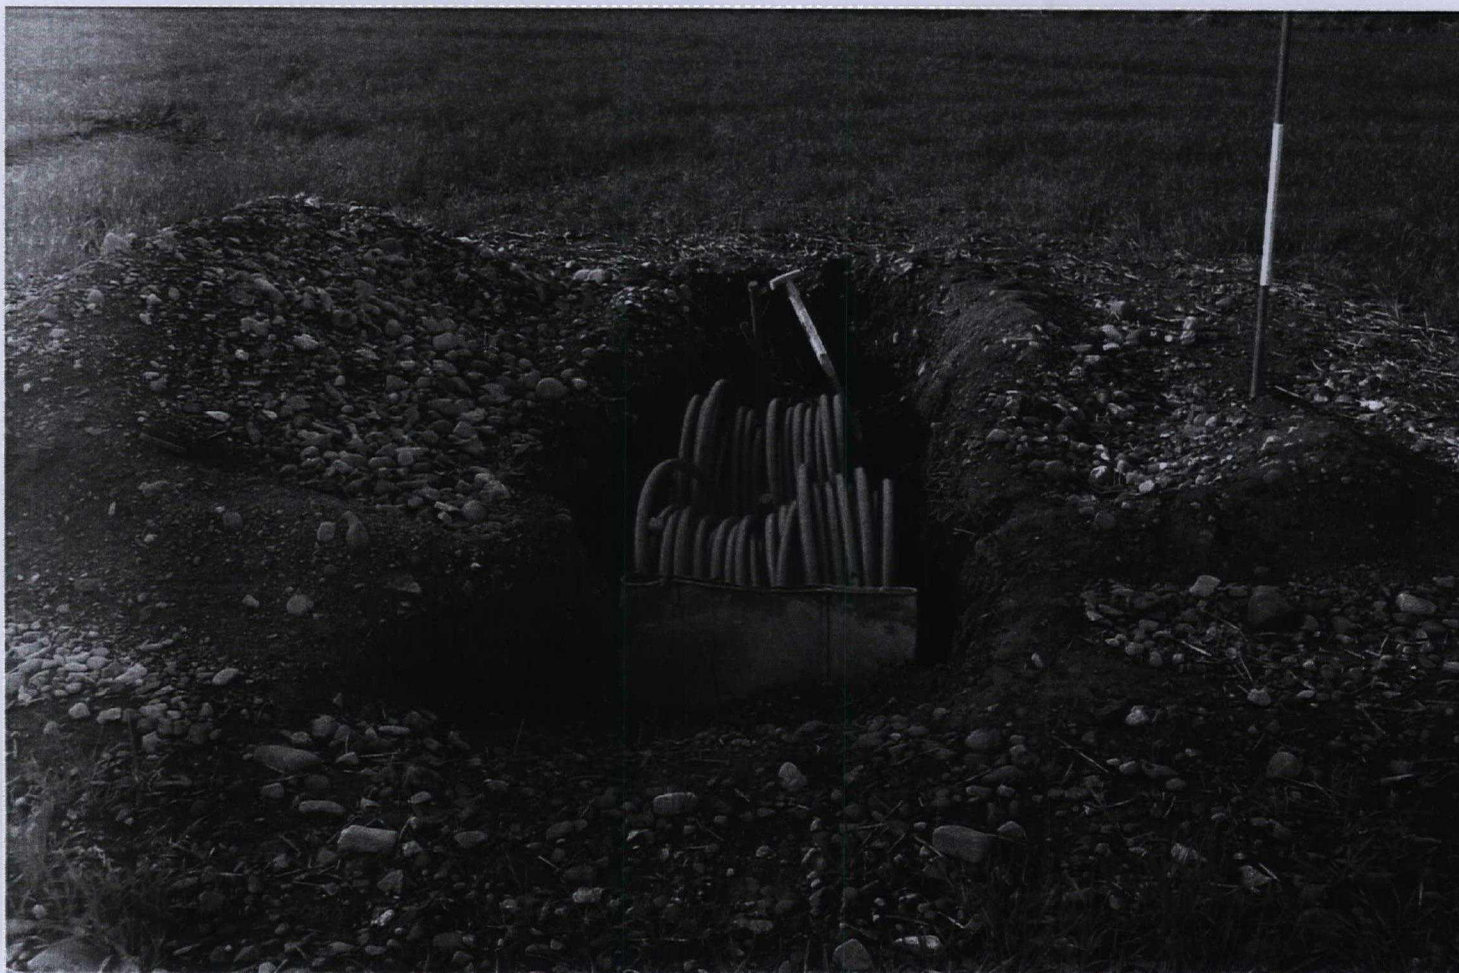
Plate 3. Open junction trench with water pipes in situ. Facing South-west.

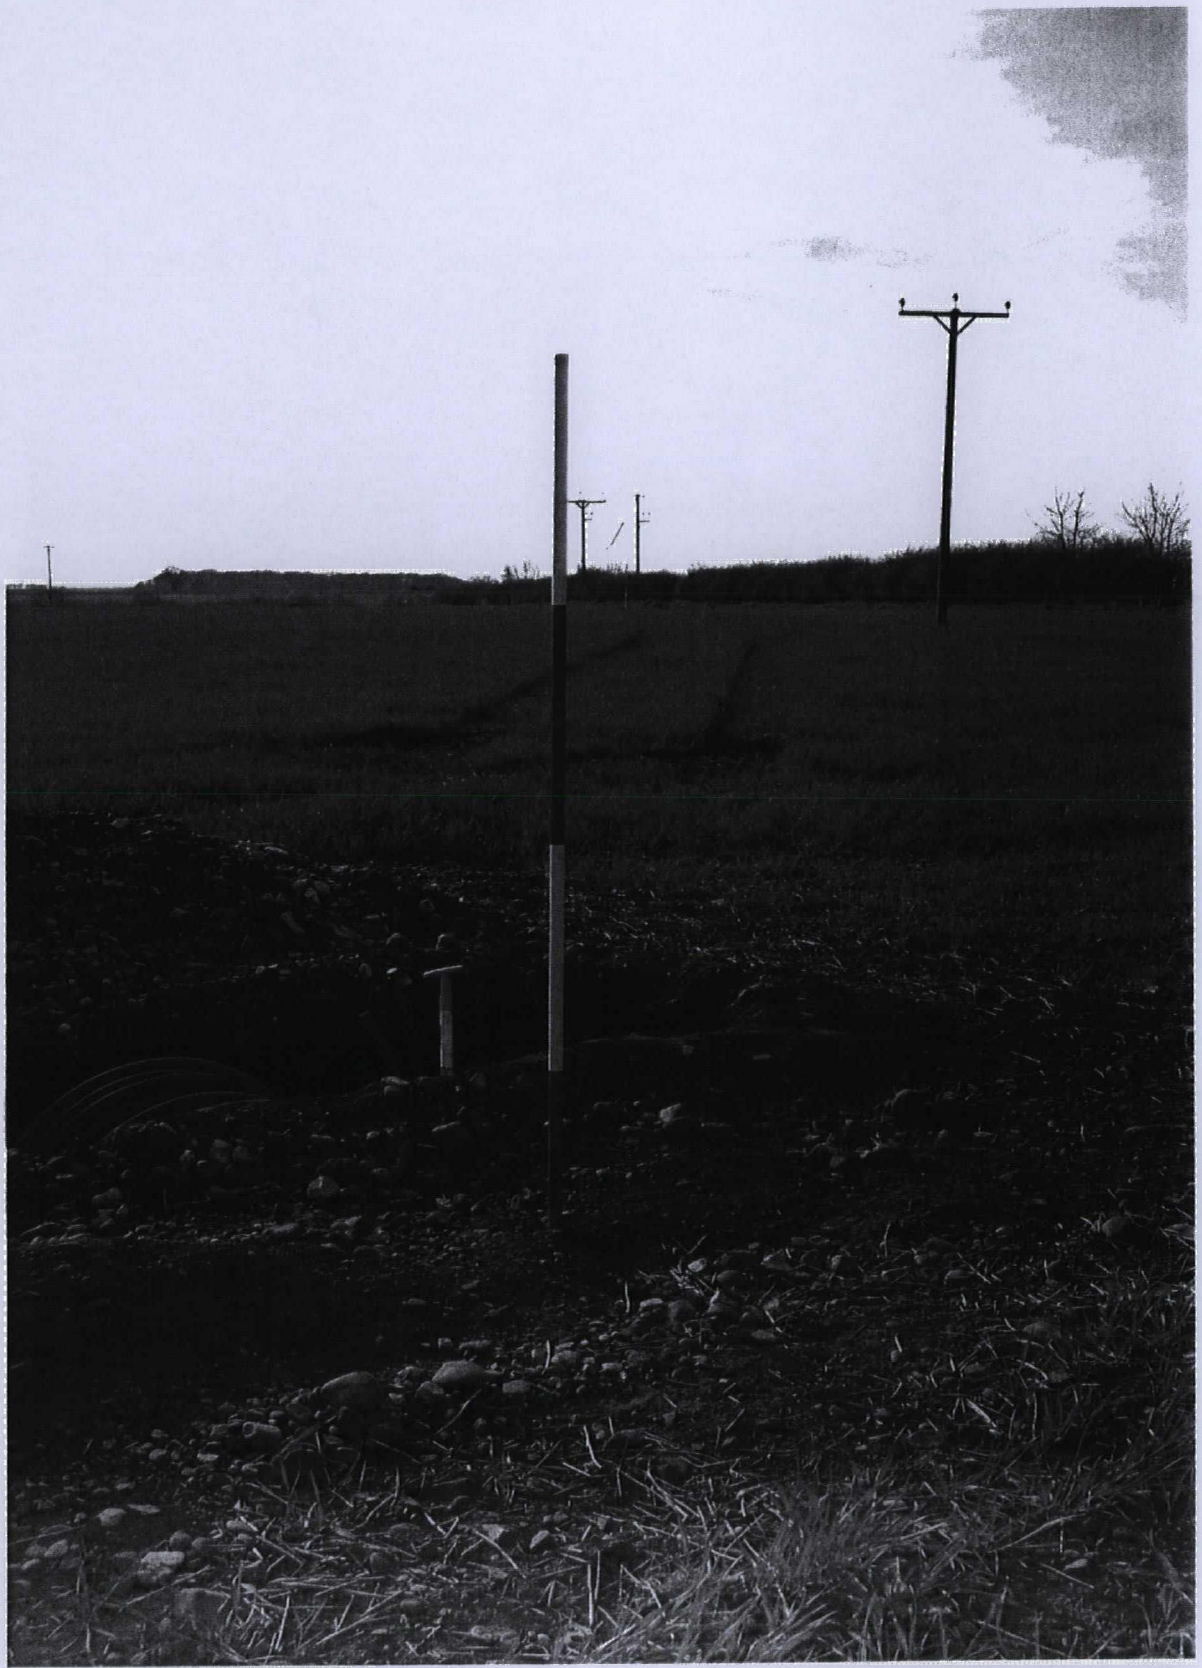
Plate 4. Alignment of Trench 1 pipe trench, prior to excavation. Facing south-east.

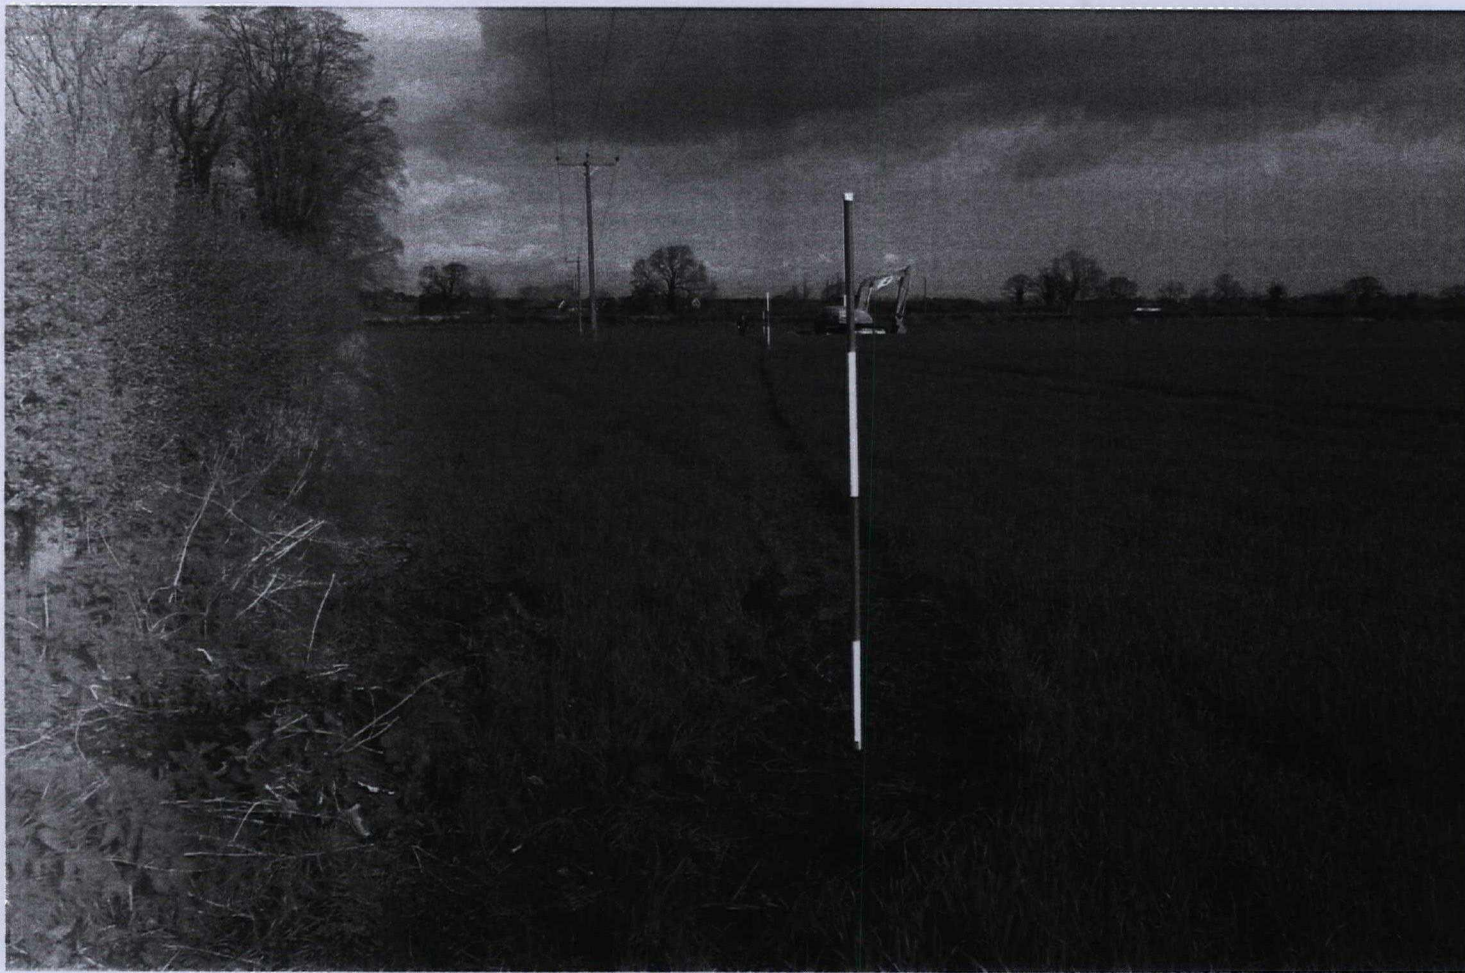
Plate 5. Alignment of Trench 1 pipe trench prior to excavation. Facing north-west.

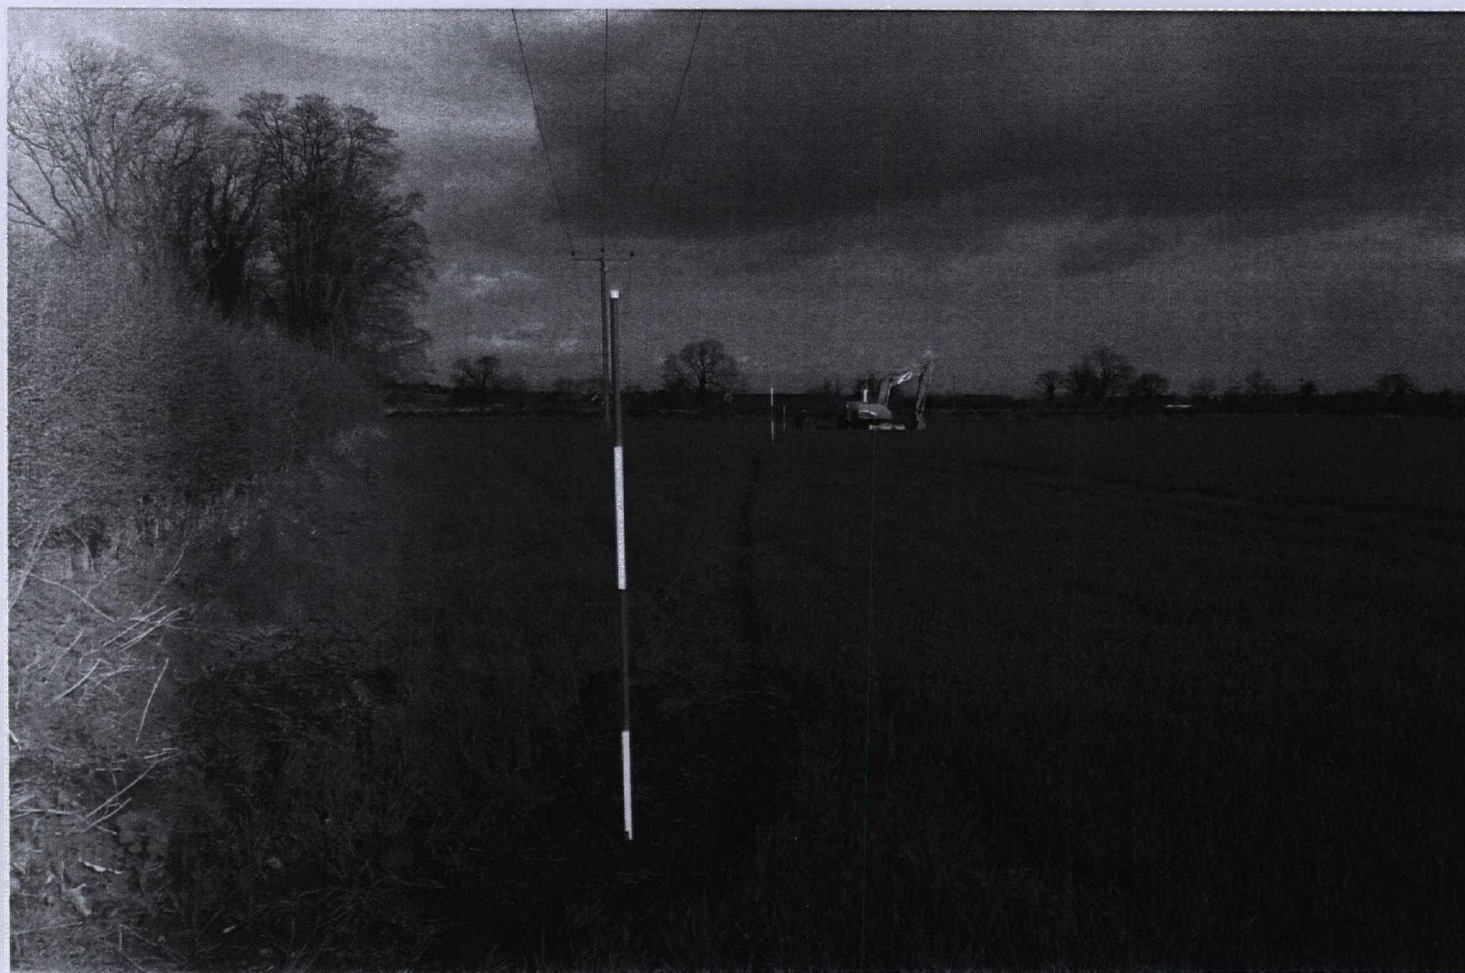
Plate 6. Alignment of Trench 1 pipe trench, prior to excavation. Facing north.

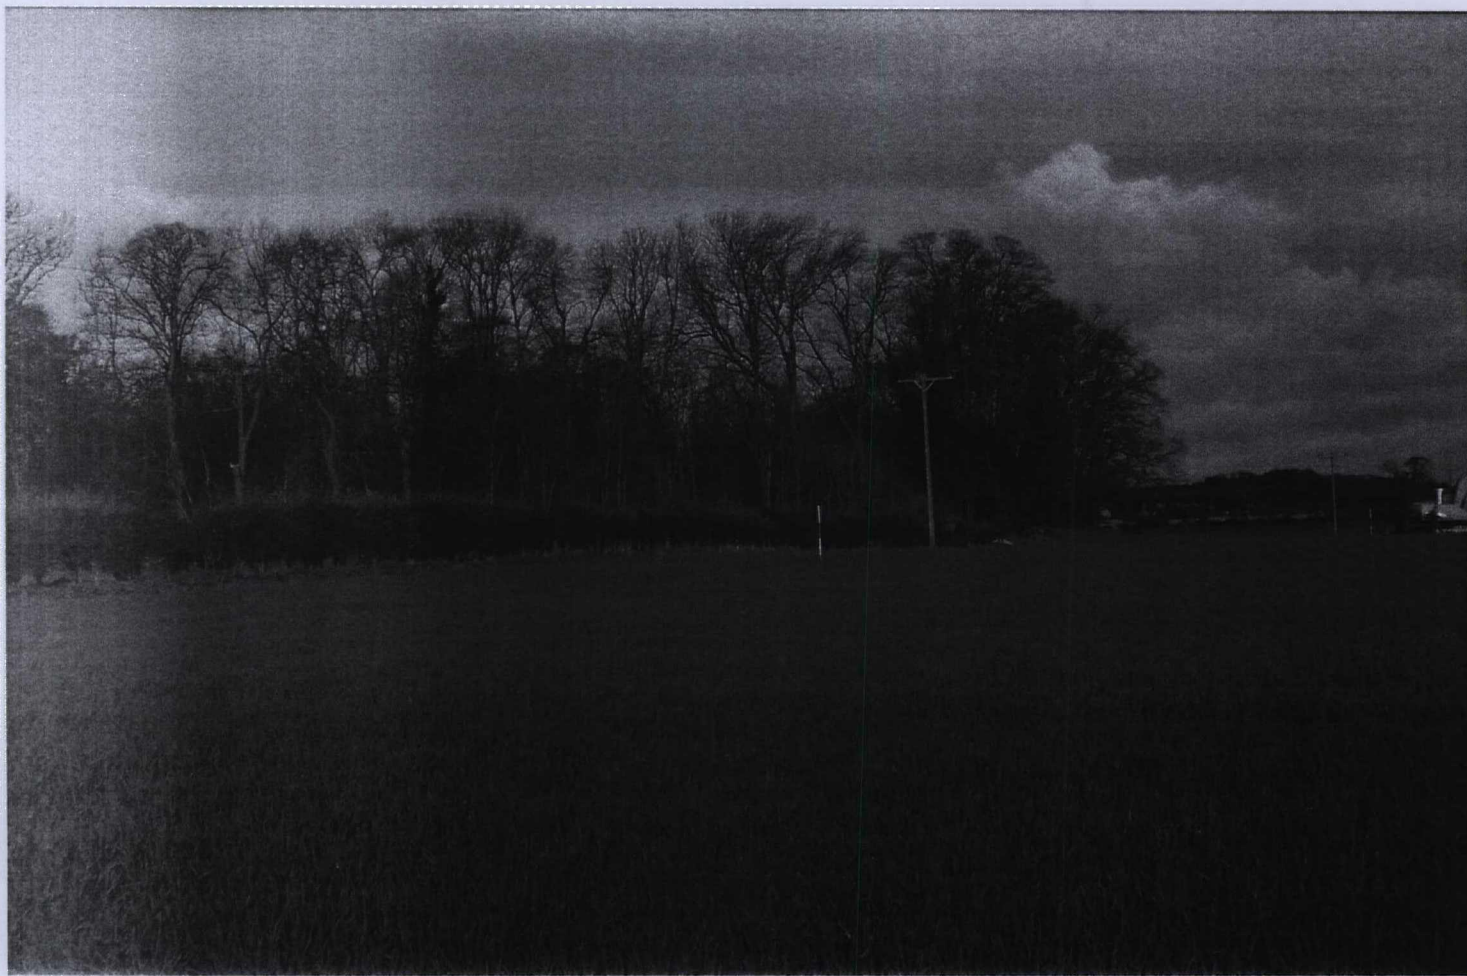
Plate 7. Alignment of Trench 1 pipe trench, prior to excavation. Facing north-west.

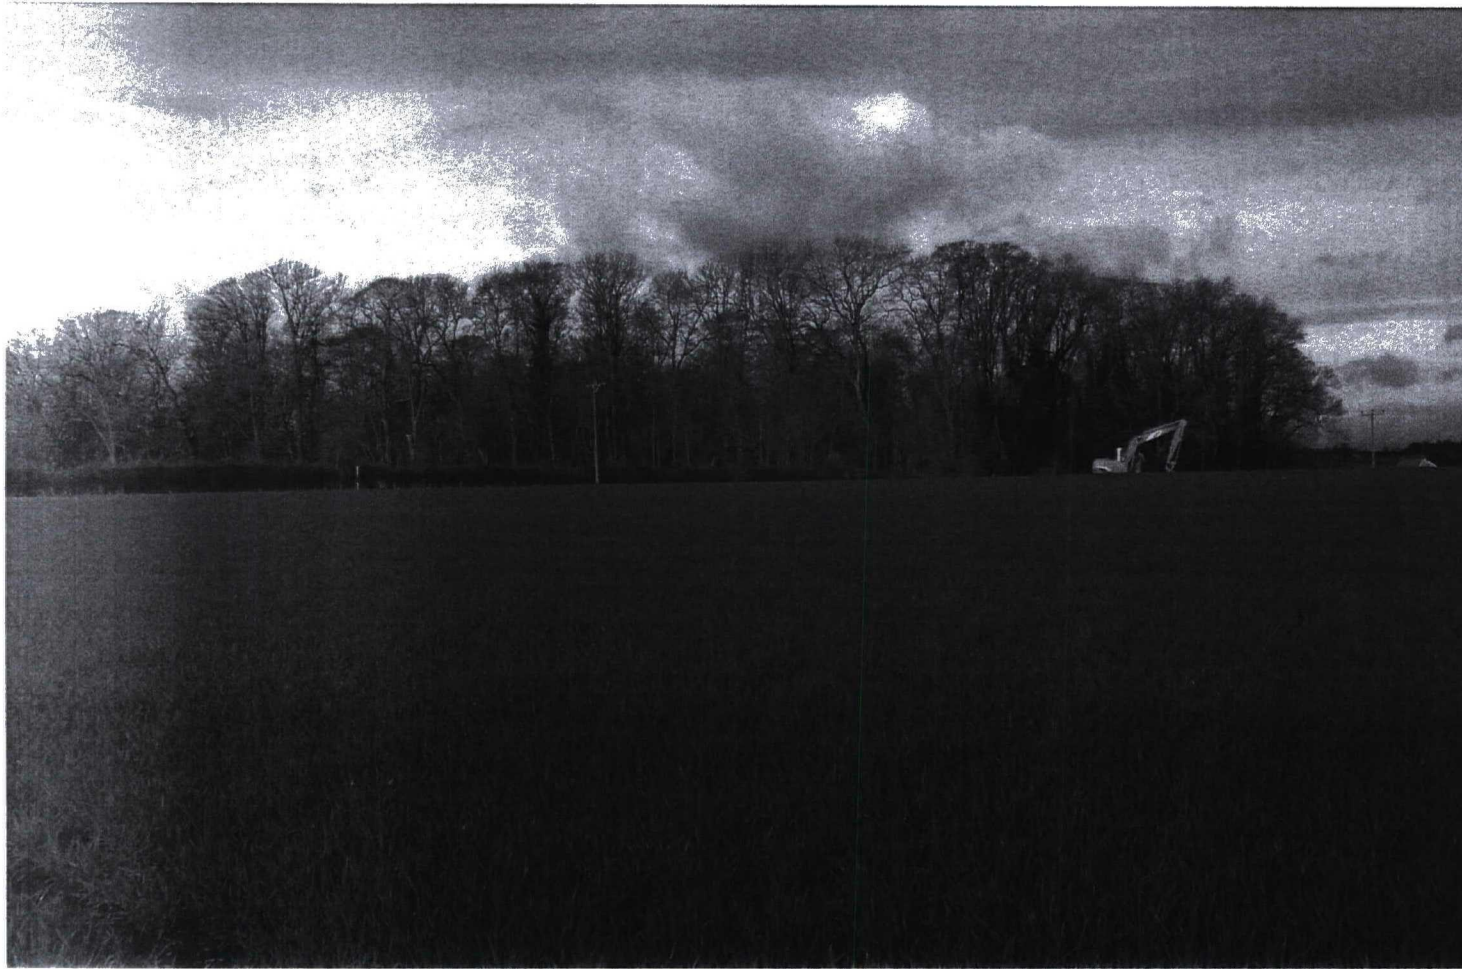
Plate 9. Alignment of Trench 1 pipe trench, prior to excavation. Facing north-west.

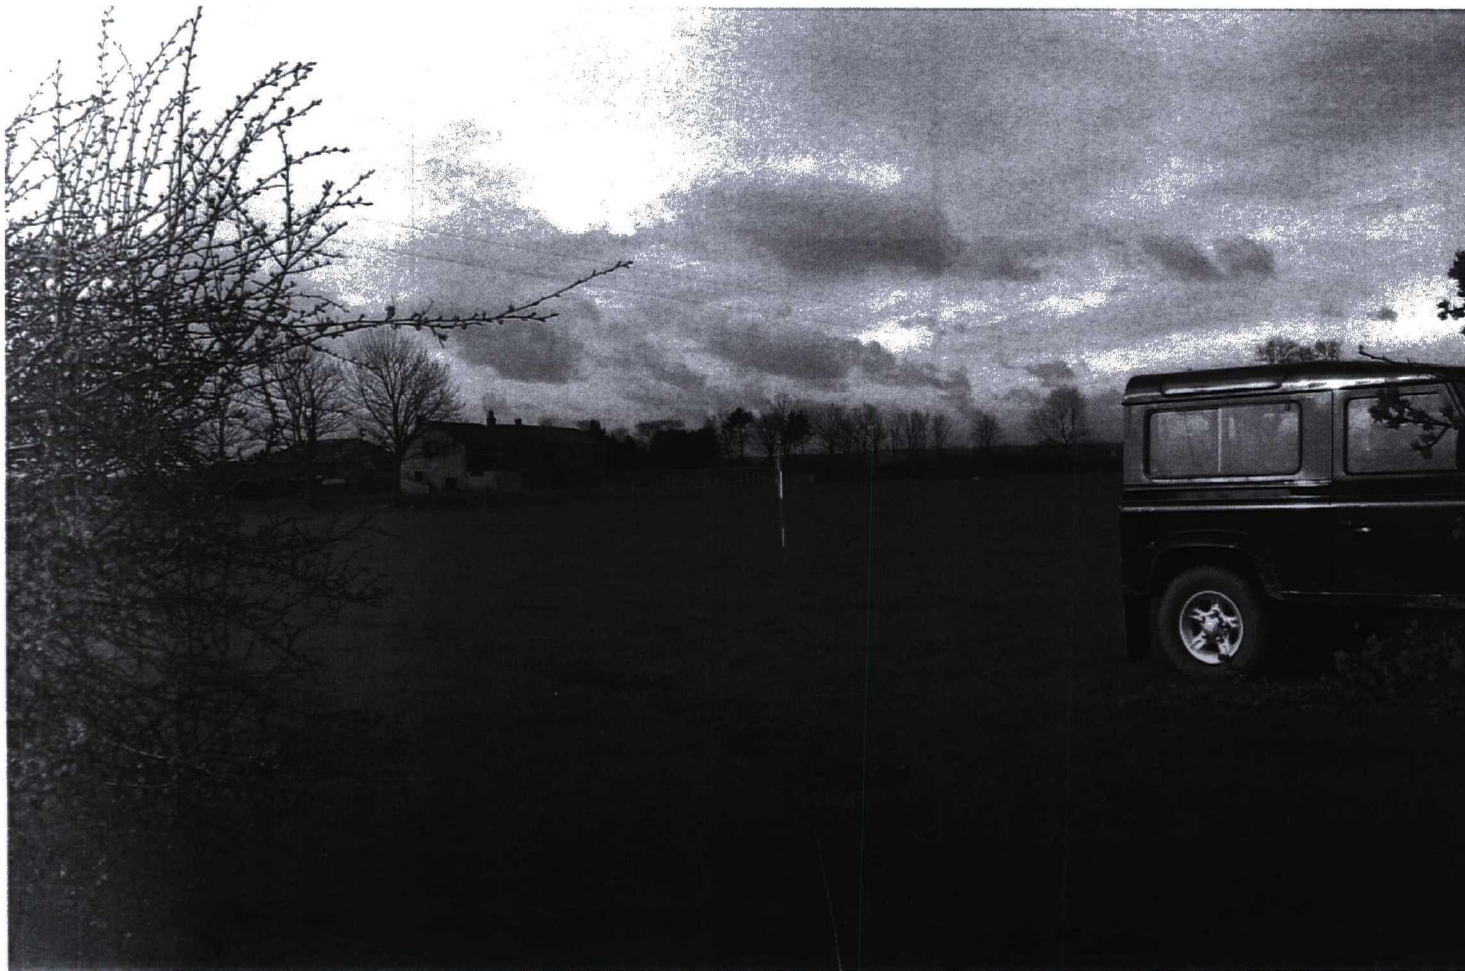
Plate 10. Alignment of Trench 1 pipe trench, prior to excavation. Facing south-west.

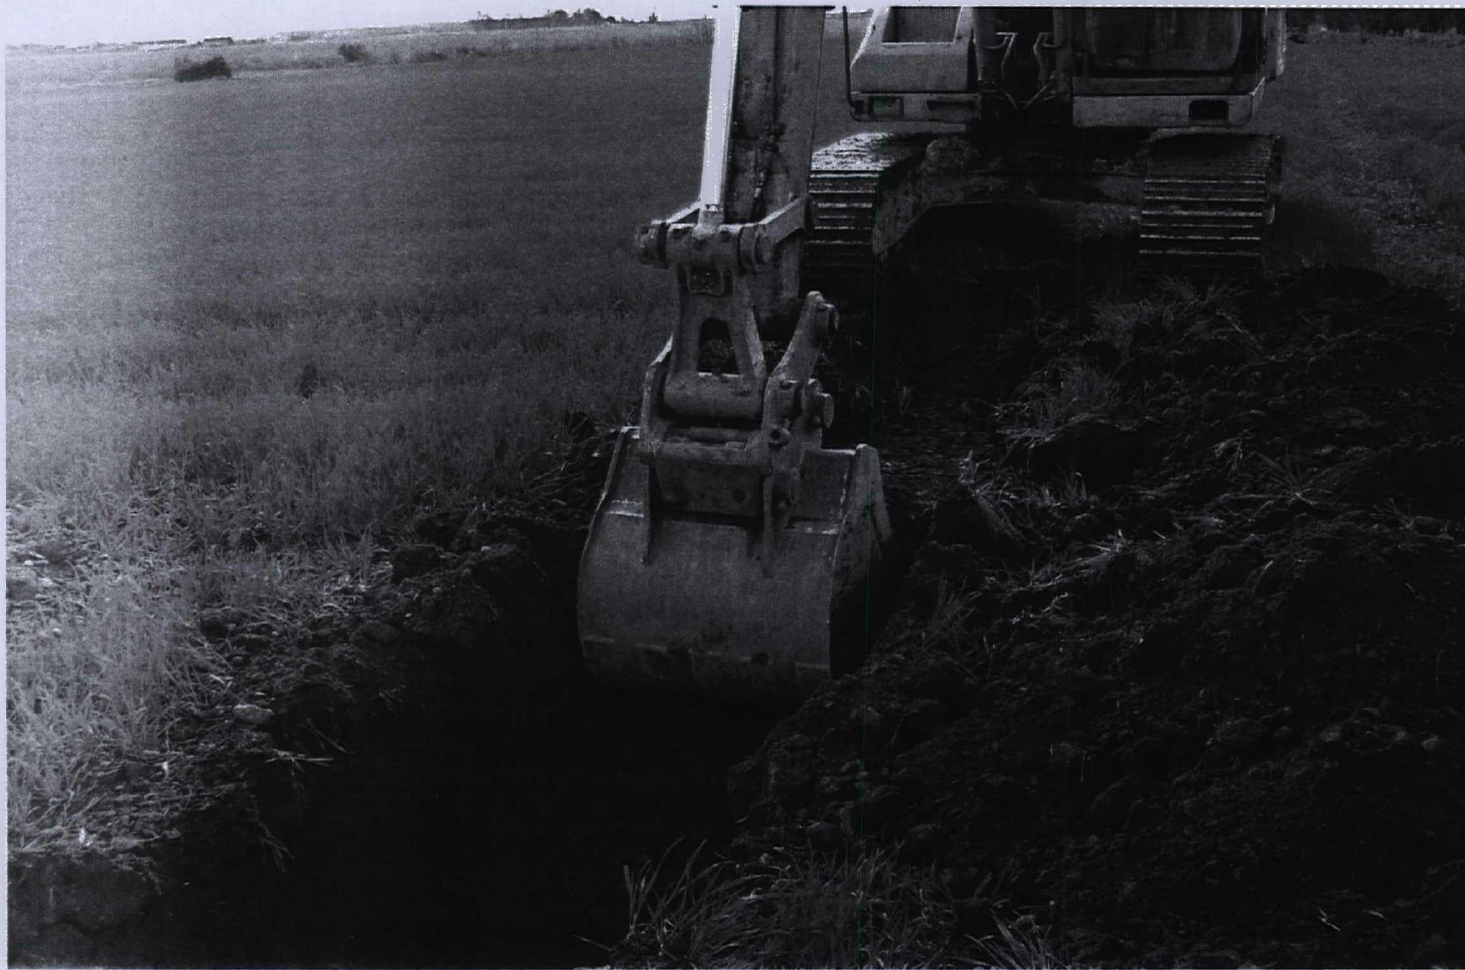
Plate 11. Trench 1 under excavation, removal of the subsoil. Facing south-east.

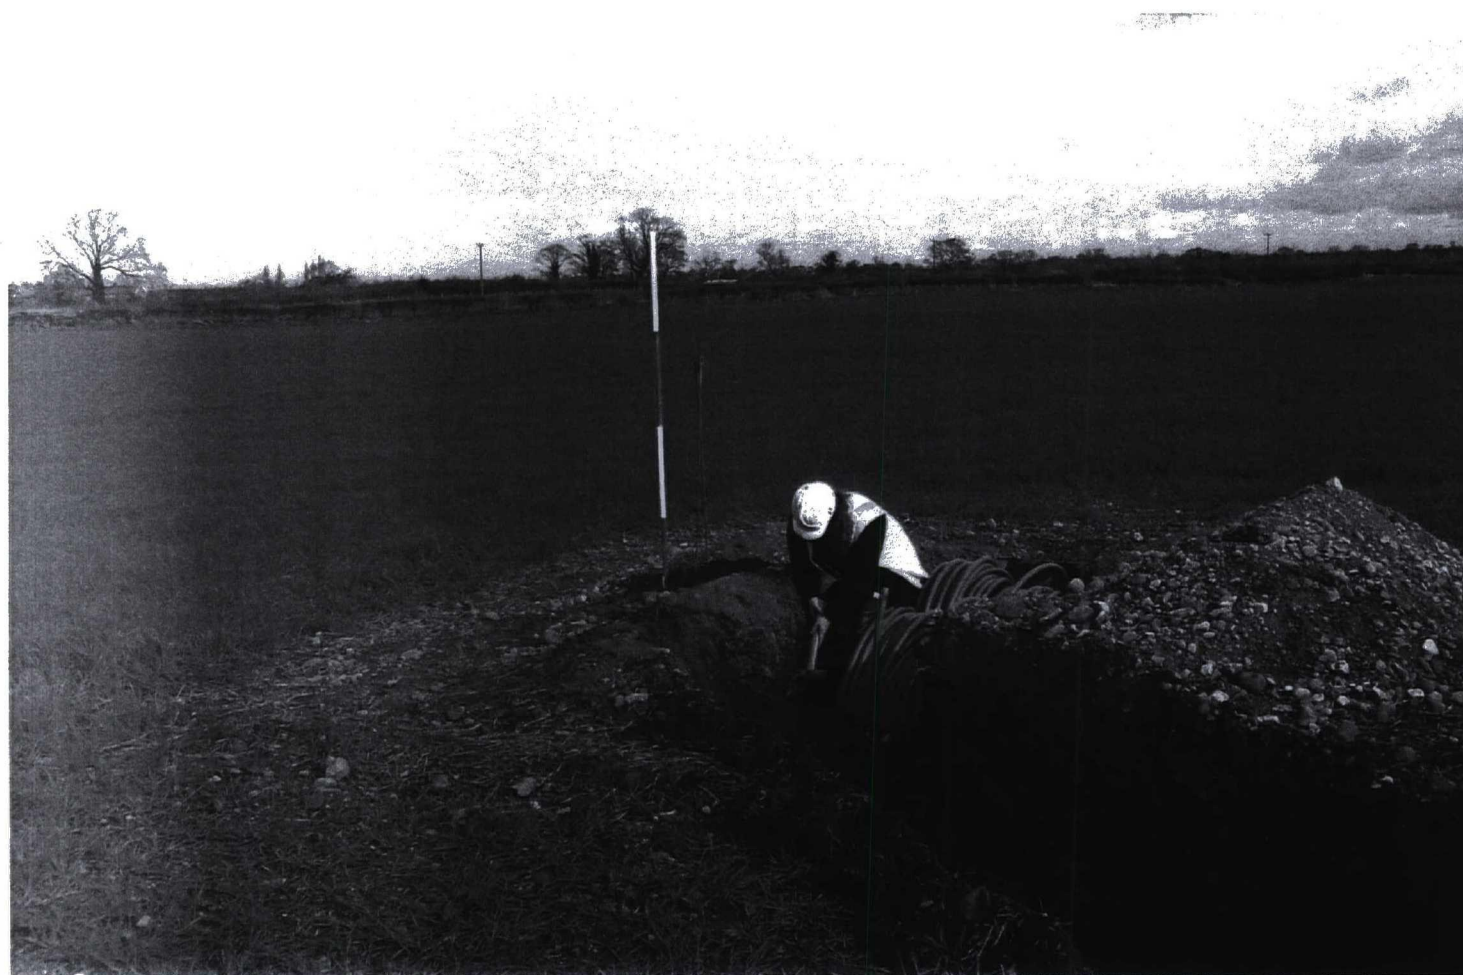
Plate 13. Placing of aluminium marker at junction of Trench 1 and previous excavated pipe trench. Facing north.
