HISTORIC ENVIRONMENT SCOTLAND PROPERTIES IN CARE MINOR ARCHAEOLOGICAL WORKS 2015/2016

Holyrood Park • Watching Brief • January 2016

SITE:	Holyrood Park, Edinburgh.
N.G.R.:	NT 275 741 – NT 286 741
DESCRIPTION:	An archaeological watching brief attached to work undertaken to repair public footpaths in Holyrood Park, Edinburgh.
PROJECT CODE:	HSCO-90131-2016-01
CONTENTS:	Introduction1
	Description3
	Conclusions4
	List of Digital Photographs5
	List of Small Finds5

SITE:	Holyrood Park, Edinburgh.	
N.G.R.:	NT 275 741 – NT 286 741	
DESCRIPTION:	An archaeological watching brief attached to work undertaken blocked drain.	to repair a
PROJECT CODE:	HSCO-90131-2016-02	
CONTENTS:	Introduction	_1
	Description	_2
	Conclusions	<u>_</u> 3
	List of Contexts	_3
	List of Digital Photographs	3

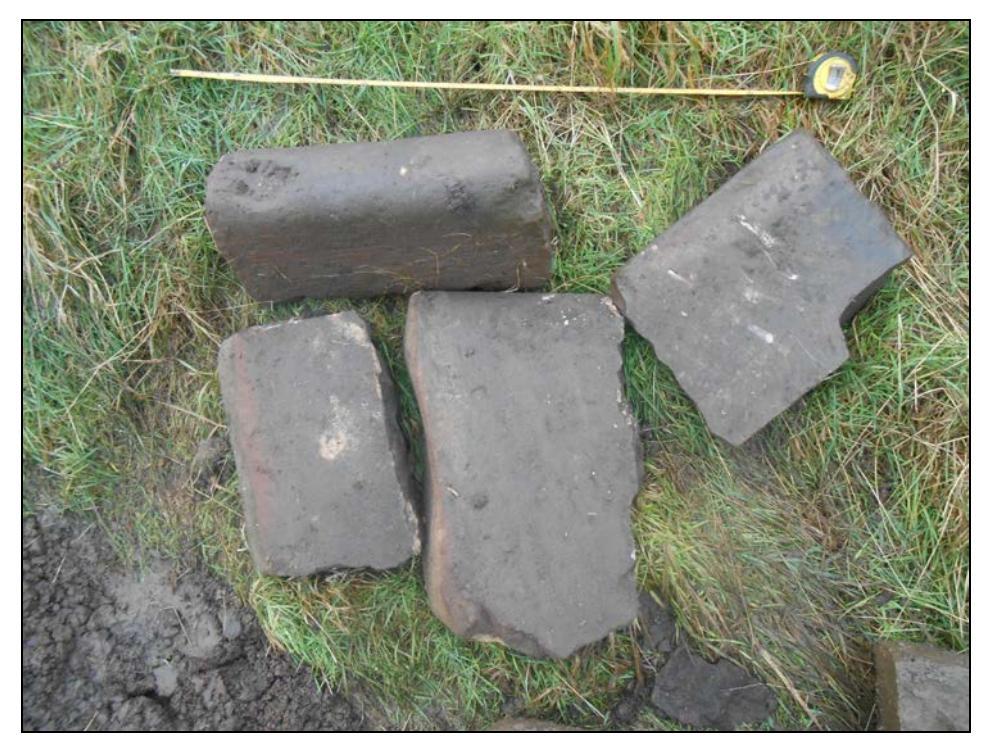
Plate 1: The four dressed stones from Area 9.

The existing kerb, built of often substantial boulders located on the downslope (north-east) side of the path, was dismantled in Area 9. This was found to overlie an iron drain demonstrating that the kerb is not of great antiquity. Four dressed stones were recovered from this wall, all similar both geologically and in terms of treatment. The four were fine-grained sandstone slabs some 0.1m thick with well finished faces and fine tool marks visible. Although often broken along their edges, two had curved profiles, again finished to a high standard. These stones were rebuilt into one of the cross drains in Area 9.

The four dressed stones recovered were considered to be of little interest, and allowed to be rebuilt back into the path. The well finished, heavily tool marked nature of these stones indicates a probable late (nineteenth century or later) date for their working. The consistently thin width and curved edges might suggest kerb stones of some sort; in all likelihood they were imported to the site in the relatively recent past as rubble used to build the path.

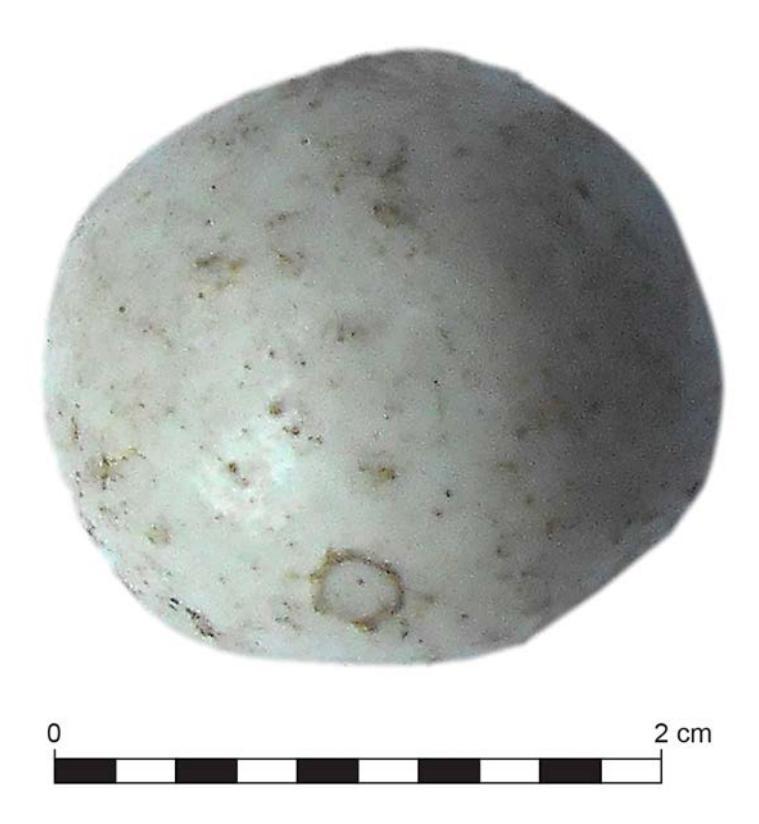
Excavation results in areas 1 and 2 were extremely limited. Bedrock was frequently close to or even at the surface in this area, and almost all digging was through earlier path material. Occasional stretches filled with dark brown silty clay were observed. Only a single artefact (other than modern detritus), a ceramic bottle stopper, was noted from these two areas (Figure 3).

Figure 3: The ceramic bottle stopper (SF001). Scale: 4:1 @ A4.

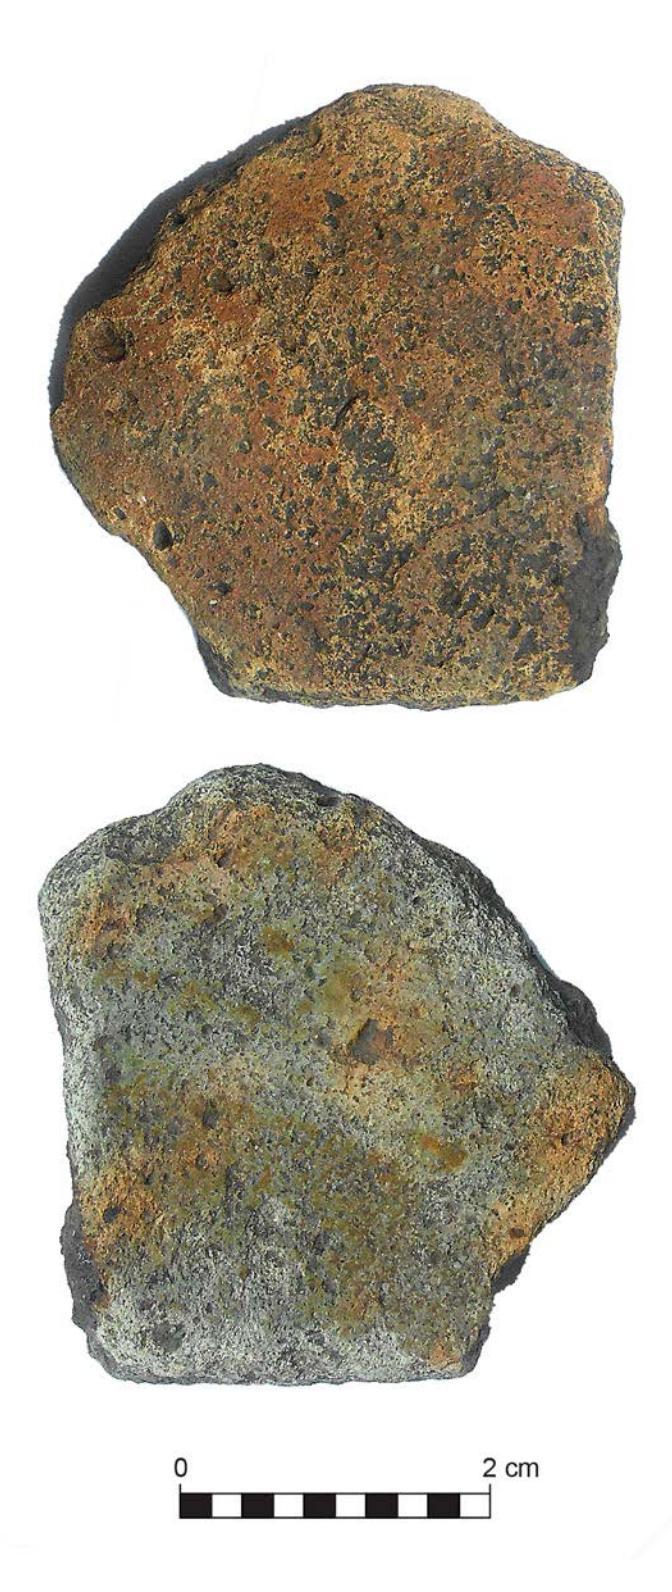
In Area 9 all excavation was through redeposited material, with path gravel and flecks of blaze throughout all the deposits. Significant amounts of nineteenth century (or later material) were noted, with a small selection retained. A single body sherd of broadly medieval date was retained from an erosion scar adjacent to the path (Figure 4).

Figure 4: The sherd of pottery SF002 (both sides shown). Scale: 2:1 @ A4.

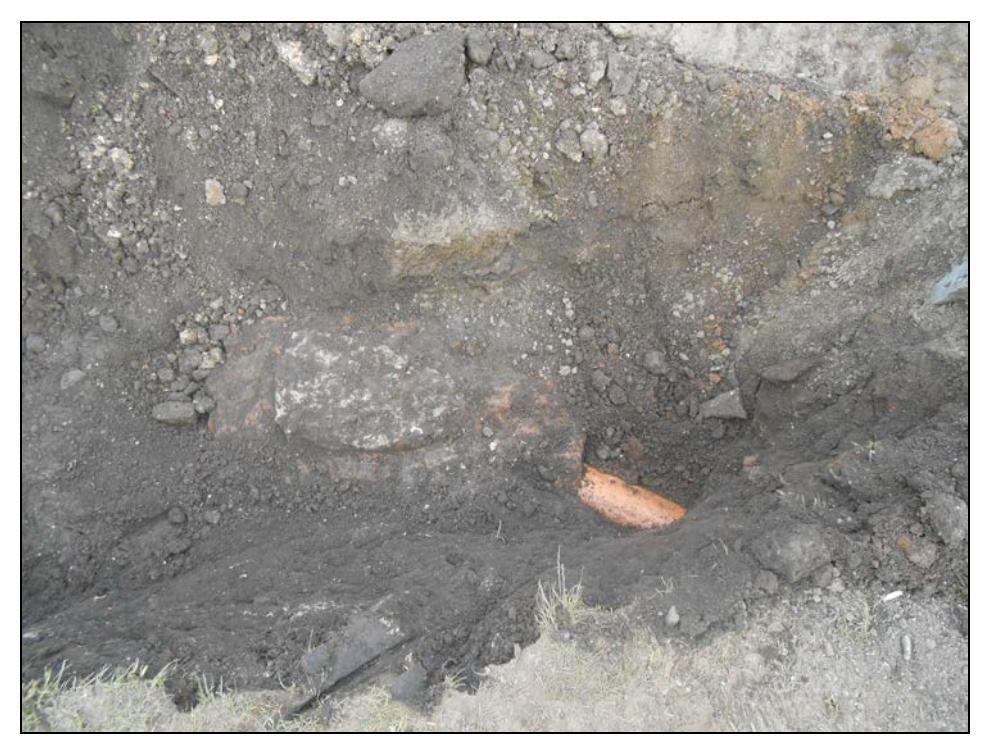
The initial aim was to locate the existing drain pipe near the junction of Volunteer's Walk and the Duke's drive. A nearly square trench measuring 2.15 m NE/SW by 2.1 NW/SE was taken down a total of 0.8m. A pipe **102** ran west into the trench from its eastern corner, before turning to run south-west, continuing out of the trench. The top of **102** was 0.7m below the ground surface, and no sign of a cut was identified for it.

Plate 1: The pipe 102, as revealed.

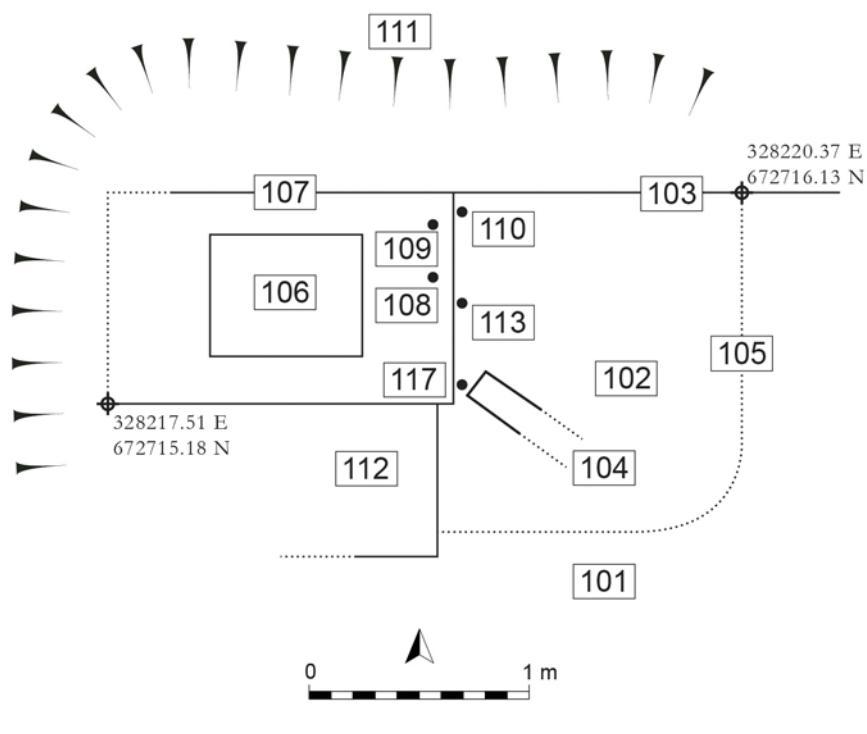
Figure 2: Plan of Delf's Well.

On arrival the opportunity was taken to make a detailed written and photographic record, including a measured sketch plan, of Delf's Well (Fig.2). The site sits close to the base of the steep hillside to the north, and has clear traces of an overgrown cut, **111**, running around its north and west (upslope) sides. The eastern face and the top of the well have been exposed, presumably by this cut.

The well today is capped by a single large (1.78m x 0.85m x 0.09m) sandstone slab **107**, laid E/W and with a definite hollow worn in to the eastern end of its upper surface. A concrete services cover, **106**, has been set into **107**; presumably a hole was cut through the slab to take this. In the north-east corner of **107** is **109**, a broken-off iron fitting set in lead, while just south of this **108** is an iron ring set in lead with a short chain, terminating in a hoop attached to it.

The eastern end of slab **107** rests on brick built wall **112**. This was found to stand eight courses (0.7m) high before widening out as footings, and was 2m long. This length meant it projected out beyond the limits of **107** above to both the north and south. To the south, the brickwork of **112** is capped by a further large sandstone slab whose upper surface is 0.15m below that of **107**.

A series of three pipes fed out of the eastern face of wall **112**. Context **110** to the north was a 25mm square lead pipe that had been pinched shut, while **113** placed centrally and high up in **112** was a large diameter (40mm) short iron pipe, and **117** low down at the southern end was a severed lead pipe 20mm in diameter.

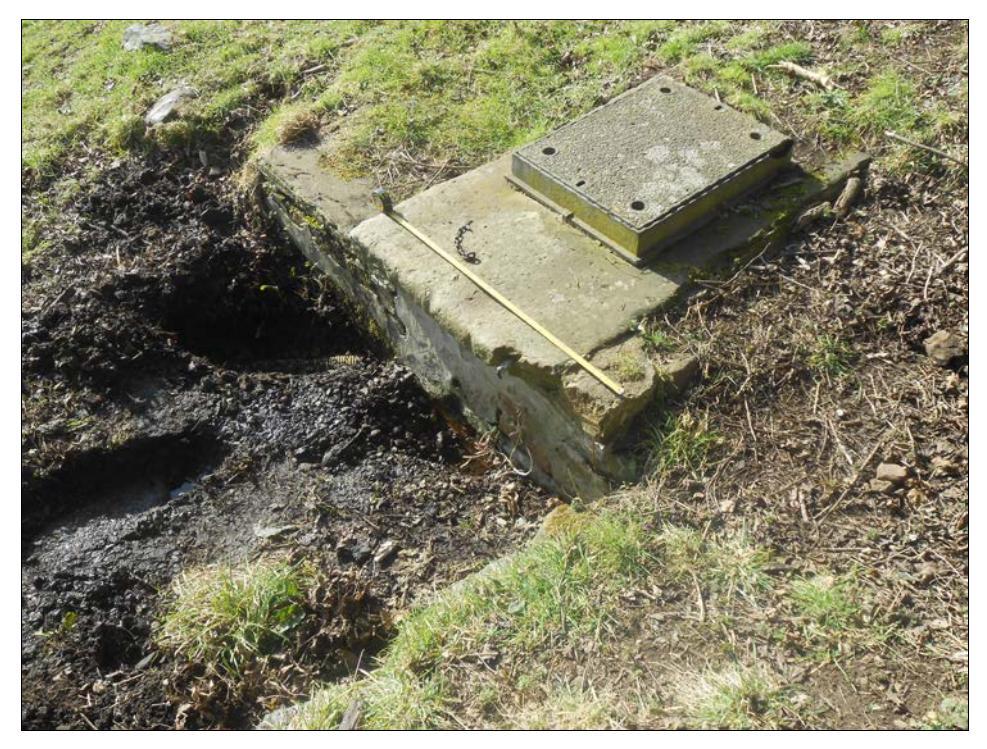
Plate 1: Delf's Well.

In the angle between the south face of **103** and the eastern face of **112** was an area of 'Type 1' gravel, **102**. A yellow perforated plastic pipe **104** ran within **102** from the south end of **112**, just beside where pipe **117** feeds out of it, heading off downslope to the south-east. Context **104** was the existing drainage pipe that the contractors were looking for.

The services hatch **106** was lifted as part of this project, allowing a view inside Delf's Well. Although dark and impossible to measure, a roughly square chamber could be seen, extending considerably beyond the northern and southern limits of slab **107**. A small brick built arch fed into this chamber near the western end of the north wall, and water ran rapidly through this.

Although only limited excavation was undertaken in the area of Delf's Well, it is here that the greatest archaeological interest lay. The well does indeed appear to be fed by springs coming off the slope, with a vigorous inflow observed coming into the well chamber from the brick built arch low down in its northern wall.

The current superstructure over the well, effectively sealing it, must be 19th century or later, with mass produced bricks used in its eastern wall fabric, **112**. The large thin slab **107** laid over this brick wall seems worn however, and it might be suggested that this is a recycled element from an earlier well arrangement. The short iron chain **108** set into the eastern end of the upper surface of this slab may have had a cup attached to it originally.

Set into the eastern wall of the well was a series of pipes, with the large iron pipe **113** set high up and still open, presumably functioning as an overflow outlet. Context **117** was set low down to the south and is a severed lead pipe whose diameter matches that of pipe **115** found crossing the trench some 7.65m to its east. These contexts are likely to represent the same pipe feeding out of the well to the east. It is unclear where this pipe is heading; it seems to be angled too far to the south to supply the lodge house at the park

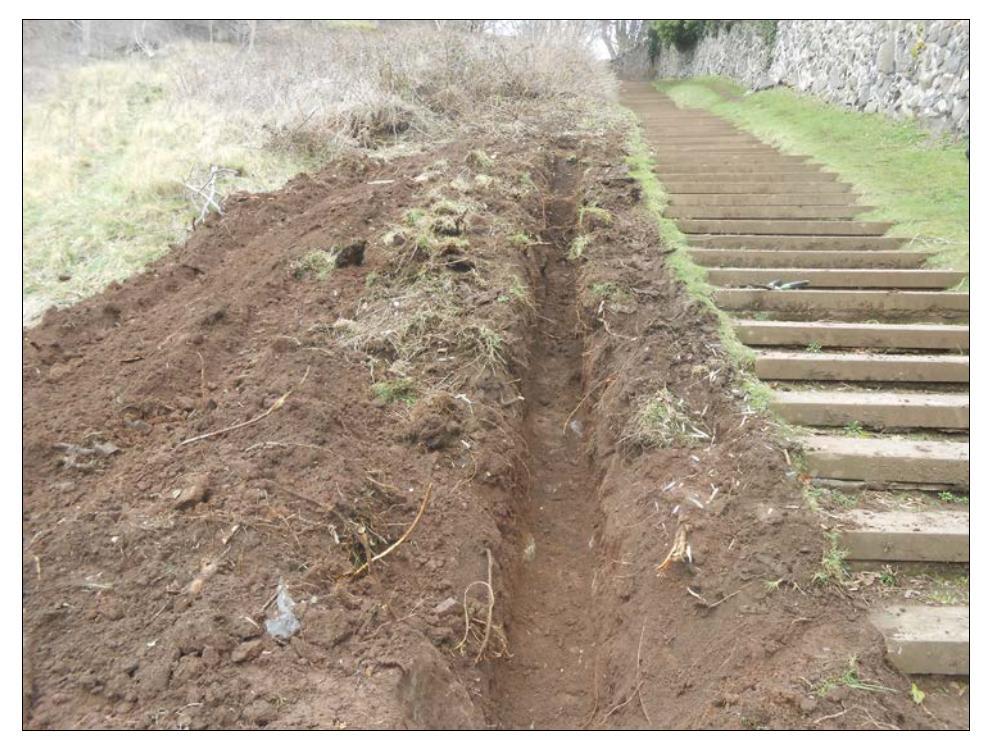
The rubble filled cut **122** sitting under the top step of Jacob's Ladder seems likely to relate to the construction of the steps. Such a substantial feature may represent a soak-away at the top of the stairs rather than a feature than runs under their entire length. The ceramic drainpipe **118** running parallel to the stairs is an earlier attempt at drainage, one that ultimately failed as the pipe was dry and choked with soil.

Plate 2: A view of the trench (with excavation in progress) adjacent to 'Jacob's Ladder'.
