**HISTORIC SCOTLAND PROPERTIES IN CARE
MINOR ARCHAEOLOGICAL WORKS 2014/2015**

Iona Abbey • Watching Brief • November 2015

SITE: Iona Abbey, Iona.

DESCRIPTION: A small scale excavation in order to locate and repair a burst water pipe
between the Michael Chapel and museum.

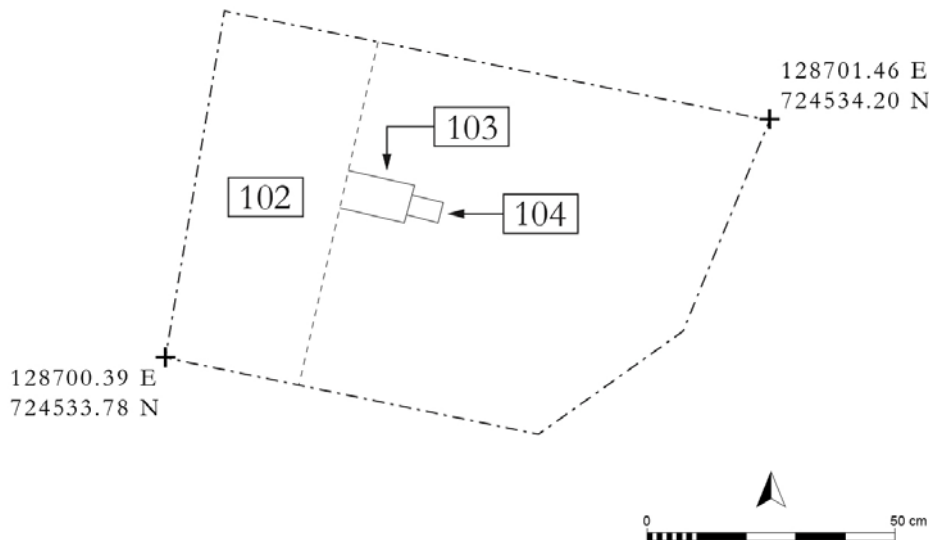
Figure 2: Post-excitation plan.

The excavation revealed extensive disturbance associated with the insertion of relatively recent drainage and services, along with associated episodes of levelling. Context **004** in particular appears to be associated with the levelling for the construction of the modern concrete step. Nothing further of archaeological significance was revealed during the course of the work.

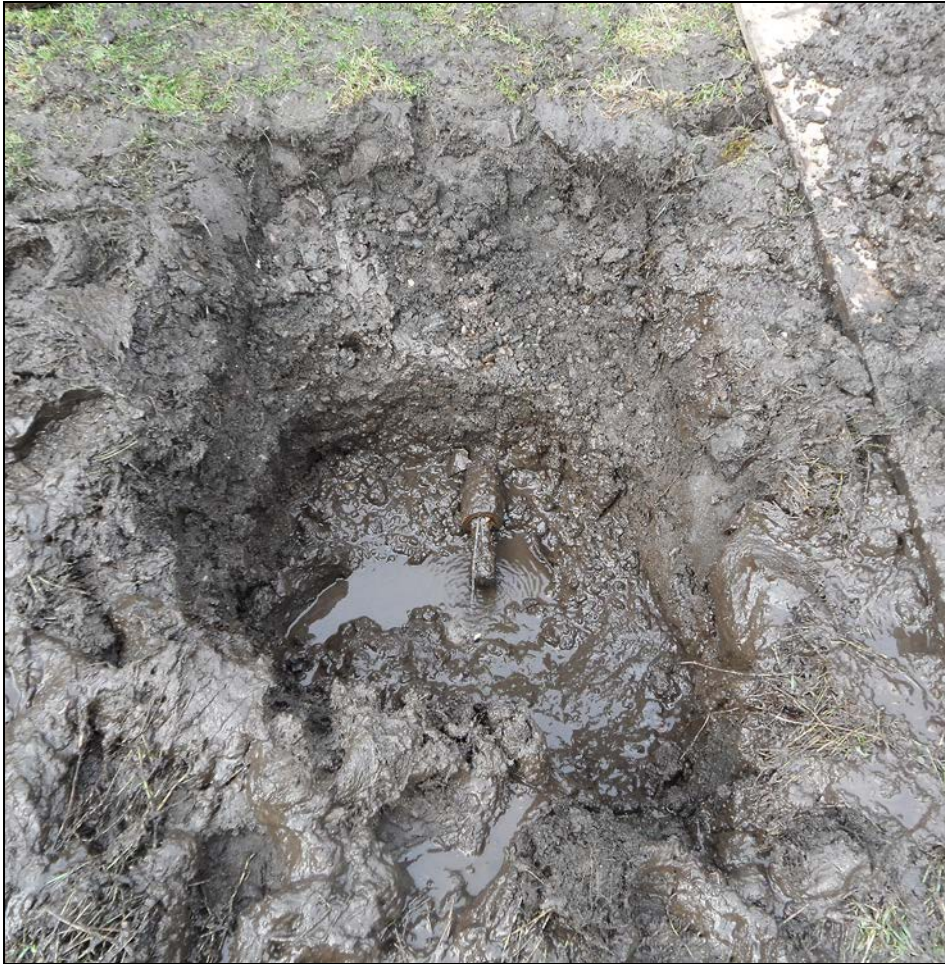
Trench 1 measured 0.7m NE/SW x (up to) 1.05m NW/SE. Towards the north-west area of the trench, a 0.15m depth was achieved, while the main body of the trench was excavated to a depth of 0.5m. The 0.15m thick turf and mid-brown silty topsoil **101** overlay a re-deposited backfill **102** of sandy gravel containing numerous pebbles and large sub-rounded re-deposited boulders up to 0.3m long (although the cut within which this material sat was not apparent). An open-ended, three inch diameter pipe **103** (running approximately NW/SE) was encountered within this backfill (with its top 0.43m below the ground surface); it had been plugged with a piece of wood **104** wrapped in cloth. Having cleared around this redundant pipe junction, the water supply was turned on and it could clearly be seen to be the source of the leak. The pipe was re-plugged with rolled Denso tape and a plastic tube. The pipe end was then capped with a plastic cover held in place by a stainless steel jubilee clip and the whole was covered with more Denso tape. Concrete blocks were then used to box in the pipe and the arrangement was left open temporarily to ensure that there was no recurrence of the initial problem. The standing water in the area started to subside almost immediately after the pipe junction was secured.

Plate 1: A view of pipe 103 with leaking plug 104 exposed, from the south-east.
