# Historic Building Recording of Grove Farm, Pulham Market

by Robert Smith with Heather Wallis

15 November 2010

Project name	Grove Farm
Client	Mr. Bim Mountain
NHER	ENF125347
Grid reference	TM 2149 8891
Date of fieldwork	15th and 25th October 2010

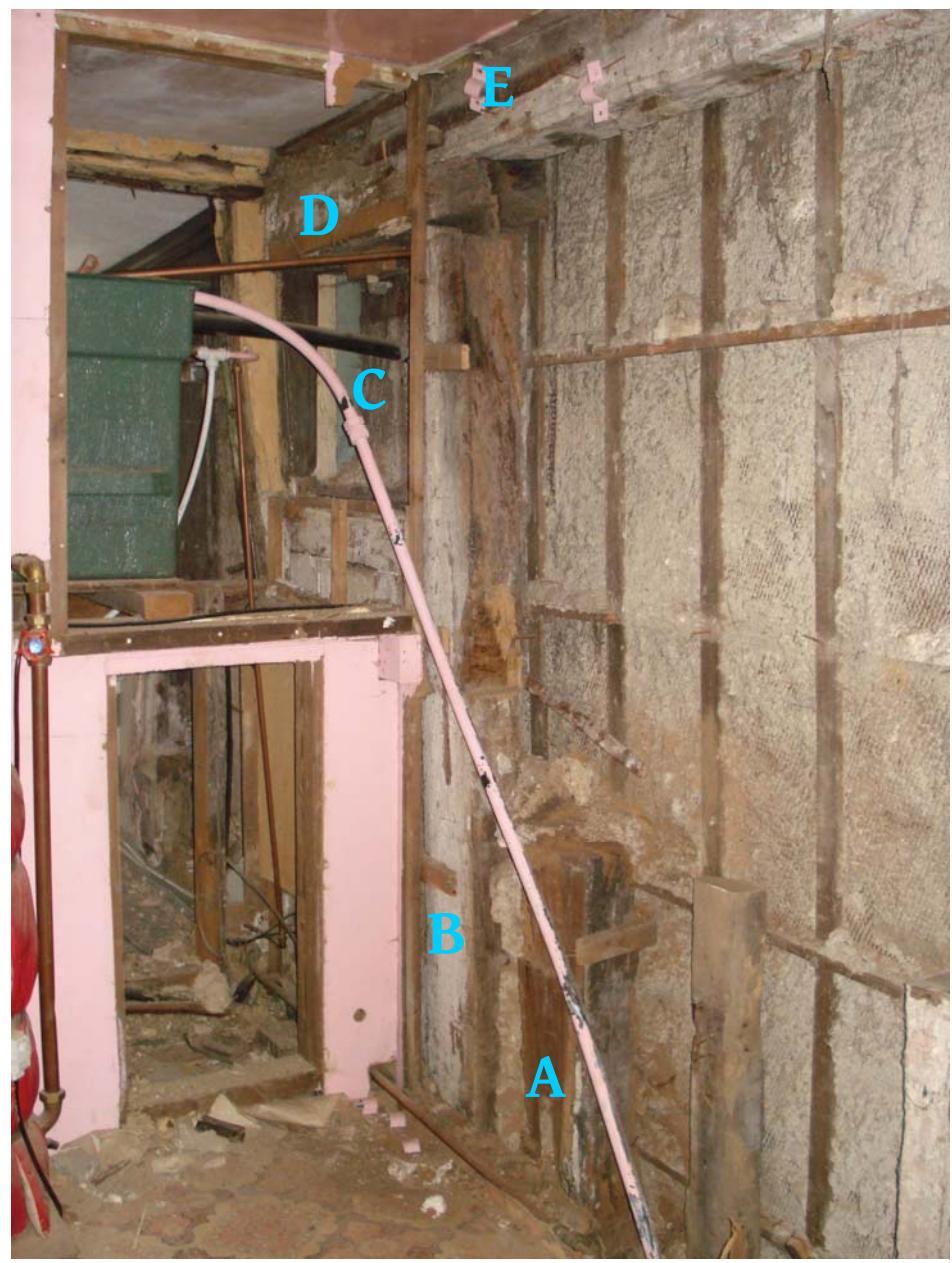
The earliest identified phase of building can be dated to the late 15th or early 16th century. Remains of this phase are scant but indicate the presence of an open hall. Evidence for this is in the form of a corner post (Plate 1 (A)), a principal wall post and the remains of the wall plate, all in the north wall. The corner post has the scant remains of what was a substantial iowl, it is some 3.70m in height and has two empty mortises presumably for decorative downturning braces between the post and the gable-end ground sill. Heywood's report has a photograph (2010, fig. 12) of the top of this post with an associated wall plate extending away to the right, the top edge of an arched brace between post and wall plate and signs of smoke blackening. The smoke blackening would suggest that this was the high end of the hall, unless of course the blackening is the result of an earlier fire. This latter suggestion is given some credibility by a post further to the east along the wall that is in the same alignment as the corner post and is contemporary with it. The top of this post has a mutilated joint that was initially related with the tie beam and the inside face of the post is completely fire-damaged (Plate 2). In what is now the north-east corner of the building there is a short stretch of the wall plate that was associated with these two posts and again the inside face of this is firedamaged (Plate 3).

Between the two posts associated with the 17-century phase there is a threelight window at ground and first floor level that had metal saddle bars and mullions with an ovolo-plus-fillet moulding although these have been removed (Plate 1 and Heywood 2010, fig. 11).

A Late fifteenth / early sixteenth-century corner post initially associated with an open hall
B Seventeenth-century corner post
C Position of seventeenth-century window
D Seventeenth-century wall plate
E Wall plate associated with the heightening of the open hall

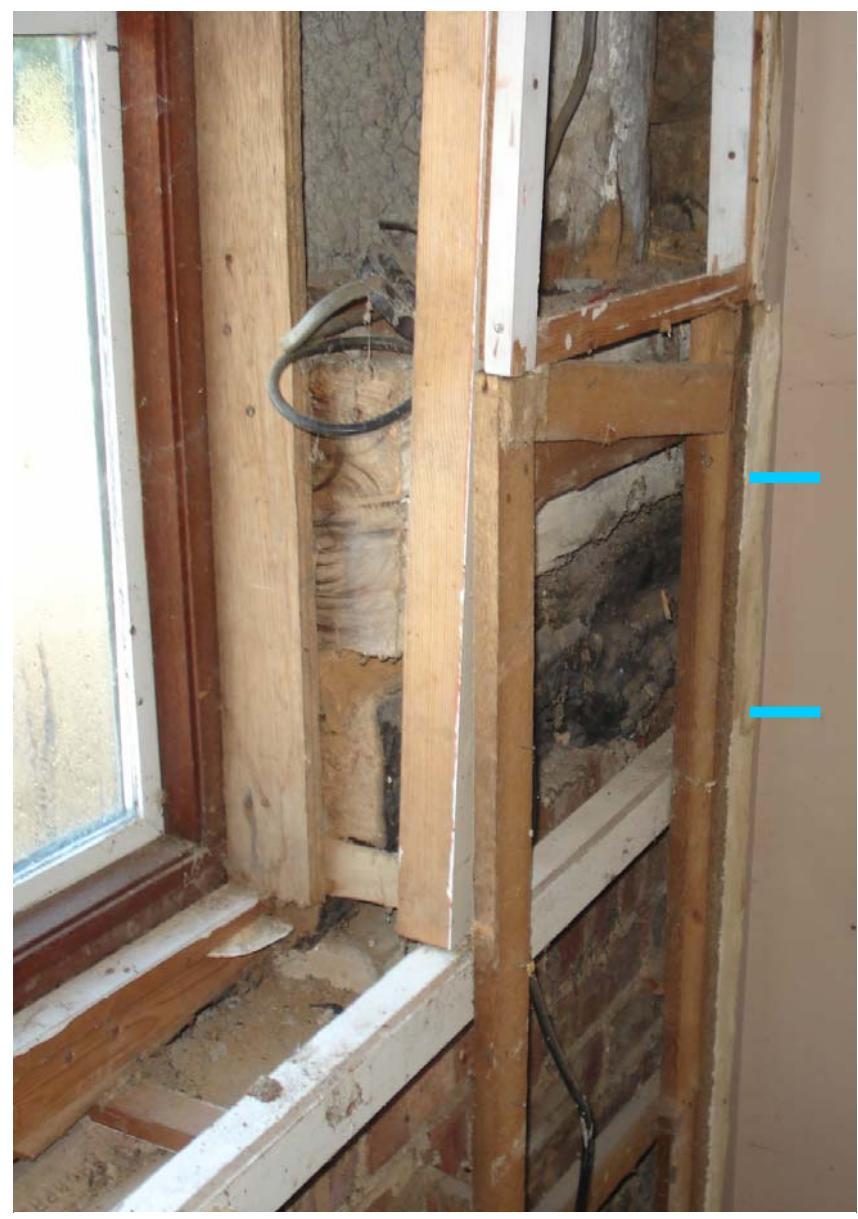
Late 15/early 16th century wall plate with charred inside face

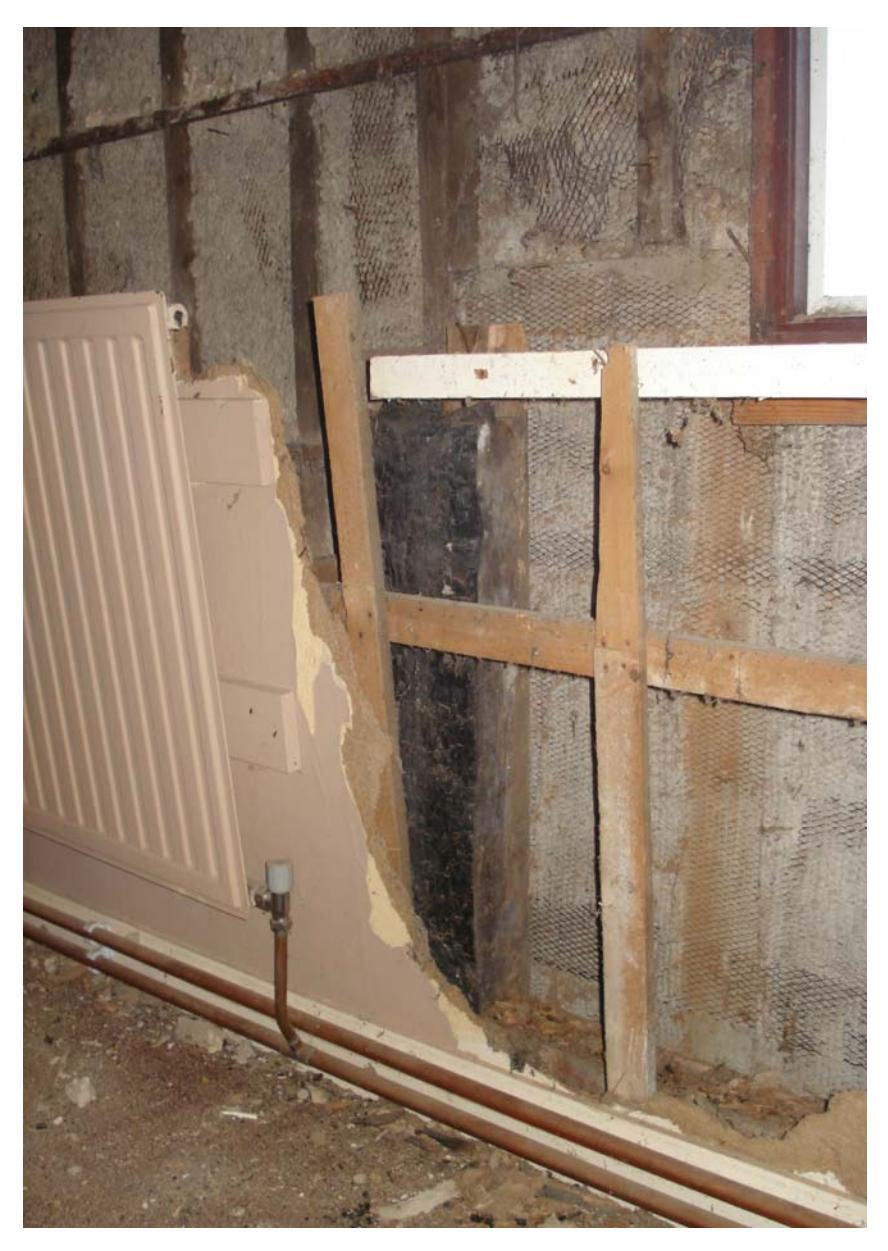
Late 15/early 16th century wall post with charred inside face

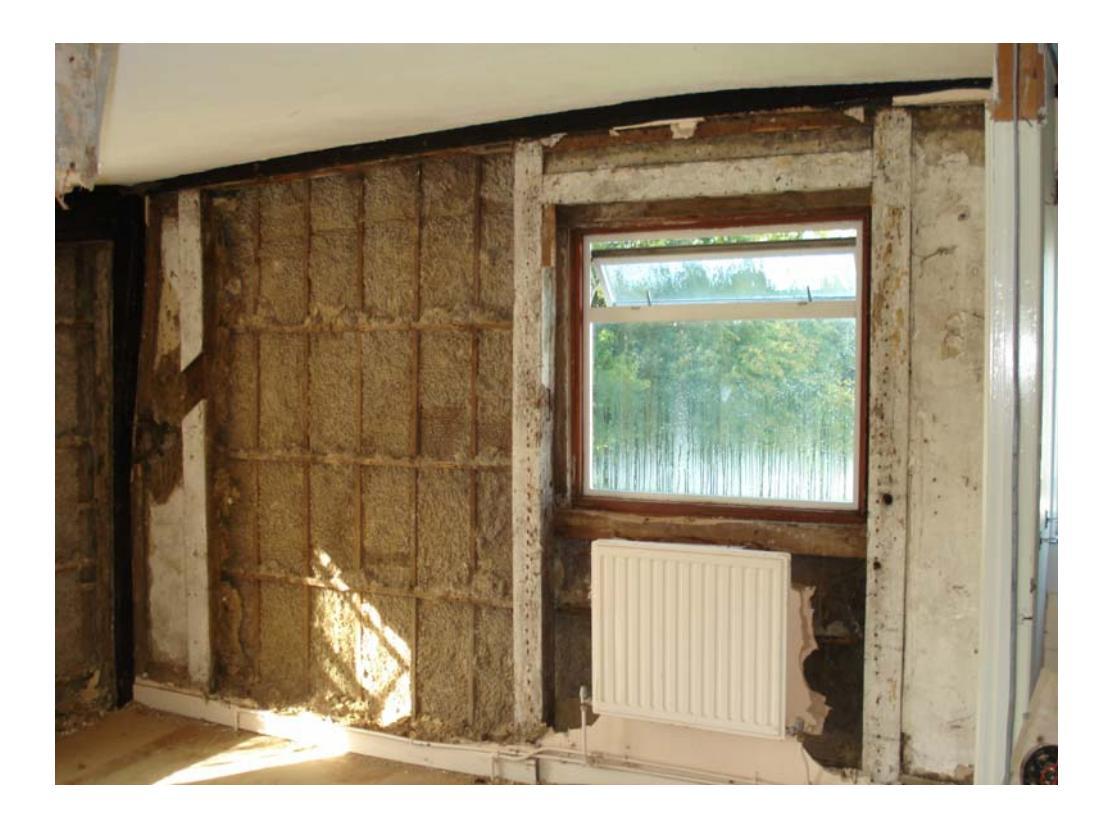
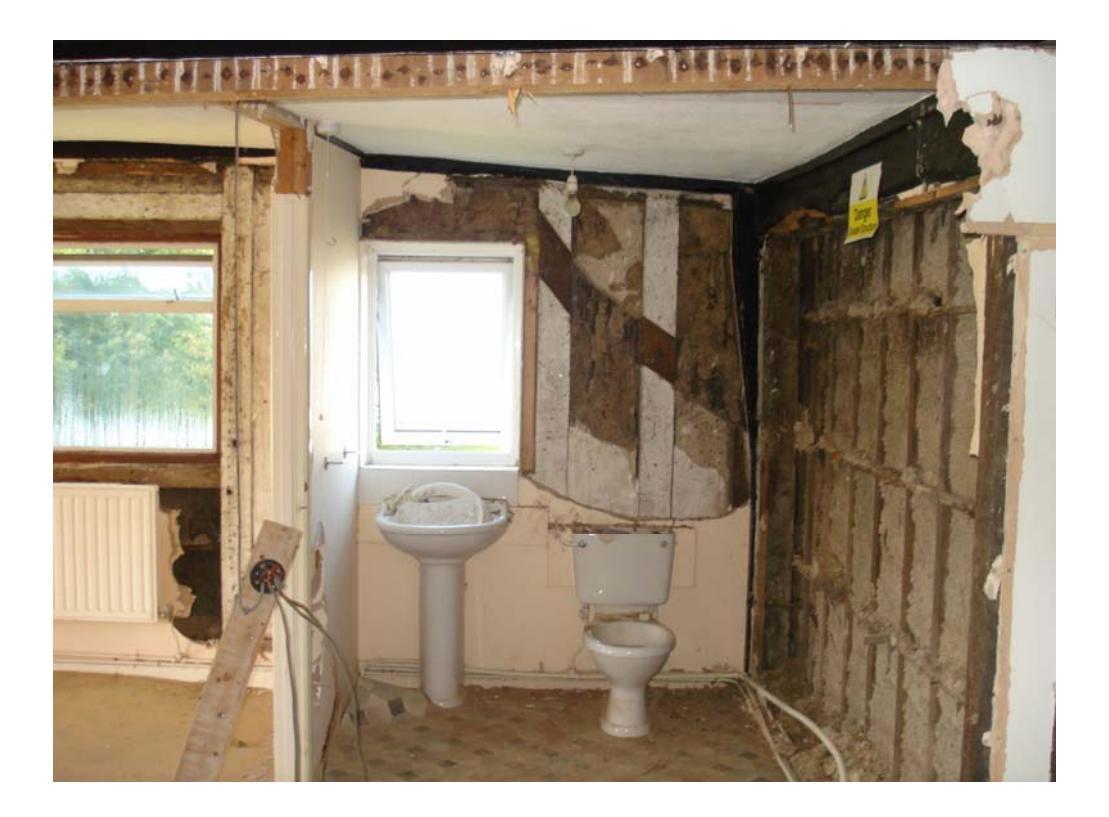
Plates 4 and 5

Despite the removal of quite a few of the wall studs (Plates 4 and 5) enough remain to reconstruct the pattern of fenestration which is of particular interest in the west gable wall (Figs 2 and 3). Here there was a central, four-light mullion window with its sill 0.8m up from floor level which was flanked on both sides by other four-light mullion window but with sill 1.5m above floor level. The lack of mortises for the mullions in the central window suggests that it was framed independently. There are no empty mortises for brackets and corbels to suggest an oriel window existed. The profile of the mullions is visible in the flanking windows and this is the same as seen in the two windows in the north wall, i.e. an ovolo-plus-fillet design.

Removed wall studs, central window and arched braces from corner posts to tie beam and wall plates at first floor level, west wall.

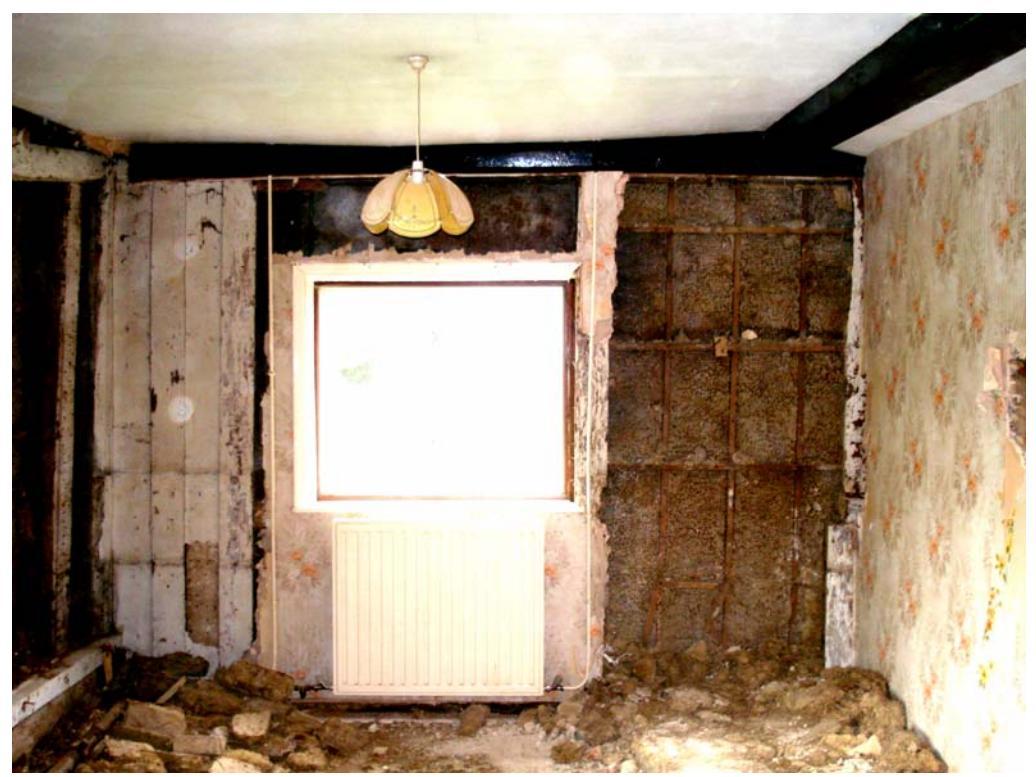
Two of the remaining posts to the left of the C20 window associated with the close studding at ground floor level

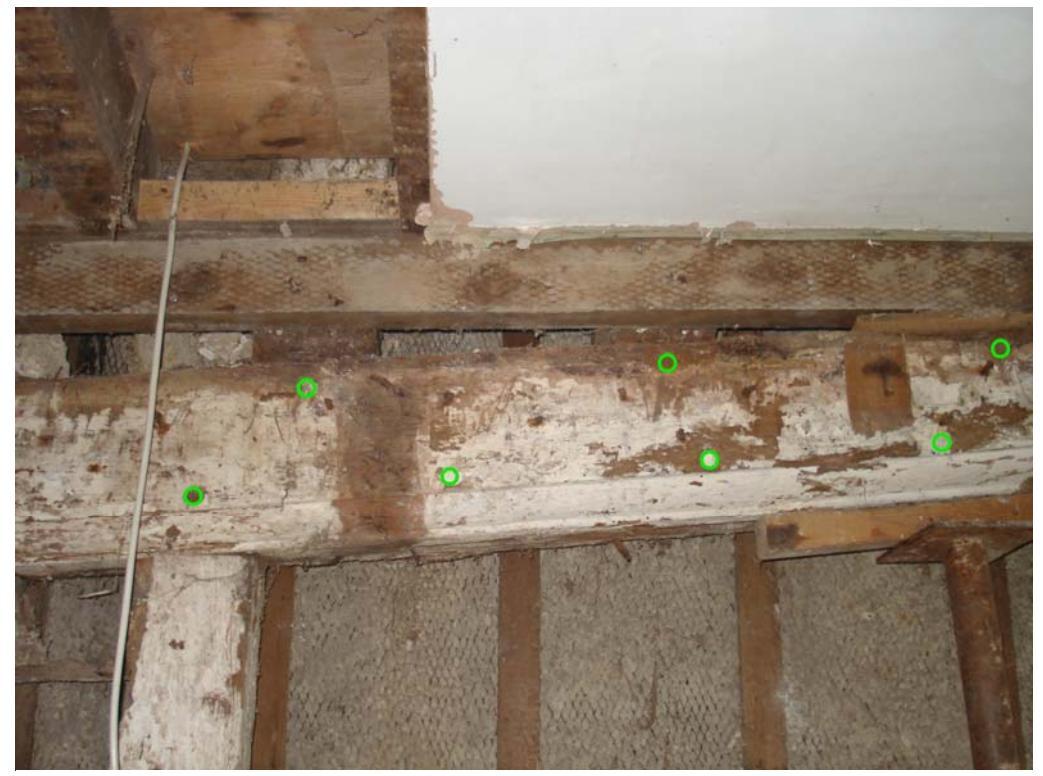
Position of the pegs associated with the wall studs above and below the mid rail

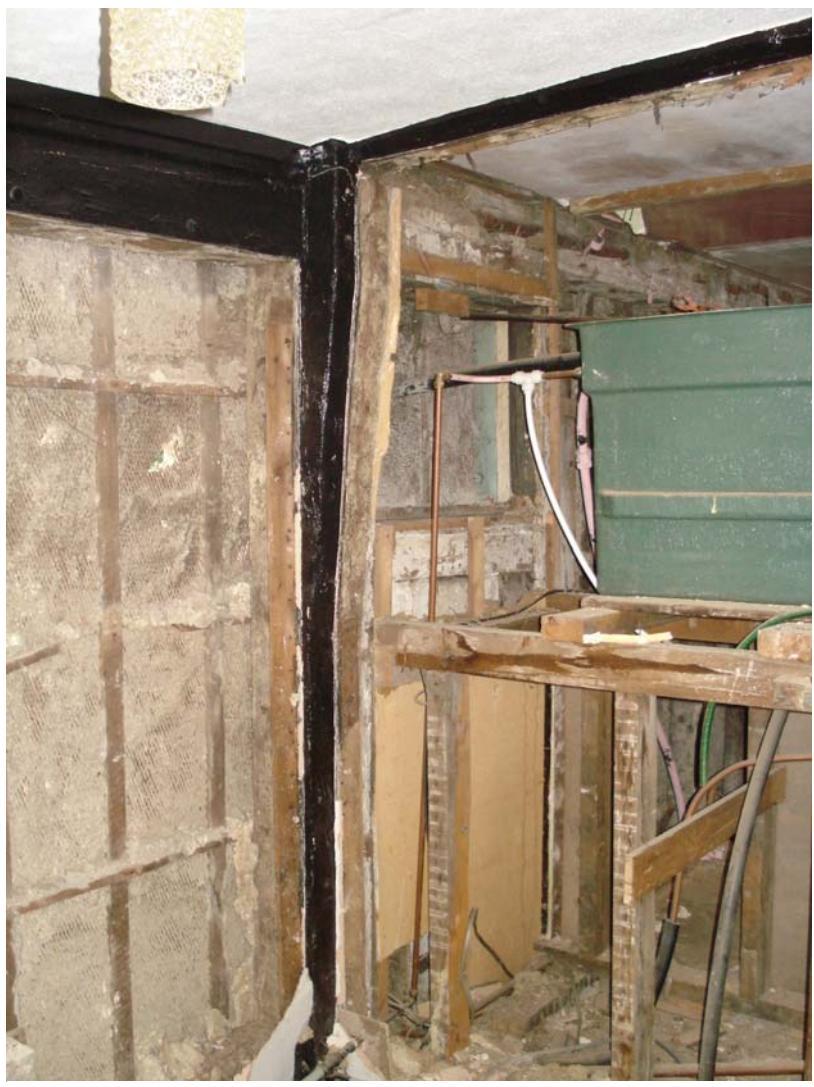
Seventeenth-century wall post with the removed arched brace at first floor level adjacent to the position of the contemporary window. The arched brace prevented access to the stack-side lobby.
