Former Union Workhouse
Hexham, Northumberland

Historic Building Recording

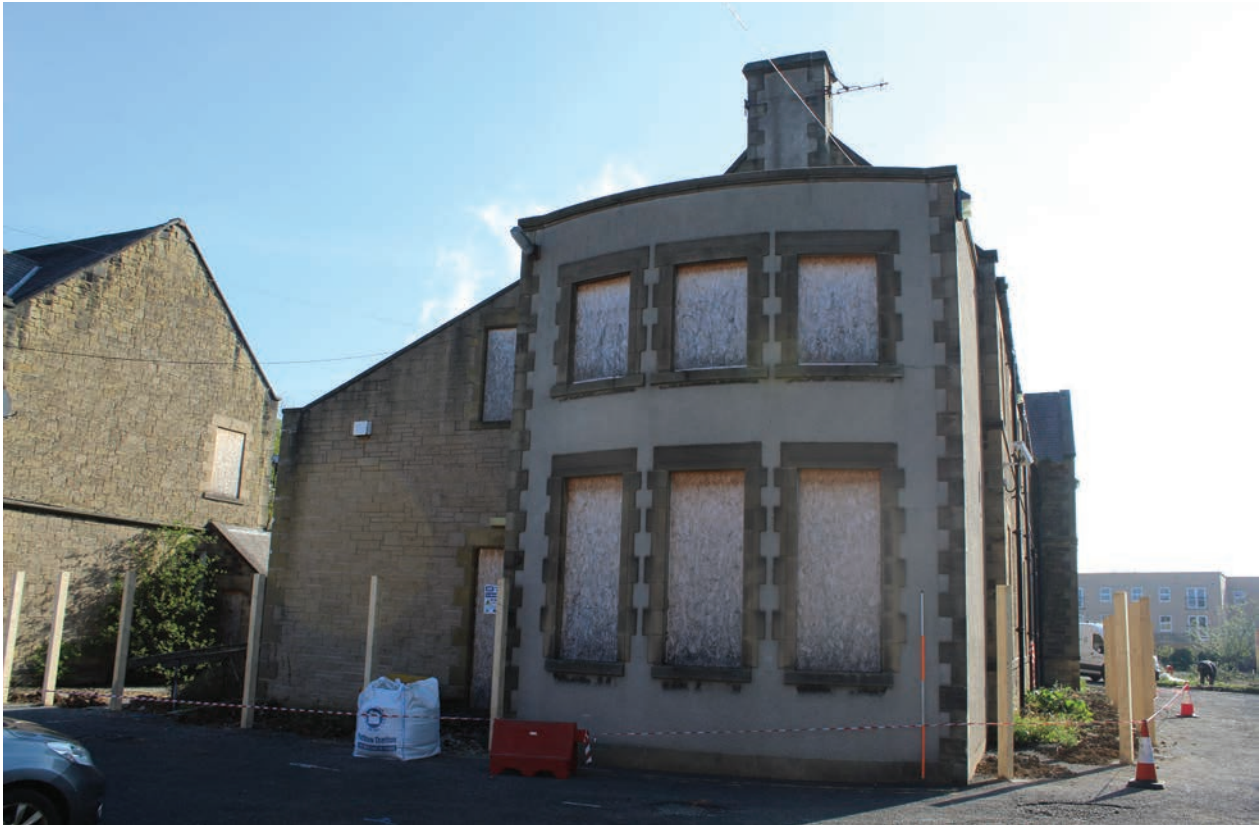
Figure 9 Western elevation of Building A, facing north-east. Scale 1x2 m

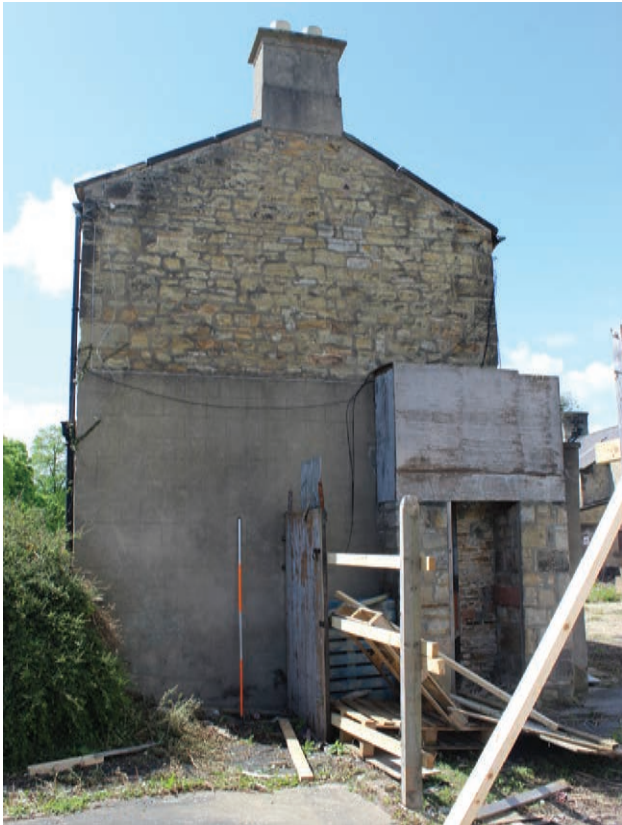
Figure 19 East elevation of Building A, facing west. Scale 1x2 m

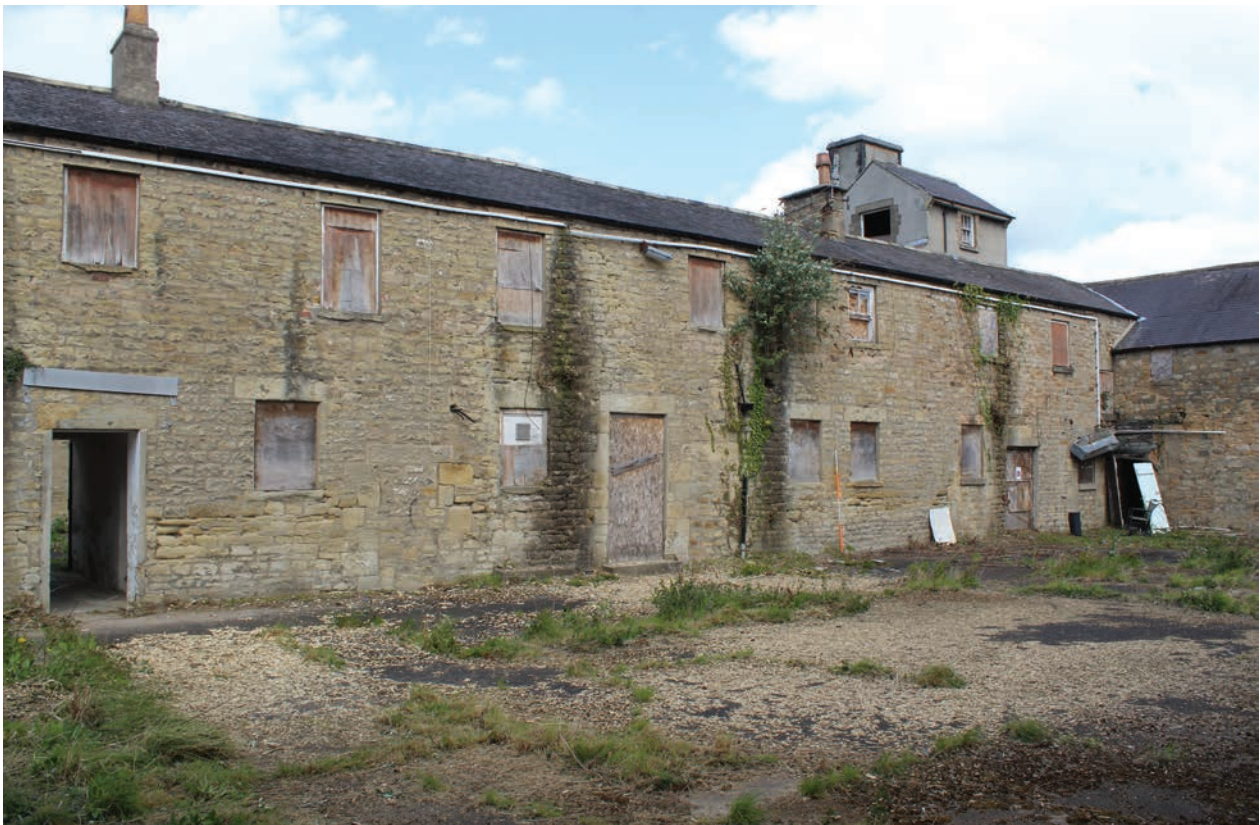
Figure 86 Eastern end of the south elevation of Building B, facing north-east. Scale 1x2 m

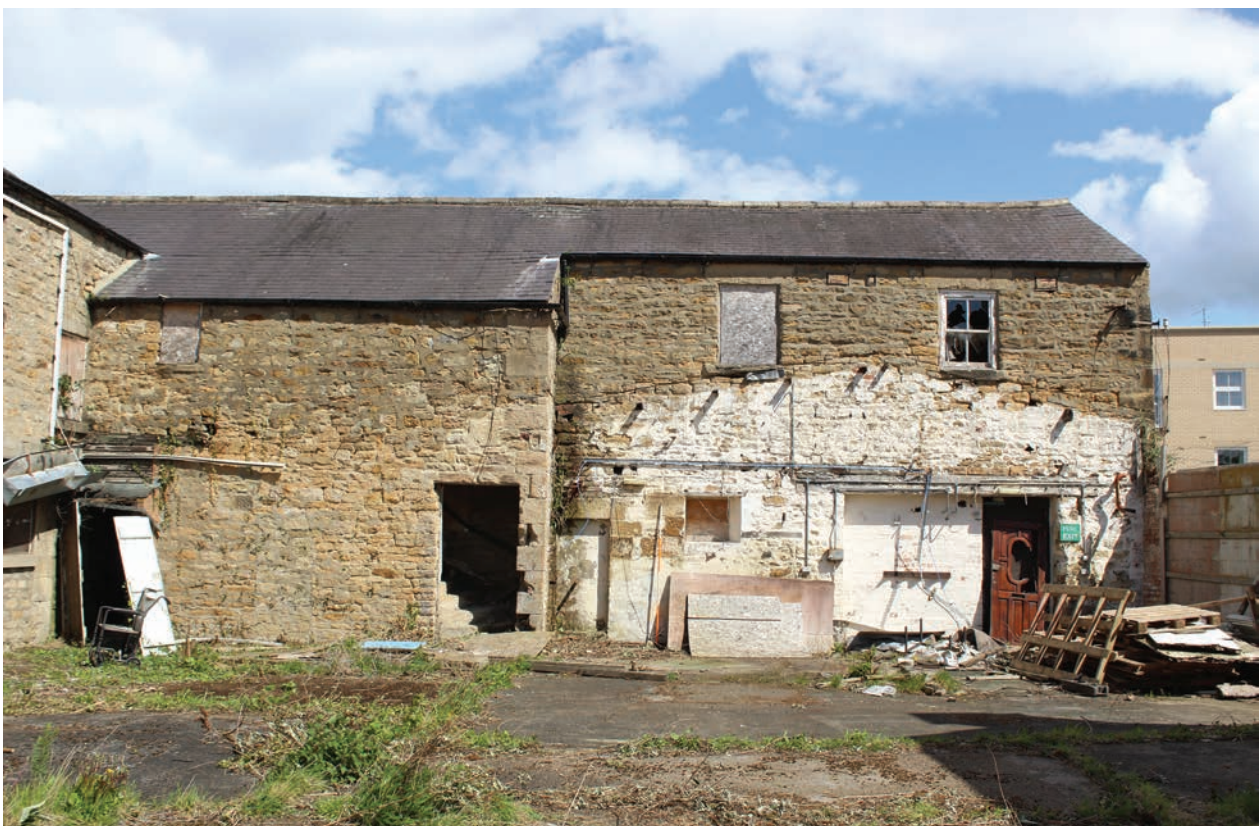
Figure 89 The western elevation of the southern section of the north/south aligned wing at the east end of Building B, facing east. Scale 1x2 m

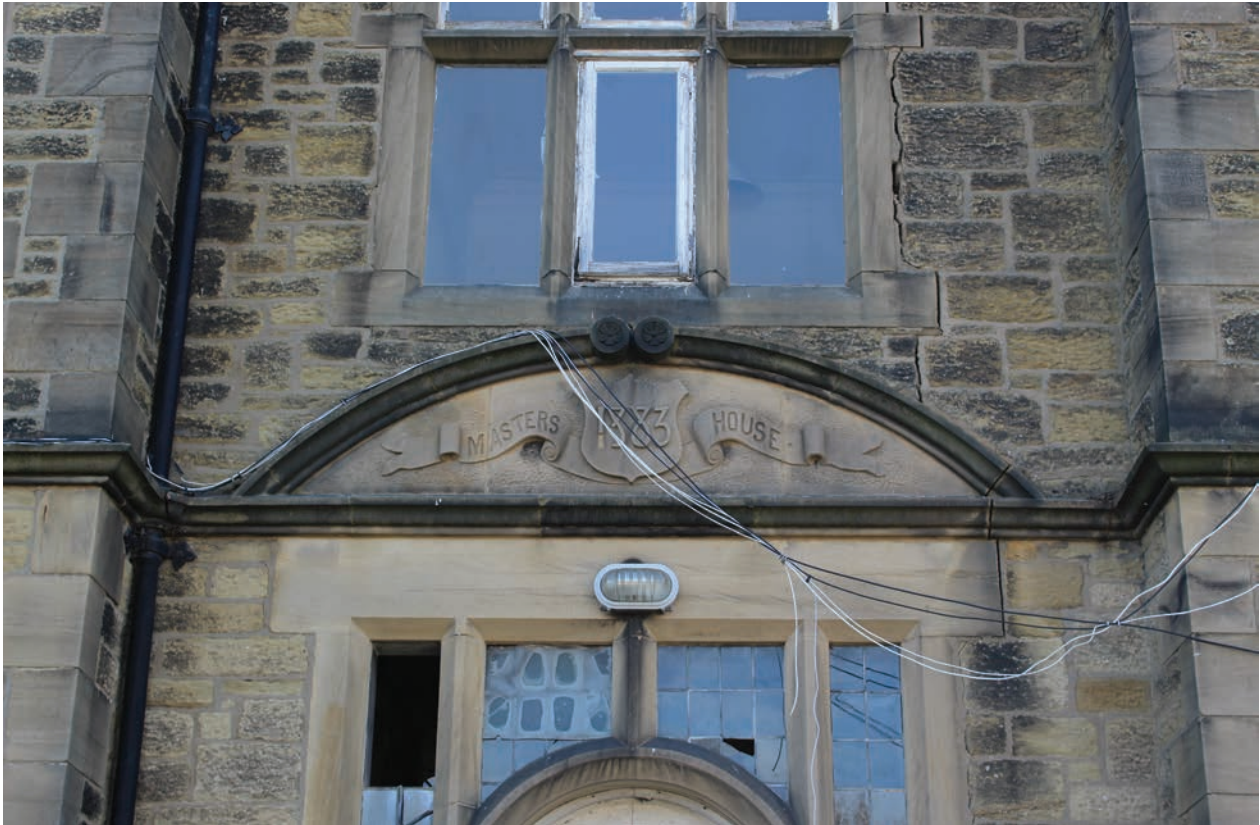
Figure 99 Detail of the shield and ribbon decoration above the entrance in the west elevation of the Master's House in Building B, facing east. No scale

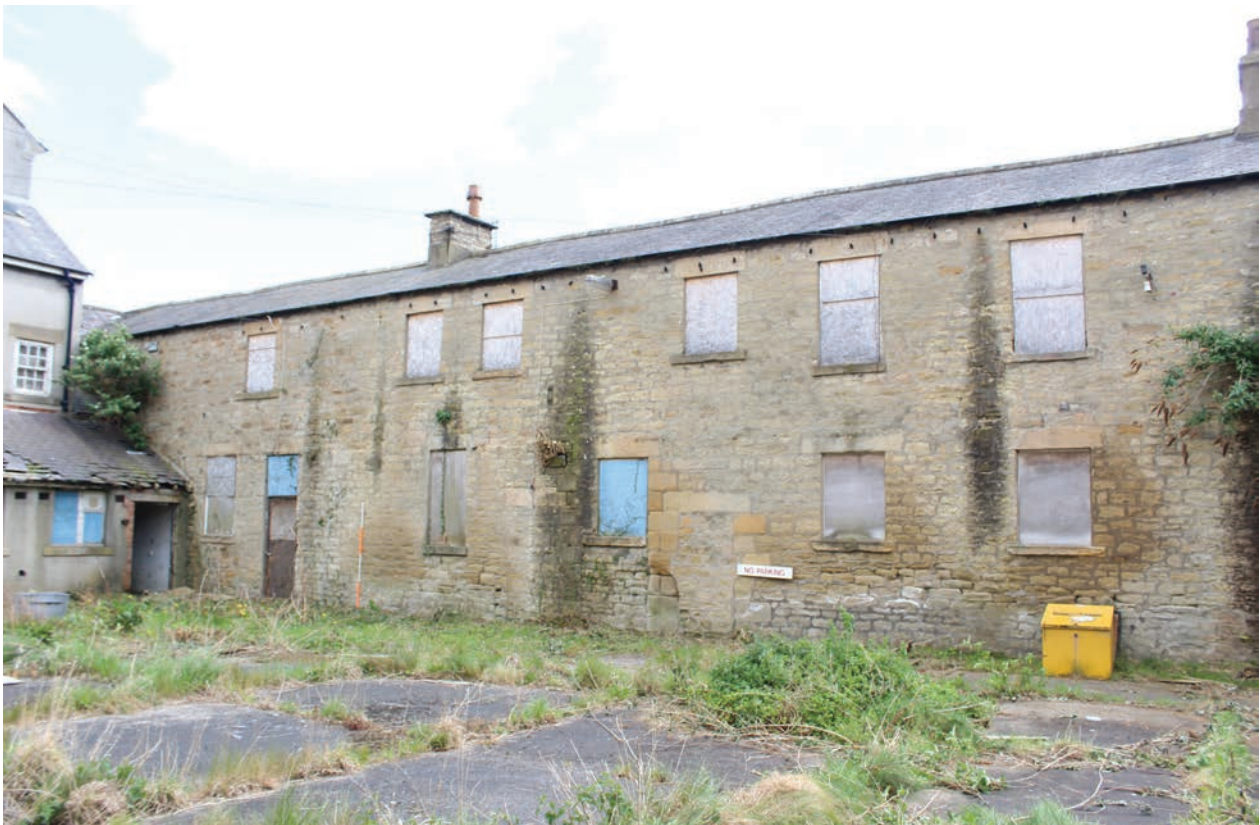
Figure 101 Eastern end of the north elevation of Building B, facing south-east. Scale 1x2 m

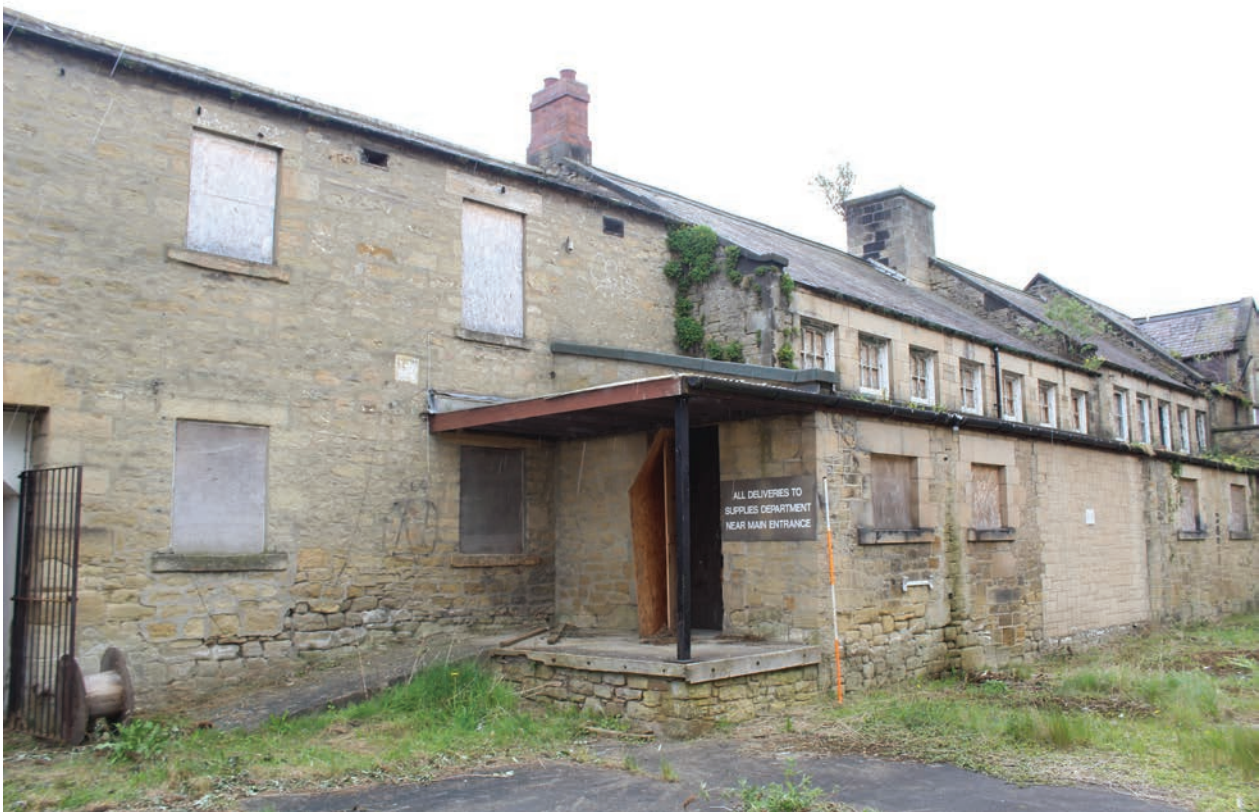
Figure 103 Detail of eastern end of north elevation of Building B, facing south-west. Scale 1x2 m

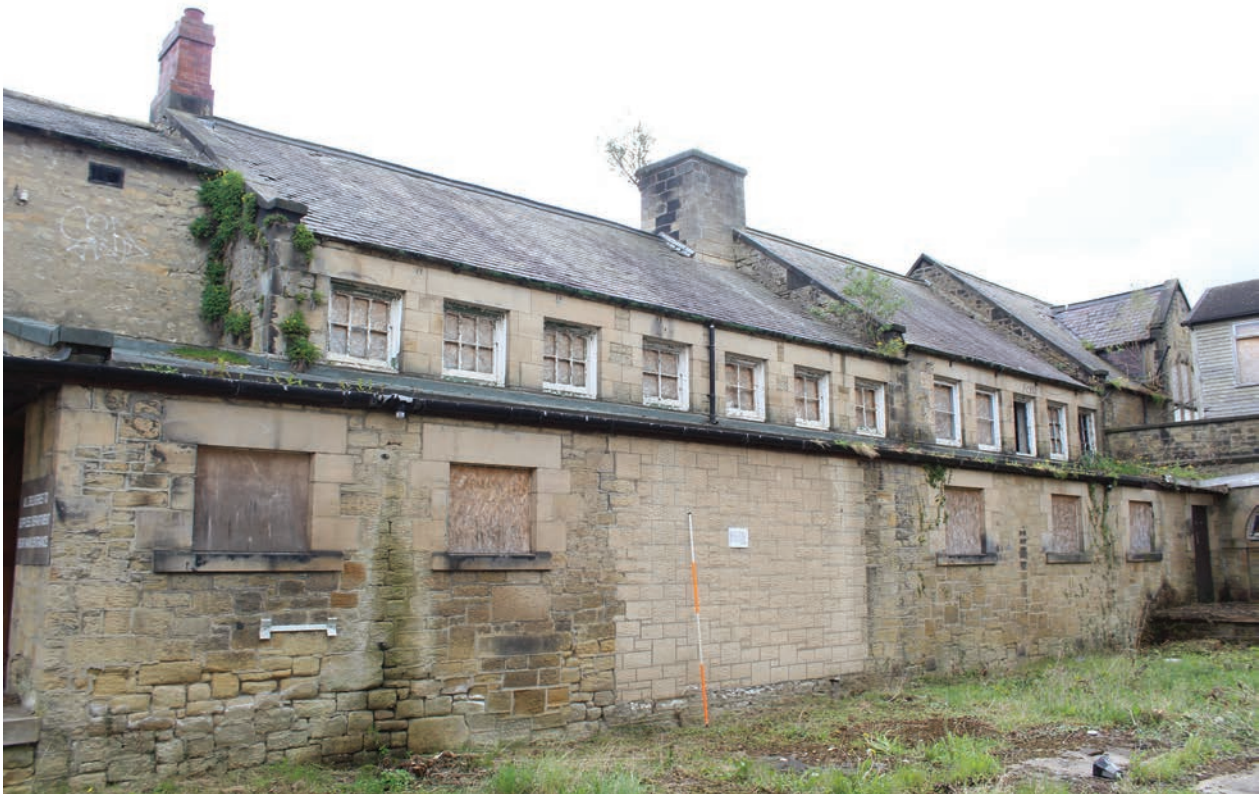
Figure 106 Detail of ranges with clerestory glazing in the 1883 portion of the north elevation of Building B, facing south-east. Scale 1x2 m

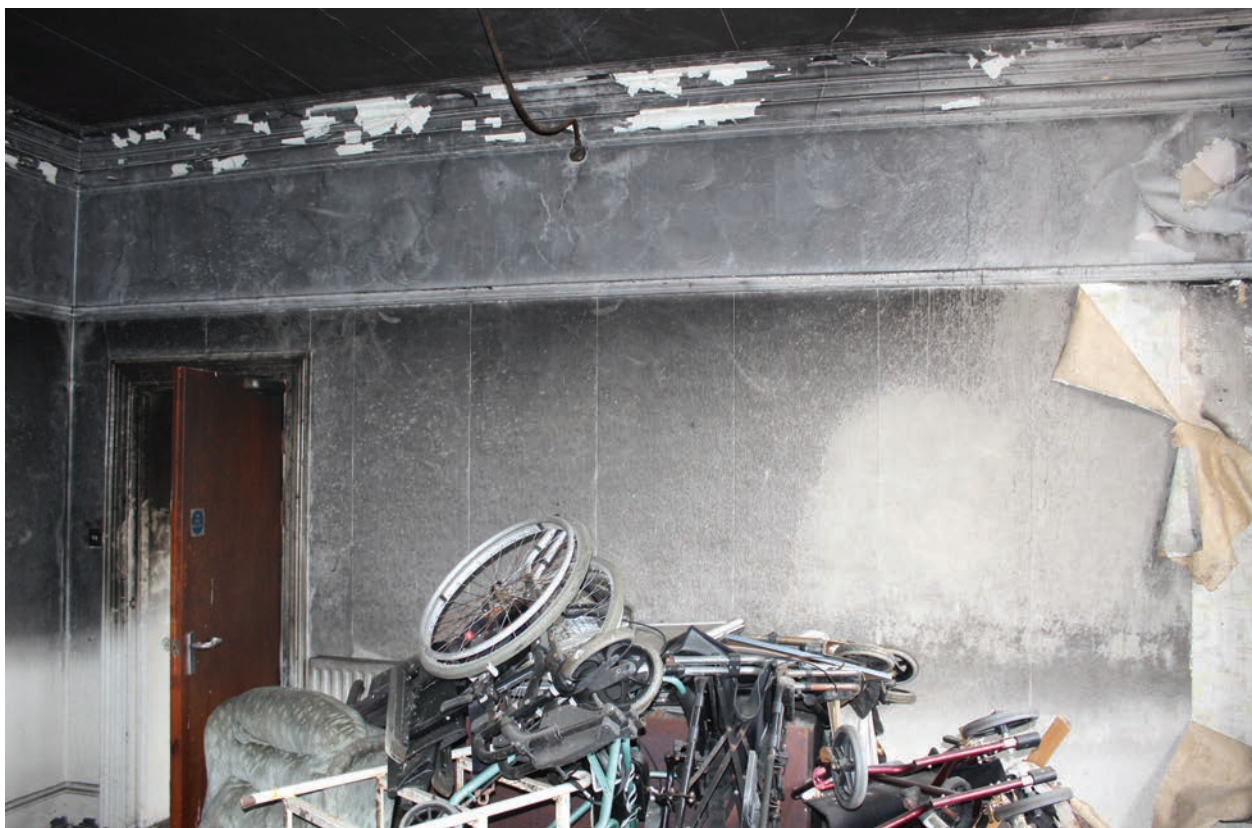
Figure 113 South wall of Room G1, facing south-east. No scale

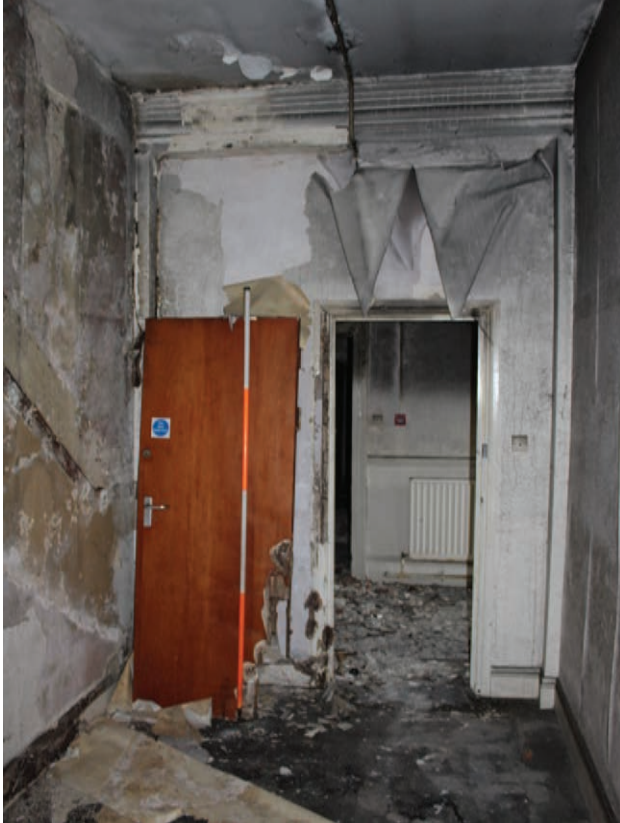
Figure 116 Room G2, looking south. Scale 1x2 m

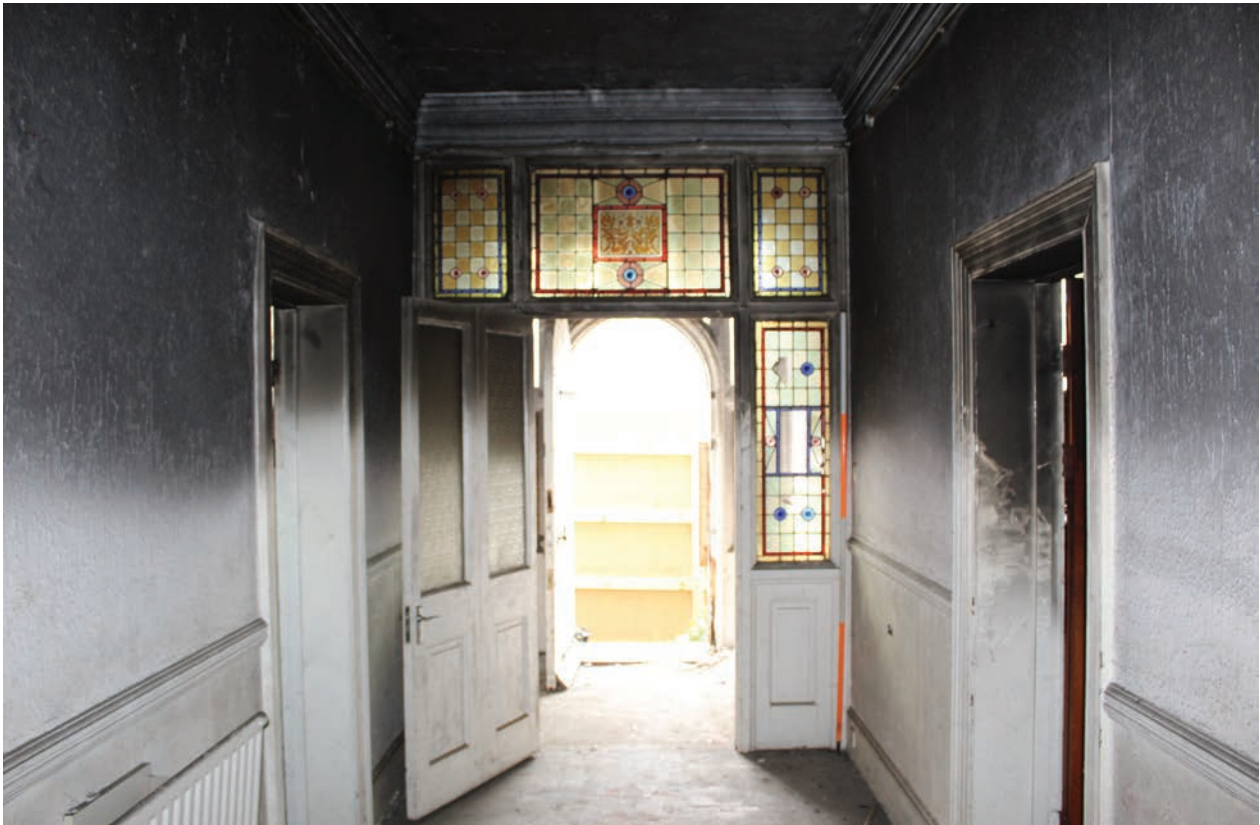
Figure 119 Room G3, facing west. Scale 1x2 m

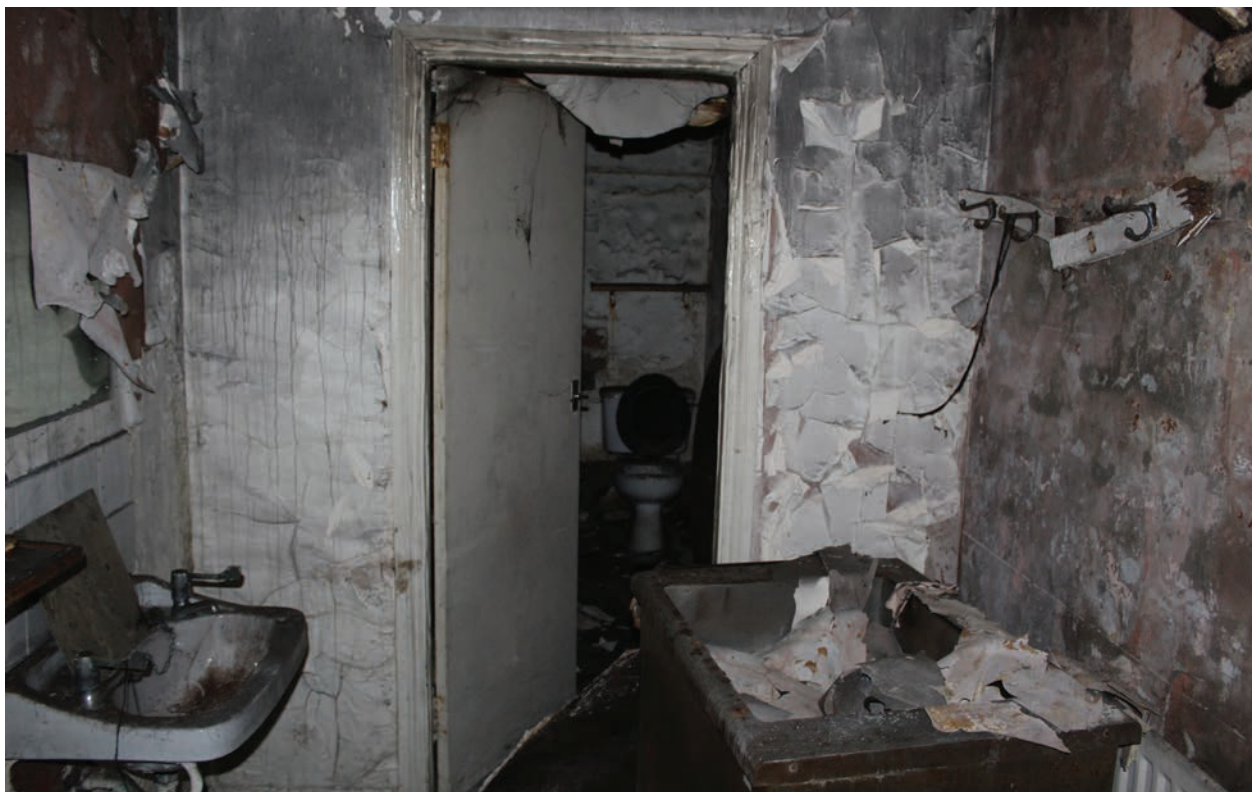
Figure 120 Room G5, facing south. No scale

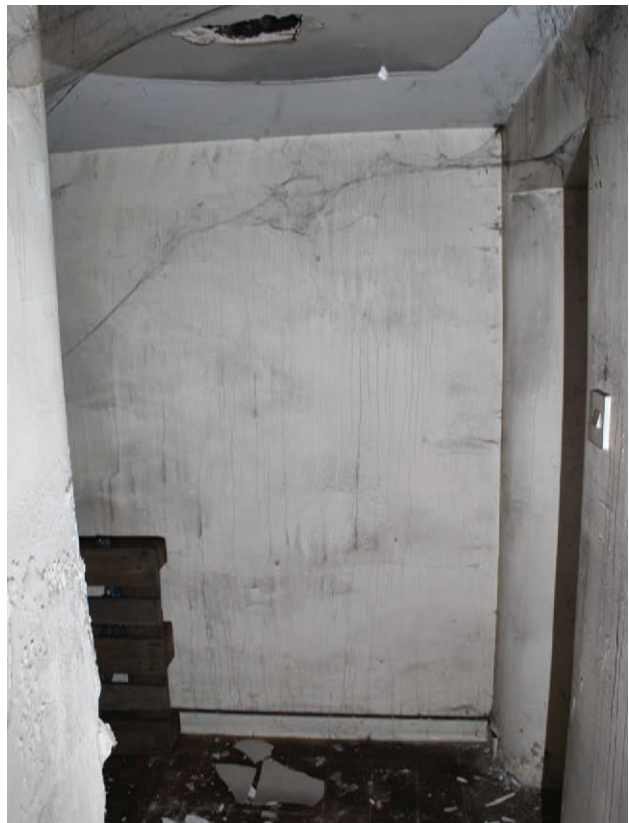
Figure 122 Room G8, looking south. No scale

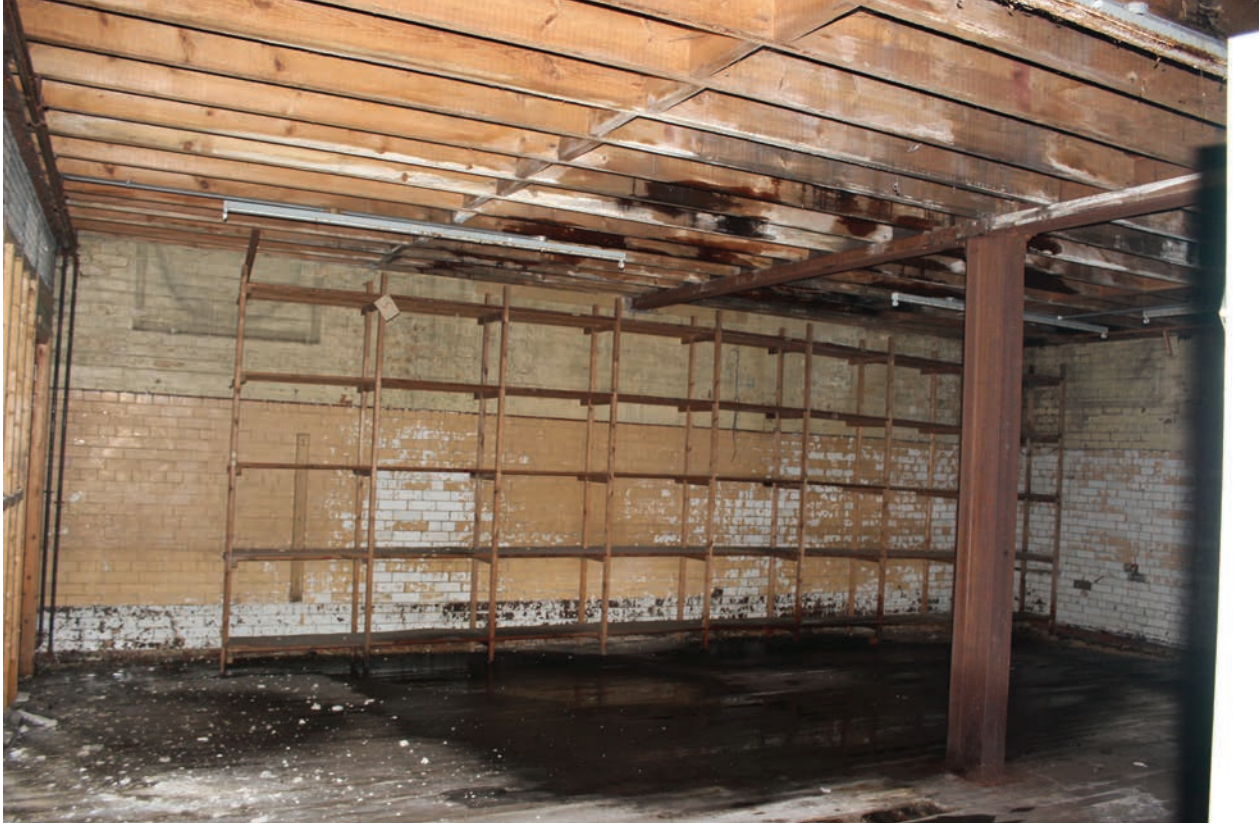
Figure 126 Room G10, looking south-west. No scale

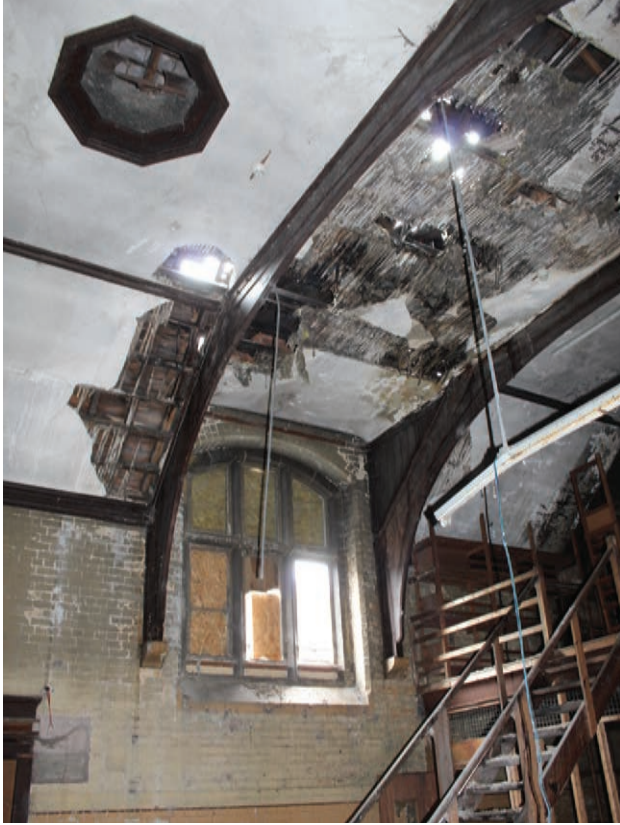
Figure 128 Detail of southern window in Room G11, facing south. No scale

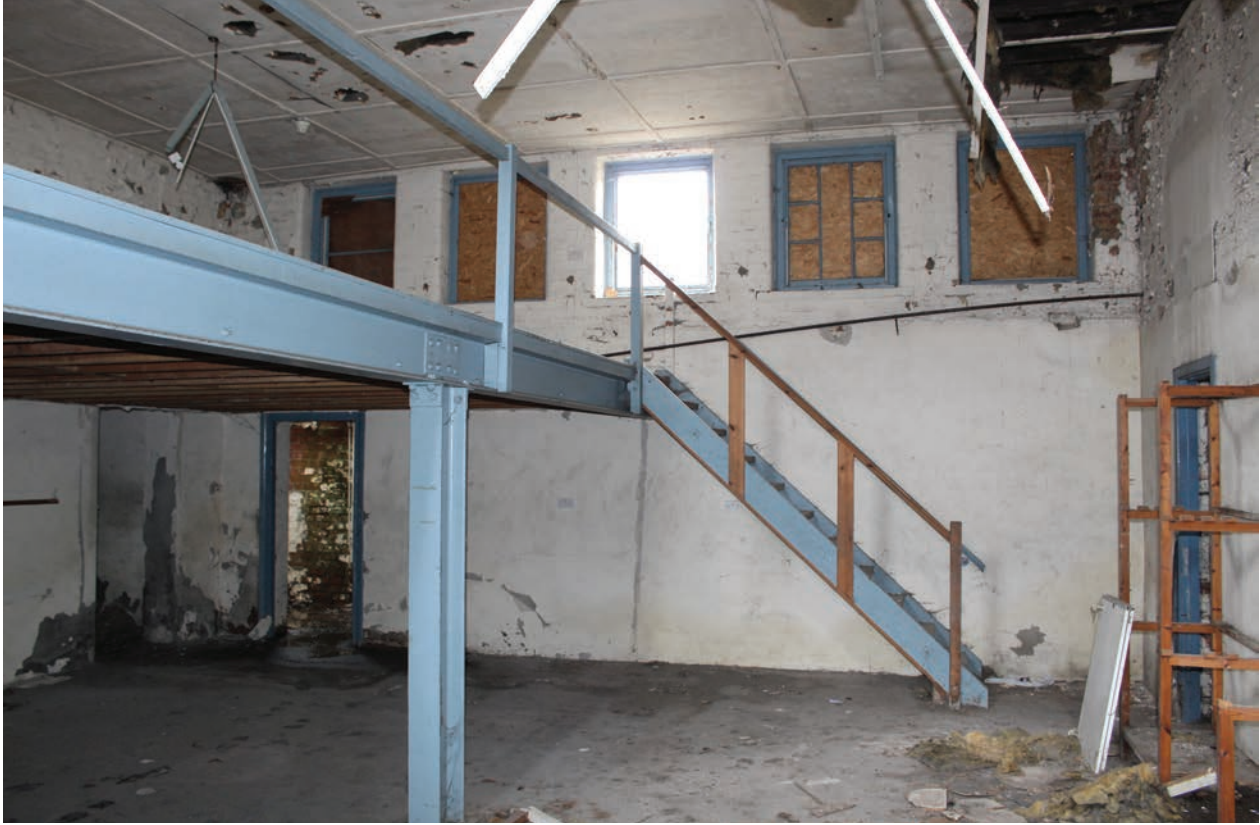
Figure 138 Room G16, looking south-east. No scale

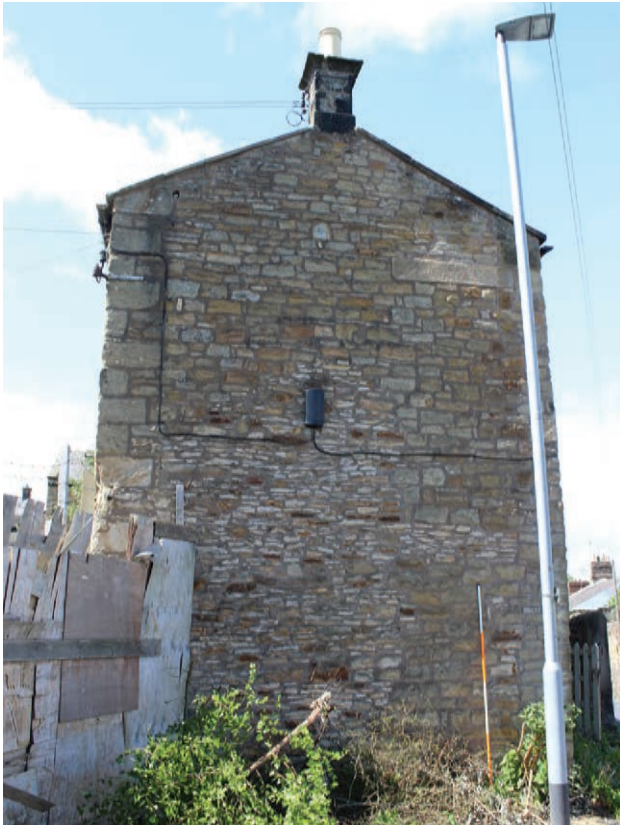
Figure 207 Detail of the north elevation of the projecting bay of the 1883 extension to the north elevation of Building C, facing south-west. Scale 1x2 m

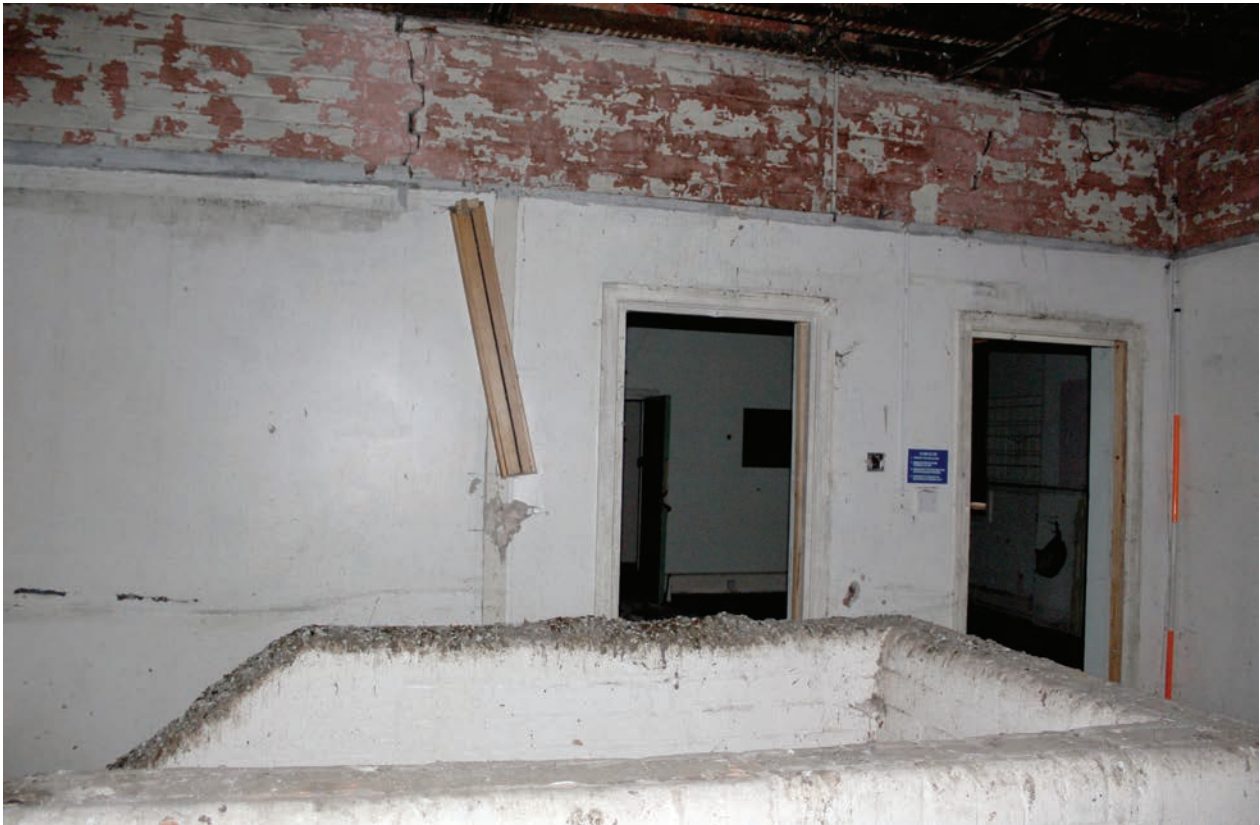
Figure 249 Room F12, facing north-west. Scale 1x2 m

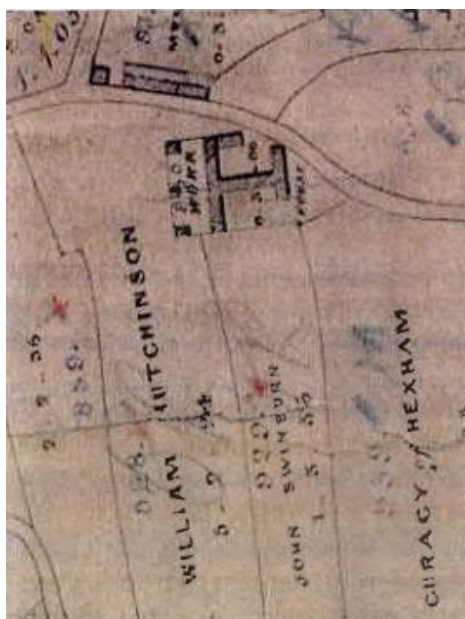
Figure 2. Extract from the Hexham Tithe Map of 1844 - the earliest depiction of the workhouse, most likely surveyed one or two years prior to 1844.

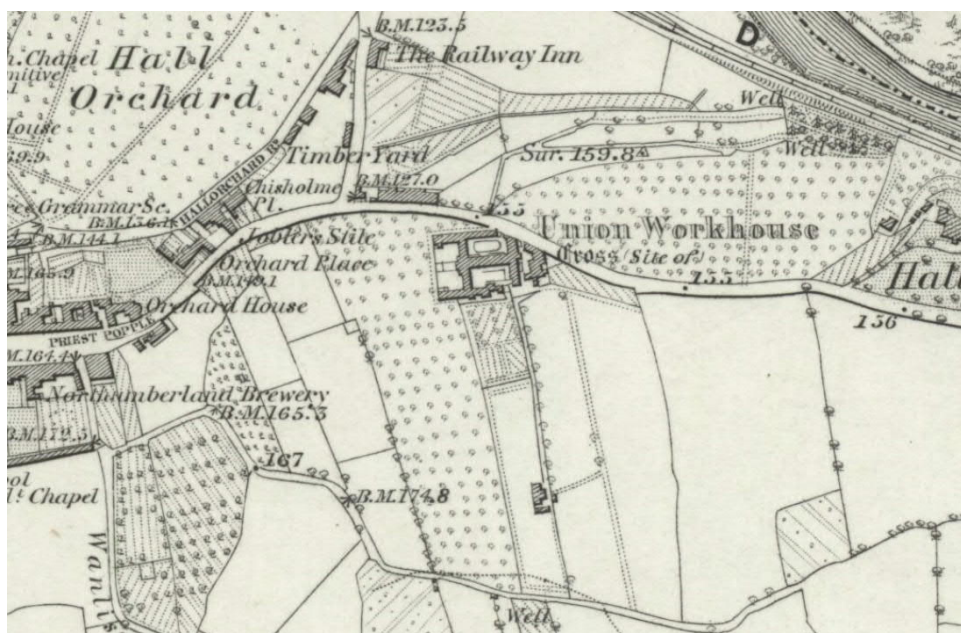
Figure 4. The first edition OS map of 1860, showing some extensions at the workhouse and details of its wider setting.

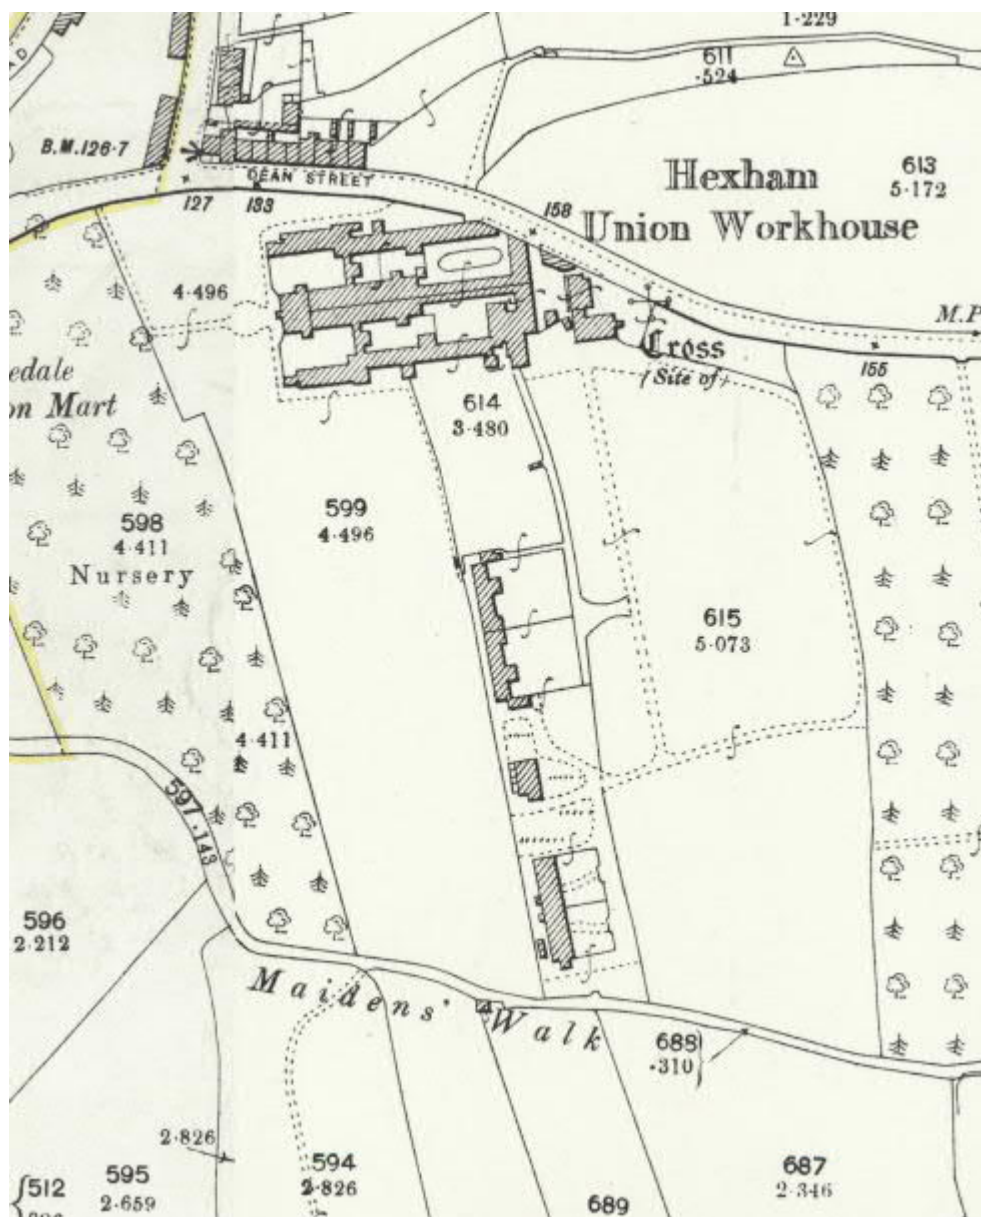
Figure 6. Second edition OS map of 1897 showing the newly-extended workhouse.

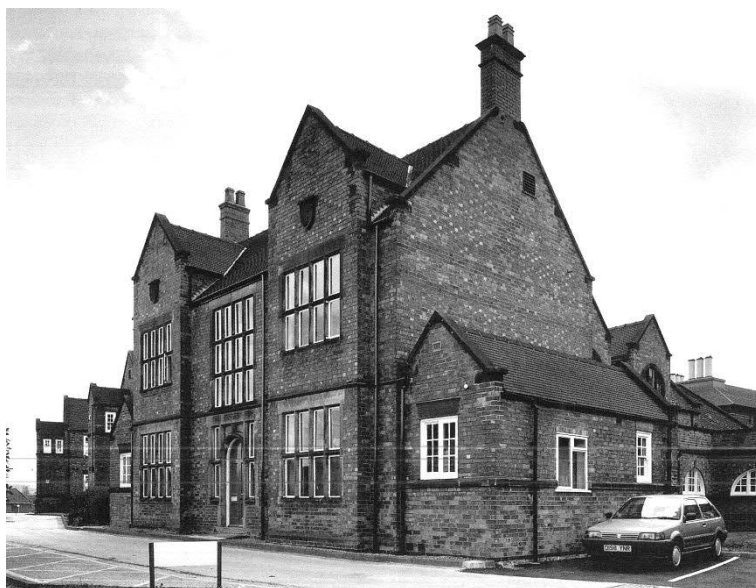
Figure 7. The central administration block of Morton's school at Burton-on-Trent workhouse, built 1880-1884 (Morrison 1999, 137) (compare to the master's house Figure 16).

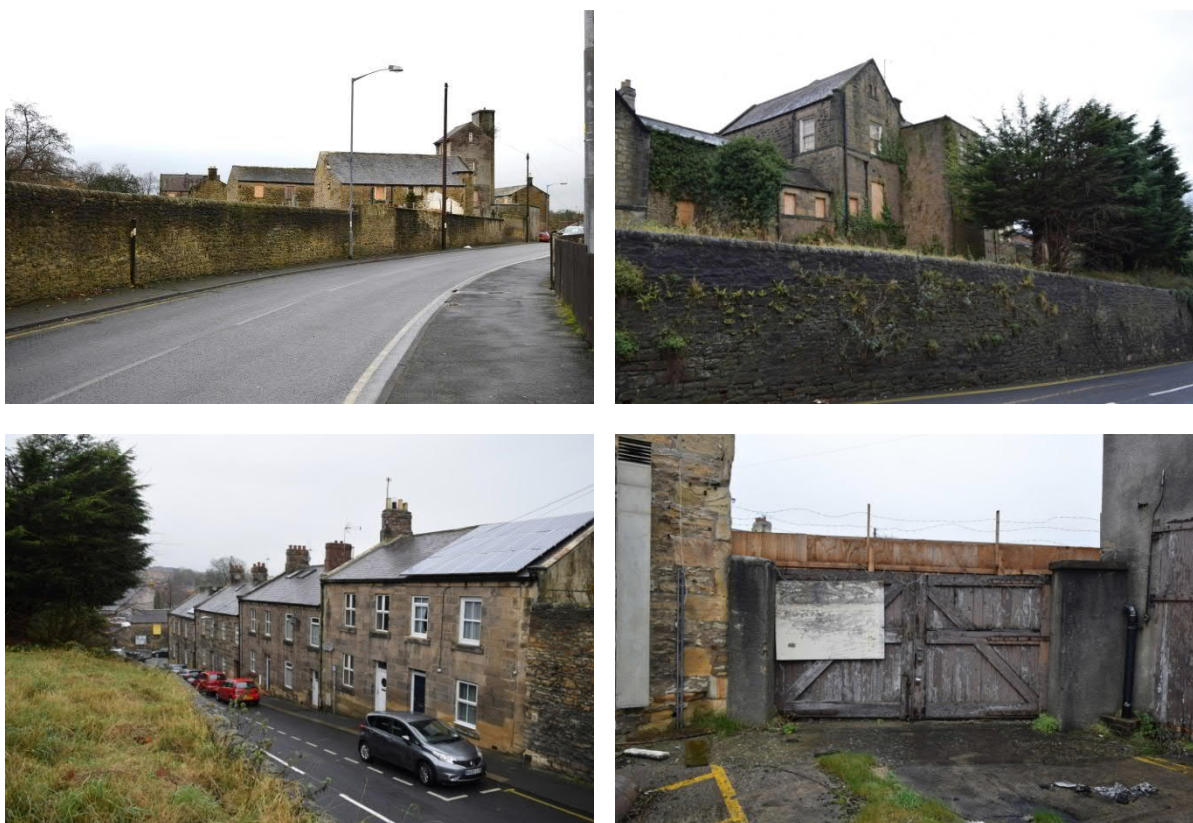
Figure 26. Selection of images from Dean Road showing (left to right): the key of the workhouse achieved from the east end of the road; the looming presence of the workhouse from street level; the 1836 cottages opposite the workhouse; and the workhouse entrance gates into the men’s yard.

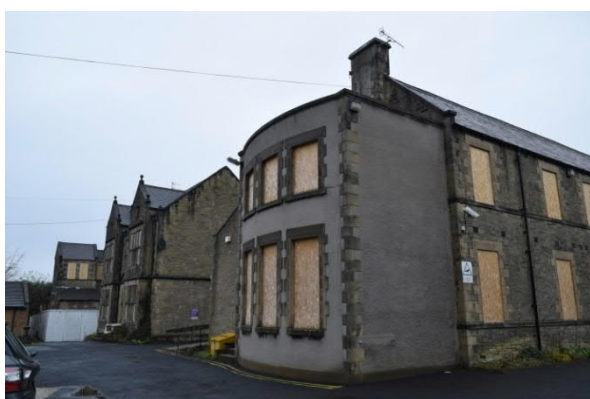
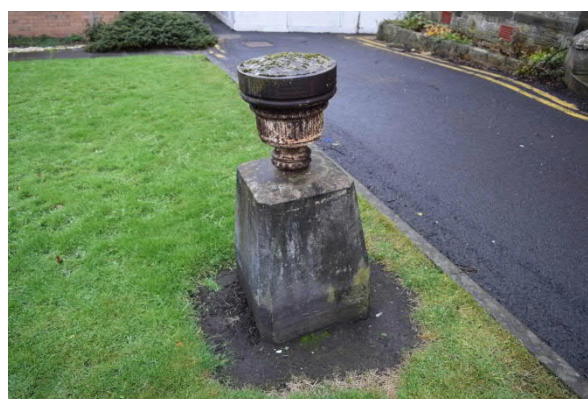
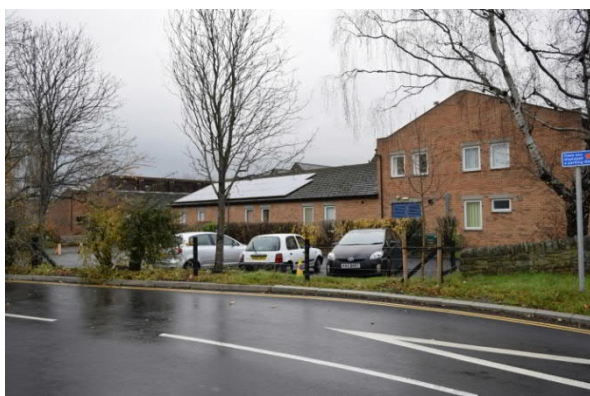
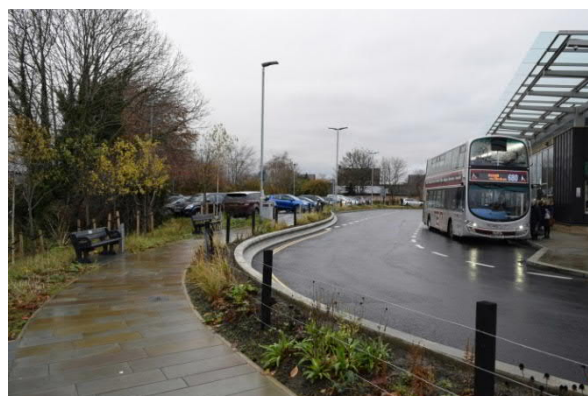
Figure 28. Selection of views representing views from the west side of the workhouse (left to right); a view north-east across the western façade of the workhouse from Corbridge Road; view of the possible section of a cast iron fountain; view of the modern buildings to the west side of the workhouse from Corbridge Road; and a view of the modern appearance of the new bus station adjacent to the workhouse.

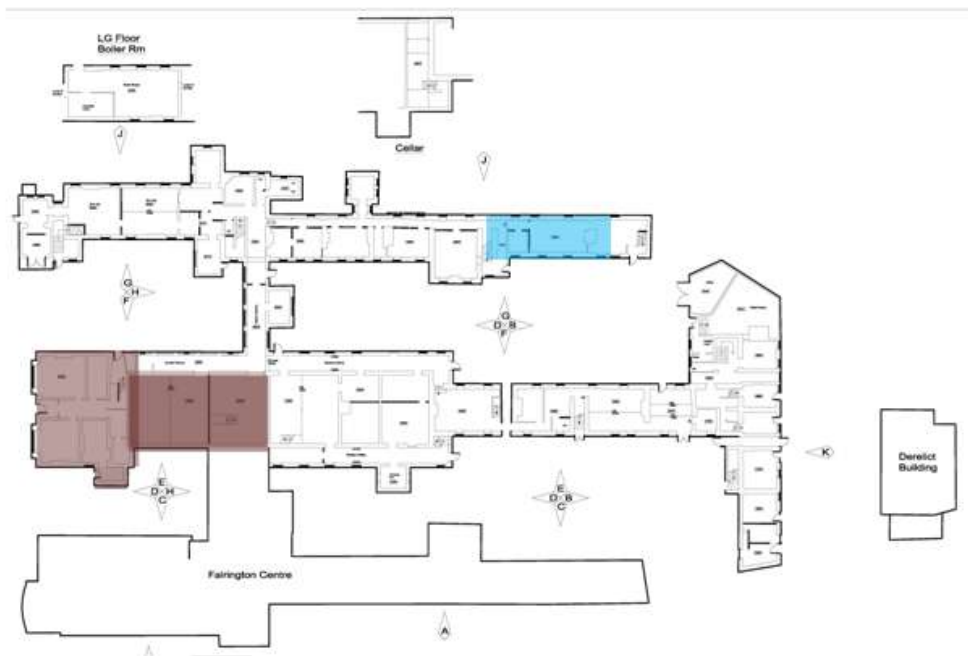
Figure 2. Zones where the interiors of rooms are more sensitive to change. The red areas are ground and first floors (Master's House and Dining Hall), but the blue area is only the first floor (room 29)

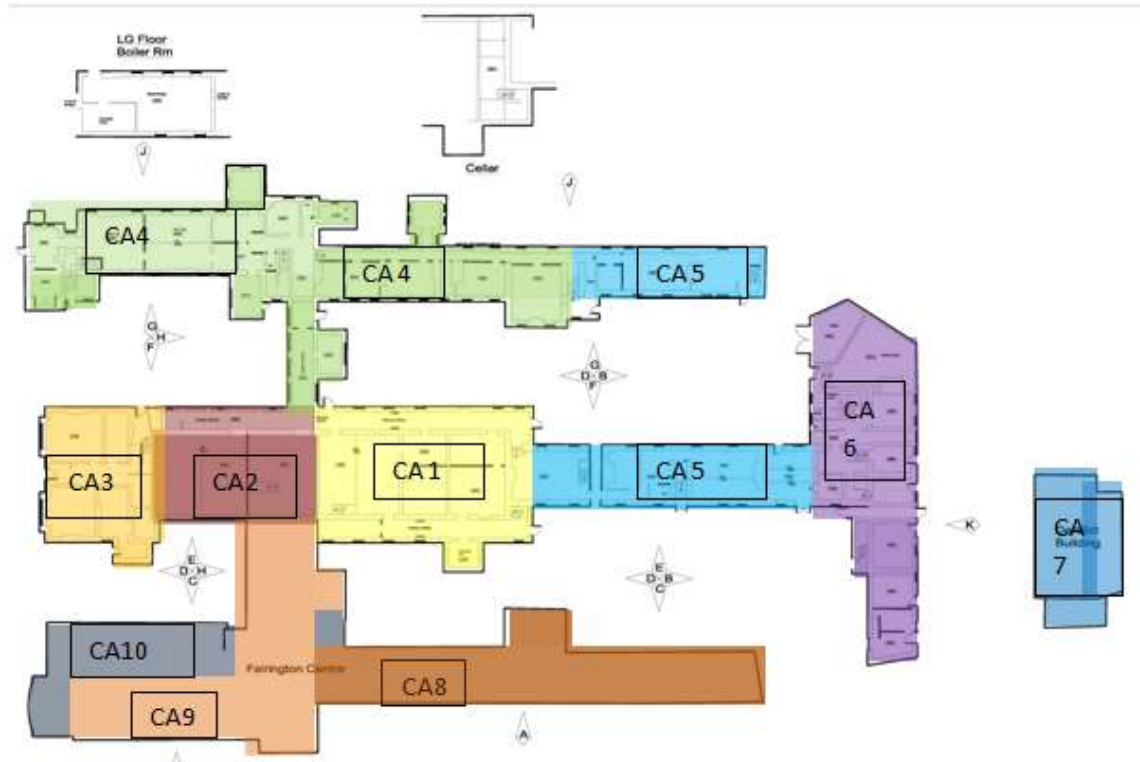
Figure 29. Character areas referred to in the text

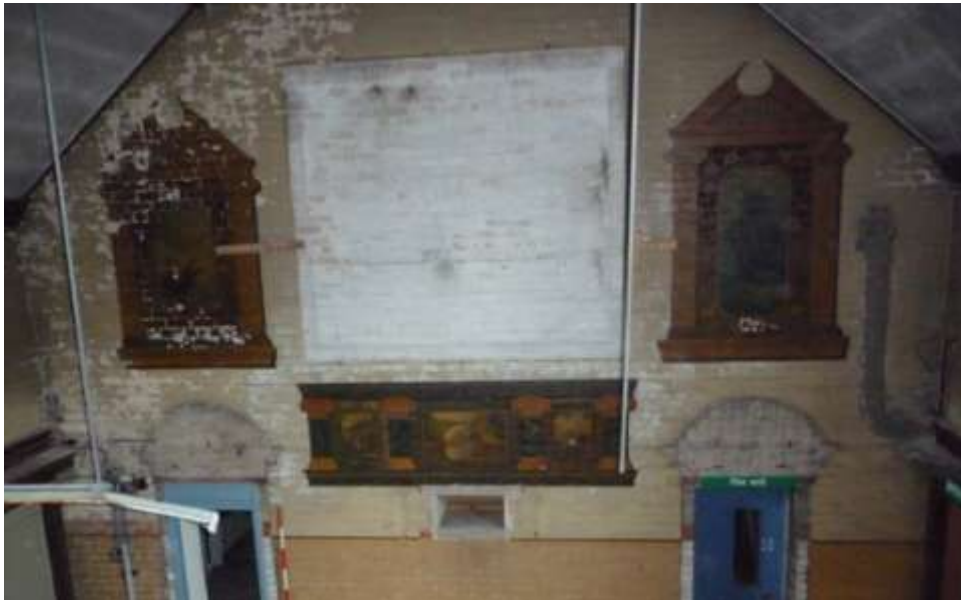
Plate 20. The wall paintings in 2012
