Former Union Workhouse
Hexham, Northumberland

Historic Building Recording

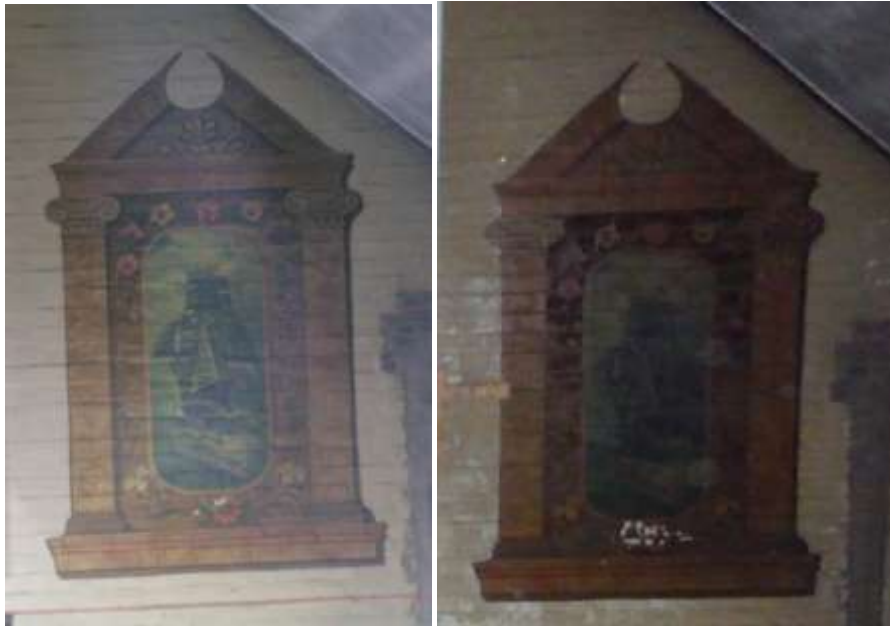
Plate 21. Detail of wall painting in 2004 (left) and 2012 (right). Some more paintwork has been chipped off below the ship.

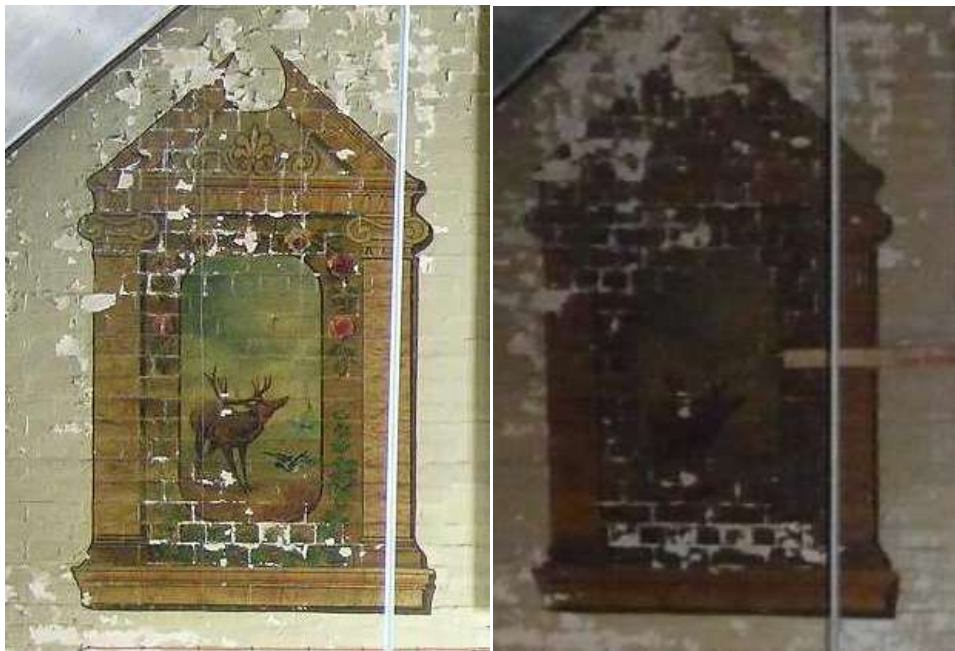
Plate 24. Detail of stag wall painting in 2004 (left) and 2012 (right). Allowing for the poorer lighting conditions once the building was unoccupied, more paintwork has been lost in the intervening years.

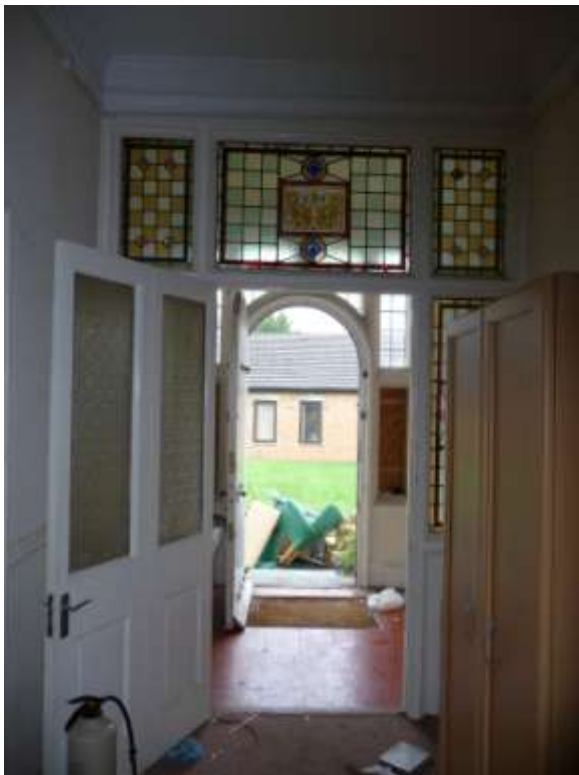
Plate 25. The robust wooden front door harks back to medieval England as does the leadwork to the windows and stained glass; all set the tone for the grand entrance to the Master’s House. The half glazed four panel door also appears to be original as are the small details such as plaster corncicing, coving, skirting boards, dado rail, tiled floor to the entrance lobby and wide moulded door surrounds. Other internal doors are replacements as is the door handle to the storm door.

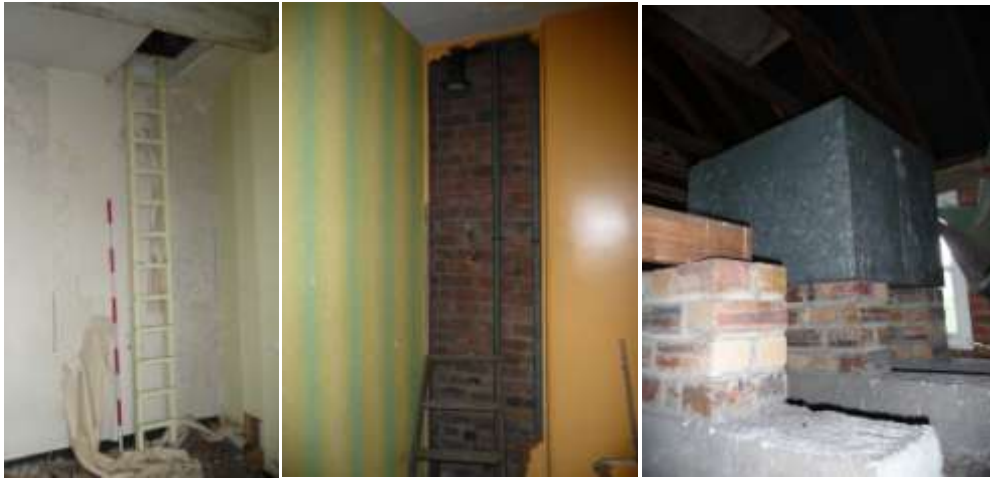
Plate 28. The ladder to the water tank in room 88 (left) and the pipes on the walls in room 87 (right). The water tank appears to be of lead and is supported on concrete beams and brick pillars.

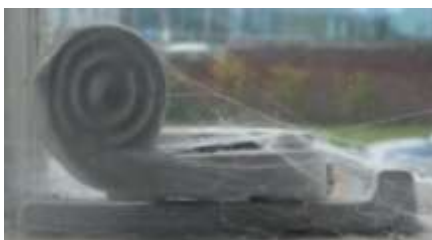
Plate 30. The lever sash of choice throughout the 1883 remodelling

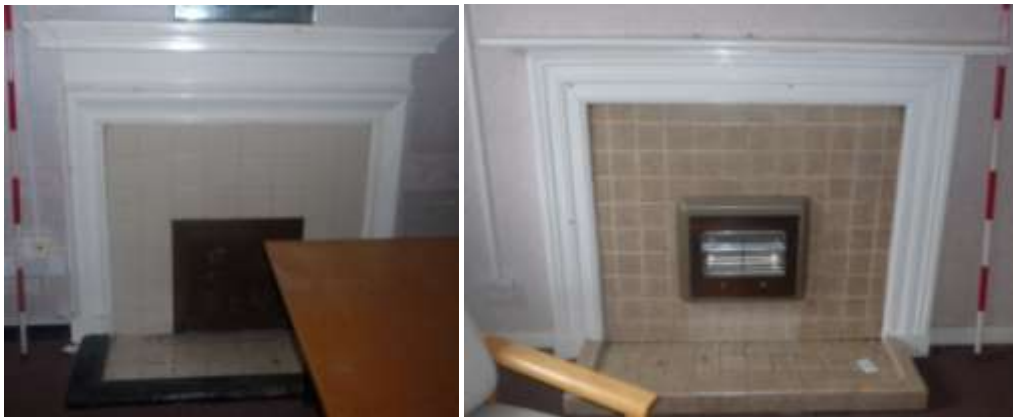
Plate 31. Surviving fireplaces in the Fairington Centre; these merit reuse to reference the Victorian character, but do not need to remain *in situ*

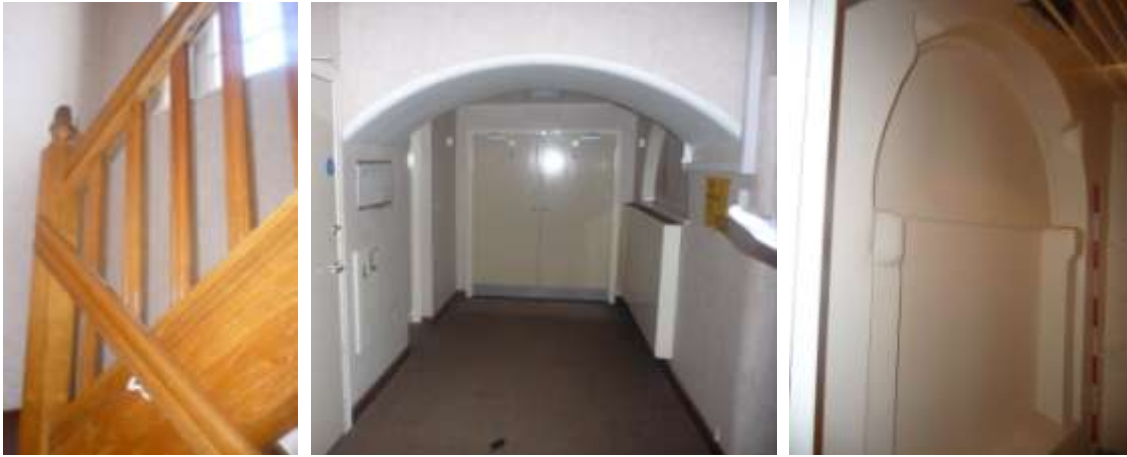
Plate 32. Characteristics of the stair hall with blocked archways also found in the linking corridors which join the central and northern ranges.

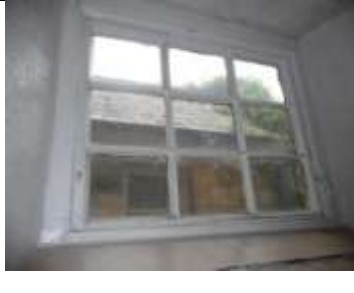
Room no.	Location/description	Items of significance	Image
		replacement? 20 pane casement;

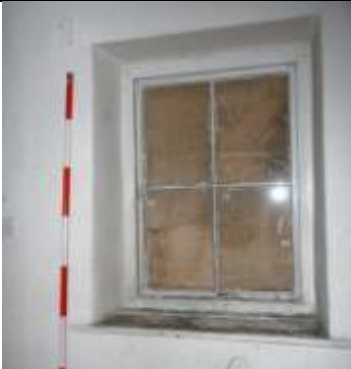
17	Room with modern partition.	2 pane sliding sash, catches intact. 2/2 pane sliding sashes with catch and rope. Chimney breast and blocked doorway to 14a. Modern partition of no interest

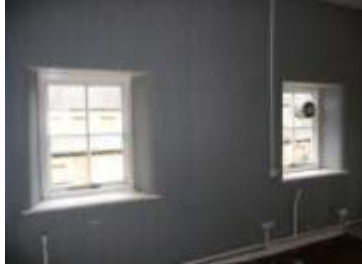
32	Flanking corridor created by modern partition of no interest	3/3 sash windows, possibly modern replacements

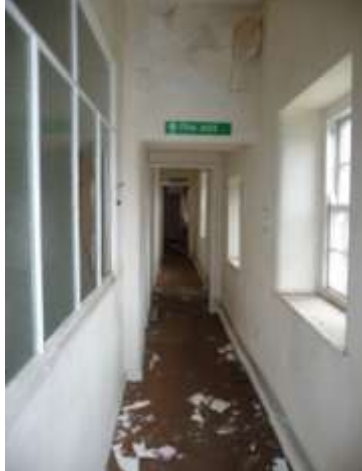
Room no.	Location/description	Items of significance	Image
33	WC inserted between two chimney breasts (same arrangement below in room 20)	4 pane sash, not extractor

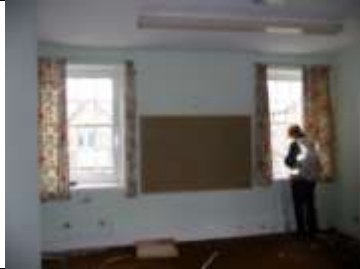
40 40a	20 th c flat roofed extension with rotten windows due to trapped moisture behind secondary glazing. 40a is access to 40 created with modern partitions of no interest

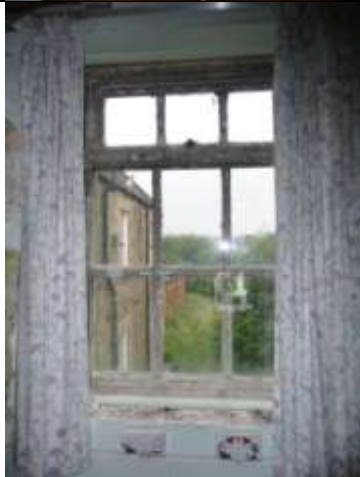
Statement of Significance – The Former Hexham Workhouse and Hospital

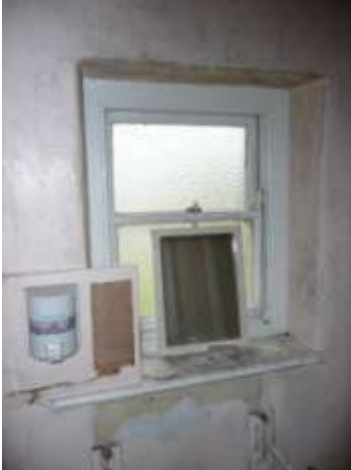
Statement of Significance – The Former Hexham Workhouse and Hospital

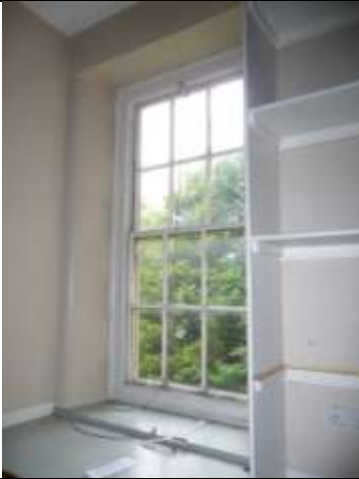
50	Stair hall		
51	19 th c block WC	Four 1/1 sliding sashes, three with catches

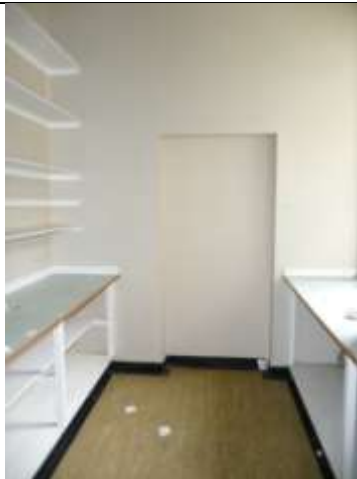
54	Later addition of no interest. Access not possible. Nothing of significance noted through glass panel in door 1970s windows and suspended ceiling

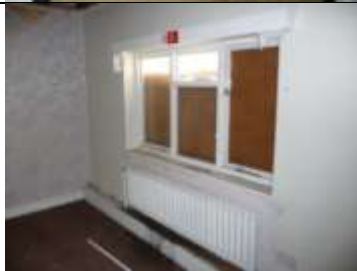
55	Possibly a late 19 th c building, but internally nothing of interest		
56	Small room created by partitioning larger room 53	6/6 sliding sash with roller and catch

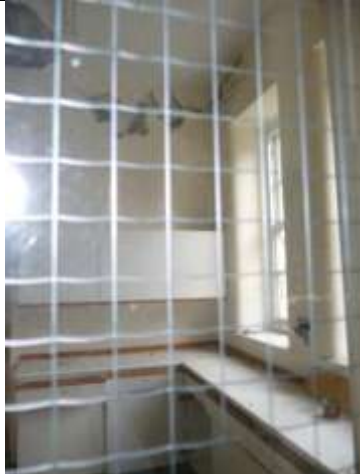
Master's house			
60	Master's house. Entrance hall	Stained glass with lead fixing to internal storm door and external door; original four panel, half glazed internal door; original external door in medieval style

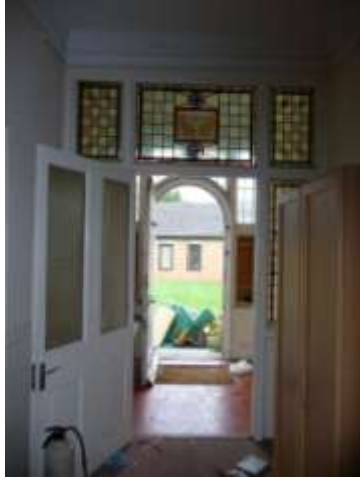
61	Main hall	Coving; ceiling rose; thick moulded door surrounds to three rooms;

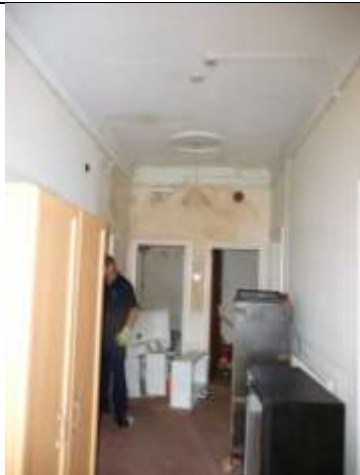
Statement of Significance – The Former Hexham Workhouse and Hospital

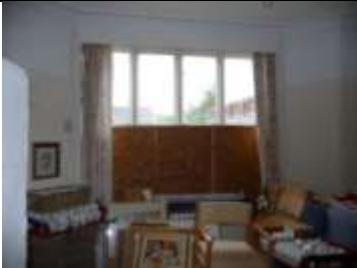
63	Reception room. Fireplace replaced in 1950s/60s	Plaster coricing; skirting boards; transom and mullioned windows; chimney breast; picture rail; coving

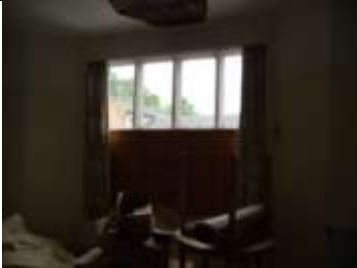
64	Back room	Some coving; window

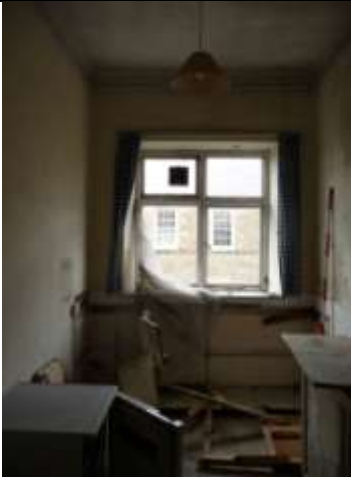
72a	The extended area allows a view through the stair light window so that the yard can be observed, but it also reduces available light from the window

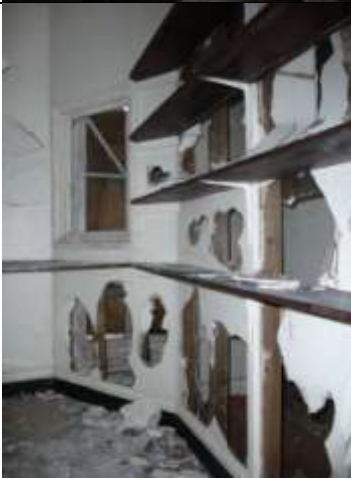
73	Second bedroom	Skirting; chimney; picture rail; coving; mullion and transom windows

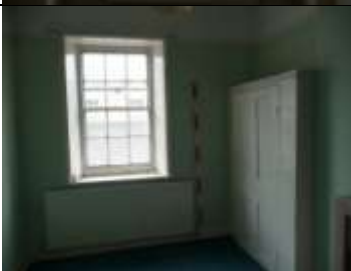
Statement of Significance – The Former Hexham Workhouse and Hospital

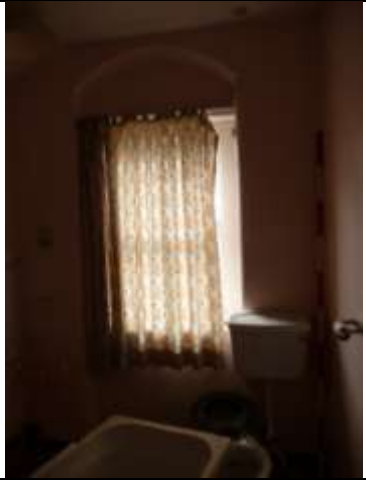
75a	Partitioned area to create wash room		No image
Mens' Yard area and vagrant wards			
76	Stone stair appears on 1841 plan	Stone stair; original battened and ledged door

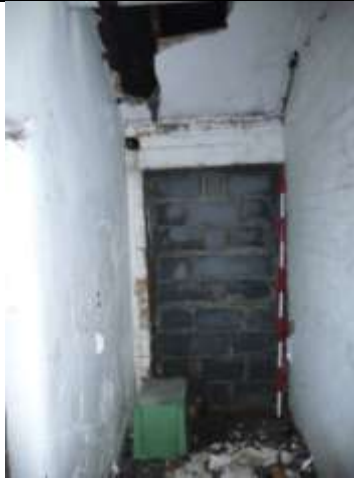
91	Small room off corridor 90, leading to three subdivided store rooms a, b, c	Half glazed door in poor condition

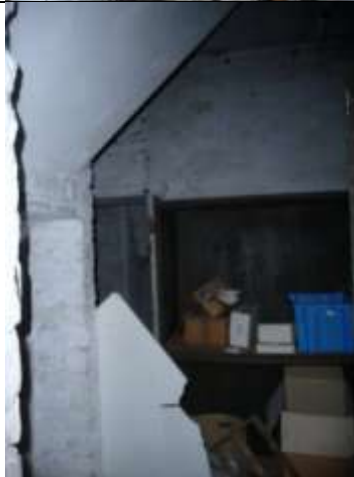
92	Room down stairs to fever ward level

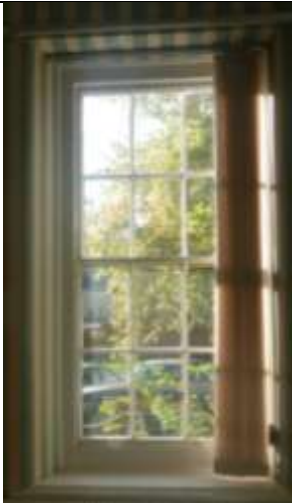
06	Office space cut from larger ward room. Partitions walls of no interest	6/6 sash windows with brass sash lifters and replacement sash fasteners

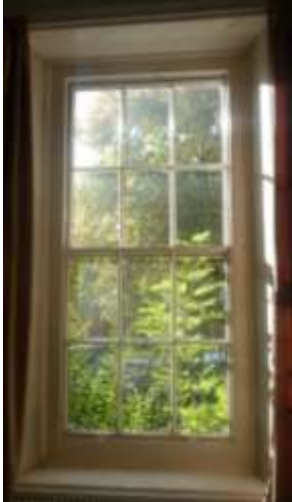
07	Office space cut from larger ward room; subdivided since modern plan surveyed. Partitions walls of no interest	6/6 sash windows with brass sash lifters and replacement sash fasteners with flattened button

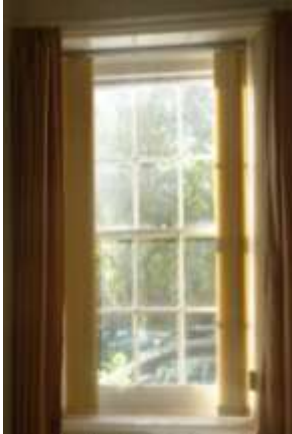
Fairington Centre: ground floor			
Room no.	Location/ Description	Items of significance	Image
07a	Part of above until recently. Office space cut from larger ward room; subdivided since modern plan surveyed. Partitions walls of no interest	6/6 sash windows with brass sash lifters and original brass sash fasteners with concentric circles

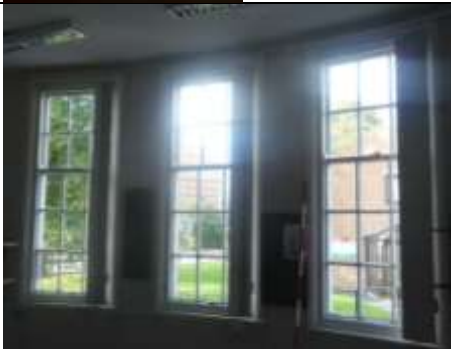
Fairington Centre: ground floor			
Room no.	Location/ Description	Items of significance	Image
11	Linking hall with offices off and attics, all modern

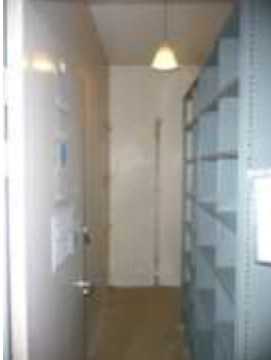
29	Services cupboard	6/6 sash with replacement fastener

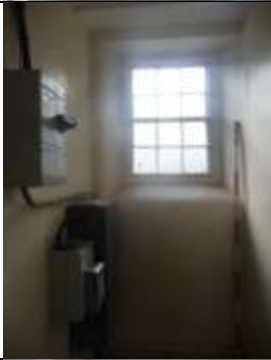
30	hallway	Six 6/6 sliding sashes with brass concentric circle fasteners all with decorative pelmets; one window set at a lower height. Doors off to individual rooms with vents above, mostly blocked. Some differences in ground levels of archaeological interest

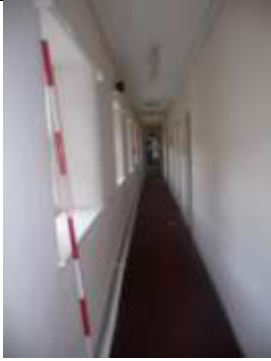
Fairington Centre: ground floor			
Room no.	Location/ Description	Items of significance	Image
31	1930s bedroom created from subdivided ward, latterly used as offices	6/6 sliding sash with sash lifter and concentric circle fastener and decorative pelmet above. Cast iron radiator below window. Cupboard with shelving, drawer and hanging space. Scar where vanity sink unit was located, but now missing. Vent above door

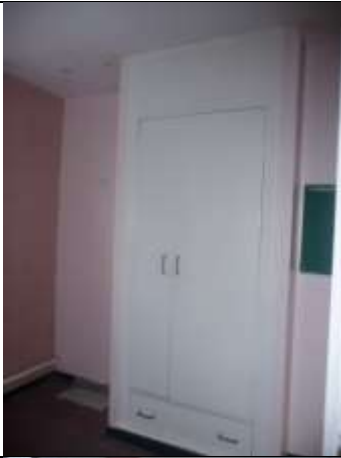
32	1930s bedroom created from subdivided ward, latterly used as offices	6/6 sliding sash with sash lifter and concentric circle fastener and decorative pelmet above. Cast iron radiator below window. Cupboard with shelving, drawer and hanging space. Scar where vanity sink unit was located, but now missing. Vent above door

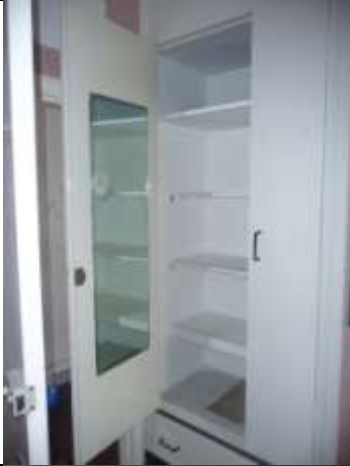
33	1930s bedroom created from subdivided ward, latterly used as offices	6/6 sliding sash with sash lifter and concentric circle fastener and decorative pelmet above. Cast iron radiator below window. Cupboard with shelving, drawer, mirror, and hanging space. Scar where vanity sink unit was located, but now missing. Vent above door, 1930s lamp on wall and socket for another, coat hook on door and brass oval handle

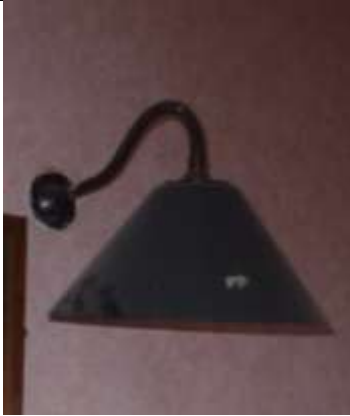
34	Room of original 19thc proportions	Two 6/6 sliding sashes, sash lifter, concentric circle fastener; window with pelmet over; door with vent over, plus additional vent, two cast iron radiators

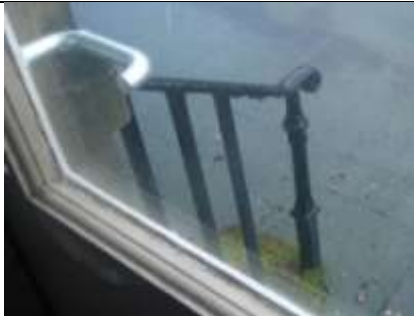
102	Lobby area but originally part of larger room	Small 4/4 sliding sash window with concentric circle fastener	
103	Originally part of larger room, since subdivided (modern plans are not accurate as show additional rooms of 105-6)	Two 6/6 sliding sashes with replacement fastener; window glass is original

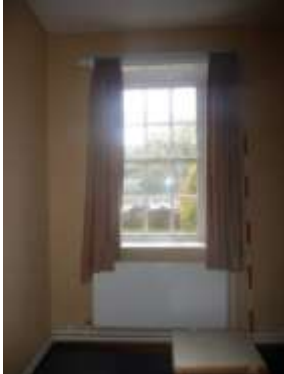
Fairington Centre: ground floor			
Room no.	Location/ Description	Items of significance	Image
109	Office space cut out from larger room/ward. Partitions and skirting of no significance in rooms 108-113	6/6 sliding sash with sash lifters and a concentric circle fastener

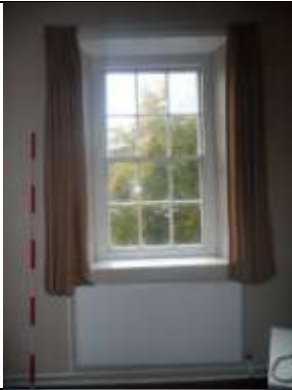
110	Office space cut out from larger room/ward. Partitions and skirting of no significance in rooms 108-113	6/6 sliding sash with sash lifters and a replacement flat knob catch

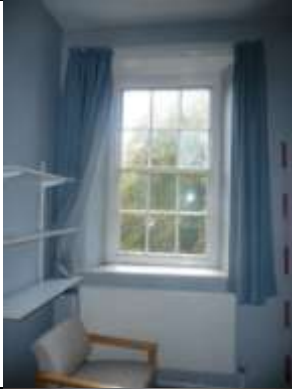
111	Office space cut out from larger room/ward. Partitions and skirting of no significance in rooms 108-113	6/6 sliding sash with sash lifters and a replacement thin knob catch

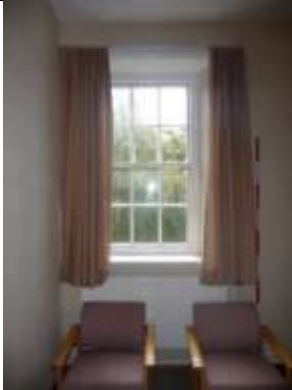
112	Office space cut out from larger room/ward. Partitions and skirting of no significance in rooms 108-113	6/6 sliding sash with sash lifters and a concentric circle fastener (broken sash rope)

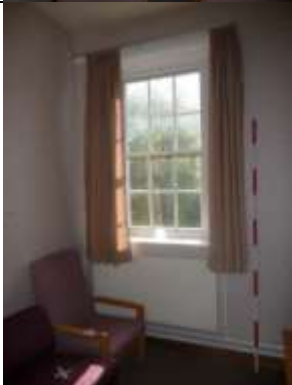
Fairington Centre: ground floor			
Room no.	Location/ Description	Items of significance	Image
113	Office space cut out from larger room/ward. Partitions and skirting of no significance in rooms 108-113	6/6 sliding sash with sash lifters and a replacement flat thumb catch

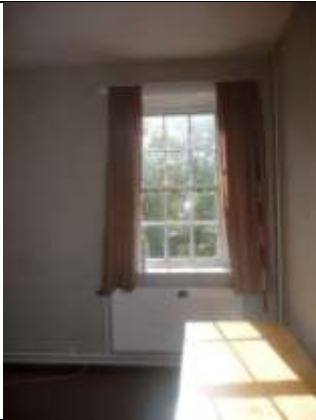
114	Bayed extension attached to west gable end of Morton's extension. Fire door to staircase FC 115 of no interest	Three 3/6 sliding sashes with concentric circle fasteners and sash lifters' chimney breast (part of Morton's building)

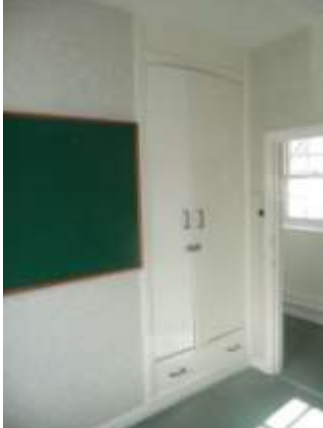
124	1930s patient's room carved from 19 th century ward.	6/6 sash window with concentric circle fastener, sash lifters, 1930s pelmet and brass curtain rail with hooks. 1930s cupboard and vent above door. Cast iron radiator. Sink vanity unit with replacement modern sink. 1930s door with oval brass handle

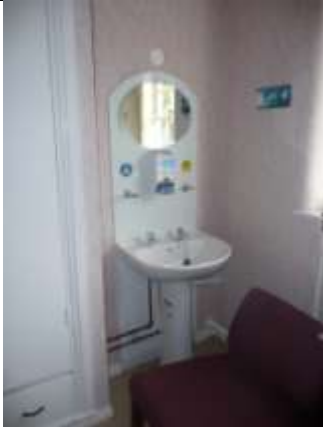
125	1930s patient's room carved from 19 th century ward.	6/6 sash window with concentric circle fastener, sash lifters, 1930s pelmet and brass curtain rail with hooks. 1930s cupboard and vent above door. Cast iron radiator. Space where sink vanity unit was located in the 1930s. 1930s door with oval brass handle
