**SANDON BURY FARM,
SANDON,
HERTFORDSHIRE**

NGR REF: TL 32271 34457

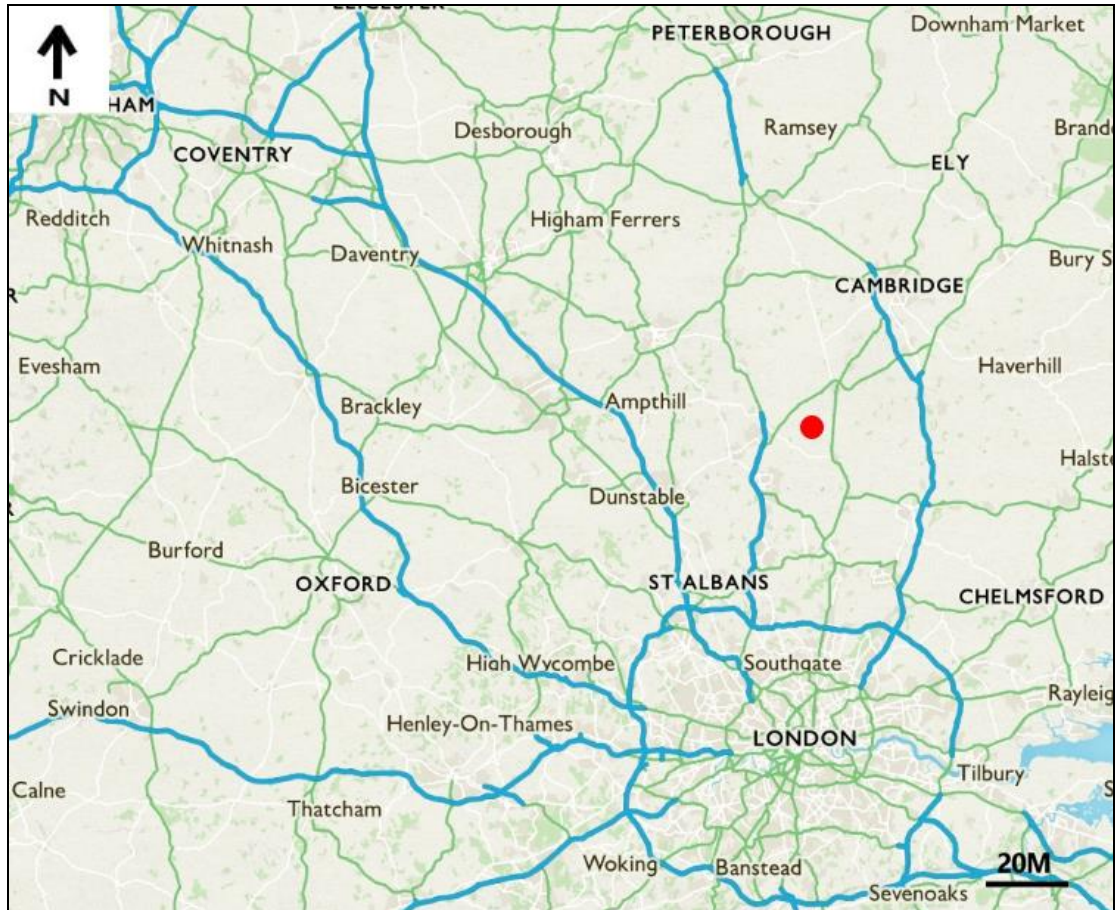
Figure 1. Location of Sandon in England. (Ordnance Survey Licence Nr 0100031673)
