Centre for Archaeology Report 50/2005

**Deconstruction and Conservation of Roman Armour from
the Millennium Excavations, Carlisle**

Jennifer Jones

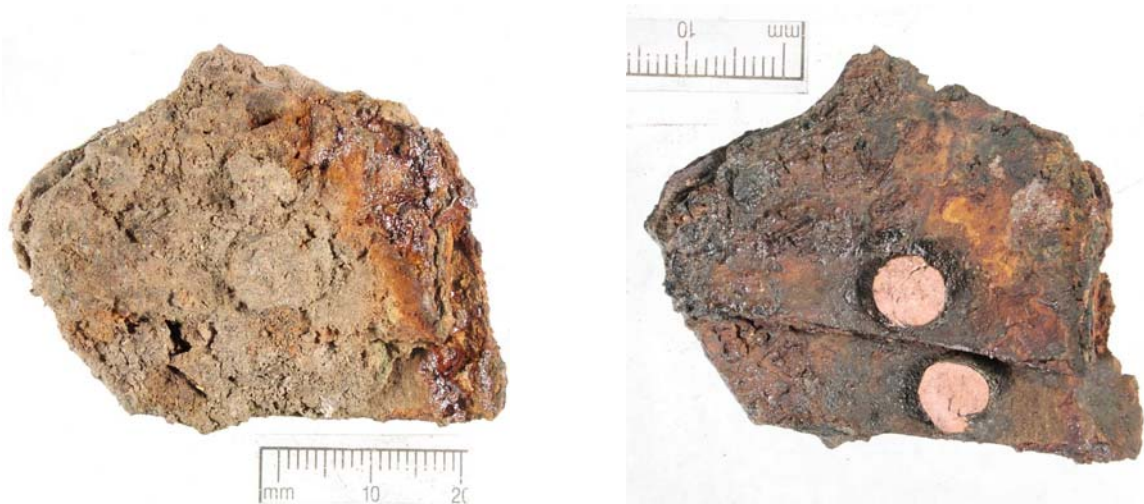
Thickness of soil cover and obscuring iron corrosion products varied from piece to piece and from block to block. In general, however, these were not voluminous (usually <5mm), and the general outline of the piece was usually visible before corrosion removal began. Sometimes the position of rivets and perforations could also be seen, though fine surface detail was invariably obscured.

Fig 13 : 3976AΔ/7 before and after corrosion removal, with obscured copper alloy rivets and overlapping iron plates revealed

Low pressure, low powder air abrasion was used first to remove soil and grit cover, revealing areas of mineralised material, and also showing the depth of iron corrosion products to be removed. Following preliminary air abrasion, the fragments were examined again under X16 magnification to assess the extent of the mineralised material. Then air abrasion at higher pressure was resumed to remove all obscuring corrosion from the object surface, while leaving mineralised material in place.

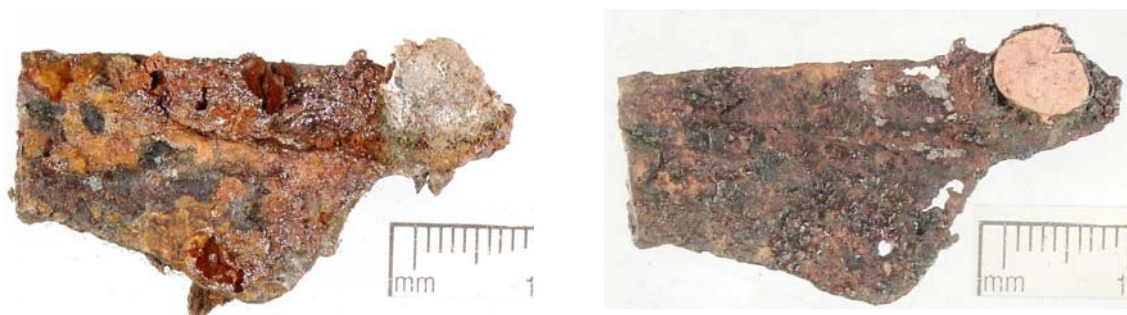
As received, many of the copper alloy rivets were covered by a thick, uneven or bubbly layer of an unusual 'brassy' coloured corrosion product, sometimes with an overlying white layer, which formed a hard shell over the rivet. Samples of this corrosion product were analysed using XRD (see Analysis section). Below the corrosion shell, the copper alloy rivets were found to be in good condition, though the surfaces were sometimes etched. A programme of EDXRF analysis was carried out on some of the copper alloy rivets, and the results can be found below.

Fig 14 : 3976AΔ/16 showing copper alloy rivet obscured by corrosion 'shell' and revealed by air abrasion

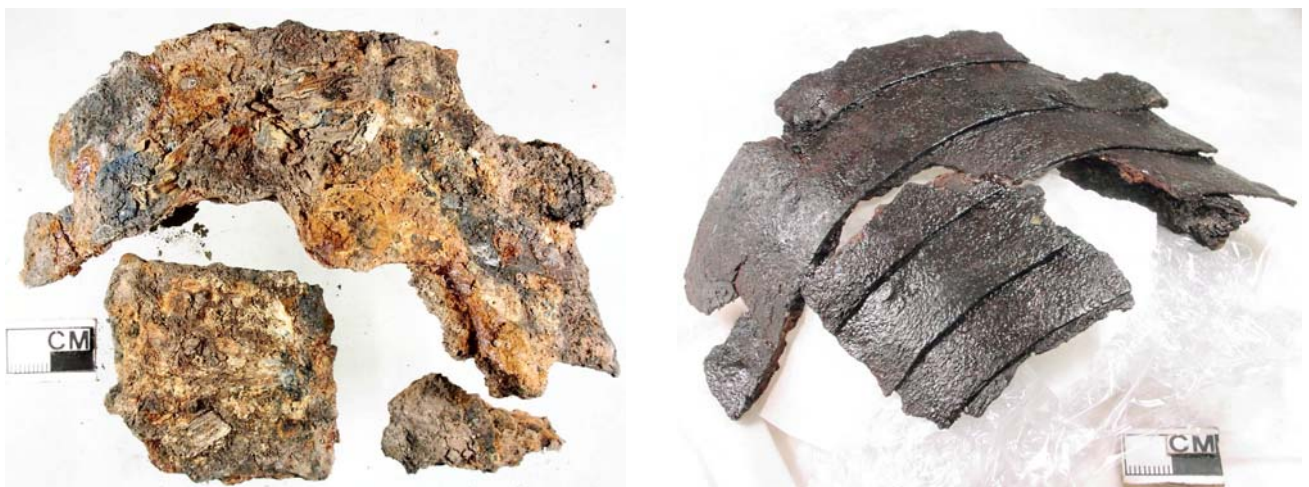
Pieces from **3979Δ/4** were 'restored' in this way. As recovered, **3979Δ/4** was in three pieces (see below), which were air abraded and then joined using Paraloid B72 adhesive.

Fig 16 : 3979Δ/4 as recovered and with the fragments air abraded, consolidated and joined

The pieces joined together well, but missing fragments left a void. To strengthen the piece, a fragment of aluminium mesh was cut to size and tacked in the void. The void was then filled, back and front with the paste as described above. When dry, the area was overpainted to blend in with the surrounding surface.

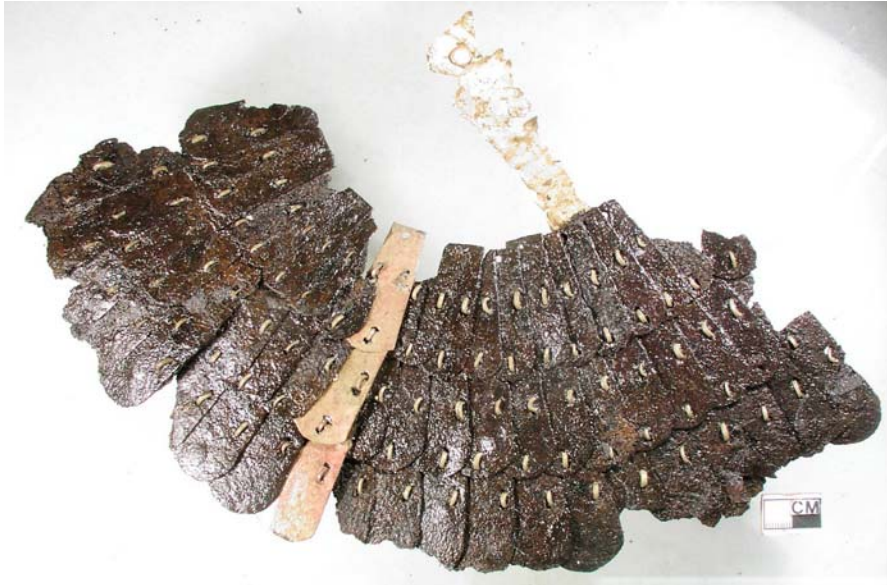
Fig 19 : 3416Δ conserved

3416Δ : The whole of this block was conserved. It was received as 5 closely associated fragmentary sections made up of small iron scales joined by copper alloy wire. The air abraded sections were reassembled using adhesive, with poor joints occasionally filled for strength as described above. Evidence for mineralised leather was found on the back of the metal (see below).

Corroded to the back of 3416Δ was a piece of unrelated copper alloy, riveted to a fragment of iron plate. Because of the overall fragility of 3416Δ, this piece of copper alloy was left *in situ*, as its removal might have seriously weakened the piece.

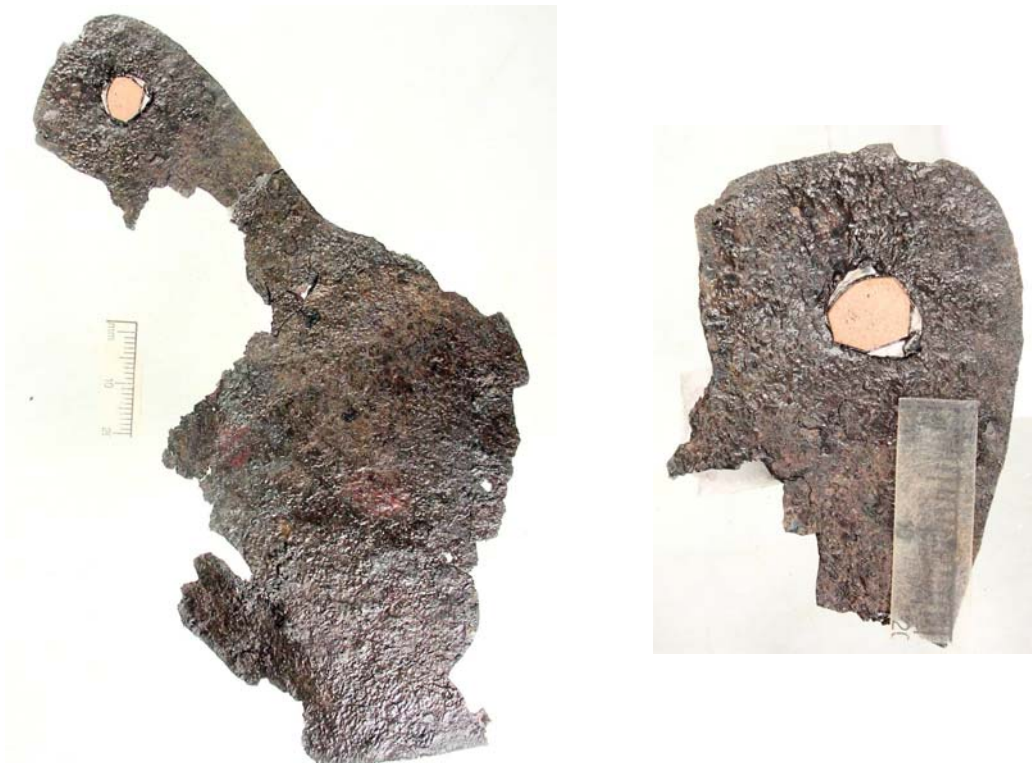
Closely associated with 3416Δ were two fragments of shaped iron, which joined and proved to be part of a helmet cheek piece. There was a copper alloy rivet still *in situ*, and caught below this were the remains of a layer of metal foil with a high silver content, which had evidently been clipped away prior to disposal. EDXRF analysis was carried out on the copper and silver alloys used (see below).

Fig 20 : 3416Δ/6 iron cheek piece, with detail showing copper alloy rivet with silver foil caught below it

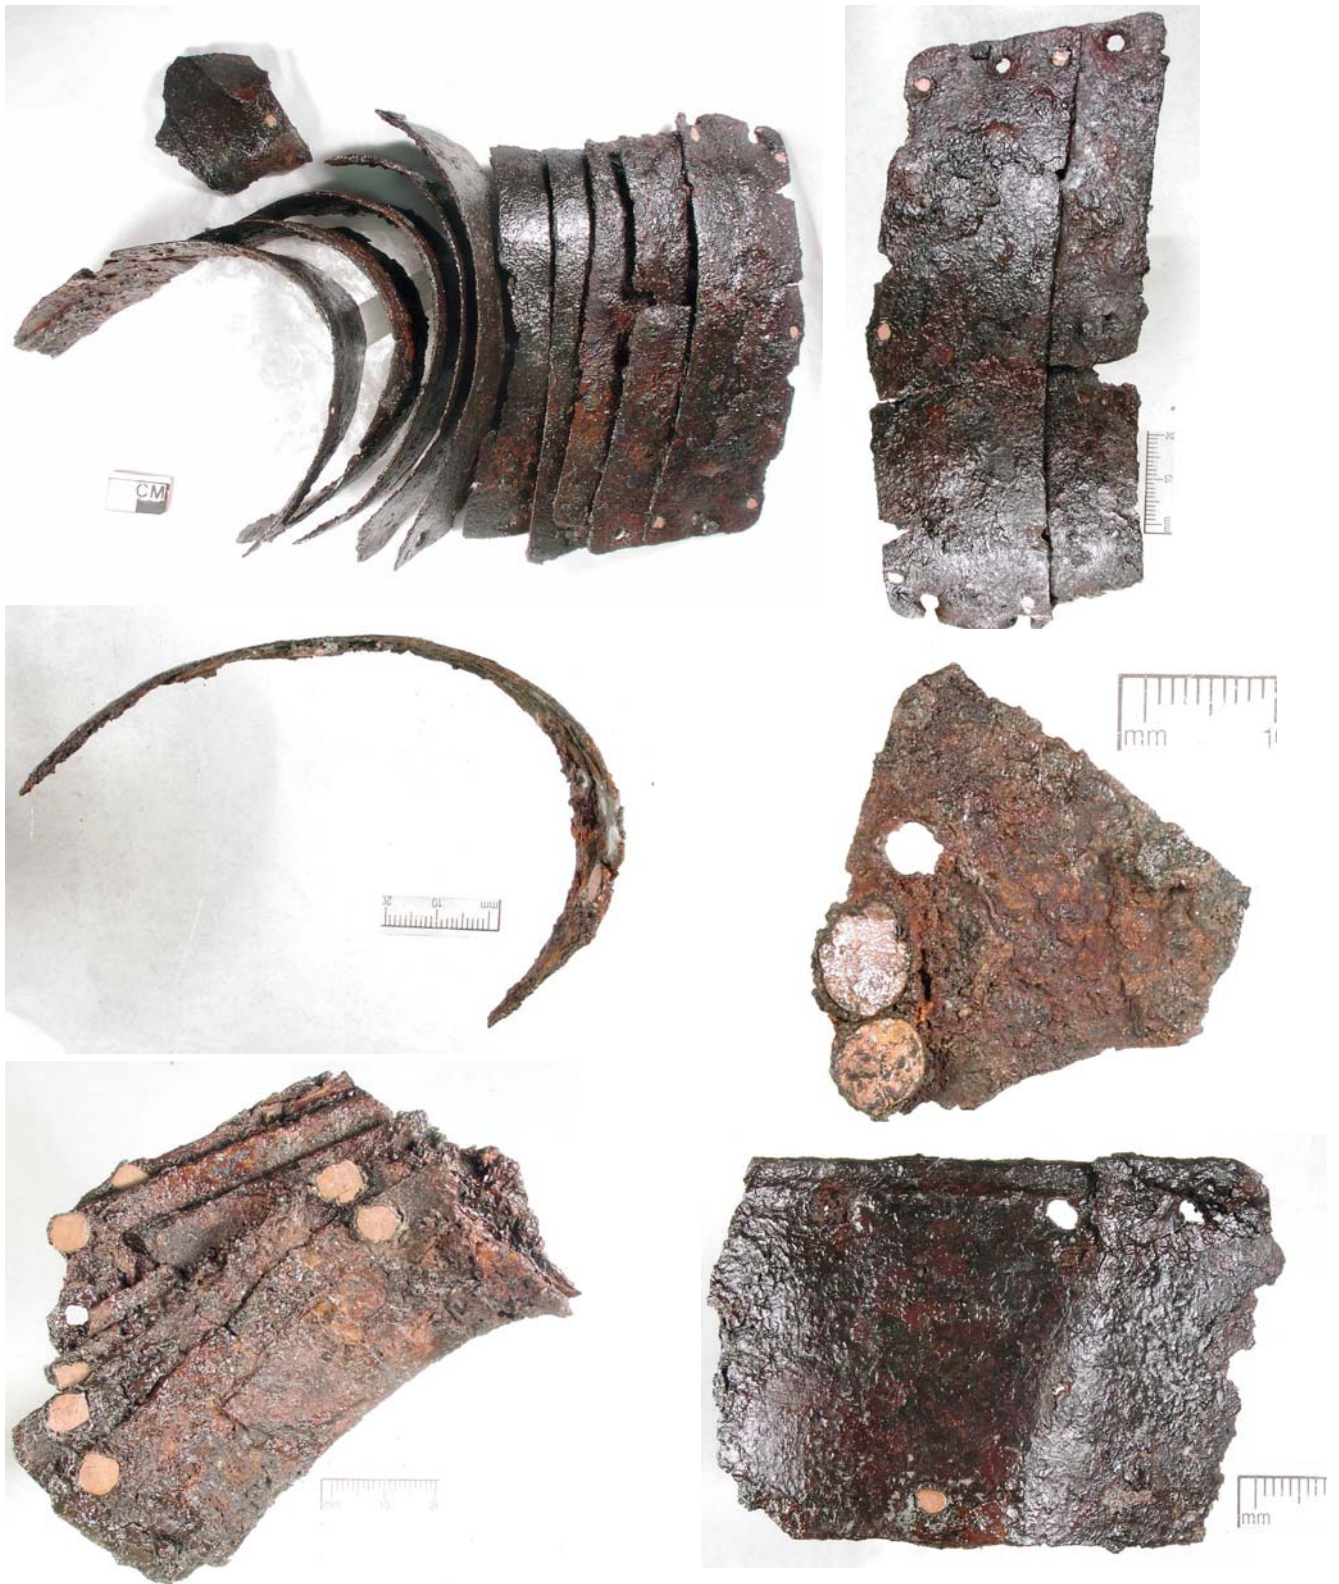
Fig 21 : Conserved pieces from 3976ΔA

3976ΔA : 35 partial plates and fragments were conserved from both ends of this shoulder defence, leaving the middle section unconserved. All the pieces conserved were incomplete, and some were strongly curved. Copper alloy rivets, most still *in situ*, had been used to attach a leather lining, and many of the plates also had perforations, probably for lacing. Evidence – sometimes extensive – for mineralised leather was found on the back of 28 out of the 35 pieces conserved (see below).

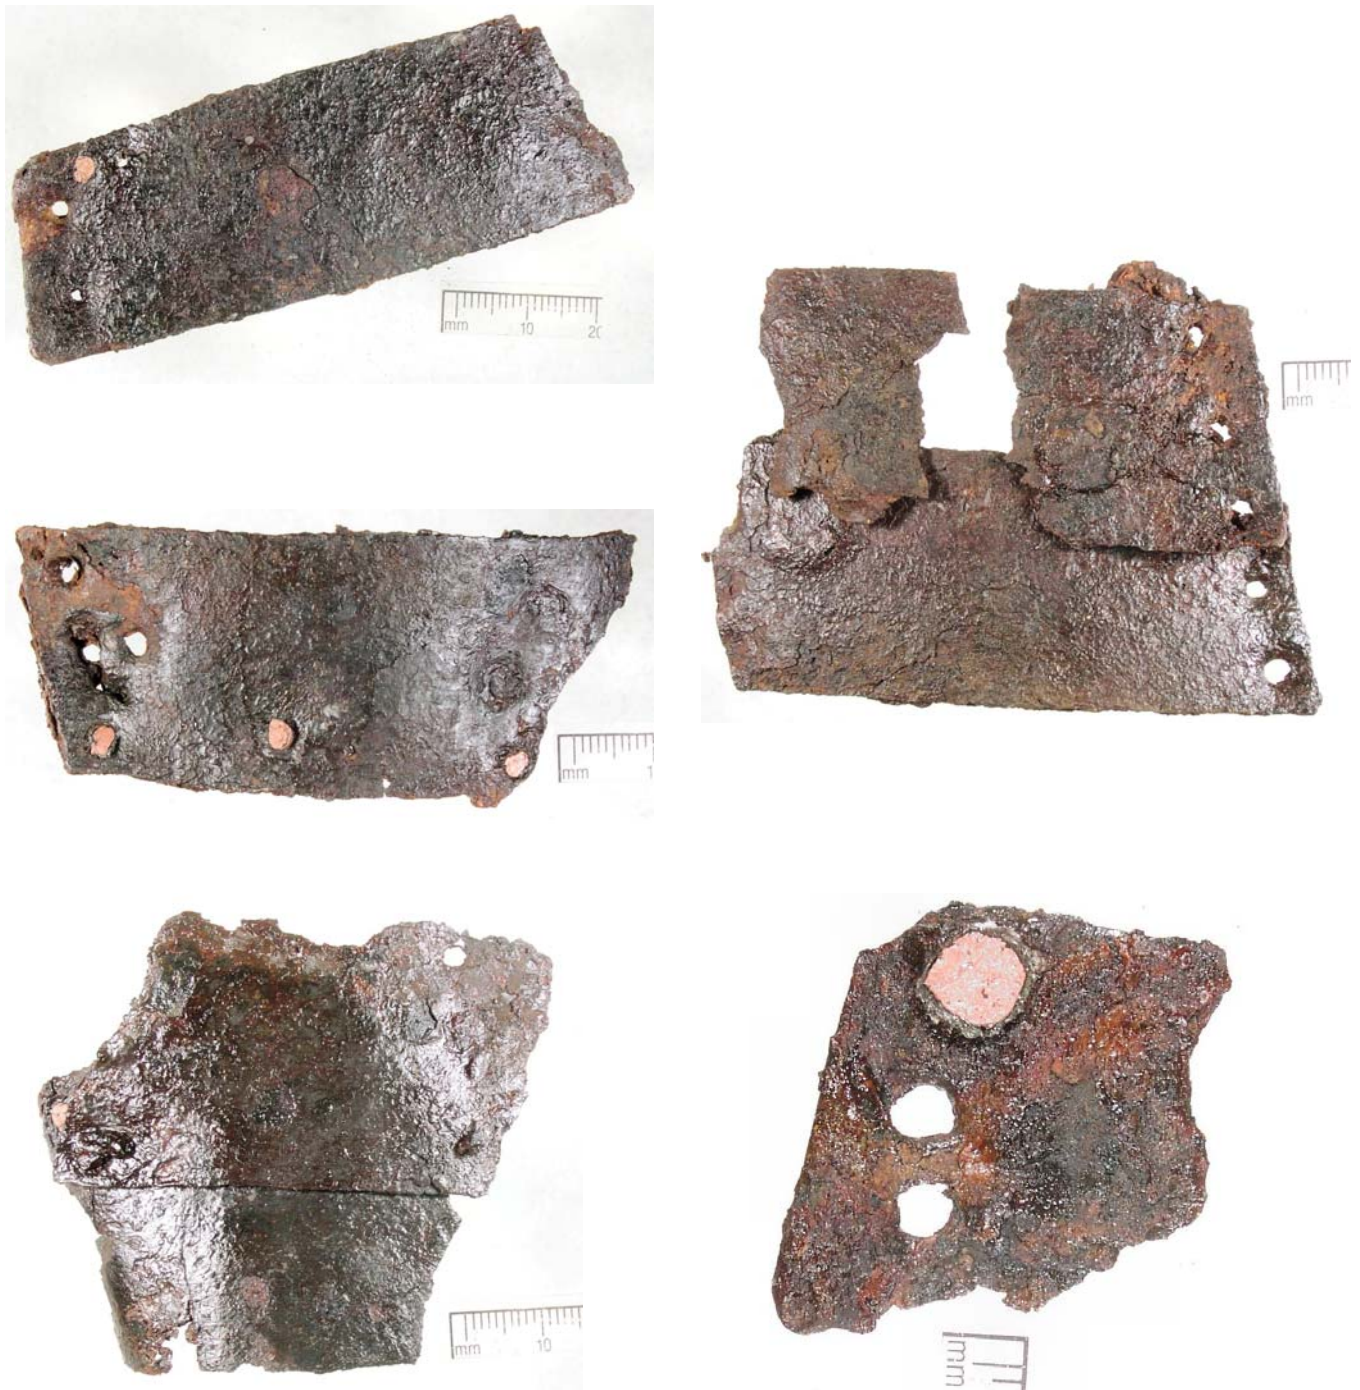
Fig 22 : Conserved pieces from 3976ΔB

3976ΔB : 53 mostly fragmentary plates were conserved from this part of 3976Δ, most either flat or slightly curved. Only pieces from the top layer were at all complete, with those below being severely damaged and displaced. It had been intended to leave part of this block unconserved, but as most of the pieces were not found in their original positions, it was decided to conserve all but the smallest fragments. Both copper alloy and iron rivets were used in the construction. There were lacing perforations, and evidence for mineralised leather on the back of 38 out of the 53 pieces conserved (see below).

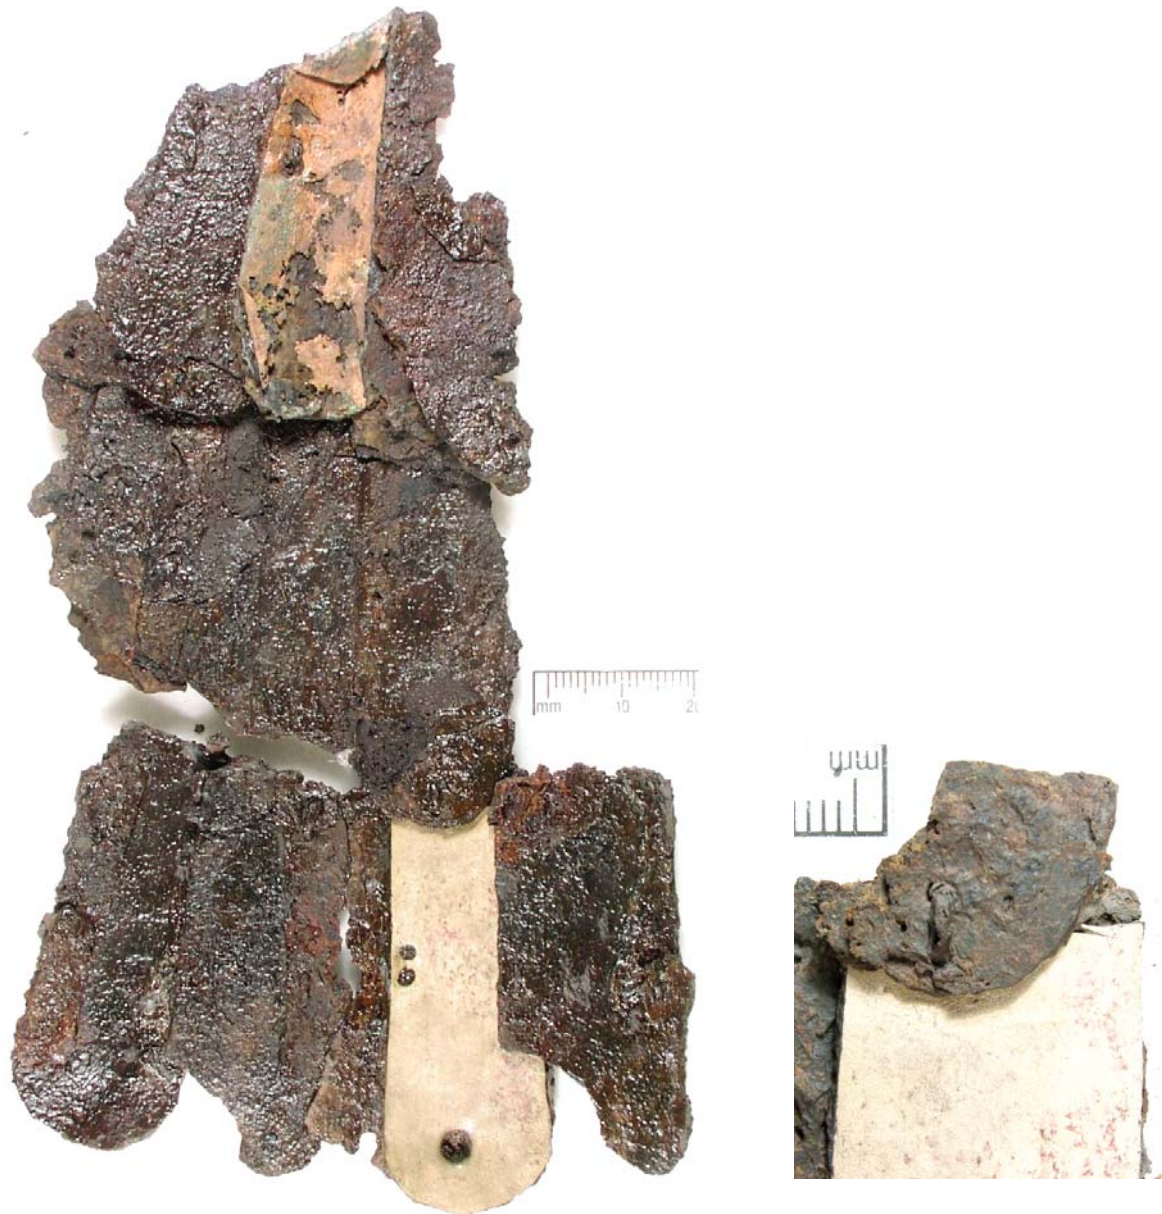
3978Δ : The better preserved area of this block was worked on, which consisted of 6 fragmentary but joining sections made of iron scales, some plated with copper alloy. The scales were joined by thin iron wire. The air abraded sections were reassembled with adhesive and filled as necessary, and the rest of the block was stored unconserved. Evidence of mineralised leather was found on the back of 3 of the conserved sections of metal scales (see below). EDXRF work was carried out on the copper alloy platings (see below).

Fig 23 : Conserved pieces of 3978Δ, with detail showing fine iron wire joining the scales

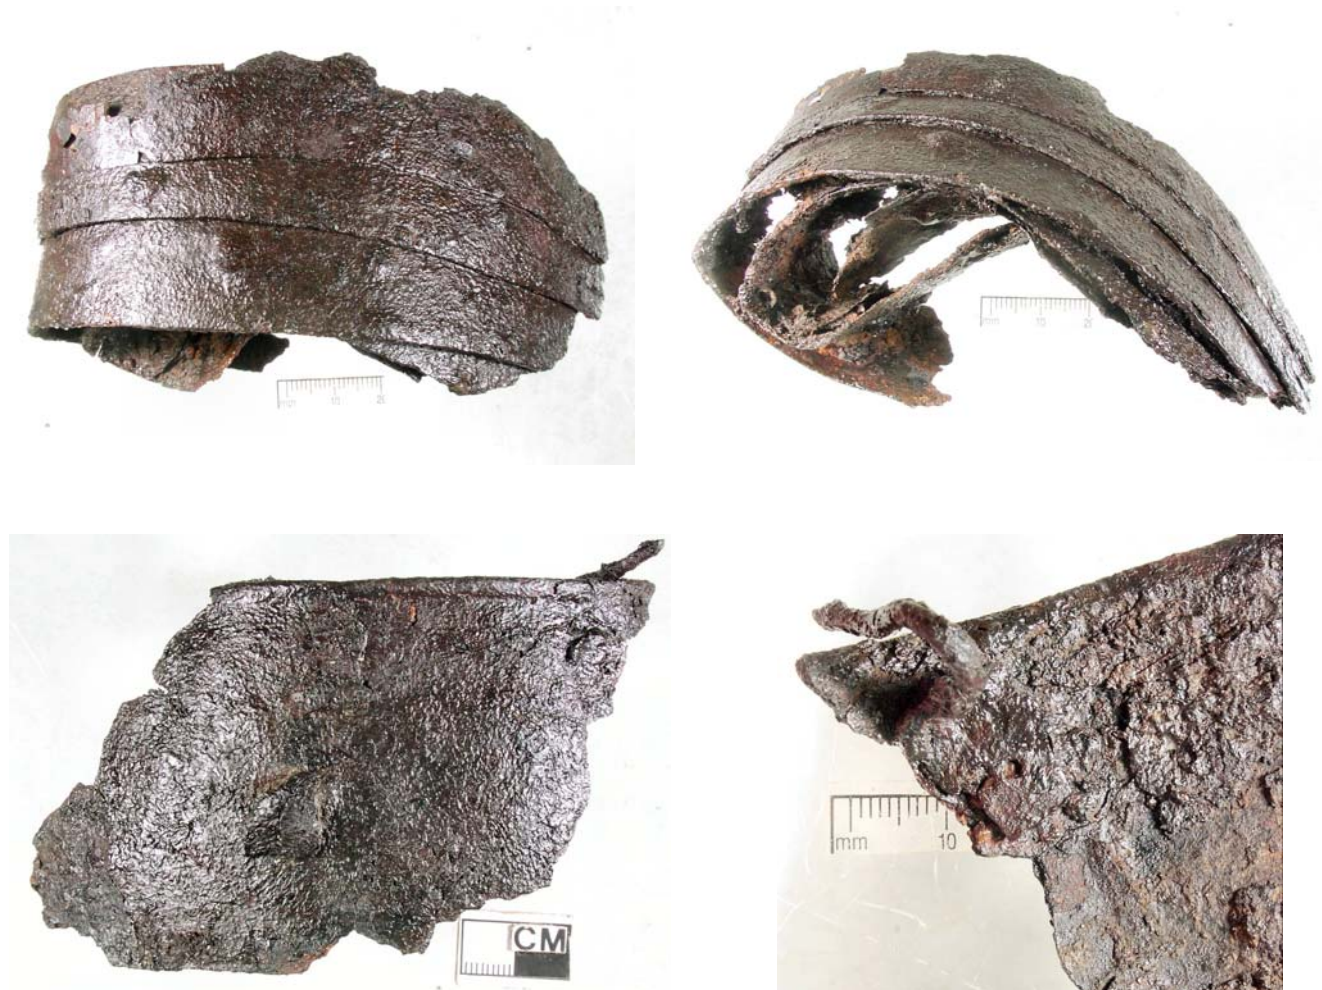
(3979Δ/5) being very distorted. The seventh, non-joining conserved piece was evidently the end of the arm guard, and had one rolled edge with an iron hook riveted to it. The rivets in 3979Δ were made of iron. All seven pieces had evidence of mineralised leather on the back (see below).

Fig 24 : Conserved pieces from 3979Δ, with detail of rolled edge and hook

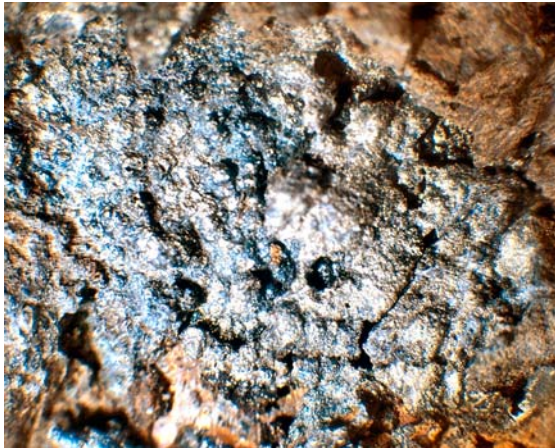
Many of the armour's copper alloy rivets, and some of the copper alloy platings (as in 3978Δ, see Fig 32 below) were covered with a thick layer of a hard, dull gold-coloured corrosion product, often present as a 'shell' over the copper alloy below. This was sampled for XRD analysis. Similar corrosion products have previously been observed on artefacts from other excavations in Carlisle, and they have also been noted by conservators elsewhere (*Duncan & Ganiaris 1987*). The corrosion product is characteristic of copper alloys excavated from anoxic waterlogged environments.

Fig 32 : 3978Δ Chalcopyrite corrosion over copper alloy
