Centre for Archaeology Report 70/2005

**Conservation and analysis of a Roman glass vessel and
associated material from Botchergate, Carlisle**

Jennifer Jones

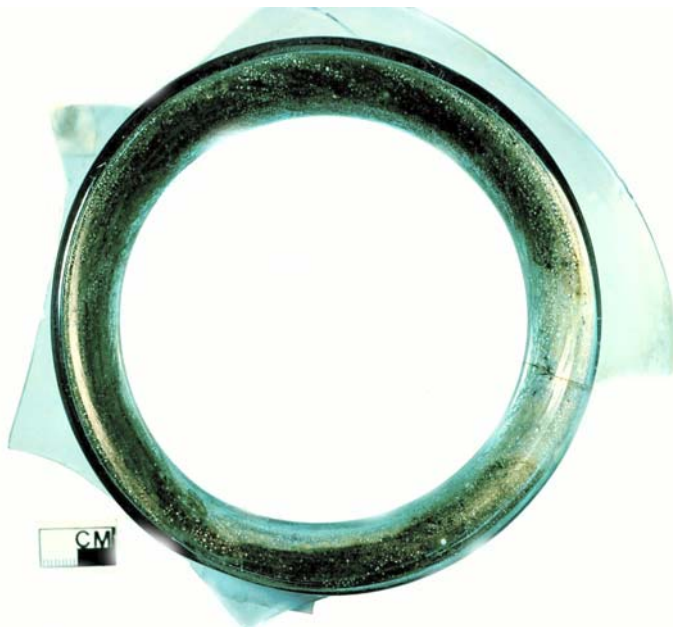
The rim, which was made by drawing the hot glass up and then folding it out on itself, had one crack running through both layers and extending down onto the body of the vessel. A brownish deposit, which appeared bubbly and crazed when viewed through the microscope, had built up inside the hollow rim. This was thought to be a biological slime created by water and micro-organisms entering through the crack in the rim during burial, and flourishing in the conditions found there, leaving the dried slime and soil now coating the inside of the hollow rim.

Fig 1 : Discolouration of the rim caused by biological slime

An attempt was made to dissolve and remove this discoloured deposit by soaking the rim in a solution of biological washing powder (Persil). However, after more than an hour, the water had penetrated less than 20mm along the inside of the rim. It was

clear that it would not be possible to remove the deposit in the time available, so the attempt was abandoned and the rim was rinsed and allowed to dry.

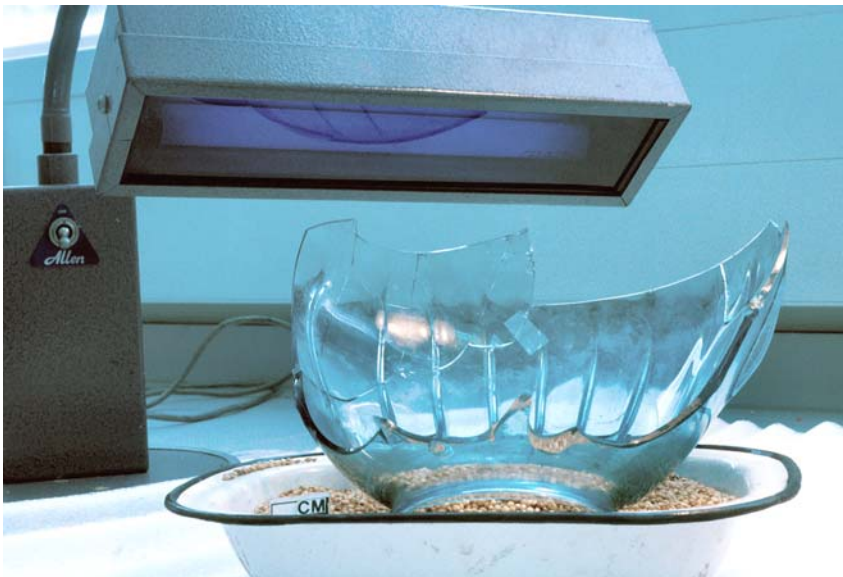
Fig 2 : Cyanoacrylate adhesive curing under UV light

Epo-Tek 301-2™, a clear two-part epoxy adhesive with very low viscosity and good optical properties, was chosen to join the glass. Because of the adhesive's tendency to run out of the joints before curing, the fragments were first tacked using spots of Loctite Glassbond, a cyanoacrylate adhesive which is cured by exposure to ultraviolet (UV) light. This was done to hold the awkward joins in place, while the epoxy was curing. A UV lamp was used to accelerate the curing of the cyanoacrylate.

The Epo-Tek was then introduced using a very thin brush applied to minor points of imperfection along the tacked joints, and the adhesive carried in by capillary action. Curing of the epoxy was complete in two days. Reassembly of the vessel was fairly successful. One or two joints could not be made perfectly, possibly due to differences in the thickness of the glass having led to 'springing'.

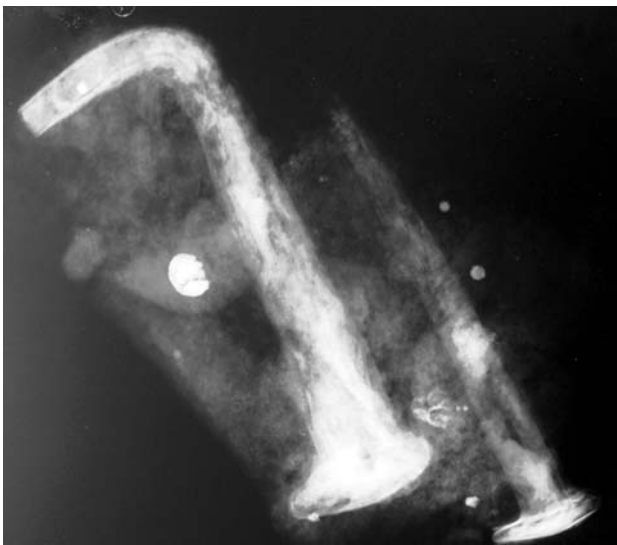
Several 'bright spots' of denser metal were observed on X-radiographs, eg on **1143Δ** a plate fragment and **1146Δ** a nail. Where this material could be detected visually among the iron corrosion products, it was analysed using EDXRF, and found to be (probably) leaded bronze.

Fig 5 : Melted CuA spots visible on XR of nails

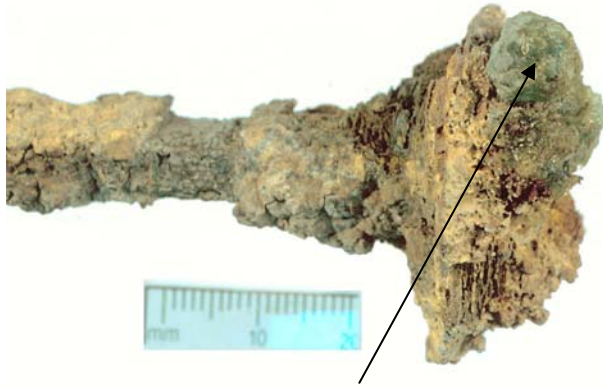
The head of the largest nail (**1141Δ**) had a melted lump of glass adhering to the iron corrosion products. Visually, this was similar in colour both to the vessel glass and to the pieces of melted glass found mixed with the fill. EDXRF analysis showed it to be most similar in composition and colourants to the melted glass fragments.

Fig 6. Melted glass on nail head
