RESEARCH REPORT SERIES no. 3-2011

KENWOOD HOUSE, UXBRIDGE, LONDON AN INVESTIGATION OF THE MUSIC ROOM WINDOW GLASS

TECHNOLOGY REPORT

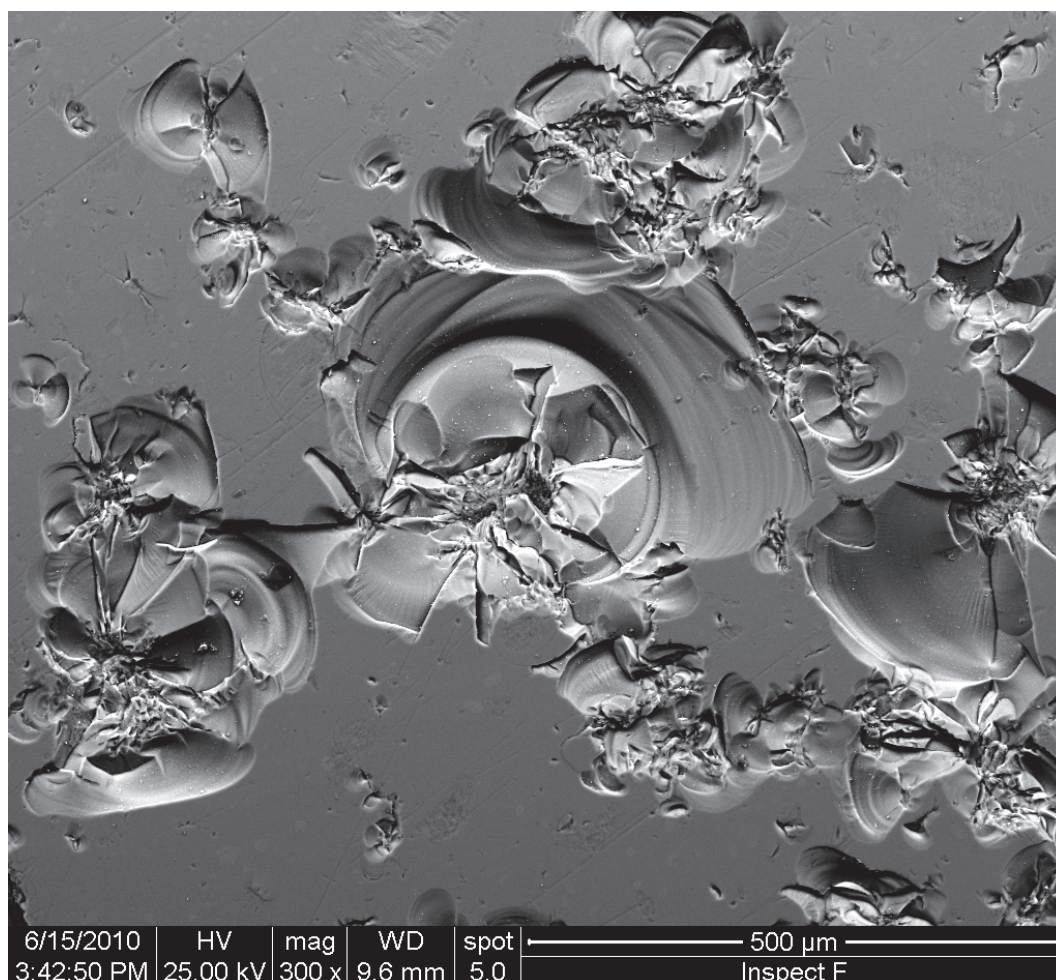
Figure 2. SEM image of the surface of the broken pane from the Music Room

The fragments of broken window submitted for analysis displayed a 'frosted' appearance on parts of one surface which consists of thousands of small impact fractures (Figure 2). The same surface was observed on several of the remaining panes at Kenwood and is believed to have been accidentally produced when the adjacent brickwork was cleaned (shot-blasting).

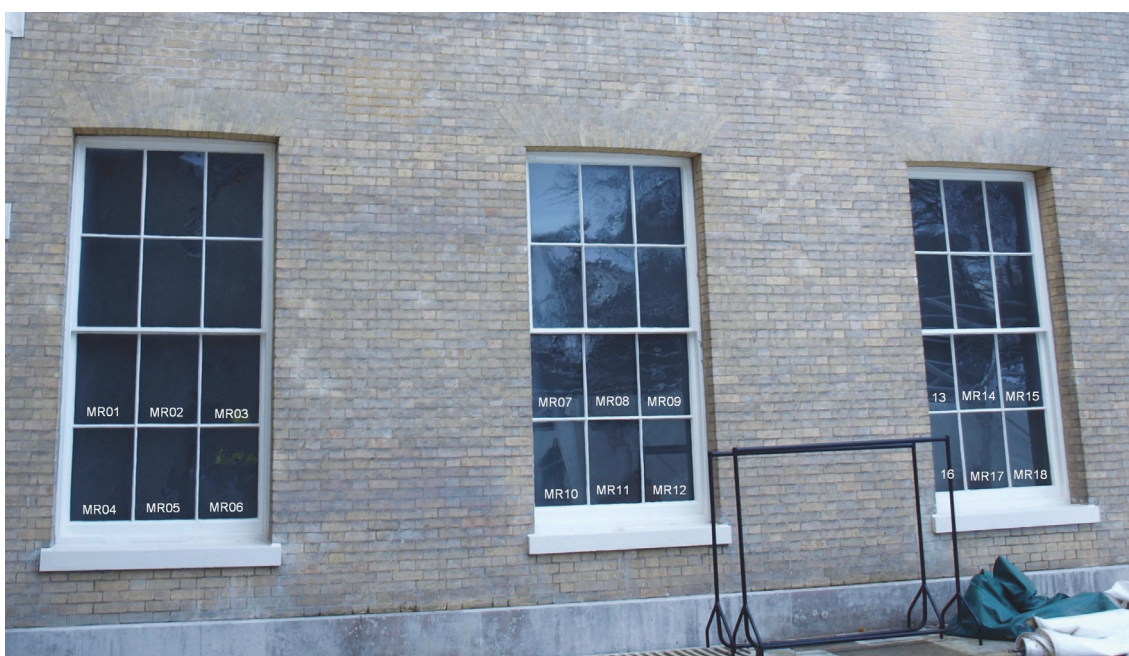
The pXRF analyses of the Kenwood windows included the lowest (and so most accessible) 18 panes from the three windows on the east side of the Music Room (Figure 3). All of the ground-floor windows on this side of the Music Room are 'blind' — behind the glass is a brick wall and the windows do not serve to admit light but merely to provide an architectural balance with the west wall of the Dining Room (whose windows are not blind). MR18 was the pane which was replaced in 2010 following the breakage. For comparison with the Music Room windows, 12 panes from two windows of the west wall of the Dining Room were also analysed using pXRF (Table 4).

Figure 3. East side of the Music Room showing the three windows analysed.
