**ARCHAEOLOGICAL
MONITORING
OF DRAINAGE WORKS**

**ALL SAINTS CHURCH
HUTTON RUDBY
NORTH YORKSHIRE**

NAA 14/98
November 2014

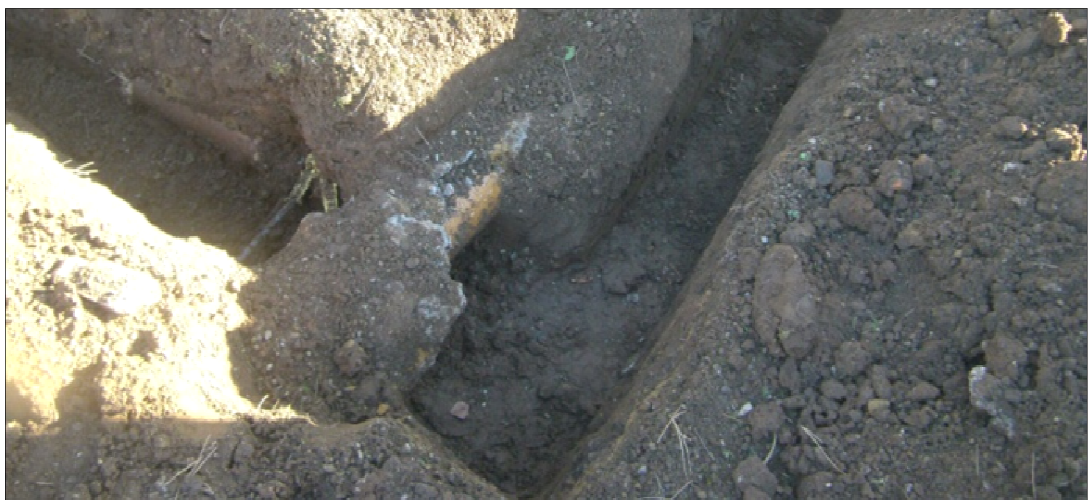
Plate 1 drain trench showing existing draining and services

3.3 At the north-western corner of the new trench, it crossed the line of existing services including another drain (Plate 1). This meant that as the new trench ran to the south, past the western end of the church, these lay immediately adjacent to its eastern side (Plate 2). As a result, most of the material excavated along this leg of the trench was again the back-fill over the earlier services, although the soil sequence exposed in the western trench edge appeared to be undisturbed. This consisted mainly of homogeneous, relatively stone-free mid brown silty sand. At the base of the trench, at c.0.9m below the modern ground level (bgl), there was a lighter brown slightly grittier sand deposit. Some disarticulated human bones were noted within the old service-trench backfill in this area. The trench was broadened to 1m wide at the point where a manhole was installed to accept the new drain running from the south-western corner of the church. The shallow (0.35m deep) trench running from the church wall was excavated entirely through disturbed ground, partly backfill over the services noted above, and also a drain running at the foot of the church wall below the new level of excavation (a drain cover for this was located immediately adjacent to the new trench).

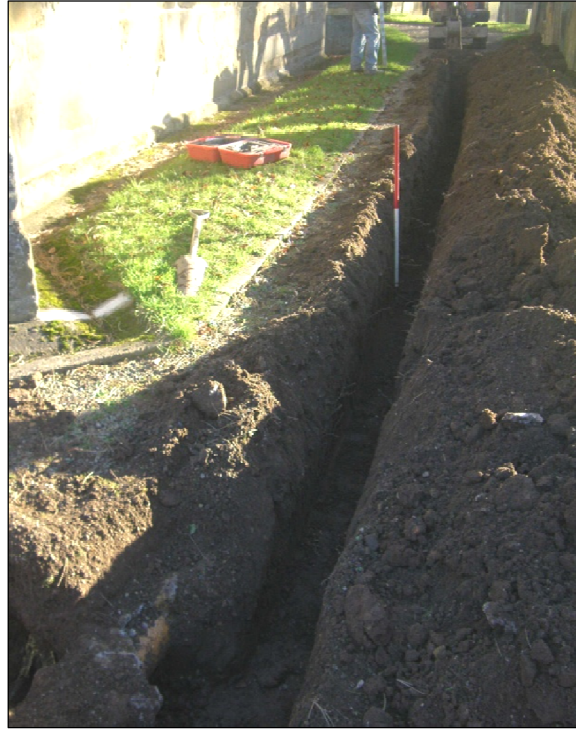
Plate 2 drain trench excavated past west end of church

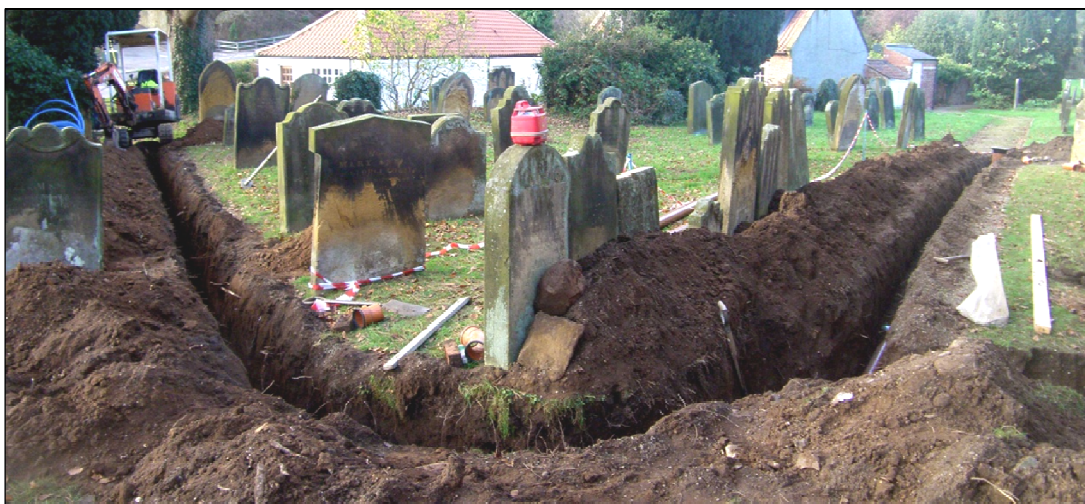
Plate 3 overall view of drain trench passing the west end of the church (to right) and turning down path to gate (left), facing north-west

- 3.4 From the manhole, the new trench curved around the corner westwards (Plate 3). At this point the base was at 0.9m bgl, and it was consistently 0.9-1.05m deep as it continued along the gravel path to the top of the steps. The soil profile observed was consistent throughout this part of the excavation, with homogeneous mid brown silty sand soil overlying the lighter sand at the base of the trench, below c.0.9m bgl (Plate 4). More disarticulated human bone was noted throughout these deposits. Some better-preserved bones within spoil derived from the base of the trench at several locations may possibly have been disturbed from *in situ* burials, although these could not be identified or accurately located given the narrowness and depth of the excavation. There was a sharp cessation of such remains approximately 9m inside the churchyard boundary, no bones being observed to the west of this point.

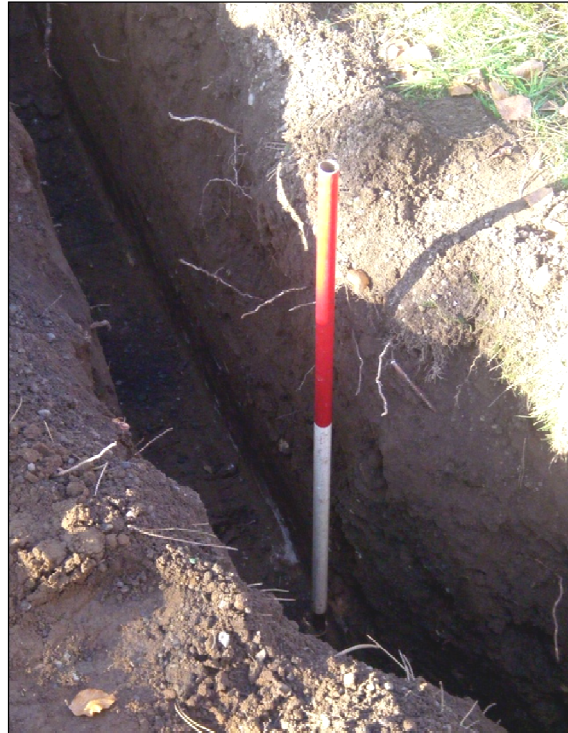
Plate 4 typical churchyard soil profile, at bend in drain trench

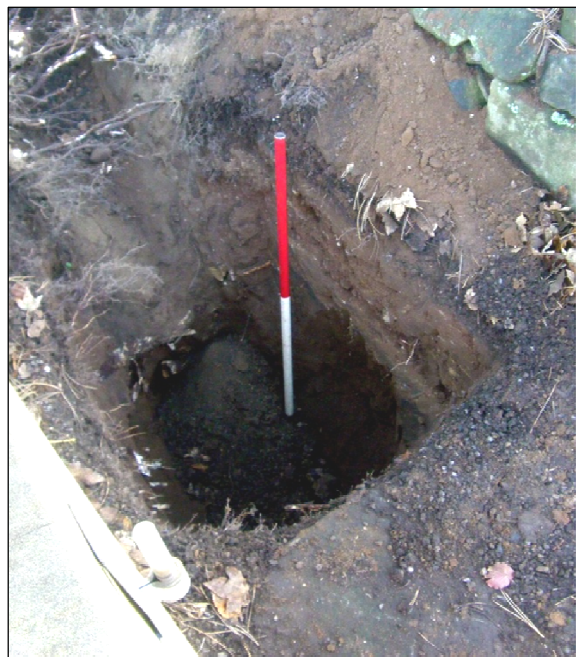
- 3.5 Where the trench ran down to the west through the area of the steps (which were temporarily removed during the works), it gradually shallowed relative to the descending surface level, so that it was only 0.4m deep nearest the gate. Here a 1.05m deep pit c.1m square was excavated immediately inside the gate to accept a manhole. At this point, 0.2m of modern gravel path overlay heavily root-disturbed mid brown silty sand extending to the base of the pit (Plate 5). Passing back upslope to the east, the light brown sand observed elsewhere in the trench base was first encountered 4m inside the churchyard wall, suggesting that the natural slope lies further back from the wall than the modern topography suggests, and that some material may have been dumped against the slope around the periphery of the churchyard perhaps during old road-

Plate 5 manhole excavation soil profile

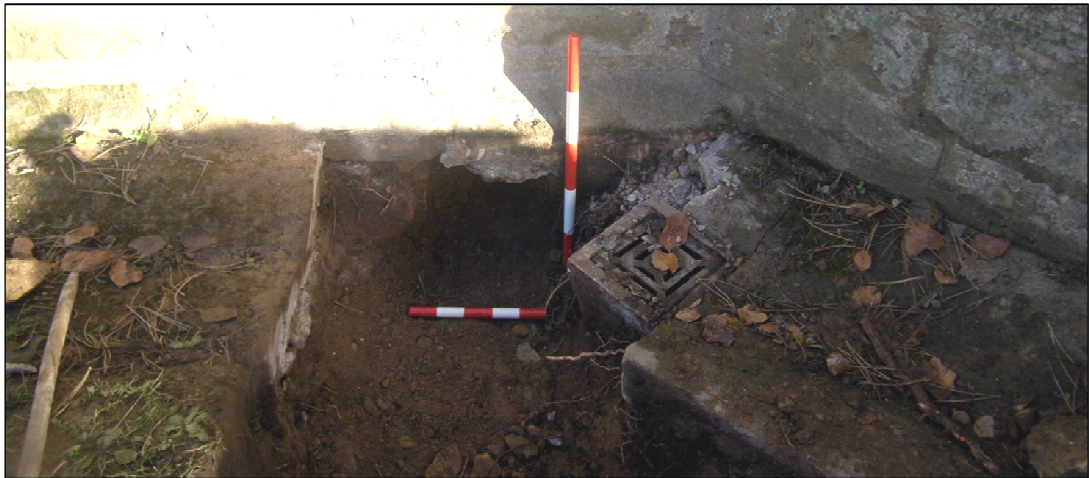
Plate 6 hole cut through west nave wall

3.6 Monitoring was undertaken during cutting of a hole through the western nave wall adjacent to the south-western corner buttress (Plate 6). At this location, a section of the external concrete gutter abutting the foot of the wall was cut out. This revealed that the visible chamfered off-set course at the base of the wall continued down vertically for only a further 0.06m, and rested immediately on top of a rubble footing. This consisted mainly of large rounded cobbles up to 0.36m in size, bonded with light brown, very coarse sandy mortar. The hole cut through the wall angled sharply up into the church, where the floor level is approximately 0.5m higher than the external ground level. It proved impossible to measure the thickness of the footing through this hole; however, extrapolating the wall-thickness down from the window above the site suggested that the footing is approximately 0.80m wide at this point.

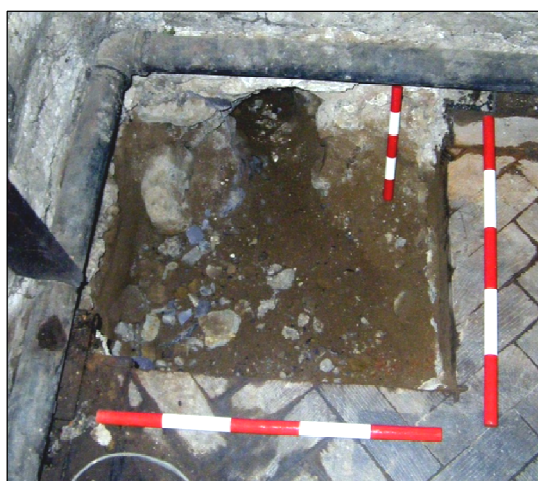
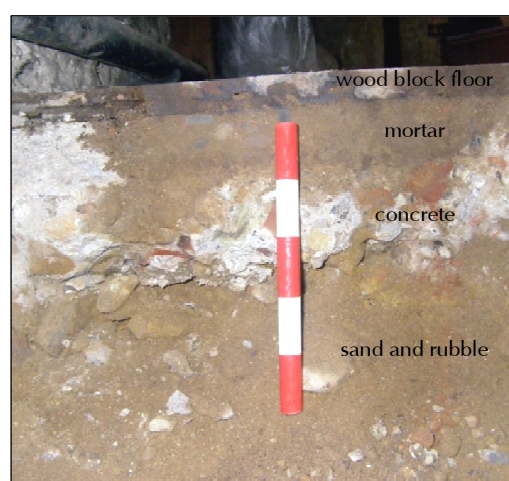
Plates 7 and 8, reception pit excavated through floor in south west corner of nave and flooring sequence exposed in its north side

- 3.7 The reception pit excavated within the church measured 0.65m from north to south and 0.55m wide, and was 0.32m deep (Plate 7). The existing wood-block floor, 0.03m thick, was bedded onto white mortar typically 0.07m thick. This in turn had been laid over a layer of concrete also typically 0.07m thick. This overlay a fairly loose deposit of sand, mortar and stone rubble more than 0.15m thick (Plate 8). The exposed interior face of the church wall was constructed of roughly coursed mortared rubble, concealed above floor level by plaster.
