ARCHAEOLOGICAL
MONITORING
OF
GROUND INVESTIGATIONS

TEES VALLEY ENERGY RECOVERY
FACILITY (TVERF)
REDCAR
TEESSIDE

NAA 20-98
November 2020

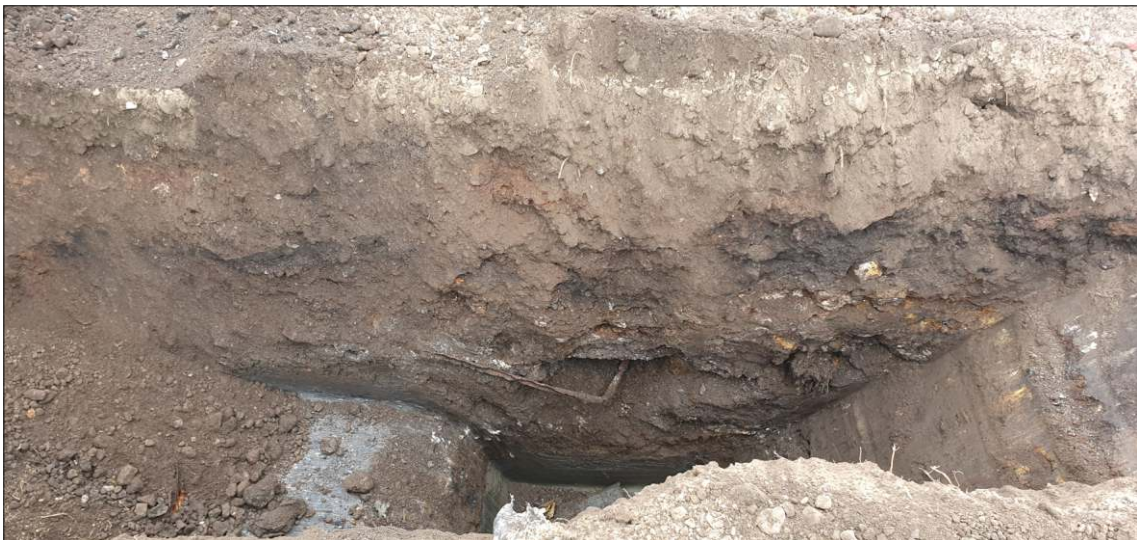
Plate 2

TVERF, Grangetown: BH1 showing industrial ash dumping directly over natural clay

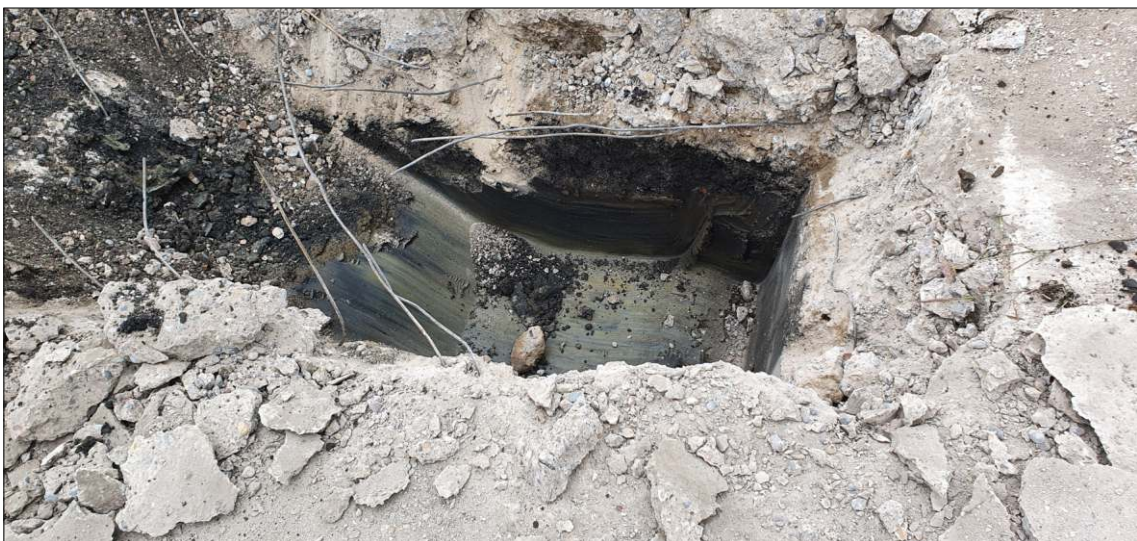
Plate 3

TVERF, Grangetown: DS12b showing industrial ash dumping directly over natural clay

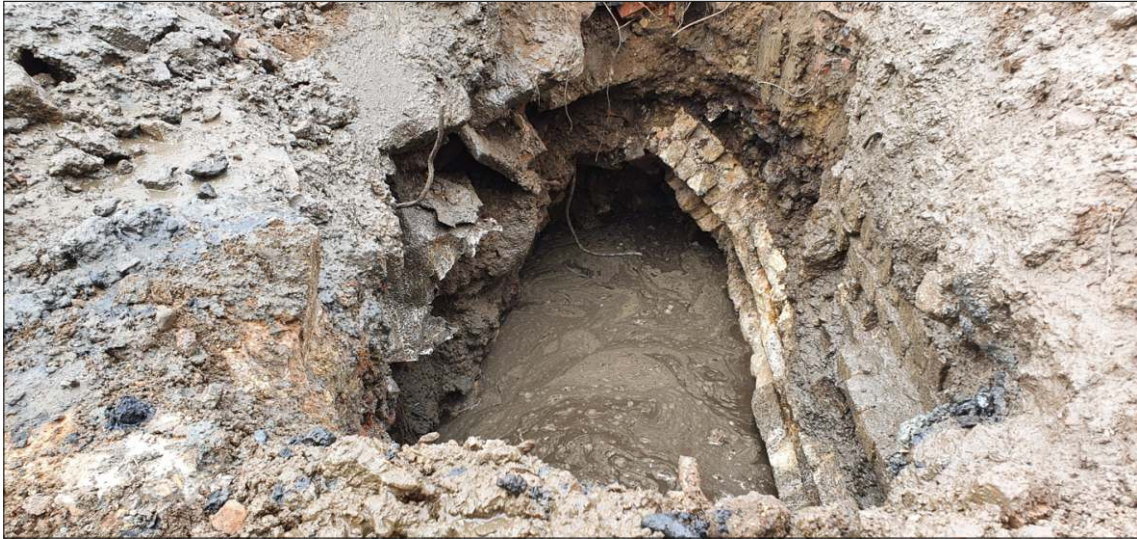
Plate 4

- 5.11 Just to the south in DS 15, demolition rubble had buried a brick-built tunnel, possibly a flue, running from northwest to south-east (Plate 4). The top of the arch was c.0.9m bgl and it extended to more than 1.8m bgl. The tunnel walls were four courses thick and the internal cavity was 0.8m wide. Another brick wall was noted in section adjacent to the tunnel. DS 15a excavated nearby recorded demolition rubble to more than 2.5m bgl.

TVERF, Grangetown: DS15 showing brick-built tunnel or flue

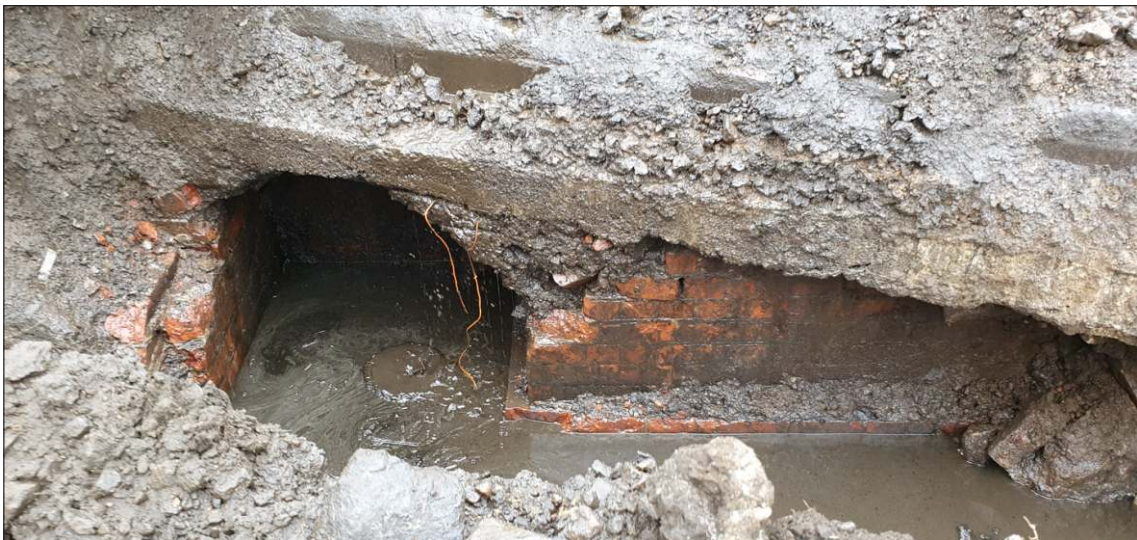
Plate 5

TVERF, Grangetown: TP6b showing brick-built tunnel or flue

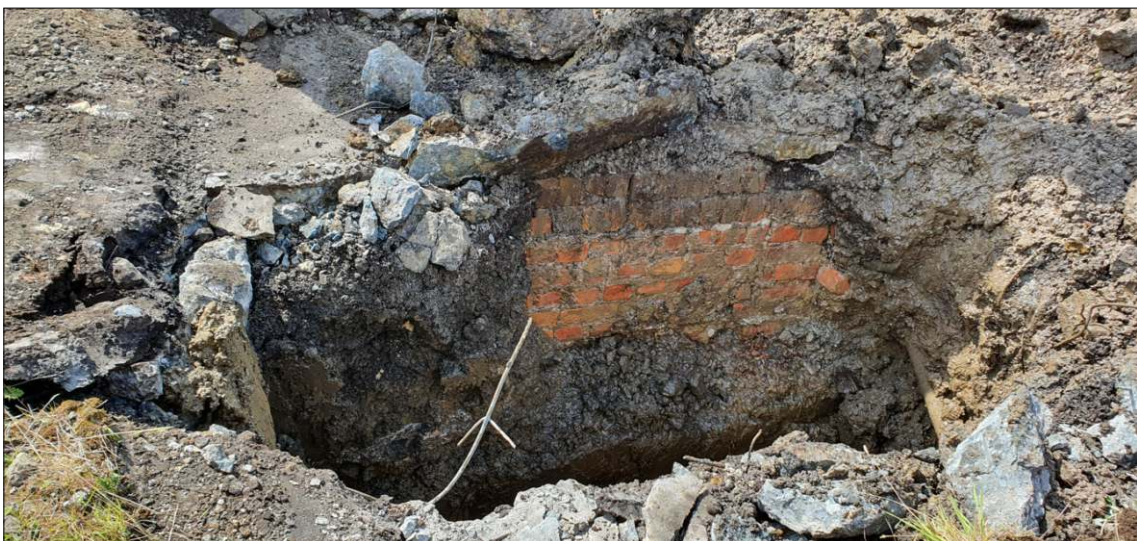
Plate 6

5.15 DS 16 a short distance to the south was excavated 1.6m into a deposit of large concrete and brick demolition rubble. Below the concrete slab at BH 7 there was mixed ash deposits extending down to clay at a depth 2m bgl. Immediately below the slab, a brick wall was observed in the west side of the excavation which survived to a height of 0.8m (Plate 6).

TVERF, Grangetown: BH7 showing brick wall

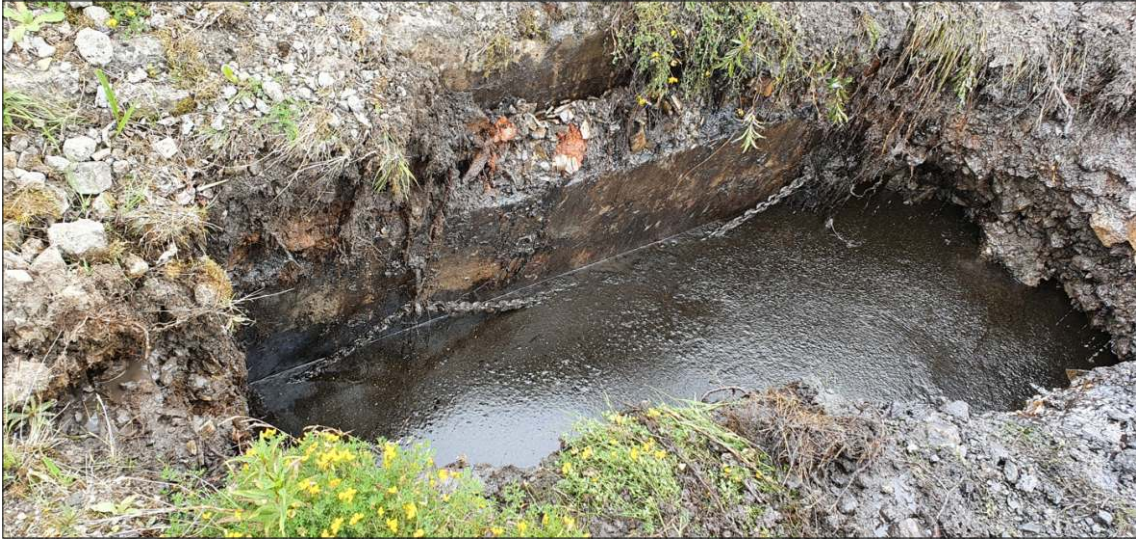
Plate 7

5.17 DS 1 encountered brick foundations and a substantial dump of demolition rubble into a deep cavity, probably part of a basement structure or service corridor. DS 1a was located c.15m to the south-east of DS 1 and was cut through a thick concrete slab. Below this, there was a dump of demolition rubble over a second concrete slab at a depth of c.1.9m bgl. DS 1b/TP 17 was excavated c.1.5m north of DS 1a in a bid to avoid the structure encountered in the previous excavation. DS 1b/TP 17 appeared to be located within a concrete chamber or tank with its base at 2.9m bgl. A chain attached to the wall may have been a handhold (Plate 7). The rubble-filled chamber also contained large electrical cables.

TVERF, Grangetown: DS1b / TP17 showing concrete lining of possible chamber and chain

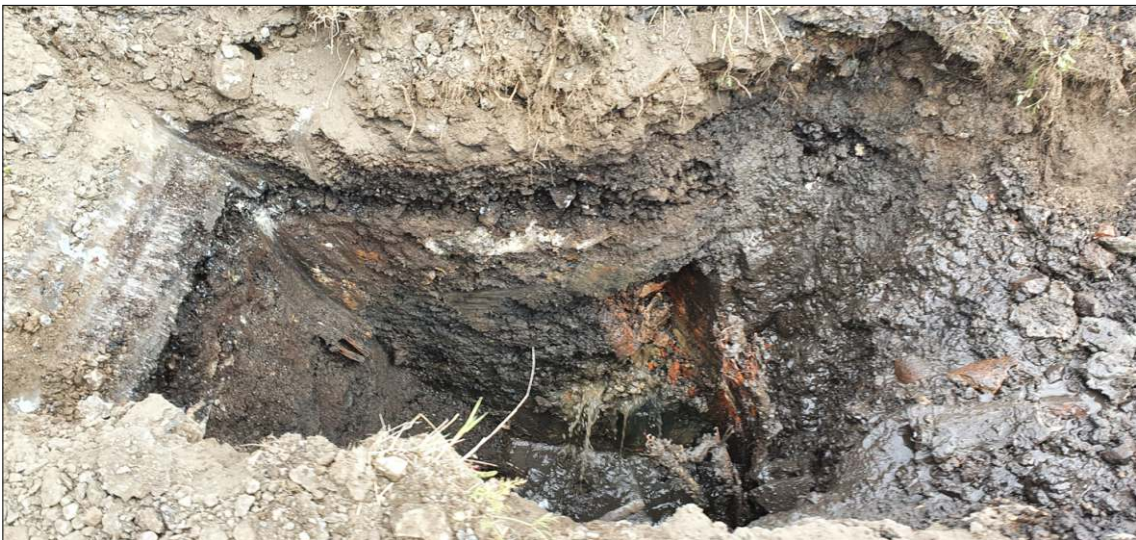
Plate 8

5.19 DS 2 encountered a concrete slab at 1.1m bgl and was abandoned. DS 2a found made ground above clay at a depth of 1.5m. Within the make-up a brick wall crossed the excavation from north-west to south-east (Plate 8). In BH 9b 0.5–0.7m of concrete overlay a deposit of ash and brick rubble, but the pit was excavated only to a depth of 1m.

TVERF, Grangetown: DS2 showing brick wall

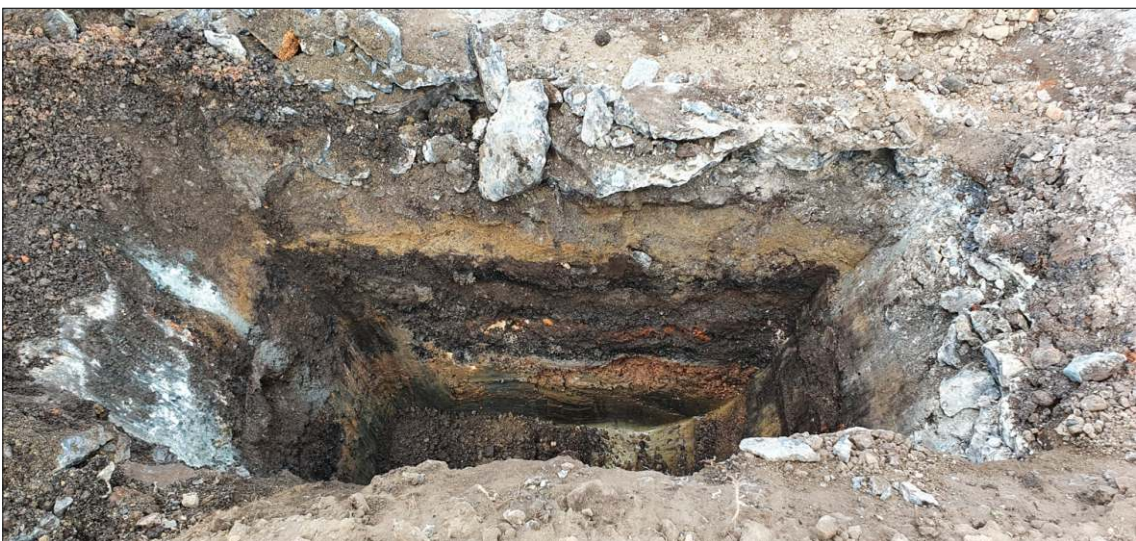
Plate 9

TVERF, Grangetown: DS4 showing industrial ash dumping directly over natural clay

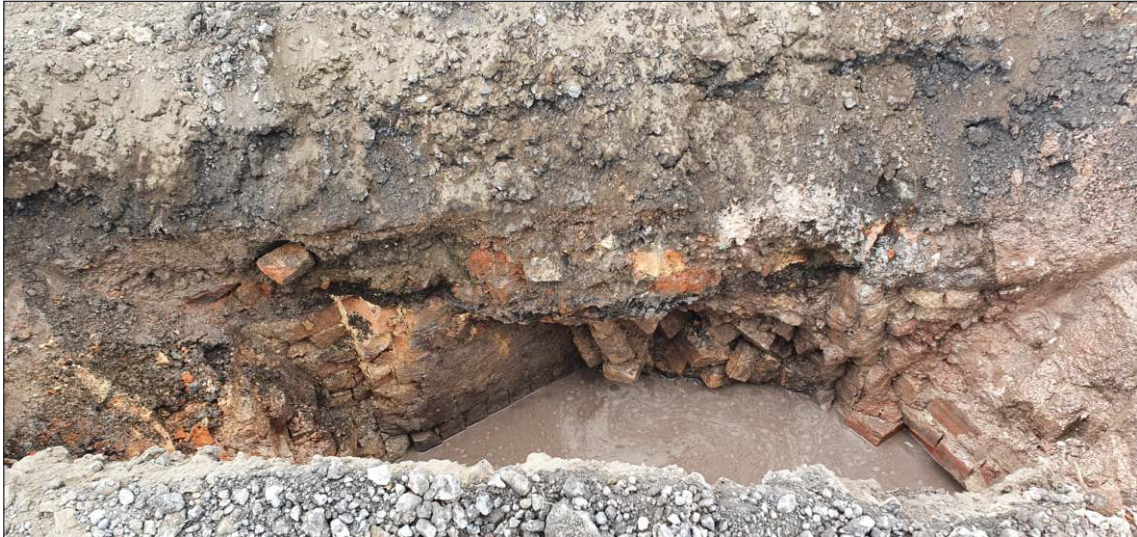
Plate 10

5.21 At DS 10, the concrete surface slab sealed dumps of clinker and rubble overlying another concrete slab at 1.9m bgl. In the replacement excavation DS 10a, demolition debris overlay a brick wall at 0.8m bgl, which continued downwards for at least 1m (Plate 10). Clay was encountered at 2.1m bgl. TP 15 encountered a thick (3m-plus) demolition deposit of wooden railway sleepers, metal ducting, steel structural elements, cabling, broken concrete and brick rubble.

TVERF, Grangetown: DS10a showing brick wall

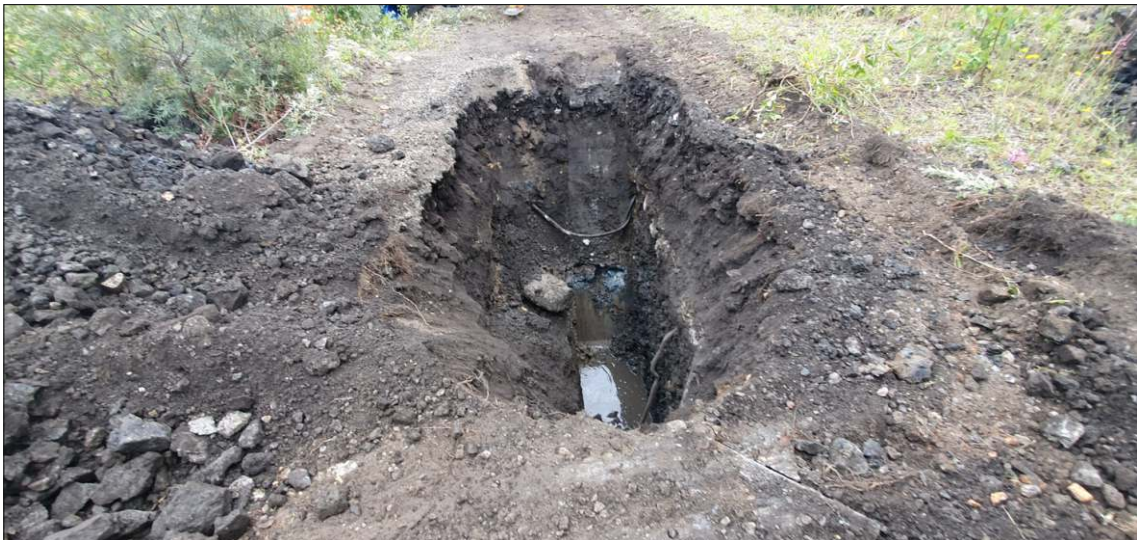
Plate 11

5.24 The area of TP 9 was covered in gravel to a depth of 0.2m, overlying ash and clinker. A deposit of yellow-brown impermeable clay was encountered at 1.1m and this darkened with depth suggesting that it was an undisturbed natural deposit. A concrete footing found at 2m bgl had presumably been cut through the clay. In DS 9, broken concrete and ash overlay a concrete slab at 0.8m bgl. Below this, made ground overlay clay at 2.2m bgl (Plate 11).

TVERF, Grangetown: DS9 showing depth of made ground over natural clay

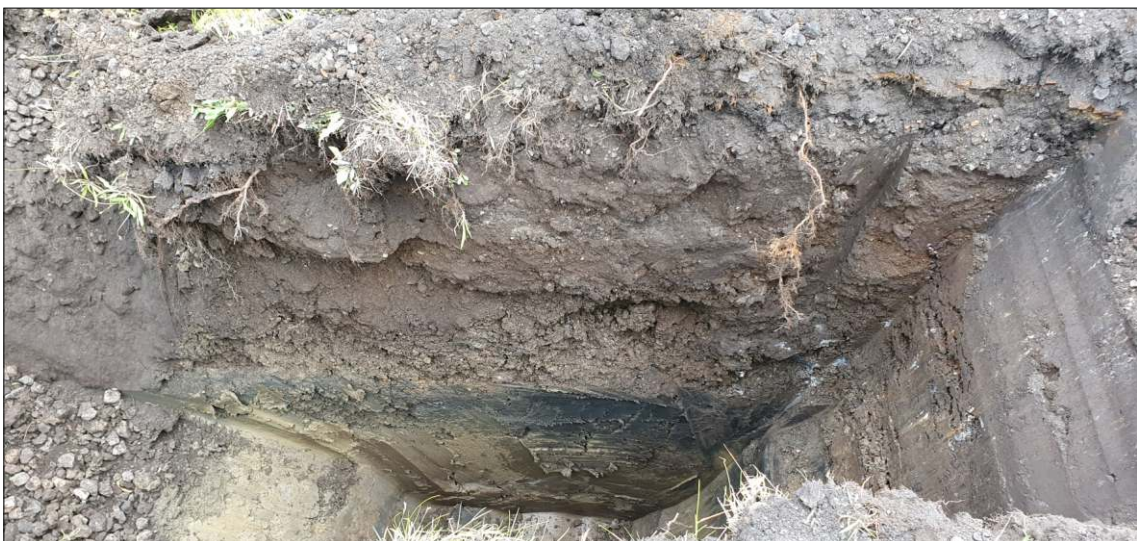
Plate 12

TVERF, Grangetown: TP12 showing industrial ash dumping directly over natural clay

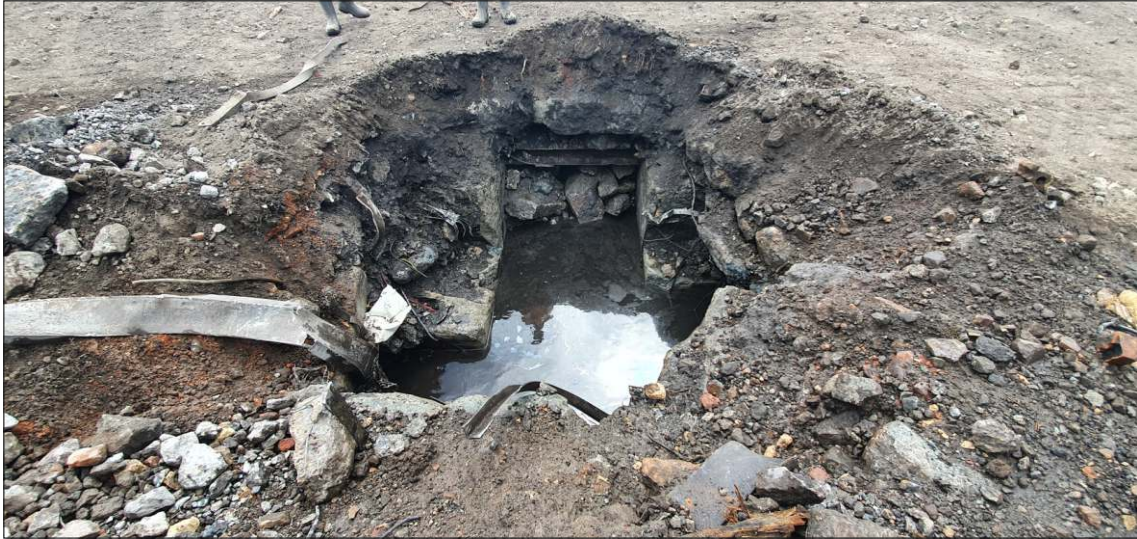
TVERF, Grangetown: BH11b / TP10 showing concrete structures Plate 13

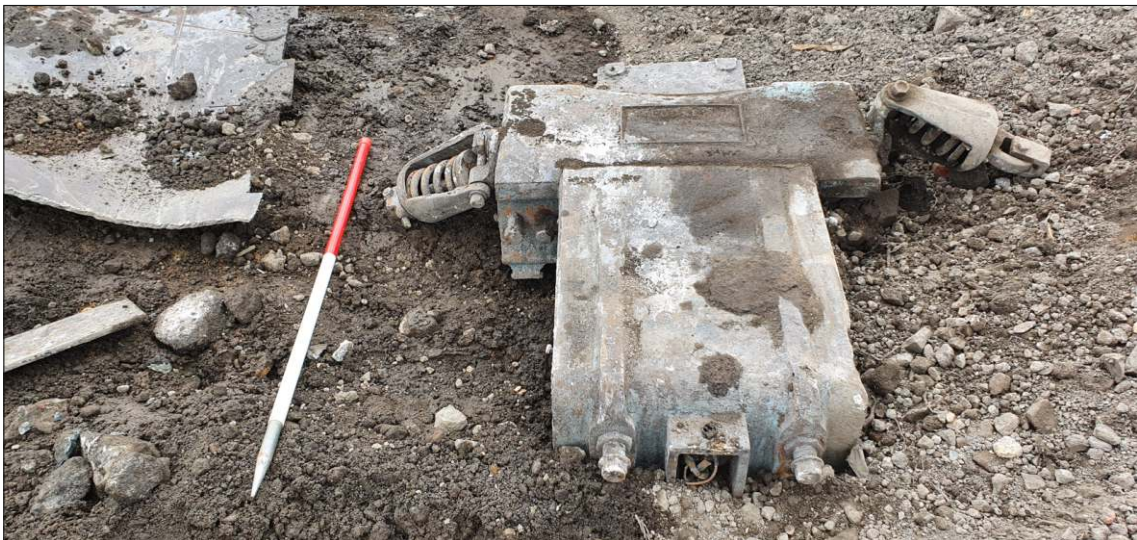
*TVERF, Grangetown: vibrator unit recovered from
BH11b / TP10. Scale 1m*
