**ARCHAEOLOGICAL  
MONITORING**

**A69 LIGHTING  
WEST DENTON  
NEWCASTLE UPON TYNE**

NAA 15/10  
March 2015

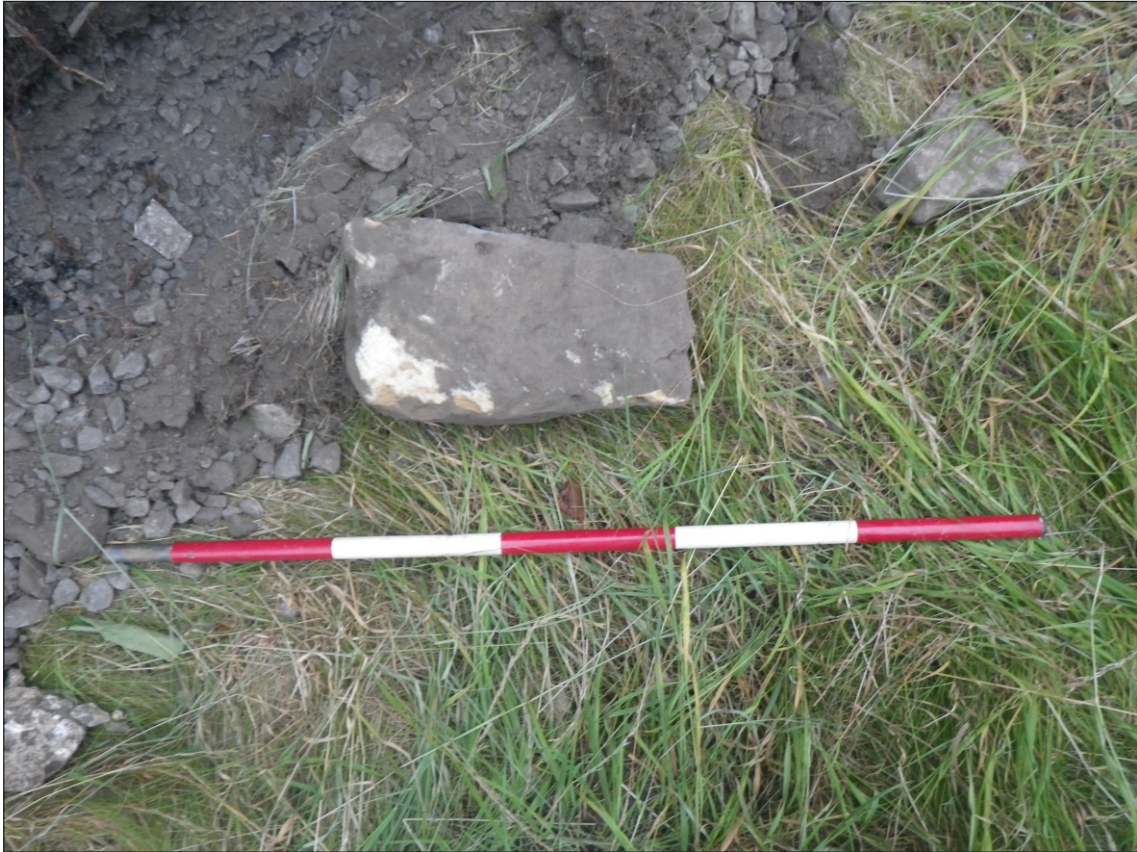
*Plate 1*

- 6.2 Two sections of cable trenching were monitored within this area (Figure 3). The first was along the verge of the slip road, where the trench was 0.55m deep and encountered only road construction layers. However, there was a fragment of dressed sandstone, potentially derived from Hadrian's Wall (Plate 1).
- 6.3 A second trench was excavated across Westlands, on the western side of the roundabout, to connect the street lighting to the existing electricity main via a distribution box known as Feeder Pillar 1 (FP1). The trench was 0.8m deep,

*A69 Lighting, West Denton: block from Hadrian's Wall?*

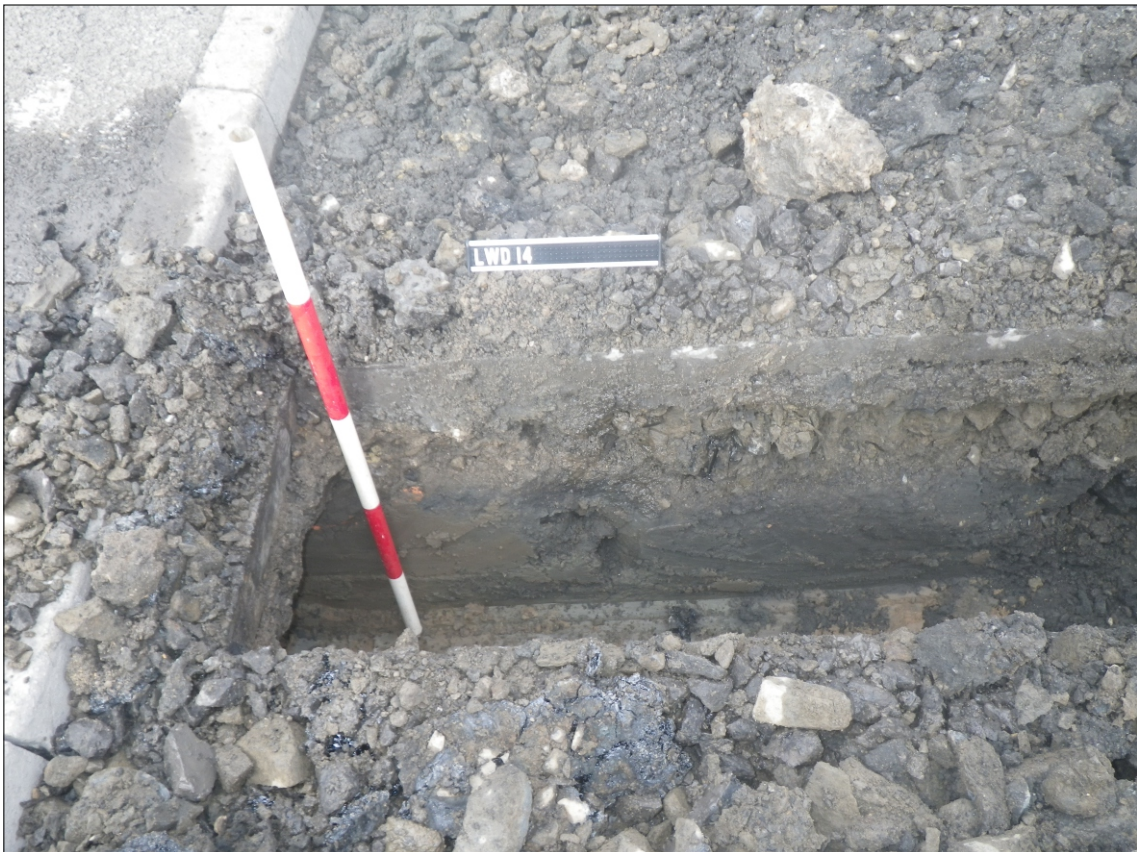
*Plate 2*

and exposed the southern edge of a ditch, filled with a humic blue-grey silt (Plate 2). The feature appeared to extend across the full length of the trench (approximately 5m) but its depth was not ascertained. It was assumed that this represented the ditch along the north side of Hadrian's Wall.

*A69 Lighting, West Denton: Hadrian's Wall ditch, southern edge  
(Westlands FPI)*

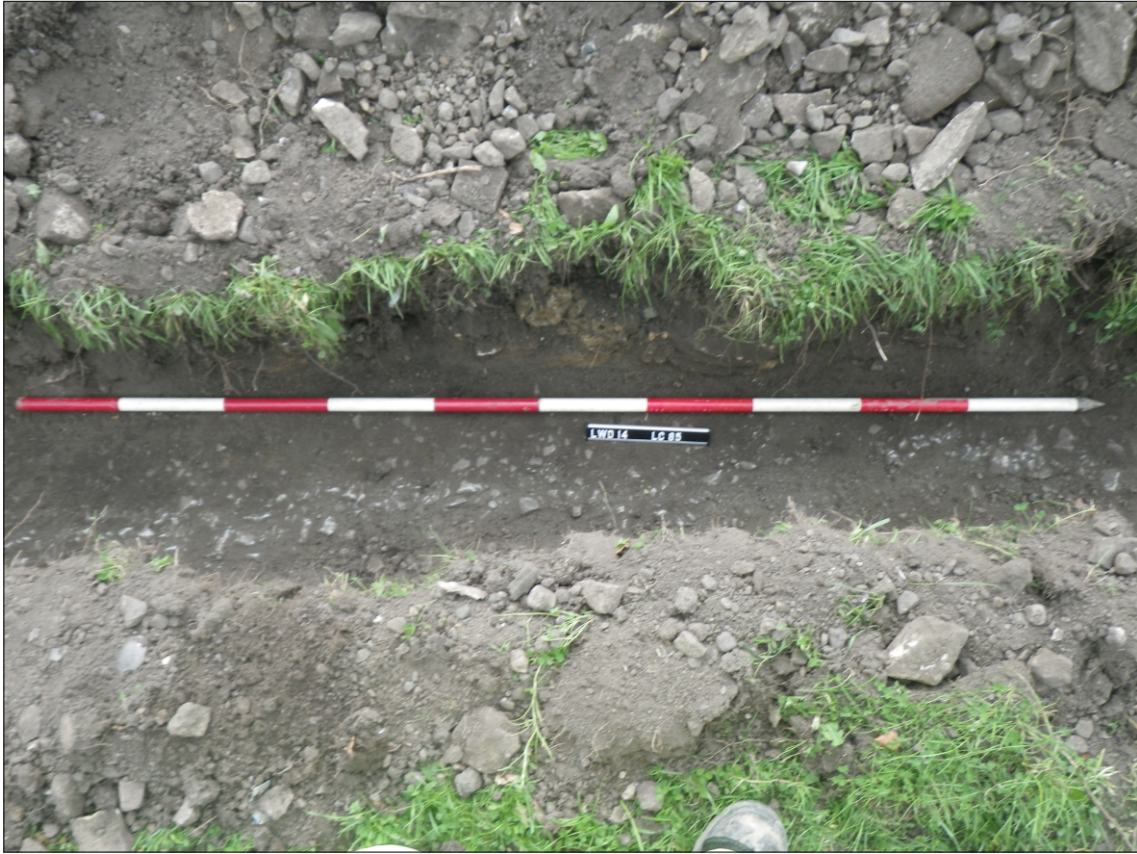
- 6.5 Within the cable trench between lighting columns LC73 and LC75 (WD25 and WD26), the north-eastern side of the trench contained a grey silty deposit that was absent from the south-western side, suggesting that here, again was the southern edge of the wall ditch. Again the adjacent columns, immediately to the south, encountered natural deposits and made ground. Trenching across Sandringham Road, between LC83 and LC85 (WD27 and WD28), revealed a blue-grey silty deposit at a depth of 0.7m. The work was undertaken at night, so no usable photograph was obtained. To the east of the road crossing, near column LC85 (WD28), the trench continued at a depth of 0.55m, revealing an earlier road surface of whinstone gravel (Plate 3).

*A69 Lighting, West Denton: former road surface near column 85* Plate 3

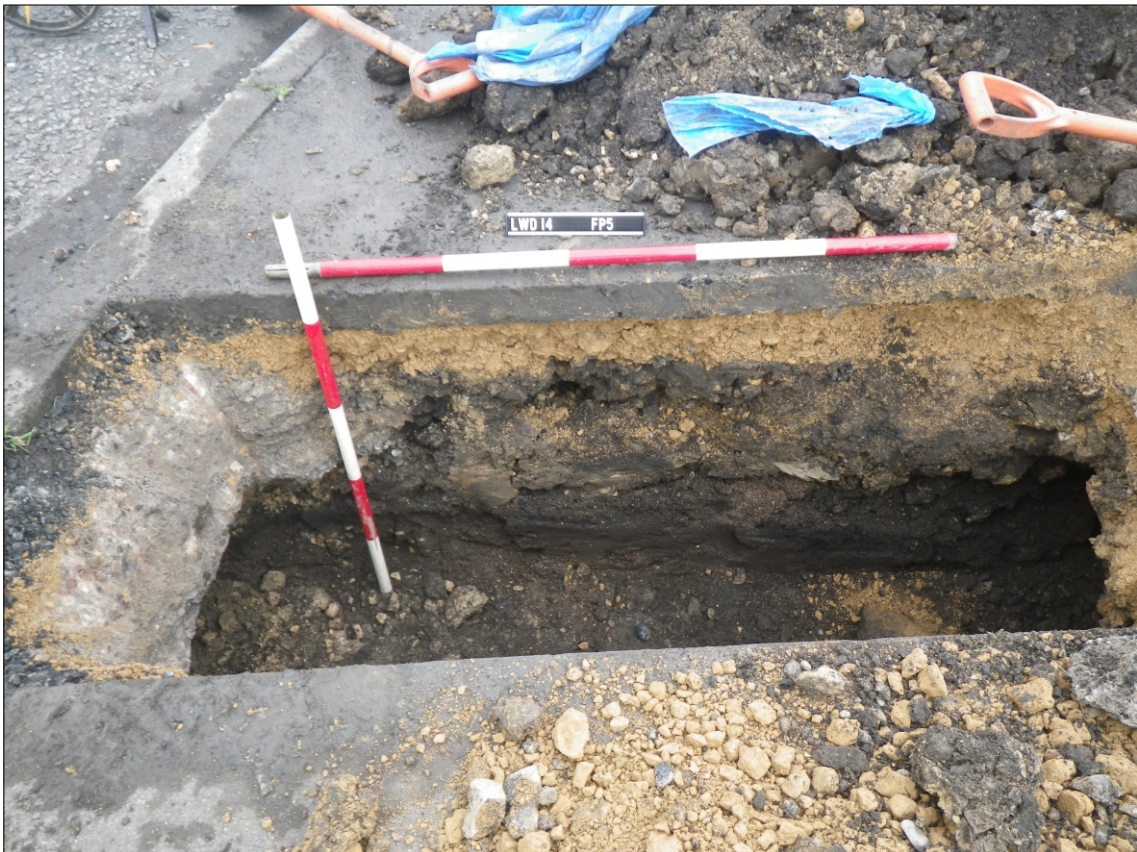
- 6.6 The trench excavated to a depth of 0.75m across South View (Plate 4), connecting Feeder Pillar 5 (FP5) to the electricity main, recorded only road construction layers overlying an 'industrial' deposit of ash and slag.

*A69 Lighting, West Denton: ashy deposit in trench for FP5* Plate 4

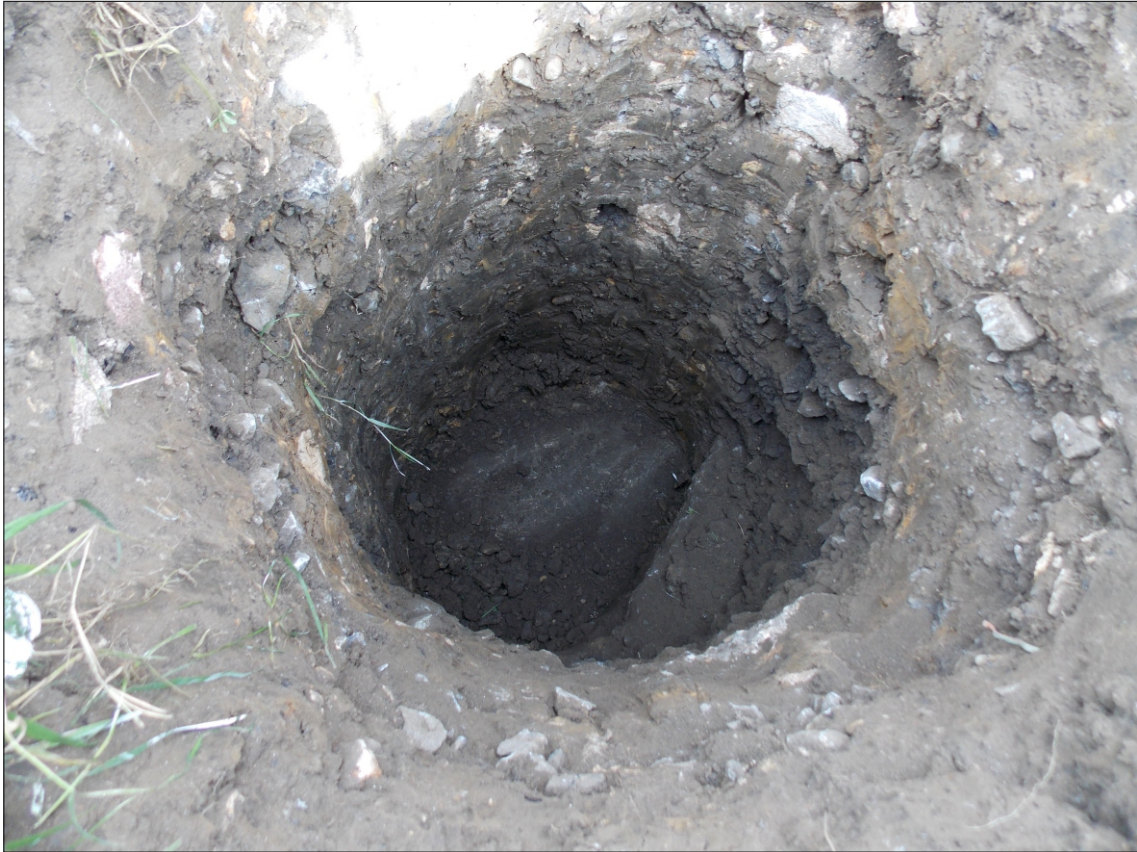
*Plate 5*

*A69 Lighting, West Denton: made ground and bedrock  
in hole for column 71*

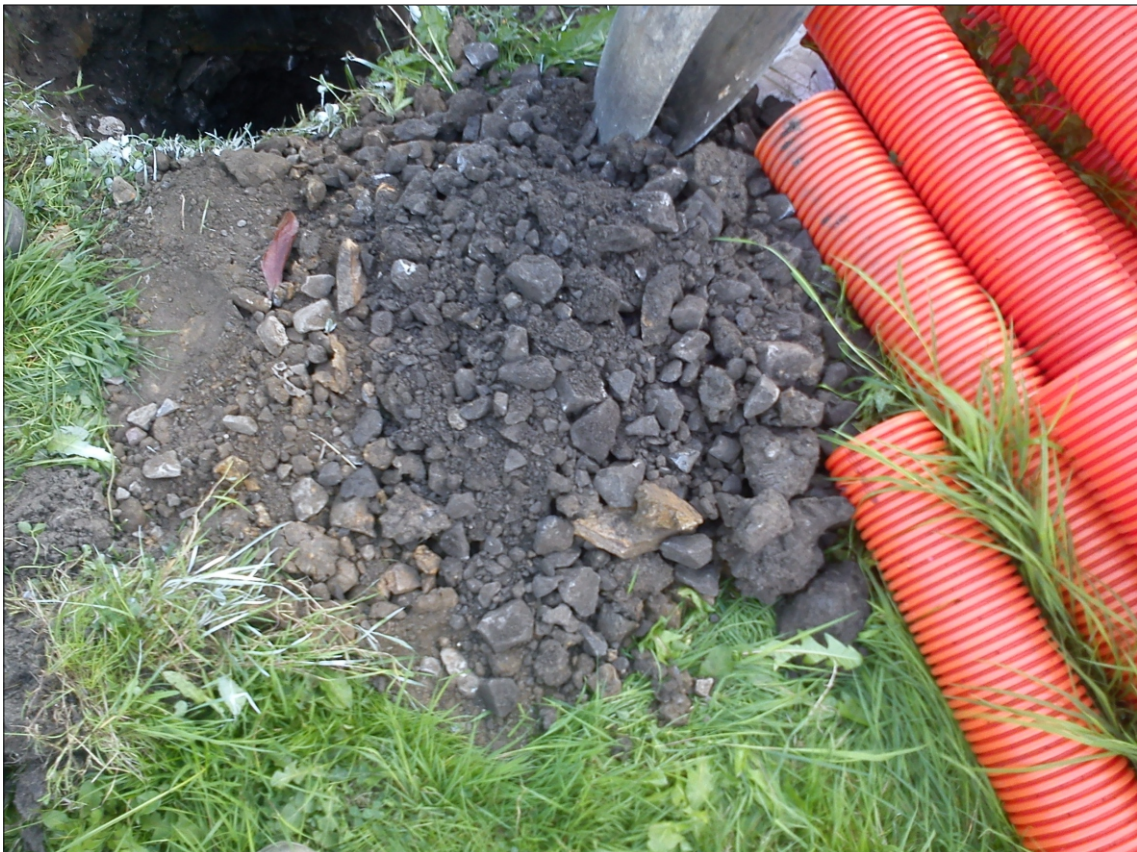
*Plate 6*

- 6.7 The remaining lighting columns within this section encountered natural deposits overlain by made ground (Plate 5), with the exception of LC69 (WD23), where the earlier road surface of cobbles overlain by whinstone chippings (Plate 6) was again encountered. Within the made ground deposits were several fragments of sandstone, again presumably displaced from Hadrian's Wall.

*A69 Lighting, West Denton: slag and whinstone from former  
road surface*

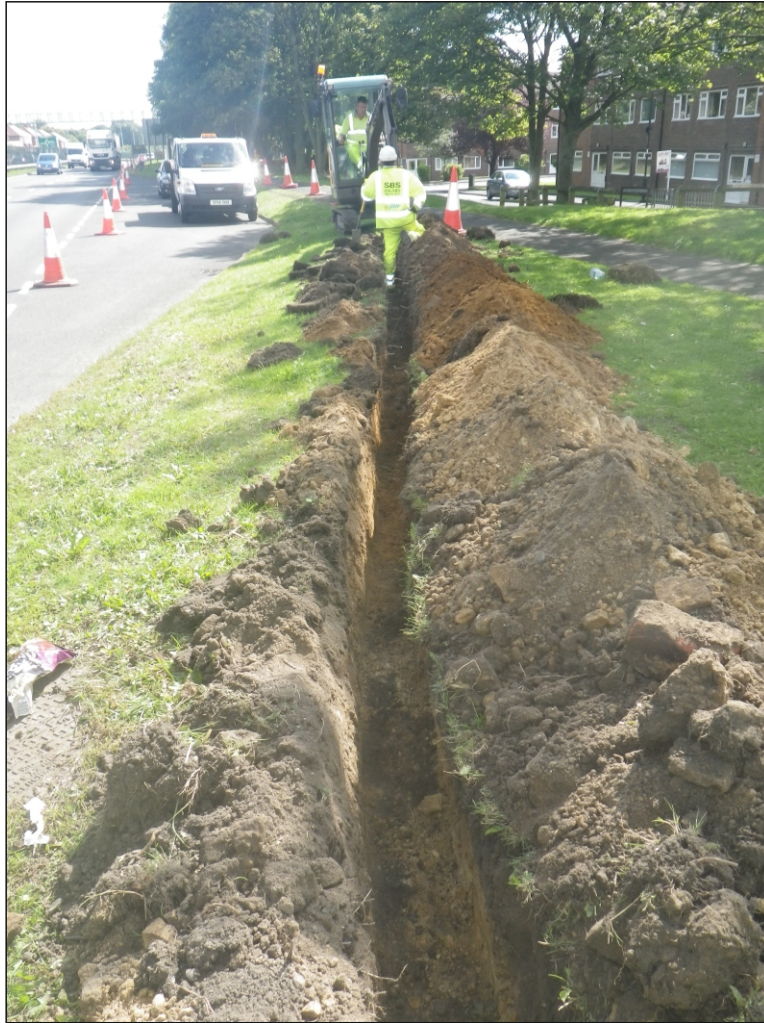
- 6.8 Within this section, a length of trenching and the excavation of one lighting column were monitored. The trenching along the southern verge of the A69, together with the pit for column LC88, revealed sandstone bedrock beneath a topsoil layer that in places was no more than 0.05m deep (Plates 7 & 8). A

*A69 Lighting, West Denton: trenching through bedrock south of A69* Plate 7

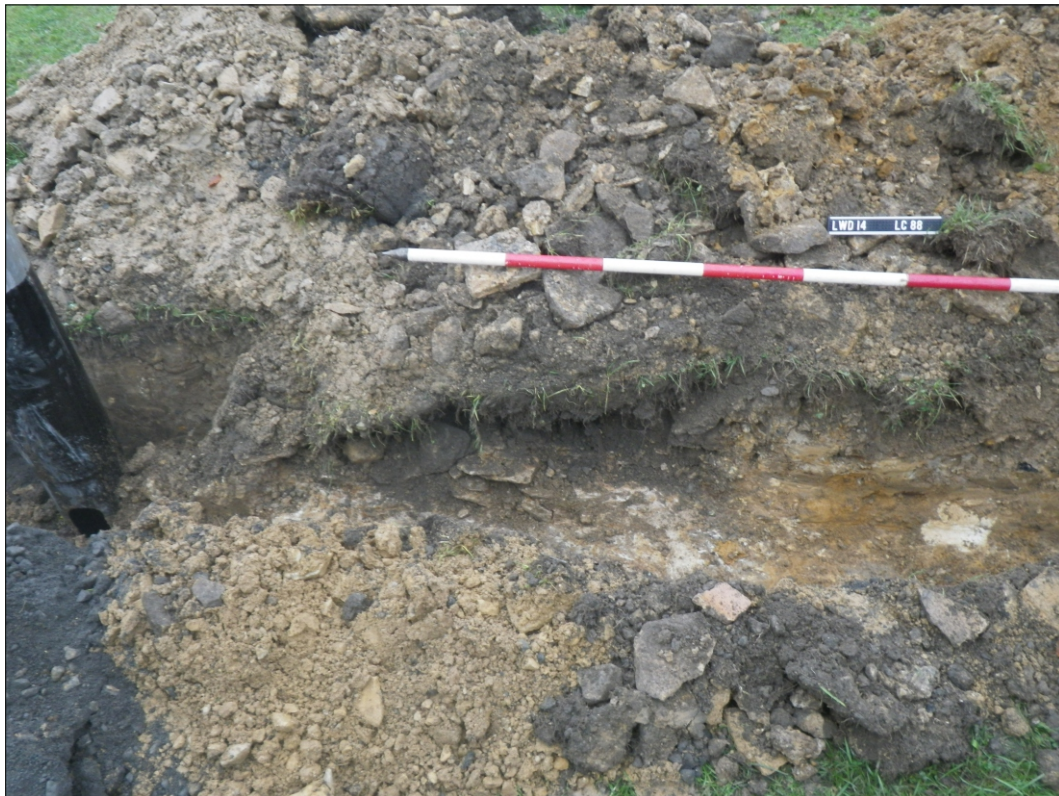
*A69 Lighting, West Denton: sandstone bedrock showing edge of cutting, near column 88* Plate 8
