WATER MAIN RENEWAL, GILLYGATE, YORK

ARCHAEOLOGICAL MONITORING

NAA Report Number: 17/92

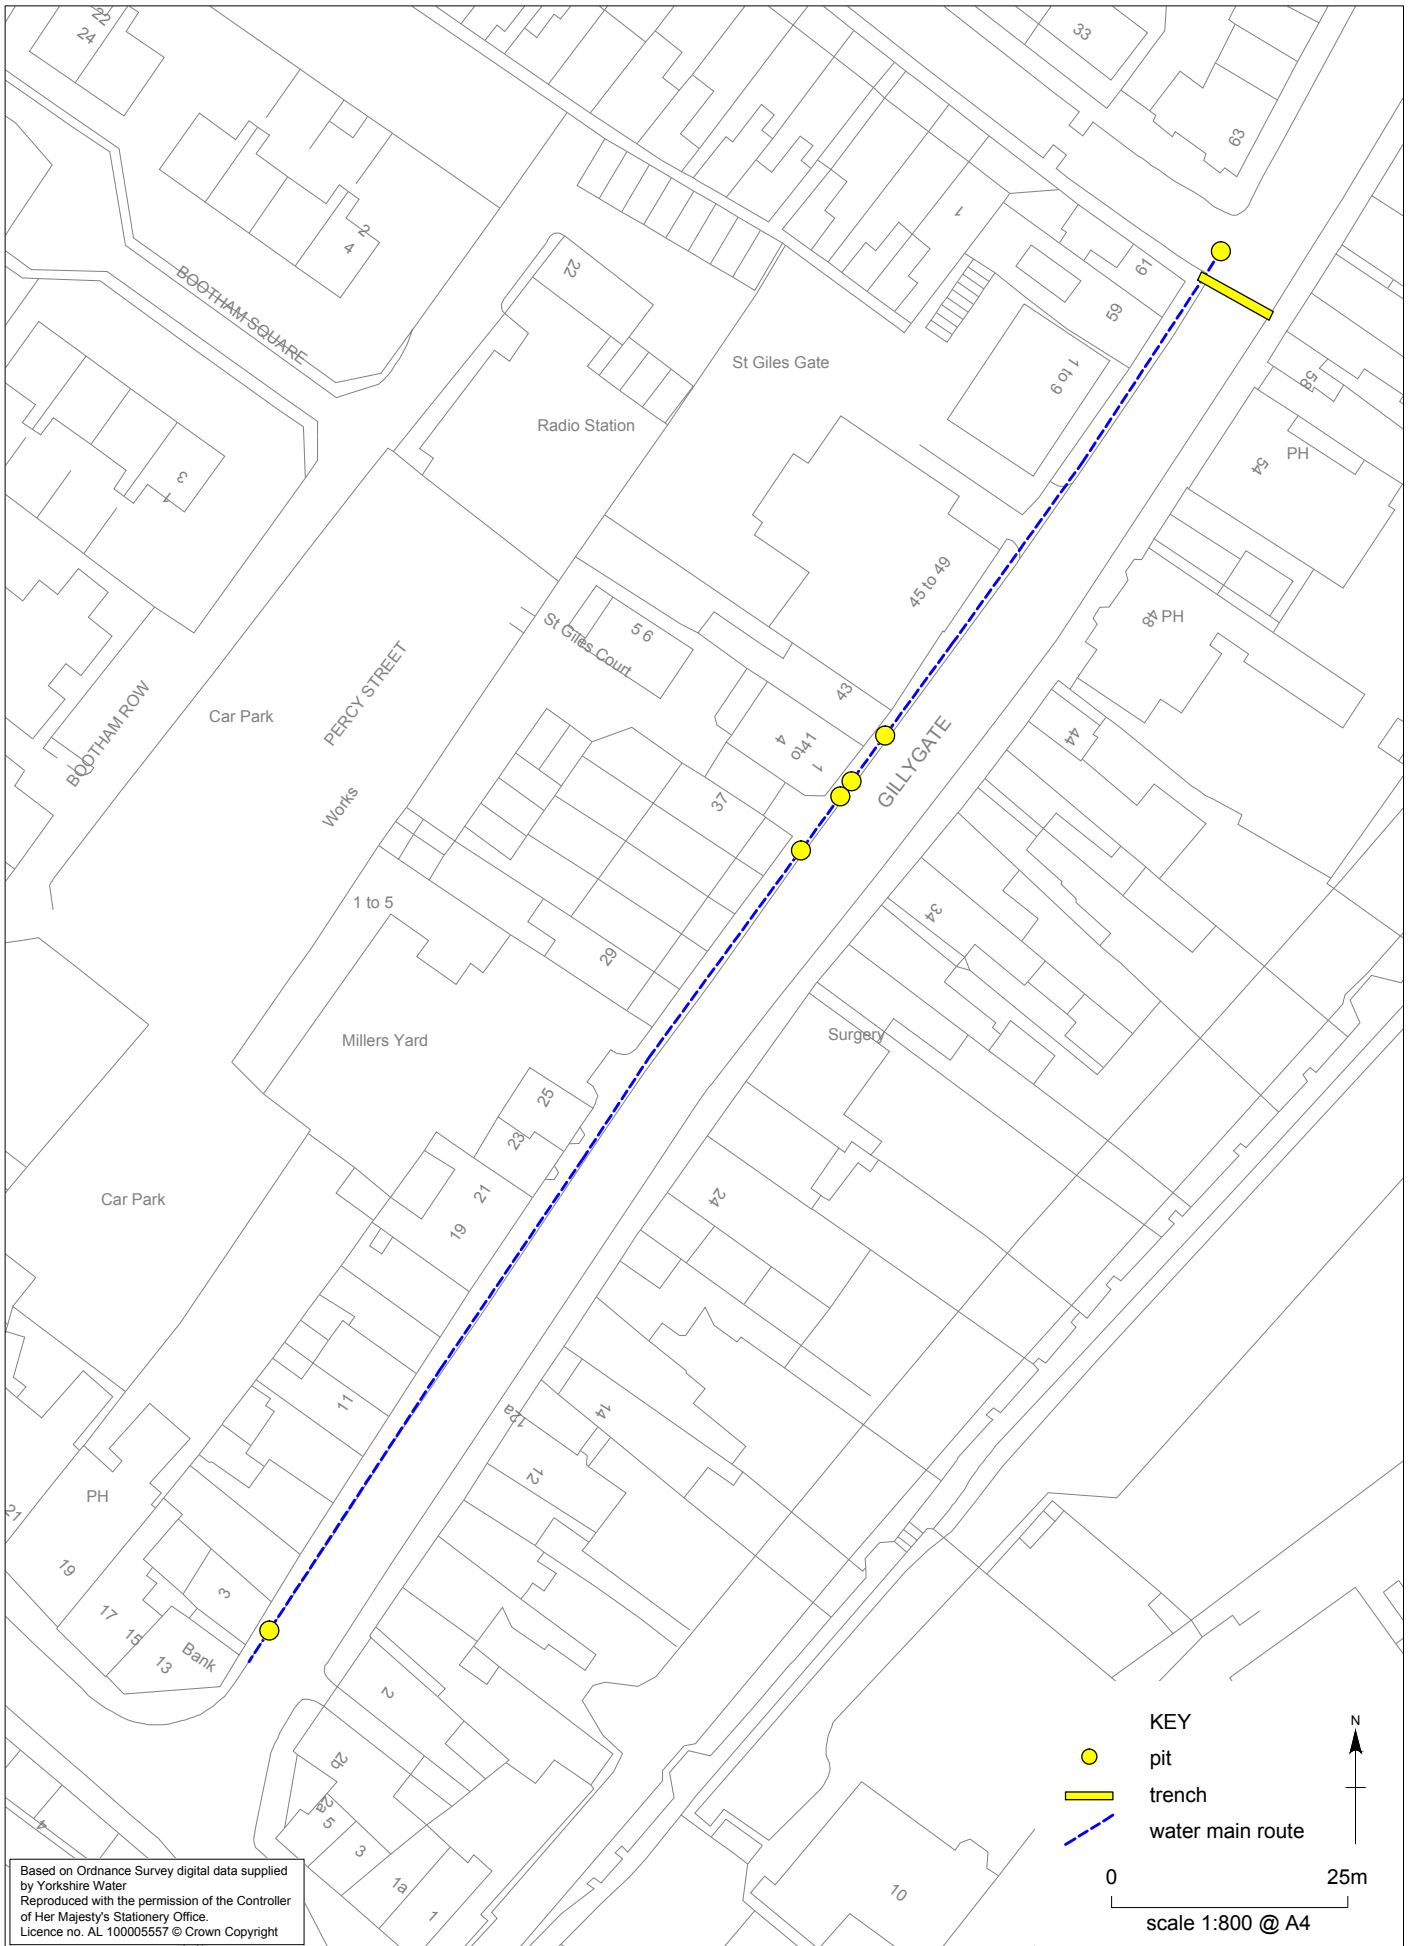
Figure 2

Gillygate, York: work location

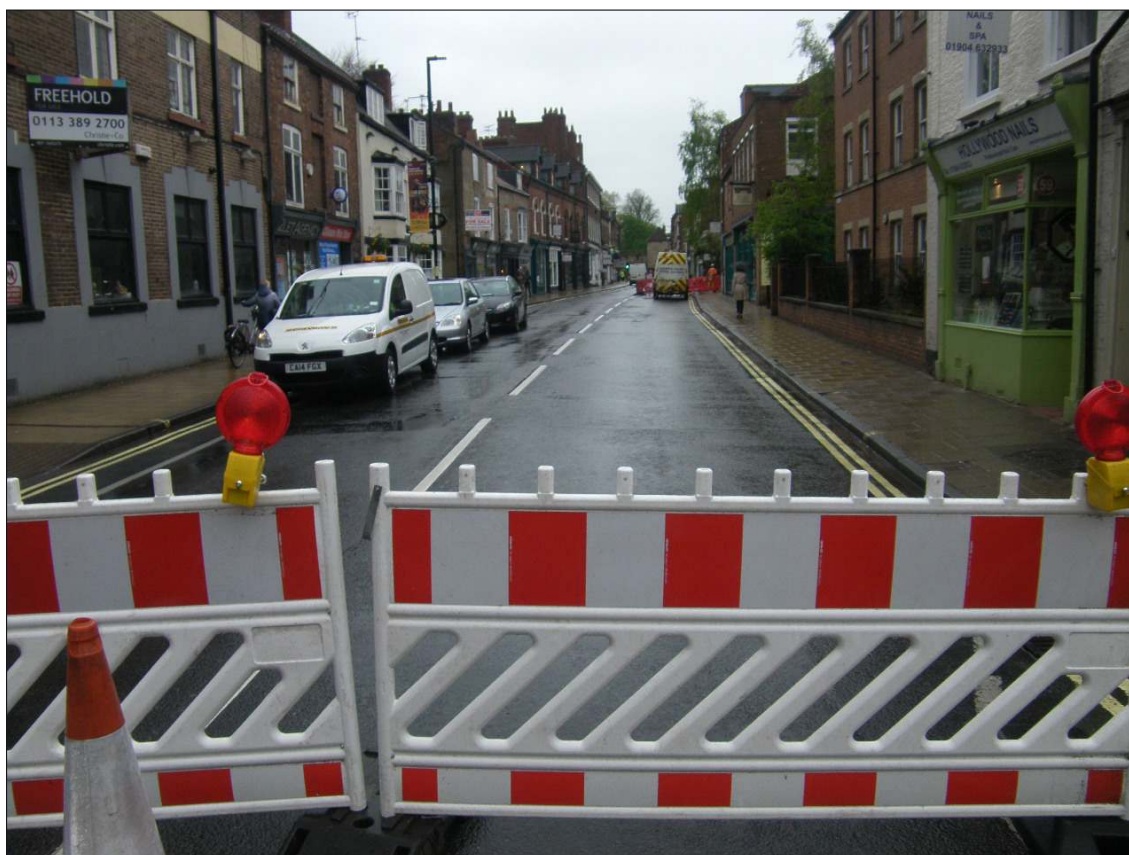
Plate 1

Gillygate, York: general view of Gillygate, looking south

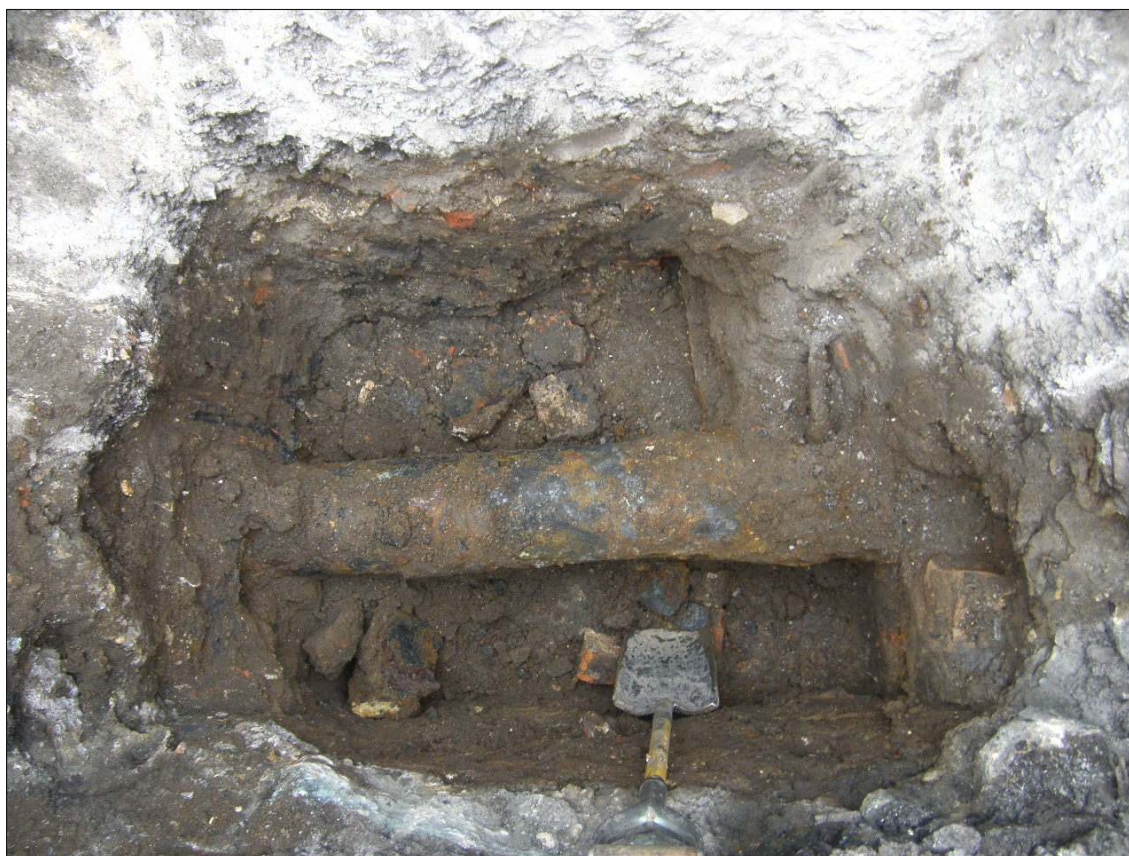
Plate 2

Excavations were undertaken by hand, apart from the trench across Gillygate. The pits within the footpath were all approximately the same size, 1.5m x 1m x 1m deep. Two further pits, each measuring 1.5m x 1.2m x 1.2m deep, were excavated for the Gillygate road crossing; one on the corner of Portland Street, the other directly opposite. The interconnecting trench was 0.6m wide and 1.2m deep, rising to no more than 0.5m deep in the middle of the road due to the presence of a concrete casing for the main sewer. Each excavation contained similar redeposited materials, consisting of silty sand, clay and fragments of modern brick and tile (Plate 2), and most excavations revealed evidence of recent disturbance for service upgrades and the installation of fibre optic cables. There were no features, deposits or artefacts of archaeological interest.

Gillygate, York: typical pit profile showing made ground and water main
