St Mary's Church Capel St. Mary, Suffolk

CSM 013
Archaeological Monitoring Report
SA CIC Report No. 2015/003
Author: Stuart Boulter
© Suffolk Archaeology CIC

Archaeological Monitoring Report

Site Code: CSM 013

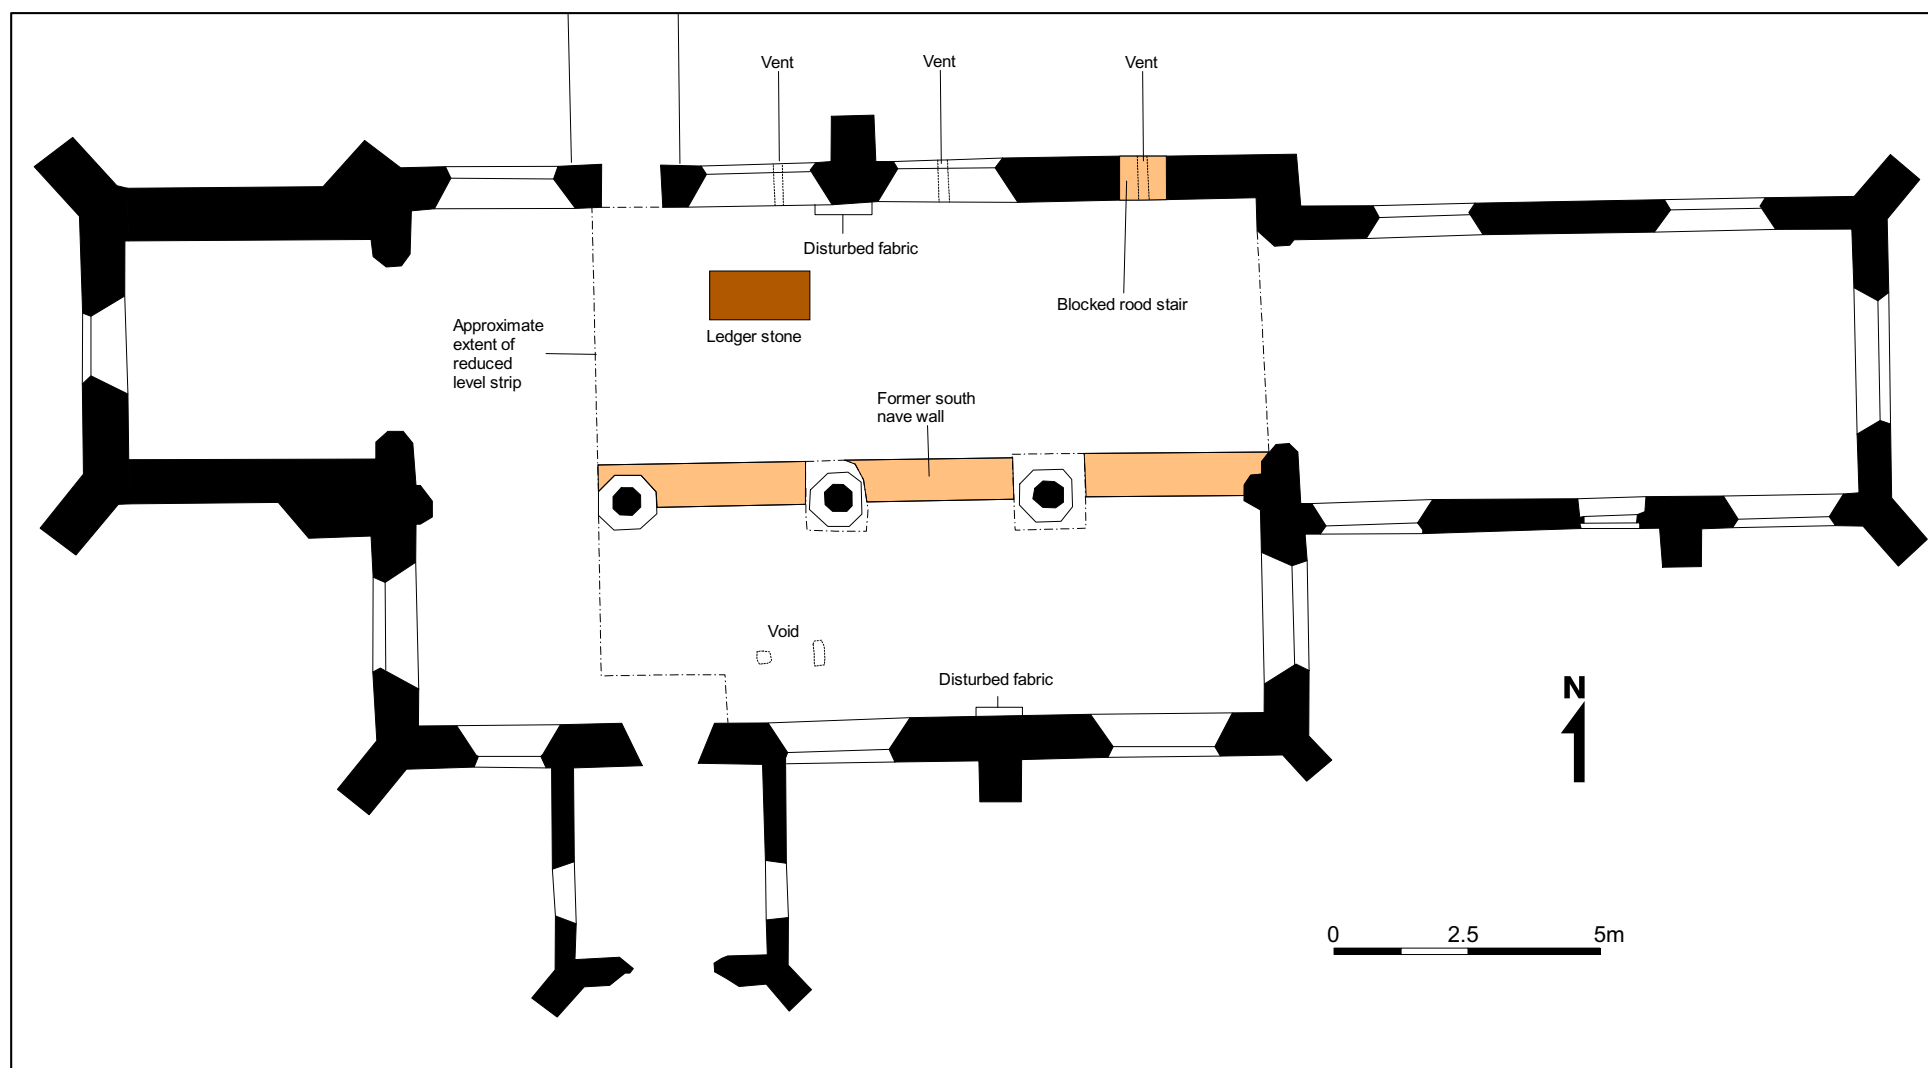
Figure 2. Plan of observed features

An area of brickwork seen below the base of the wooden wall boarding on the internal face of the south aisle wall (Fig. 2) coincided with the position of an external, mainly brick-built buttress and clearly represented where this architectural element had been tied into the medieval wall.

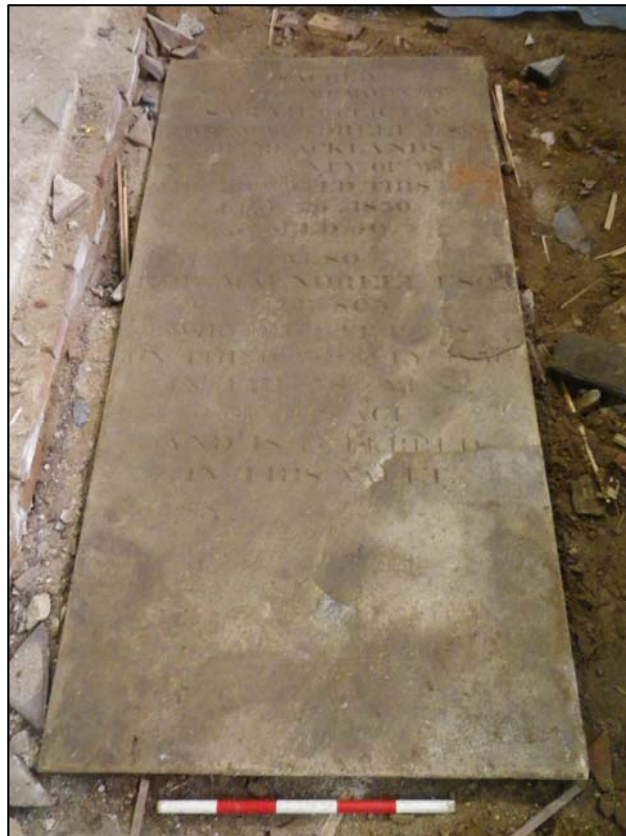
Removal of the wooden flooring prior to ground level reduction revealed the ledger stone in its entirety (Fig. 2 and Plate 1). The stone was aligned with its long axis parallel to that of the church with the inscription readable looking west. Given that stones such as these would, if *in situ*, have been located in the aisles or other exposed open floor areas not covered by wooden flooring in order to be visible, it was no surprise to find that there was no associated tomb immediately below the stone. In addition, the level of the upper surface of the stone was below that of the existing tiled aisles, an observation considered to be further evidence that the stone had been translocated from its original location within the church, probably during an earlier reordering.

The stone was rectangular, measuring 1.89m by 0.92m with a thickness of between 8cm and 9cm with cleanly cut edges at 90° to the flat upper surface. Petrologically, the stone appeared to be of a type similar to York Stone, a fine grained slightly micaceous sandstone with horizontal partings, the latter resulting in some of the lettering having flaked away, while other areas seemed to have been worn, probably by the passage of feet when the stone was in its original position.

Cleaning of the stone surface revealed the inscription to its best advantage allowing for its transcription (see below and Plate 1). However, there were still areas where wear and flaking had made the inscription illegible. Fortunately a marble monument on the north wall of the chancel (Plate 2) included essentially the same details in perfect clarity which facilitated the resolution of the ledger stone text with some certainty.

Plate 1. Ledger stone; taken from the east

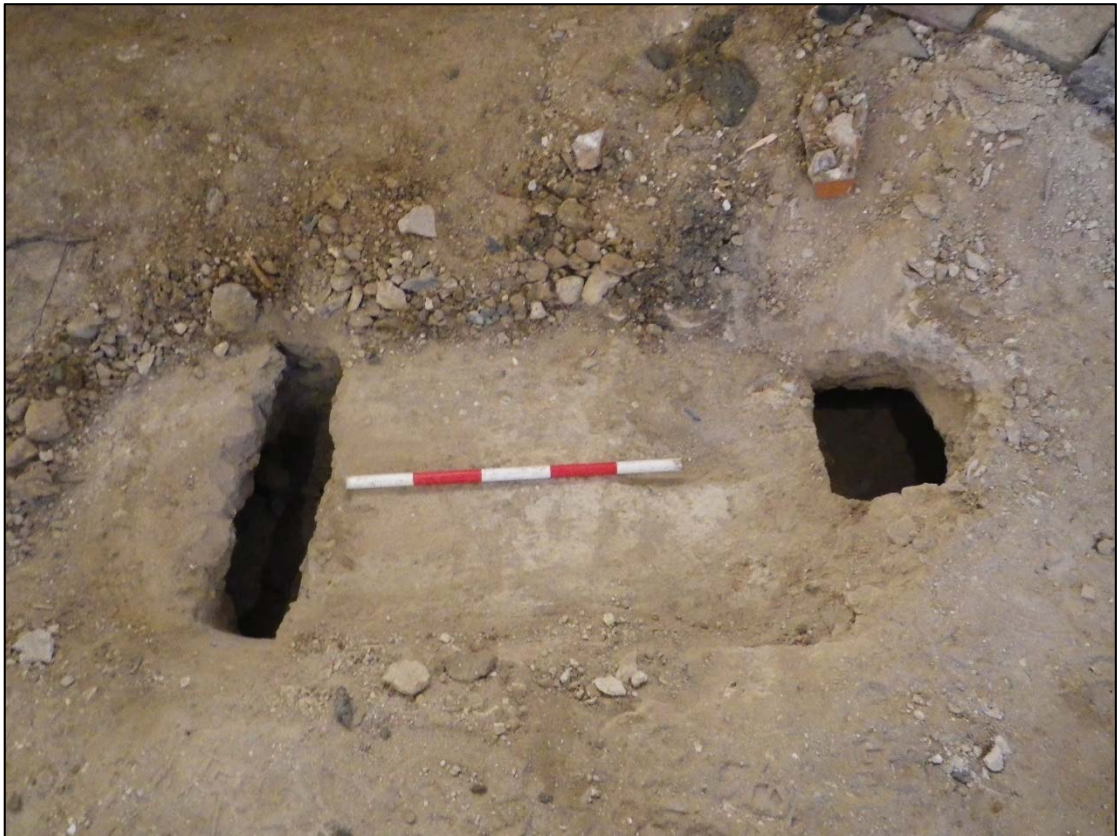
The void was located within the south aisle of the church just to the east of the doorway (Fig. 2 and Plate 3). No structural evidence such as brickwork was present to suggest that this was a compromised tomb, and it is likely that it represented a void left by the collapse of a coffin/coffins.

Plate 3. Void; taken from the north

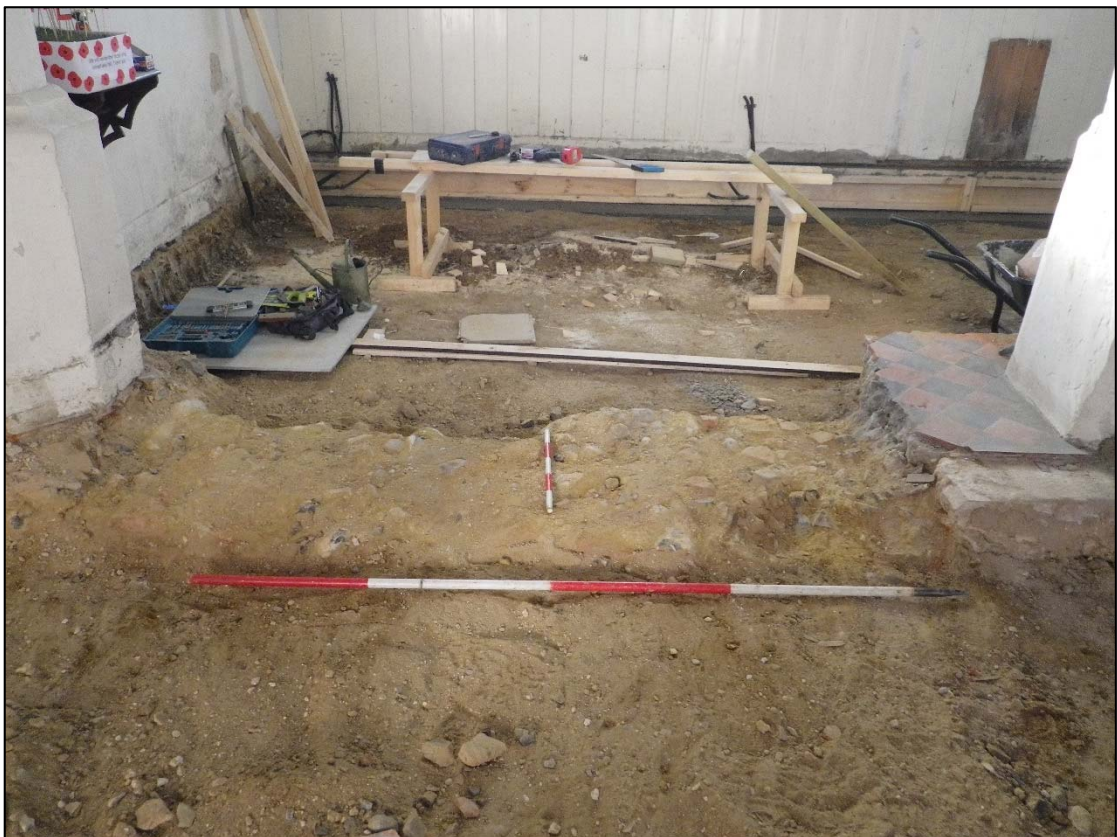
Plate 4. Stub of nave wall, easternmost arcade arch; taken from the north

The reduced level strip revealed the stub of the former south nave wall as a continuous feature running between the three aisle piers and the eastern respond (Fig. 2 and Plates 4 - 8). The existing tile floor between western respond and the westernmost pier was not disrupted during the site works (Fig. 2).

The exposed wall stub was 0.80m wide and projected up to a maximum of 0.20m above the reduced level surface. Proportionately, the fabric comprised c.80% flints (measuring up to 30cm, but mostly ranging between 5cm and 10cm), c.15% septaria and c.5% brick and tile. The latter comprising poorly mixed and badly fired pieces of varying size, but mainly quite thin. Some of the pieces almost looked Roman in date and fragments of possible opus signinum (a Roman cementitious material used frequently for flooring) was also recorded suggesting that this may be the case.

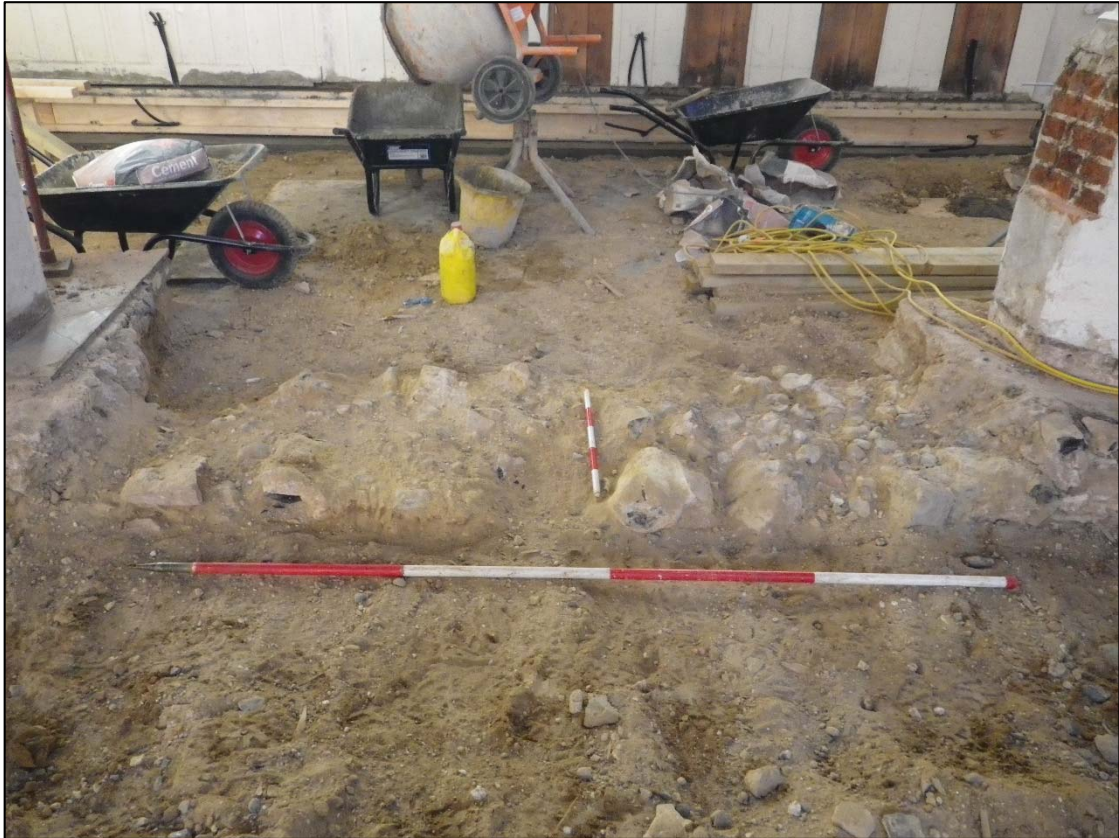
Plate 5. Stub of nave wall, second arcade arch from east; taken from the north

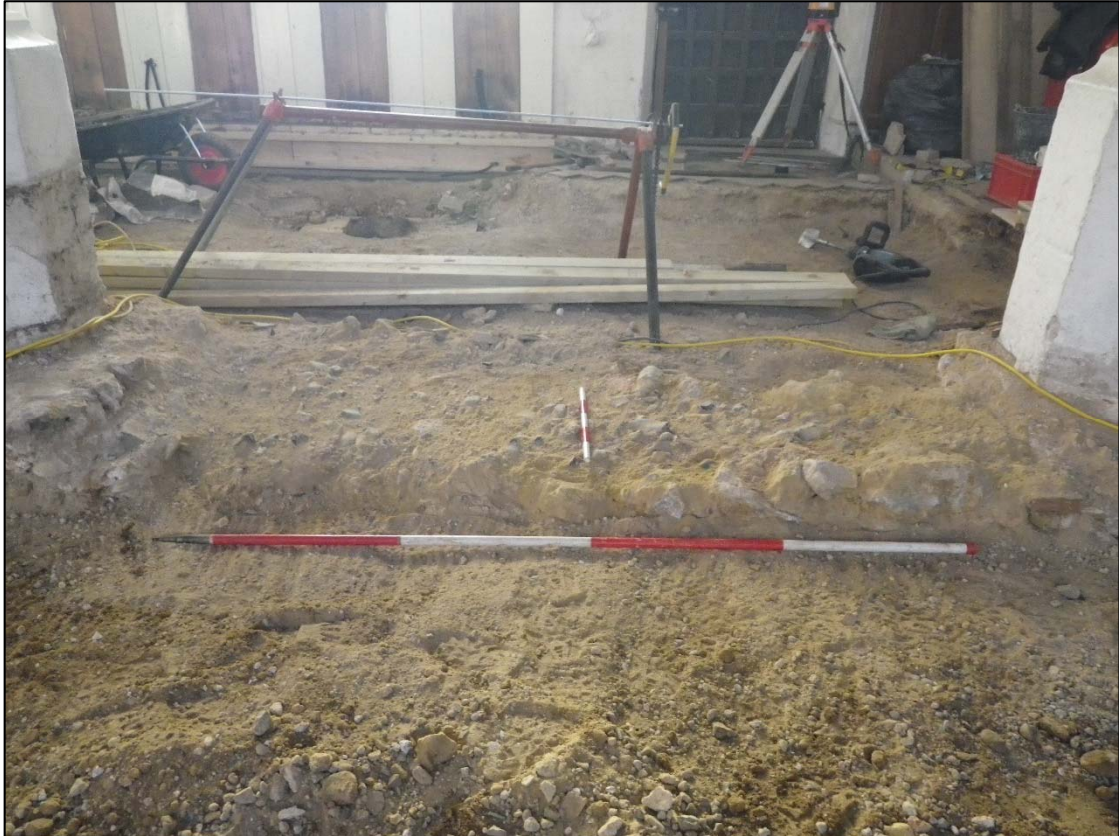
Plate 6. Stub of nave wall, third arcade arch; taken from the north

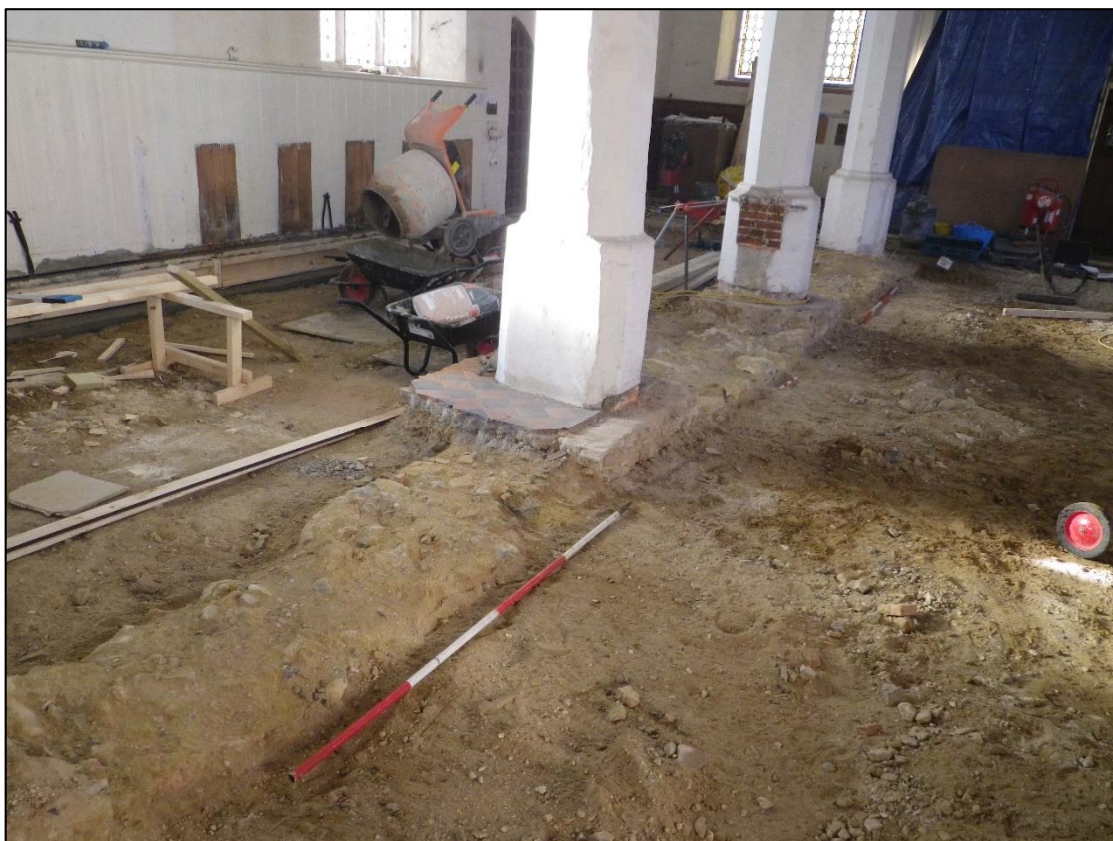
Plate 7. Stub of nave wall; general shot from the north-east

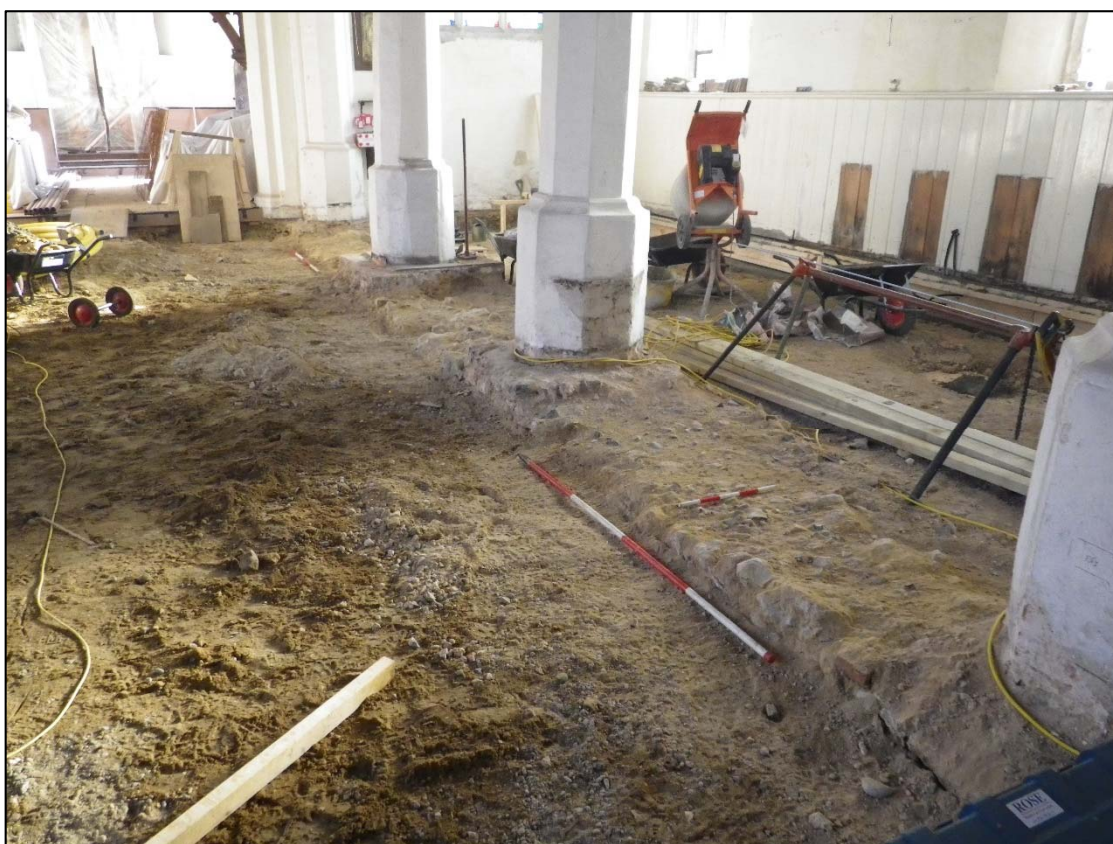
Plate 8. Stub of former nave wall; general shot from the north-west

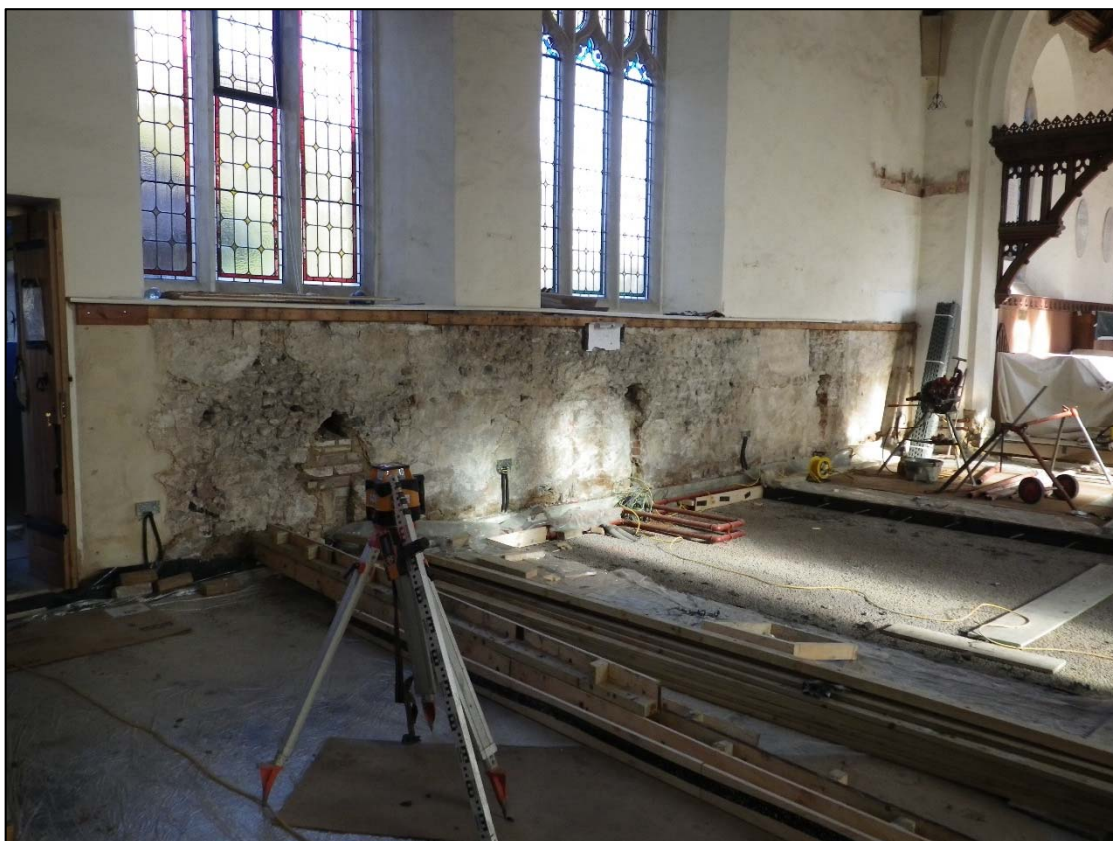
Above the level of the wood boarding the wall was plastered and whitewashed so that no fabric was visible. However the area that had been covered by the boarding was not in as good condition with plaster only surviving over c.30% - 40% of the surface, mostly lower down (Plate 9). The descriptions below relate entirely to the lower third of the wall.

Plate 9. North nave wall; general view taken from south-west

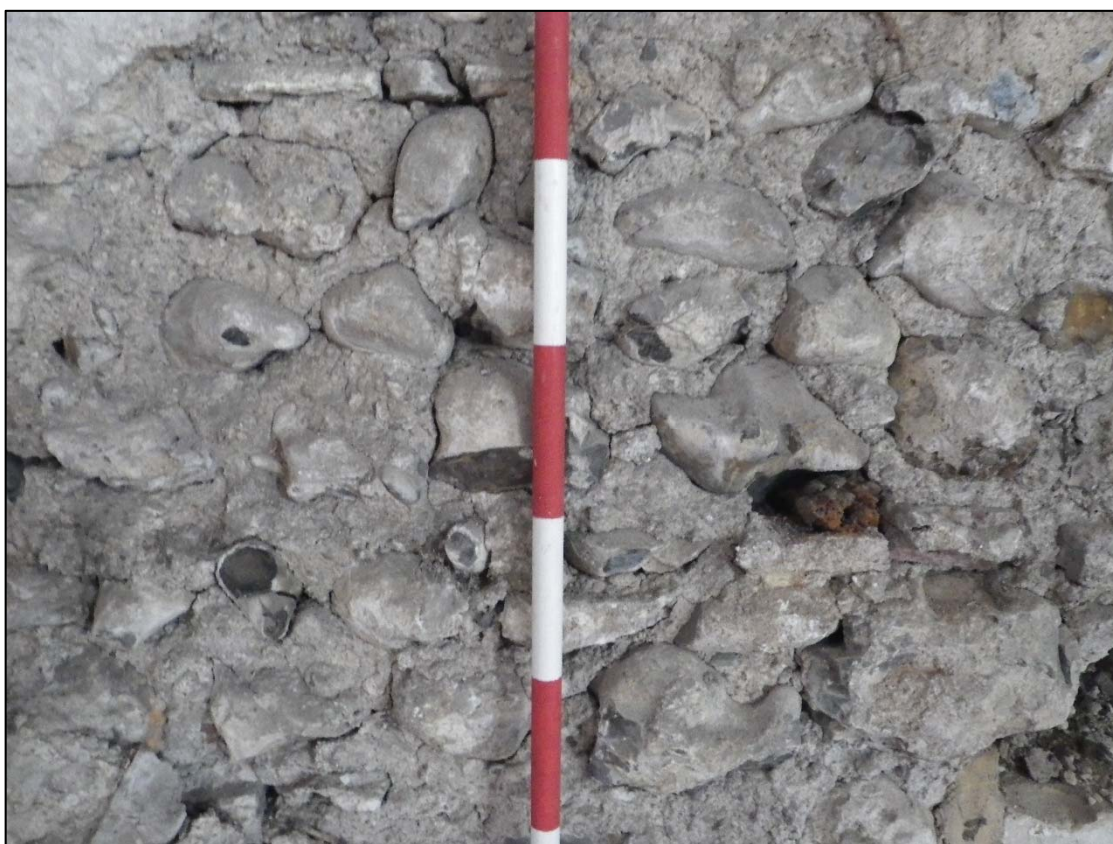
The principal wall fabric was poorly course and comprised c.90% rounded flints up to 15cm in size with fragmented septaria, brick/tile and occasional erratics making up the remaining 10% (Plate 10). The brick fragments exhibited poorly mixed fabrics with variable levels of firing and similarly to the, presumably contemporary, south nave wall stub, these could have been Roman in date. The lime mortar matrix was light cream/grey in colour with frequent small chalk lumps and small stones.

Plate 10. North nave wall; representative section of main wall fabric

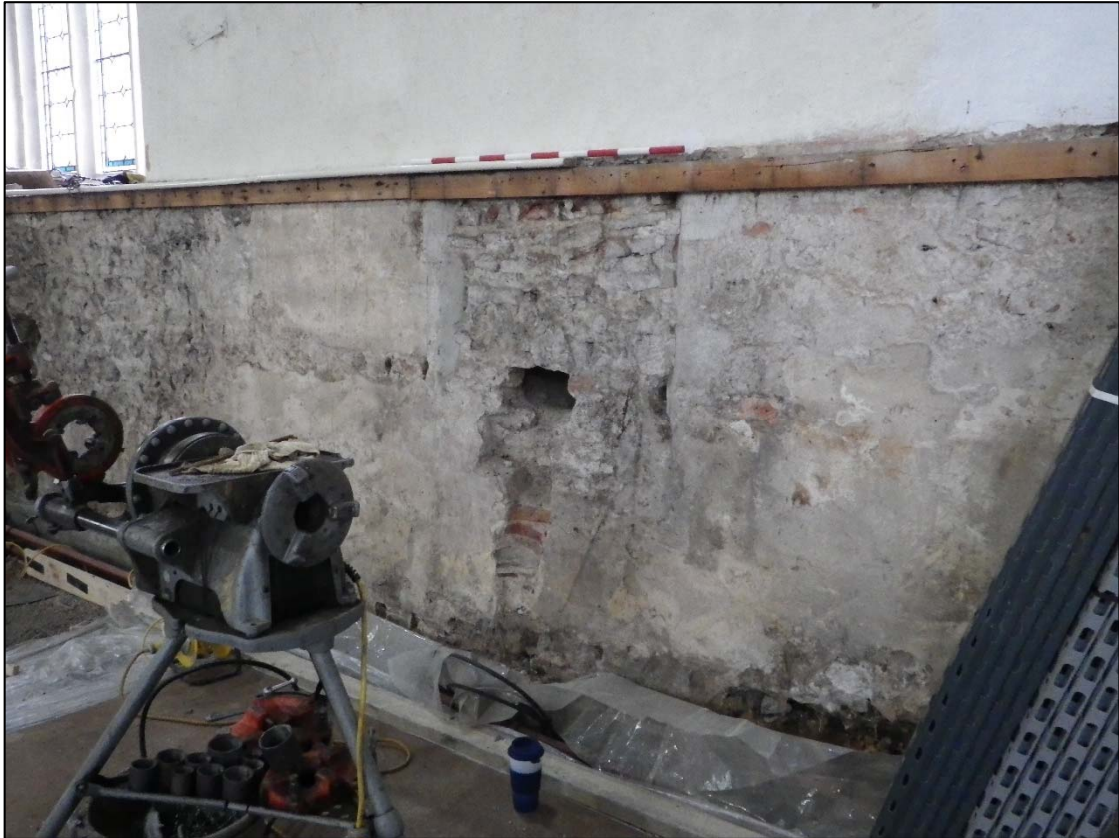
The rood stair doorway was 0.88m wide with mouldings cut from a fine-grained grey/green limestone with some localised survival of lime wash paint on their surface (Plate 11). The material blocking the opening comprised 95% brick with occasional flint pebbles and exhibited wide uneven joints (Plate 12). Brick sizes varied between 1.5 inches to 2.5 inches in thickness and were markedly different in character to the fragments within the main wall fabric. The lime mortar matrix was yellow/cream in colour with frequent inclusions of small pebbles and chalk lumps.

Plate 11. North nave wall; blocked rood stair opening taken from the south-east

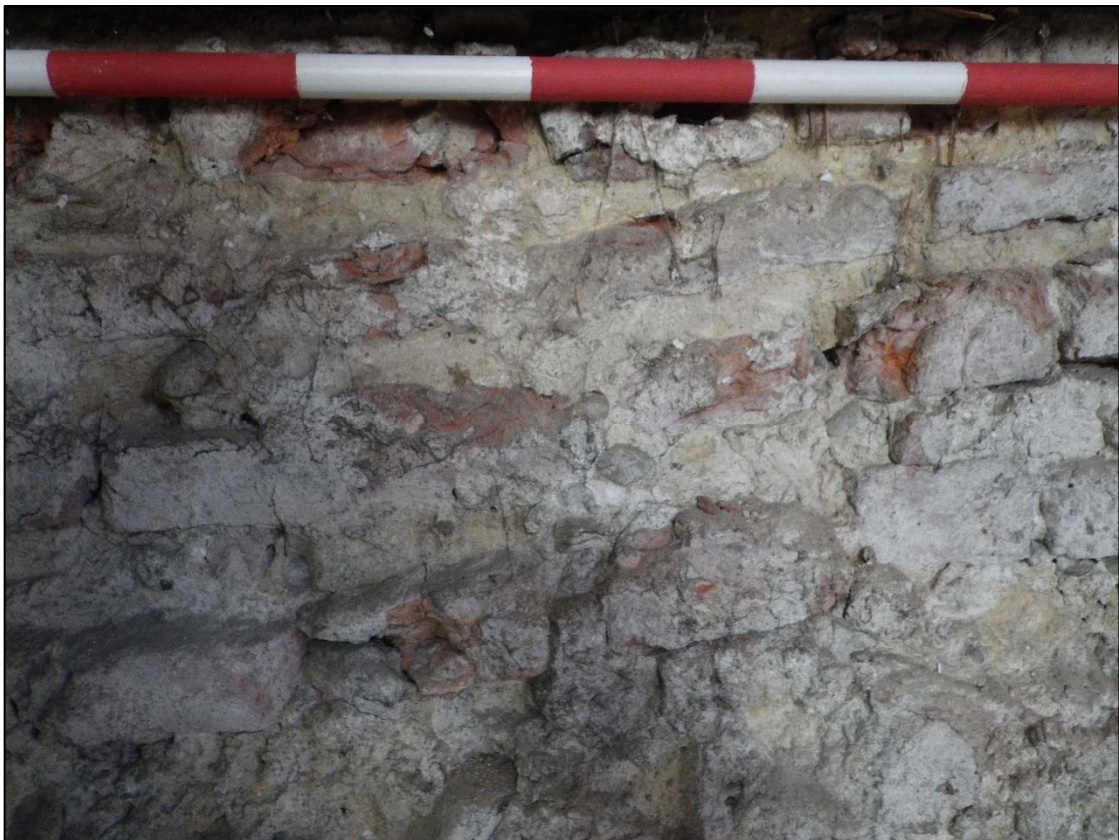
Plate 12. North nave wall; detail of rood stair opening blocking, from the south

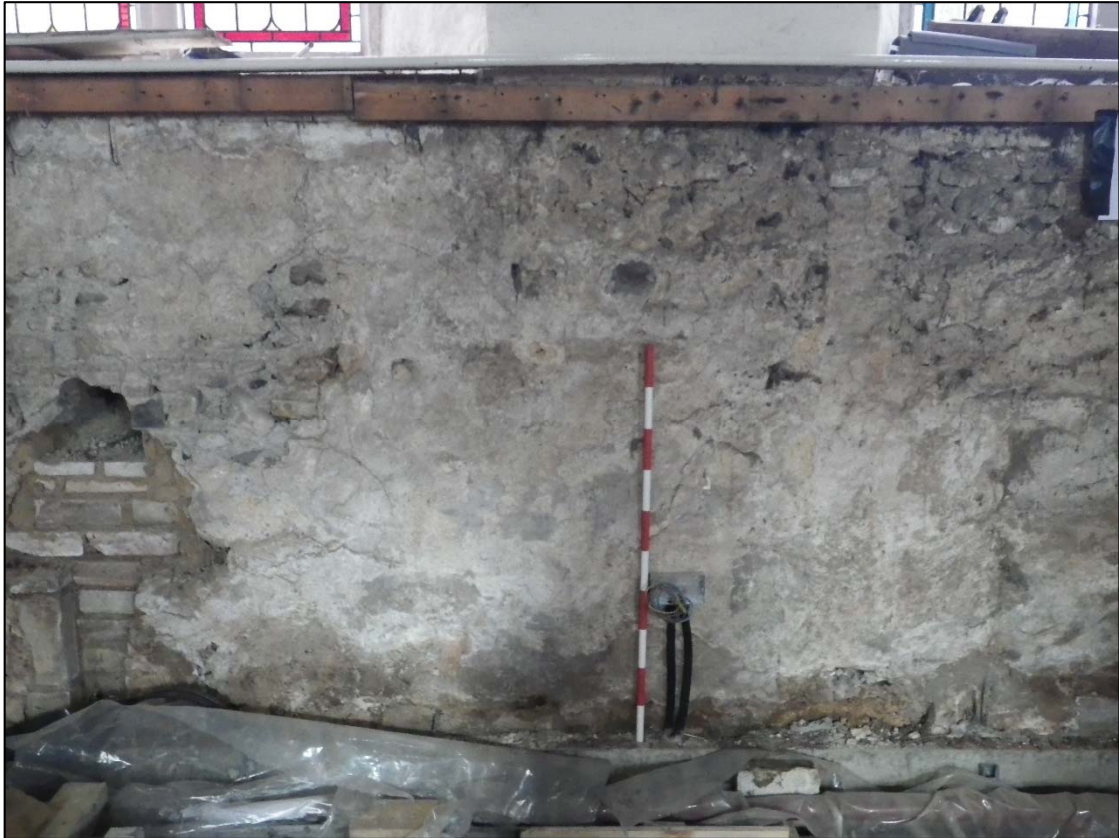
Plate 13. North nave wall; possible blocked opening, taken from the south

A second possible architectural feature located between the two windows to the east of the extant doorway was more difficult to interpret (Figure 2). A 1.10m wide vertical strip of wall fabric was clearly different in character from the flanking main wall (Plates 13 and 14). The eastern junction between the two fabrics was marked towards the top by what appeared to be a surviving jamb (Plate 14) constructed from 1.5 inch thick pieces of brick similar in character to those seen elsewhere in the fabric of the north nave wall and the south nave wall stub and tentatively identified as roman. In addition, vestiges of the plastered face of the jamb survived. To the west, the junction was simply defined by a vertical interface between the two markedly different wall fabrics; that of the original nave wall to the west, and the blocking material to the east comprising predominantly of randomly lain small rounded flints with occasional fragments of septaria set in a dark cream coloured lime mortar with frequent inclusions of gravel-sized stones.

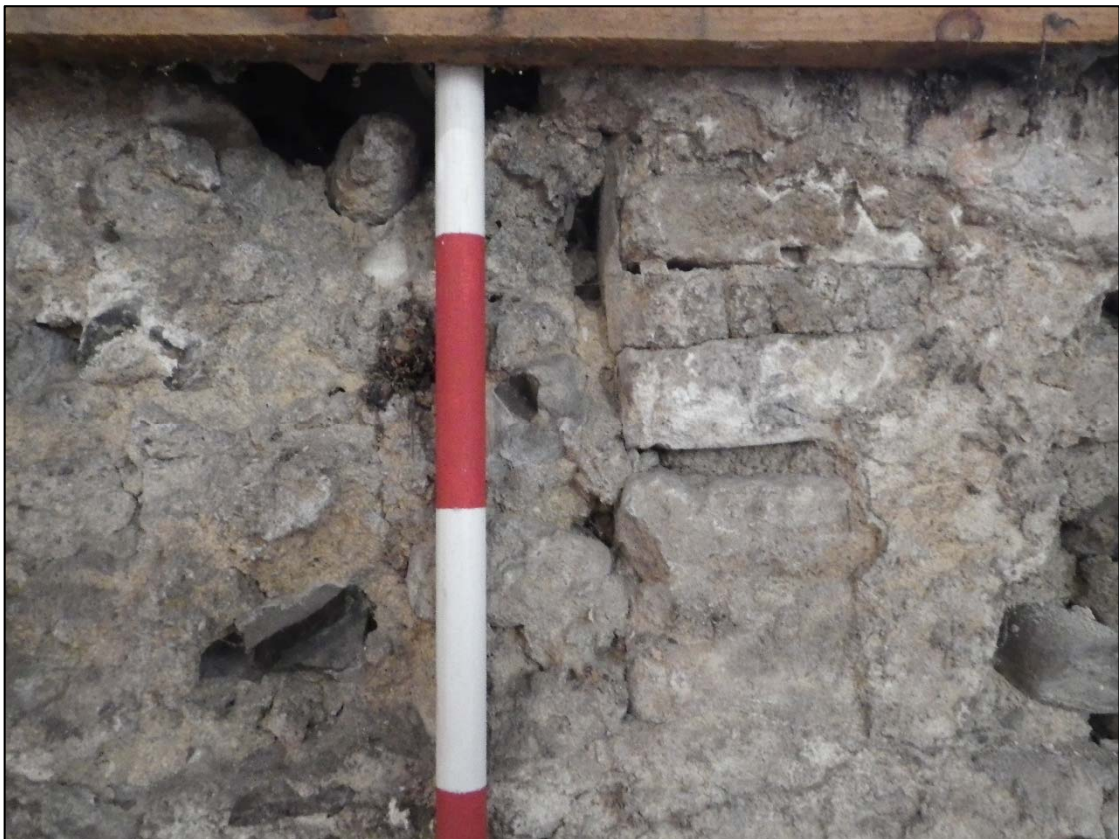
Plate 14. North nave wall; possible opening, detail of jamb, taken from the south

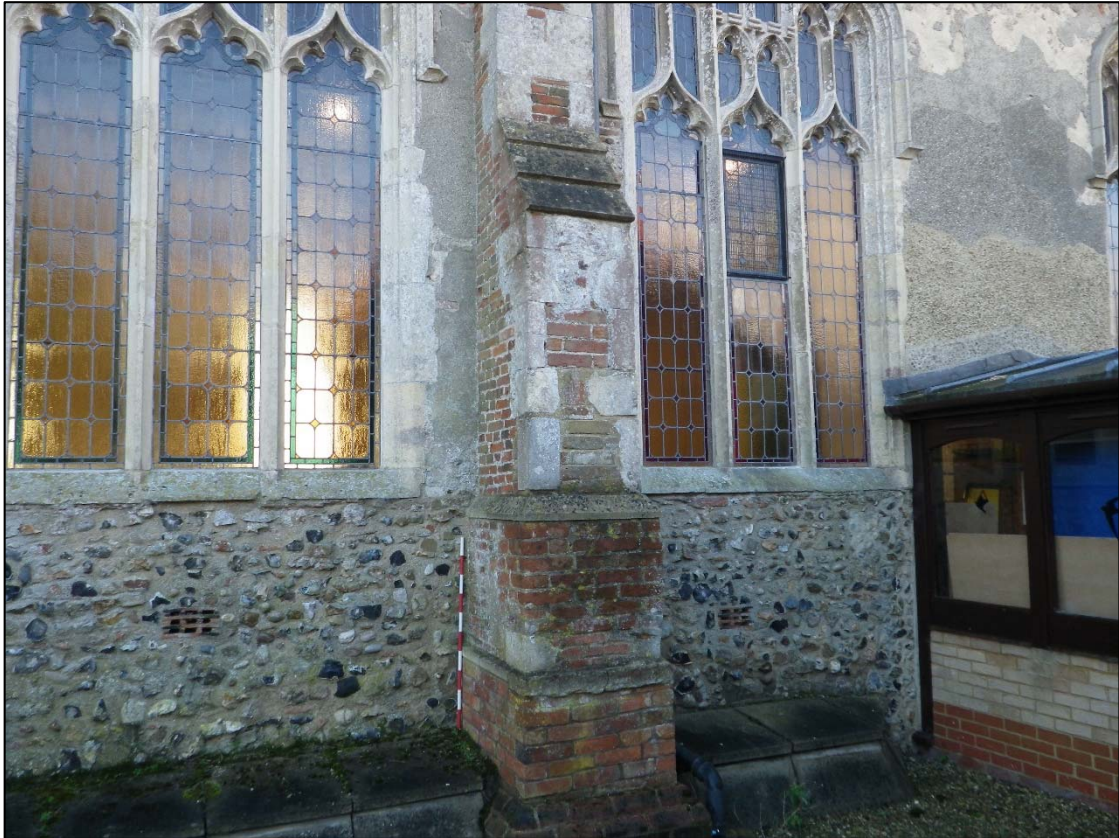
Plate 15. North nave wall; brick-built buttress, taken from the north-east

Interpreting this feature was somewhat problematic. Externally, this strip of fabric coincides with the location of a brick-built buttress (Plate 15). A similar and contemporary buttress constructed external to the south aisle was visible internally as an area of brick fabric in the narrow strip exposed during the reduced level excavation below the level of the wood boarding. This is also the most likely explanation for the observations made on the north wall although this does not explain the surviving possible jamb, or the lack of bricks in the blocking fabric. While definitely not a blocked window, the junction continued below the level that could be expected if this were the case, it is possible that it represents an earlier blocked doorway that predated both the inserted perpendicular windows and the later buttress.

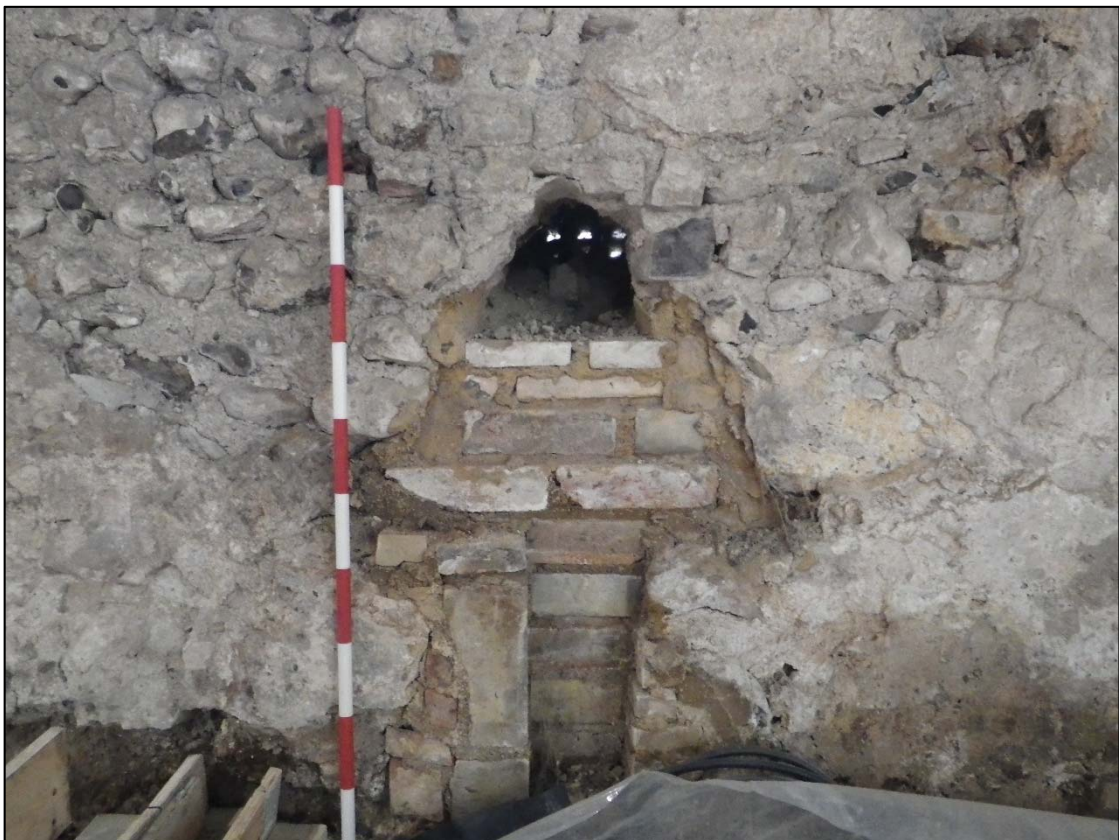
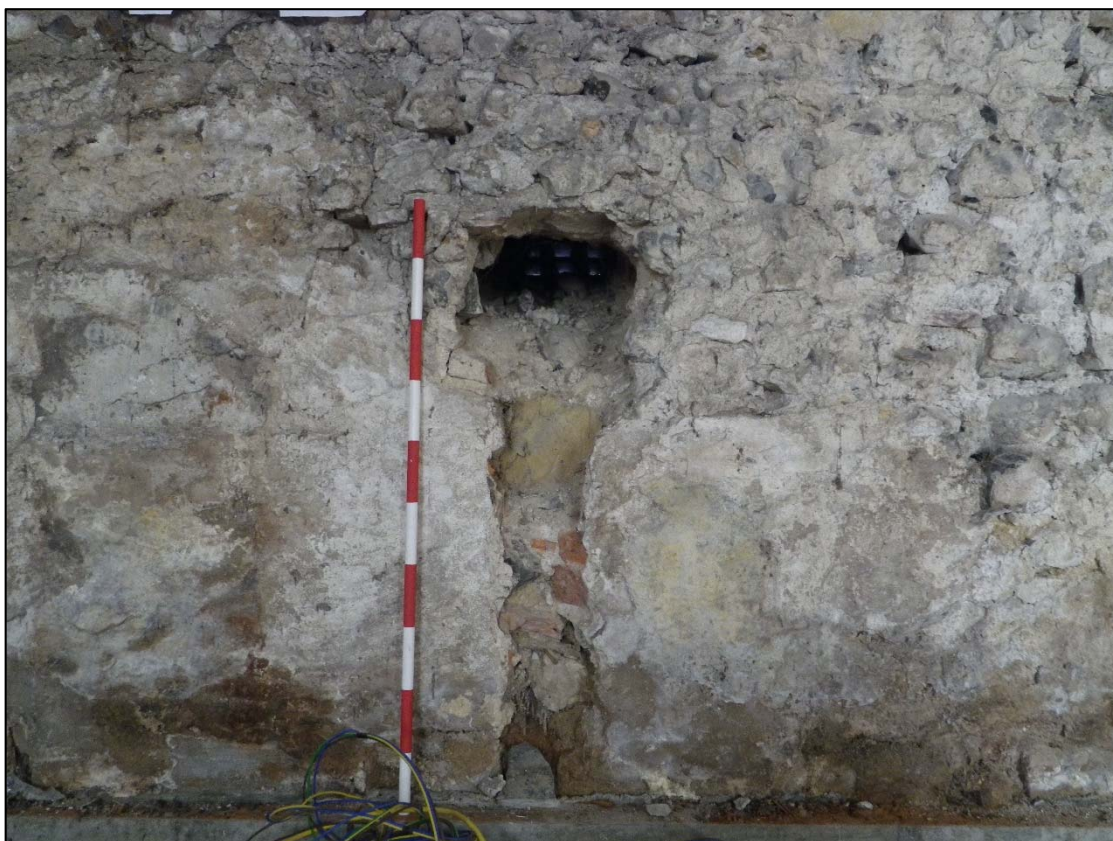
Plate 16. North nave wall; westernmost vent, taken from the south

Plate 17. North nave wall; middle vent, taken from the south

Three air vents had been inserted through the wall; two through the early fabric (Plates 16 and 17) and the third through the brick blocking of the entrance to the former rood stair (Plate 11). These were clearly designed to provide circulation of air both behind the wall boarding and on down beneath the pew floor bases. Externally, the exits of the vents were constructed from roof tiles (Plate 18) while the internal cuts of the westernmost two were formalised with re-used bricks and floor bricks.

The three vents recorded in the north wall were relatively recent in date, almost certainly inserted either to prevent damp or in response to an existing damp problem. With the external ground level to the north being higher than that internally, the wall at this juncture would be particularly prevalent to damp. This was also attested to by the presence of a layer of plastic sheet placed behind the wood boarding on the north side of the church. While ultimately ineffectual as a solution, this clearly indicated that the problem had been recognised and an attempt at mitigation made.

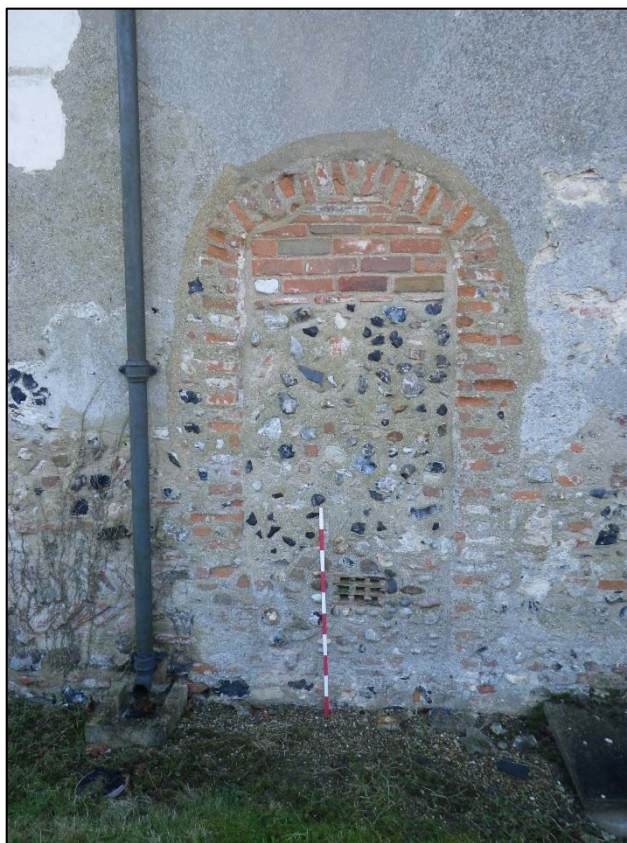
Plate 18. North nave wall; external opening to easternmost vent, taken from the north
