**The Pipeworks,
Hoxne, Suffolk
HXN 031 (ESF24110)**

Historic Building Record

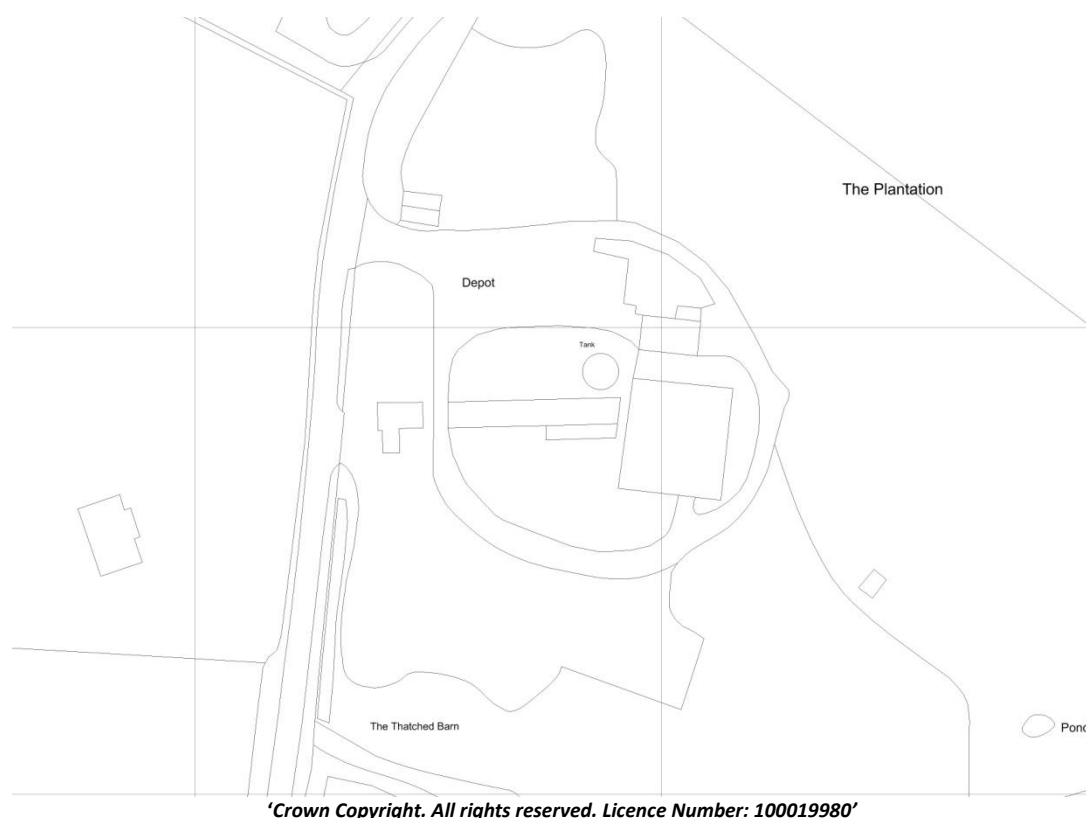
Figure 1. Current site plan showing Eye Road to the west of the site and the linear drying shed interrupted by a later circular vehicle track. The large, square building to the east of the site had been demolished prior to inspection.

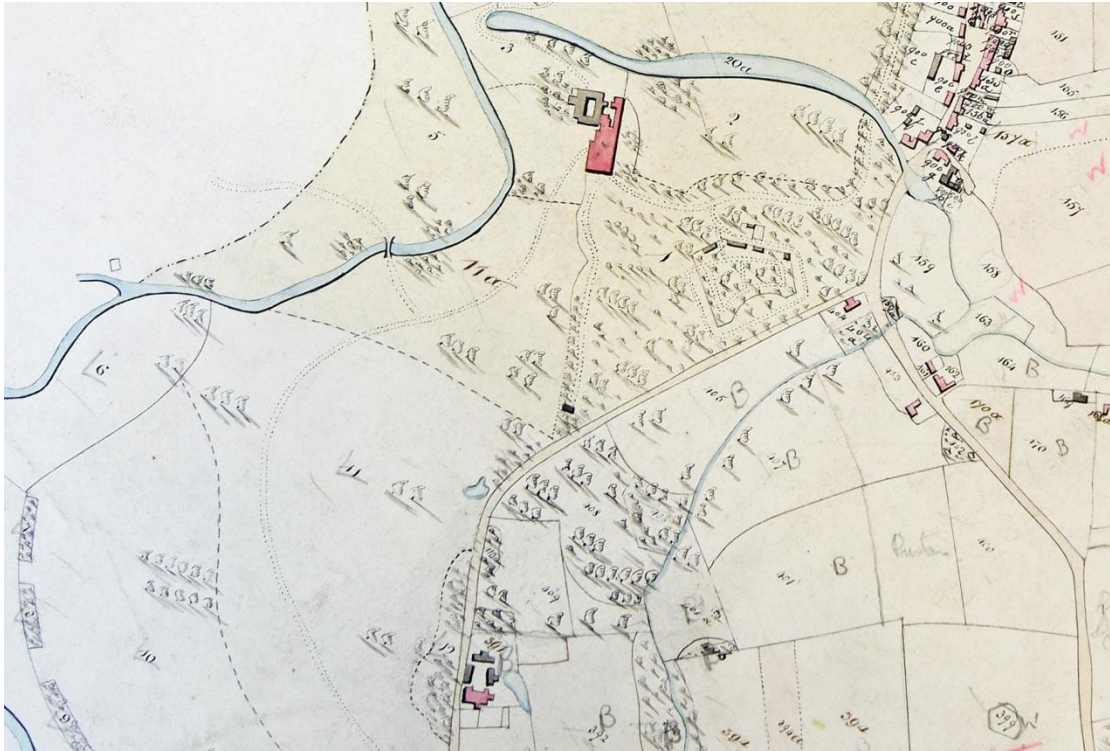
Figure 3. The Hoxne tithe map of 1843 showing Hoxne village and Oakley Park to the north of the site (Suffolk Record Office).

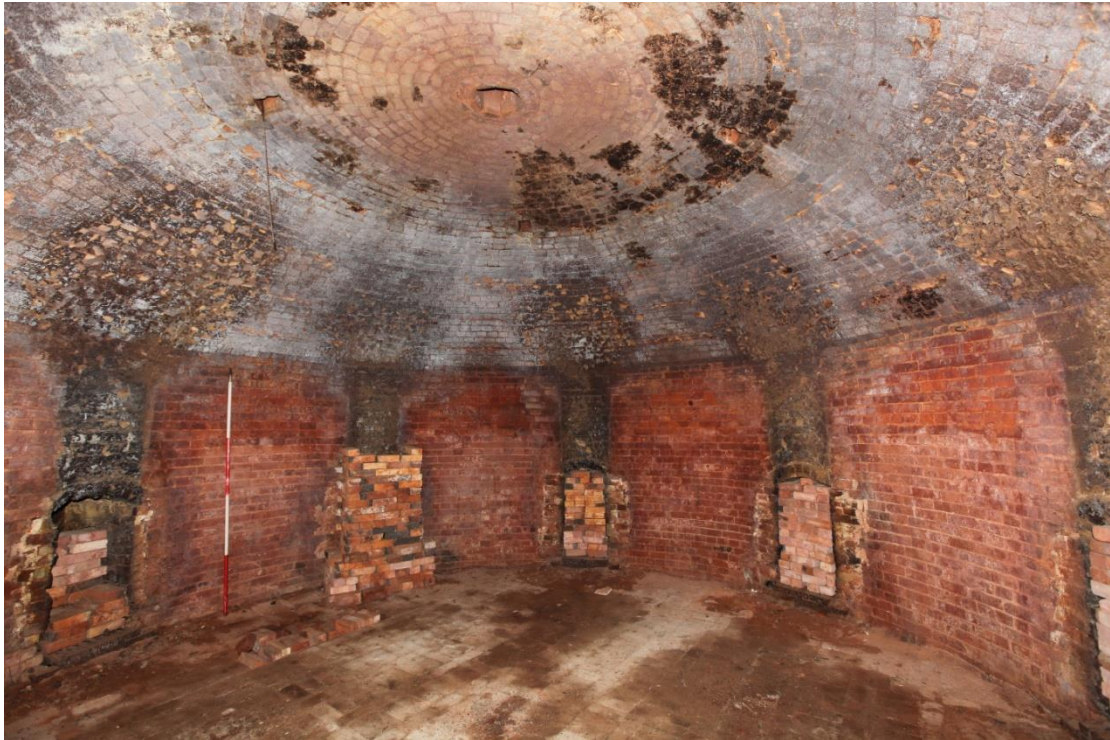
Illus. 7. The interior of the kiln (1) from the south showing its domed vault with a brick fire baffle or bag wall *in situ* to the right of the scale rod. These bags enclosed the fires and directed their heat upwards. The loose bricks in front of the scale have been removed to expose the under-floor flue channels leading to the chimney. The central vent is surrounded by smaller apertures used to damp the kiln.

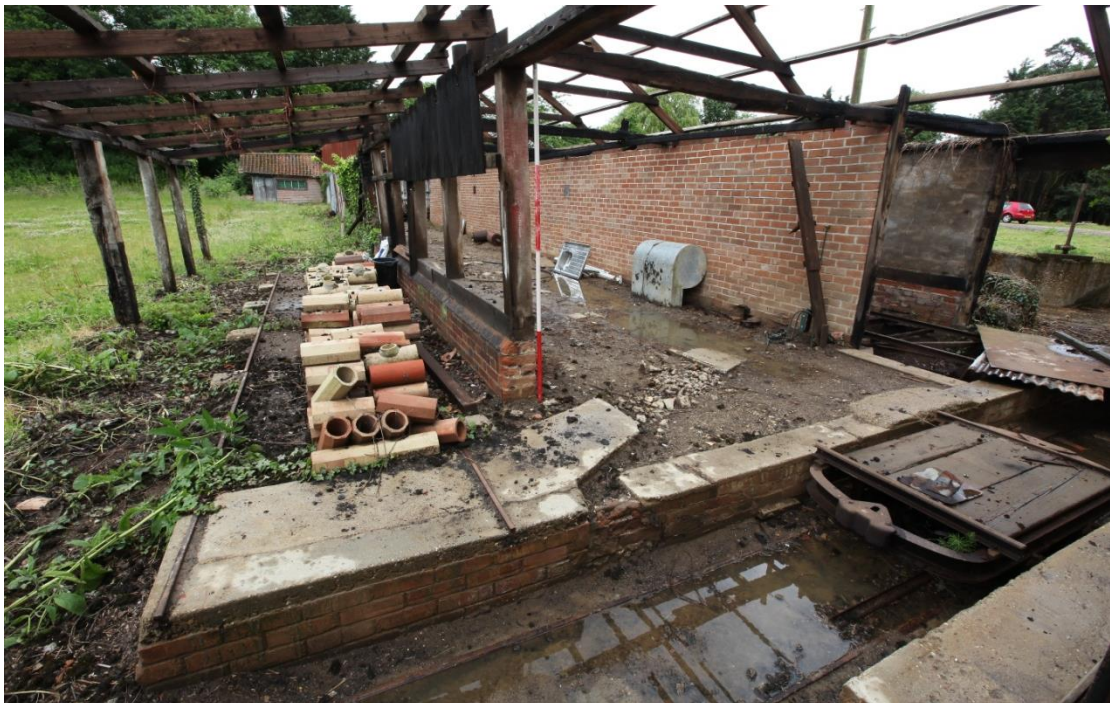
Illus. 8. The interior of the roofless drying shed (4b) from the east showing its open-sided southern lean-to (4d) on the left and the drying tunnel (4a) on the right. Each of the three compartments contains iron rails to transport the drying racks with a sunken trolley in the foreground which runs on lateral rails to transfer the racks from one track to the next. The land drains on the left were presumably made on the site.

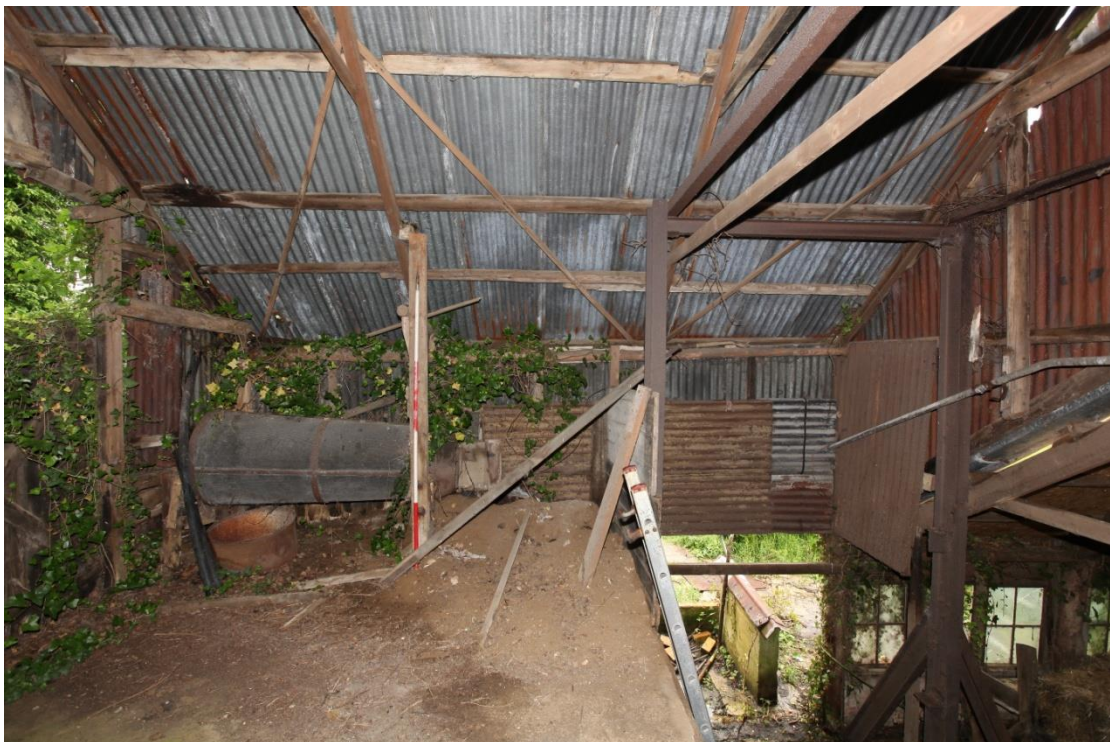
Illus. 14. The interior of the extrusion shed (3a) from the south. The concrete platform on the left is entered by double doors at road level in the western gable to the extreme left, and retains a drum sieve for ‘fining’ sand and clay. The void on the right retains a framework of iron girders that supported the missing extrusion machinery that was presumably loaded from this upper level.

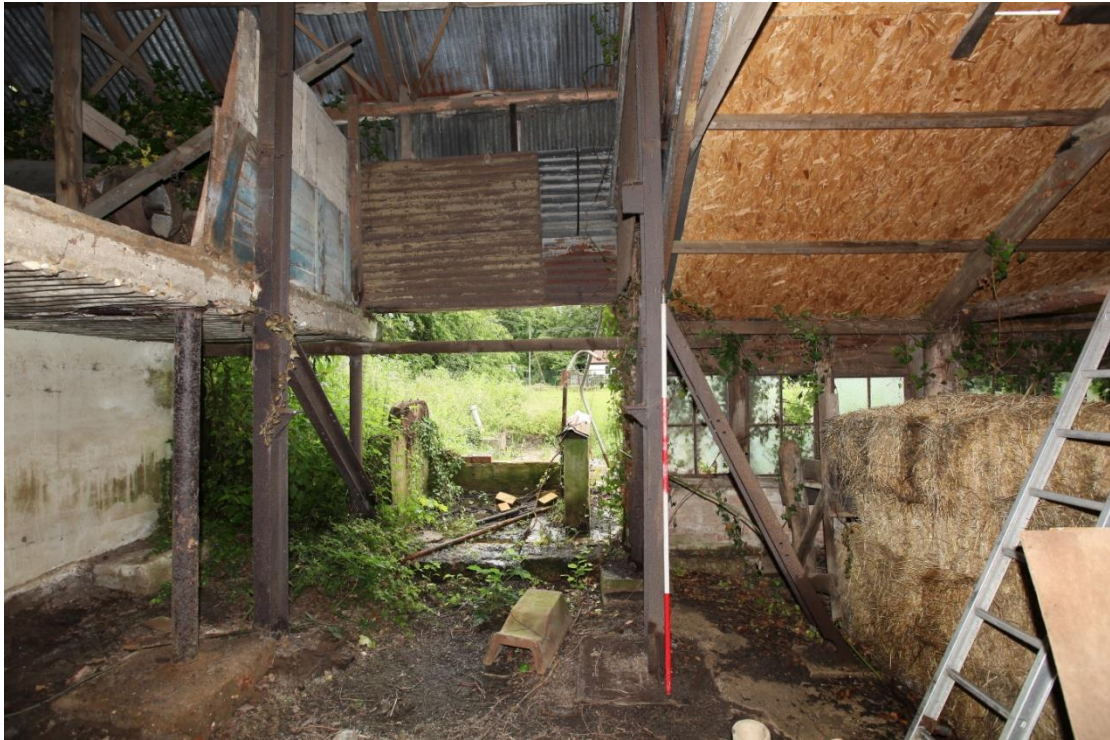
Illus. 15. The lower level of the extrusion shed (3a) from the south showing the position of the missing machinery in the centre with the concrete platform of the loading and clay fining area on the left and the ‘making shed’ (3b) on the right. A demolished additional structure extended northwards from this part of the structure.

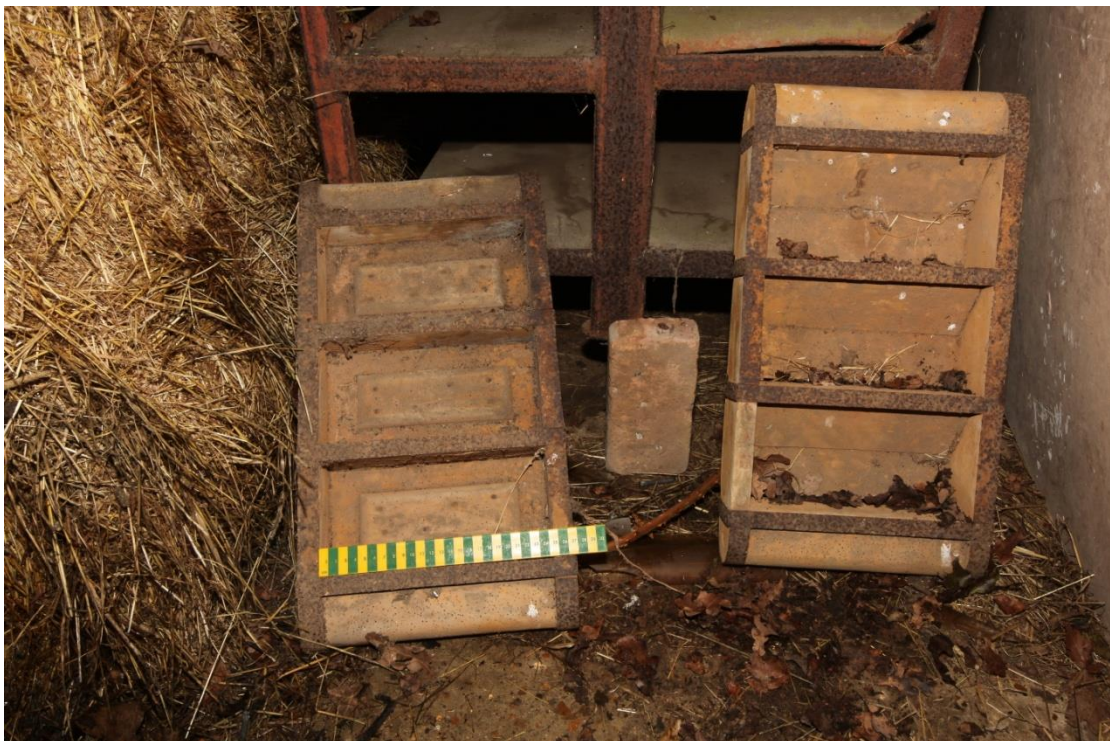
Illus. 16. A detail of the wooden moulds in the making shed (3b). The mould on the left is for bricks with frogs but no manufacturer’s name and that on the right for chamfered bricks with diagonal edges to form plinths and copings.

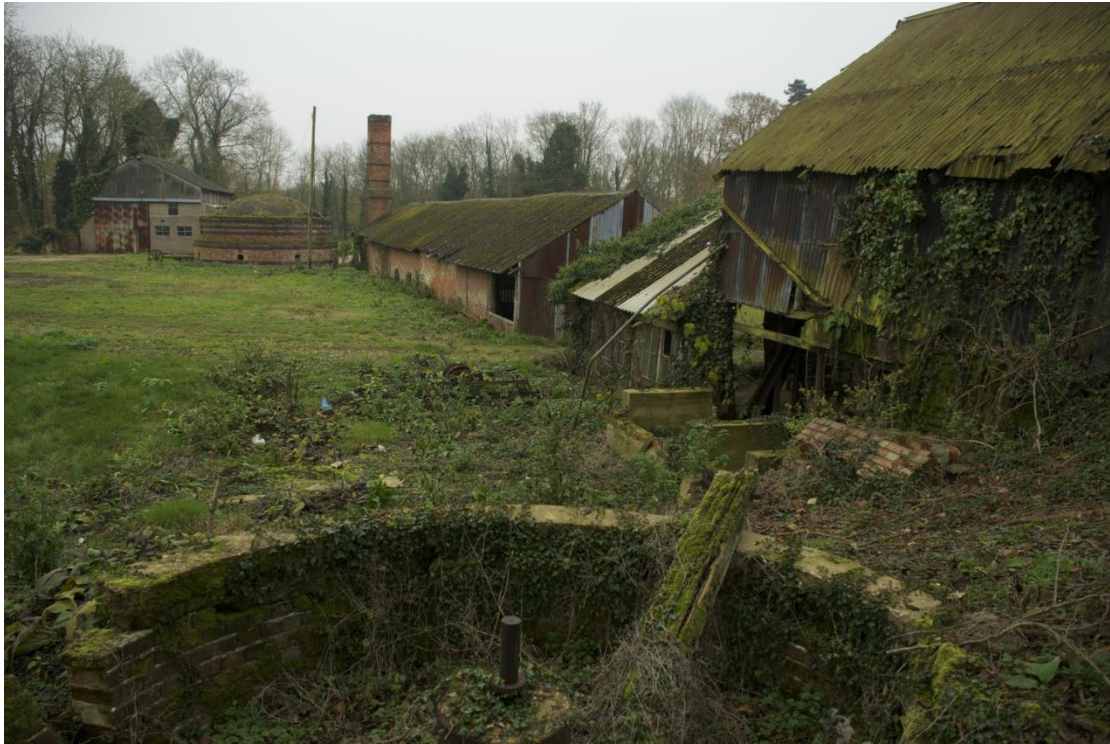
Illus. 17. A 2014 photograph of the site looking east from the pugmill (2) showing the corrugated asbestos roof covering of the drying sheds with the uncovered kiln (1) in the rear. Note the concrete blocks for missing machinery adjoining the extrusion shed (3a) on the right.

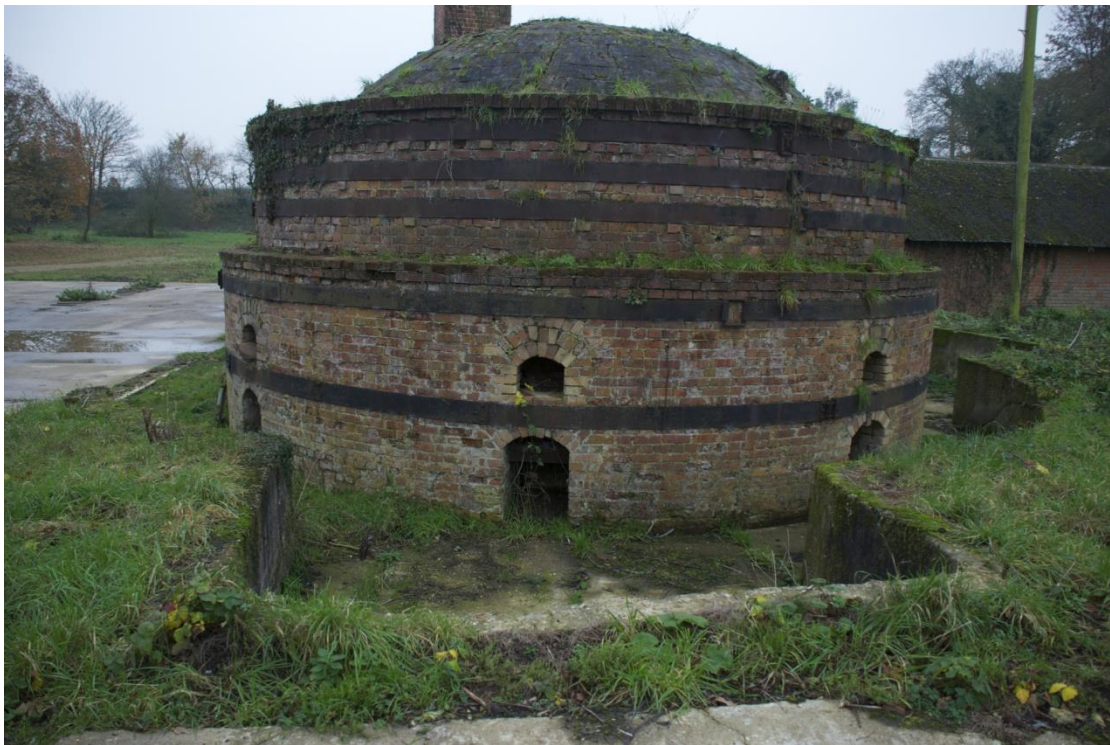
Illus. 18. A 2014 photograph of the kiln (1) from the north without a tarpaulin showing its domed roof and multiple iron straps.
