ARCHAEOLOGICAL MONITORING REPORT

SACIC REPORT No. 2016/071	Parish: Butley
Ferry Farm BUT 090	Planning Application No.: DC/16/0768/FUL
	OASIS No. Suffolka1- 262678
	HER Event No.: BUT 090/ESF24278
Address: Ferry Farm, Butley, IP12 3NJ	Grid Reference: TM 3876 4830
	Number of Site visits: 1
	Date of visits: 10/08/2016
<p>Archaeological monitoring of groundworks was required as part of a planning application for the erection of a new extension to Ferry Farm, Butley. To begin with, there would be monitoring of the ground clearance and levelling, with the potential for further monitoring of the excavated footings should undisturbed natural layers not be encountered during the stripping.</p> <p>Burrow Hill (immediately to the north of Ferry Farm house) is the site of a known Anglo-Saxon cemetery and settlement (BUT 001) and it was felt that the proposed work had the potential to encounter important evidence related to this site.</p> <p>An irregular area measuring some 13m by 9m was stripped around the north-eastern corner of the existing building, to a depth of approximately 0.4m under constant monitoring, to clear the ground under the proposed new extension (shown in red on Figure 1).</

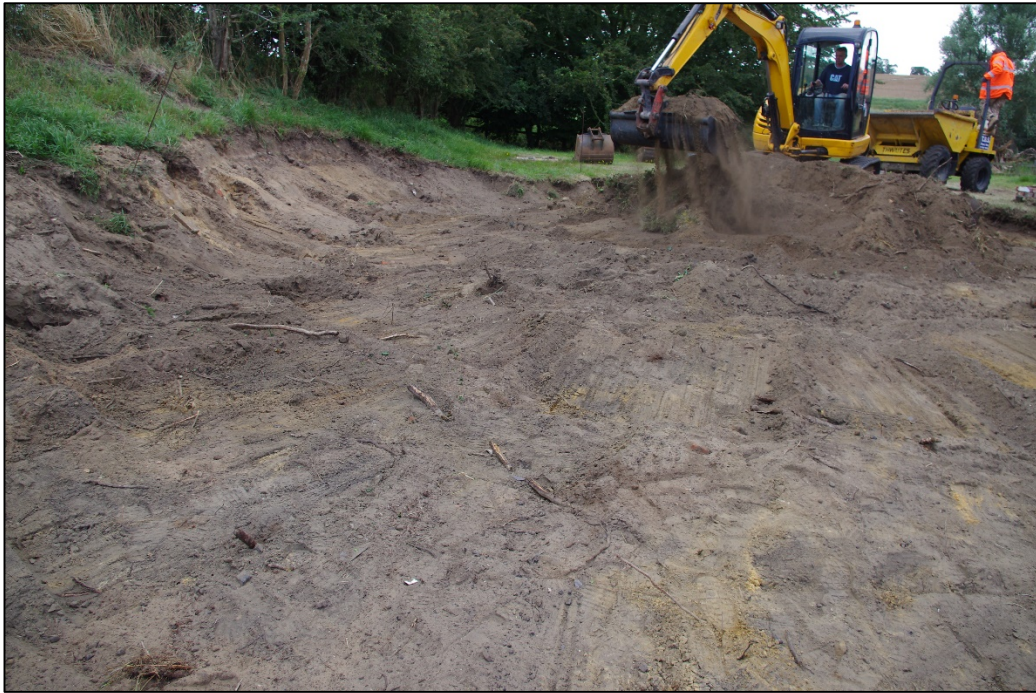
Plate 1. Stripped soil level to the side of the house (facing south)

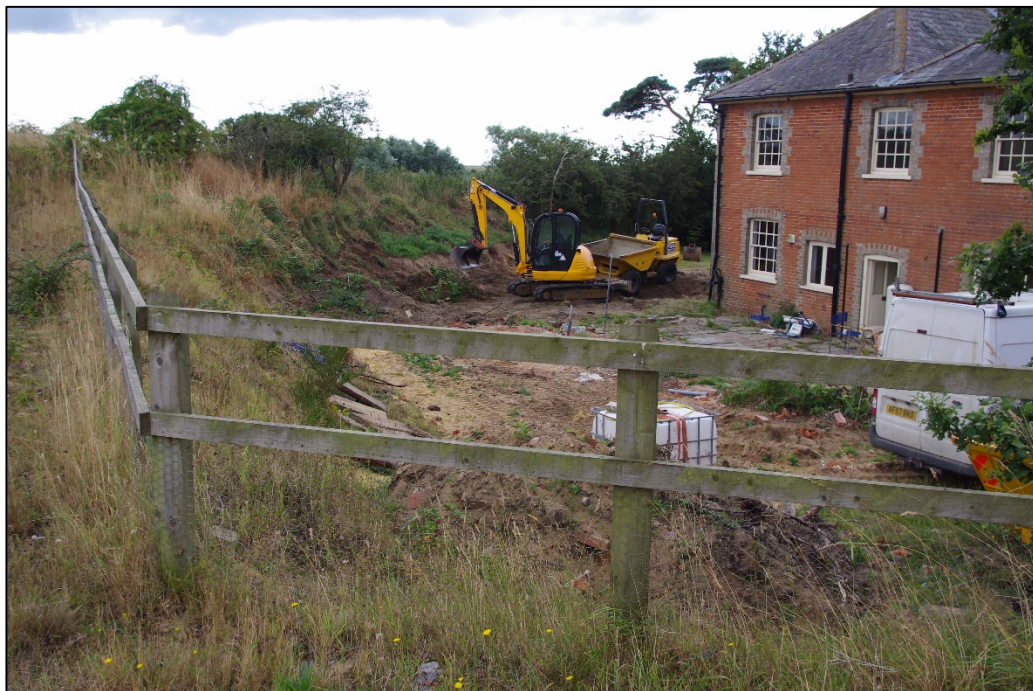
During the ground clearance and levelling strip, it became apparent that the present Ferry Farm house was located within a probable old sand extraction pit, with up to c.3m of sand already removed from the original hillside slope at the northern end of the pit, down to an estimated c.0.9m of sand removed by the front wall of the building (based on surviving ground levels surrounding the house). The material recovered from the topsoil appears to indicate only modern (post-1800) activity as would be expected in the area so close to the house. It would appear likely that, had any Anglo-Saxon remains been present in this area, they would have been removed during this (undated) quarrying event. While the date of construction of Ferry Farm is uncertain, the present building appears to be shown on the 1880 first edition Ordnance Survey map of the area (Fig. 2), which also records a sand pit just to the north of the house.

Plate 2. General site view showing house within quarry pit (facing southeast)
