Historic Building Record

24A High Street
Hatherleigh
Devon

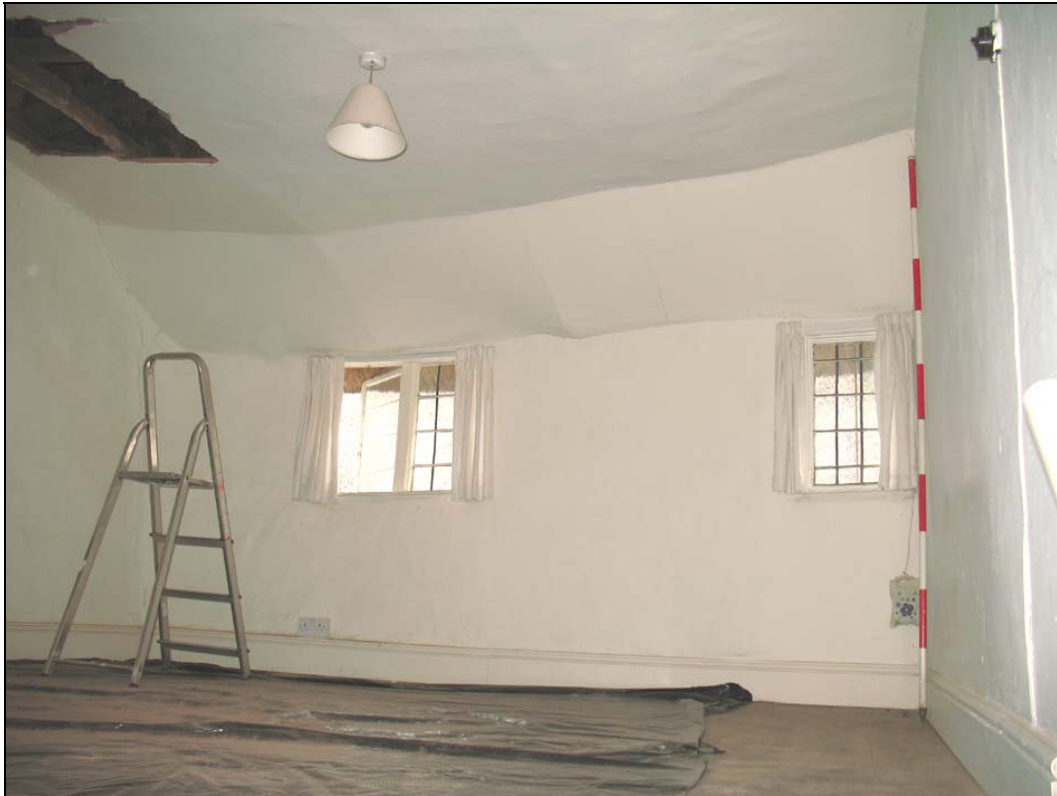
Figure 13: The first floor north wall, viewed from the south-east.
