lain Soden Heritage Services Ltd

Modern living in an historic environment

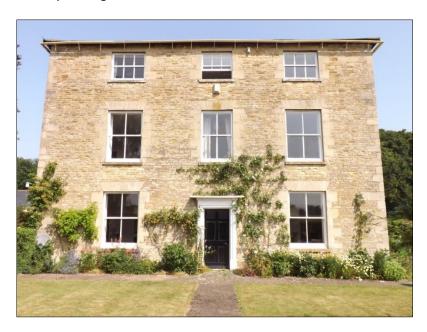
Fig 8: Geddington Grange Farmhouse; the main (south) front

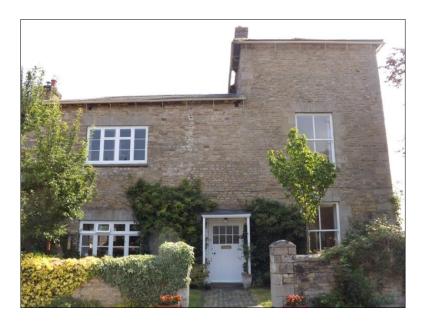
Fig 9: Geddington Grange Farmhouse; west face with side entrance and rear wing

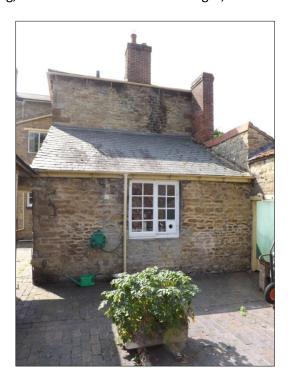
Fig 12: north-west wing; north face, the out-shut

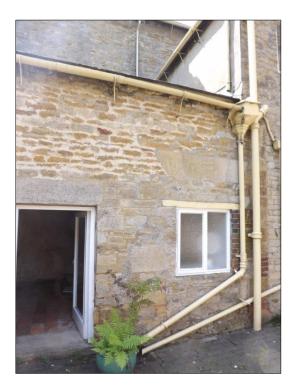
Fig 13: North-east wing: north wall.

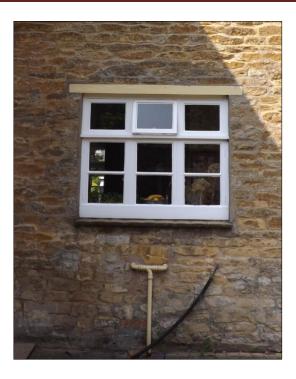
Fig 20: Inserted kitchen window (matching the pantry), with tell-tale mortaring repairs around; the coursing below is awkwardly re-set, suggesting a former doorway direct to the outside well-head

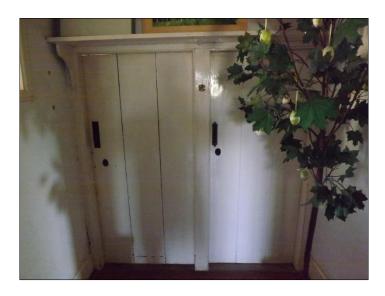
Fig 21: Rear lobby -the original, formerly external doors of the passageway to (left) 1980s bathroom in the former dairy, and (right) a WC in the former pantry/larder.

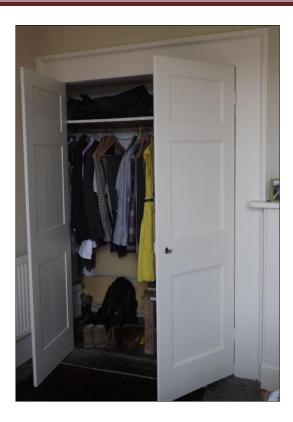
Fig 23: Bedroom 1, walk-in wardrobe where there may once have been a doorway direct (through what is a wafer-thin partition) to the north-west wing, before a passageway was created out of this same bedroom adjacent to the stairs
