Report of Work under Archaeological Supervision and Control

St Peter's Church, Yaxham, Norfolk Upgrade of electrical supply and installation of water supply

ENF 145433

January 2019

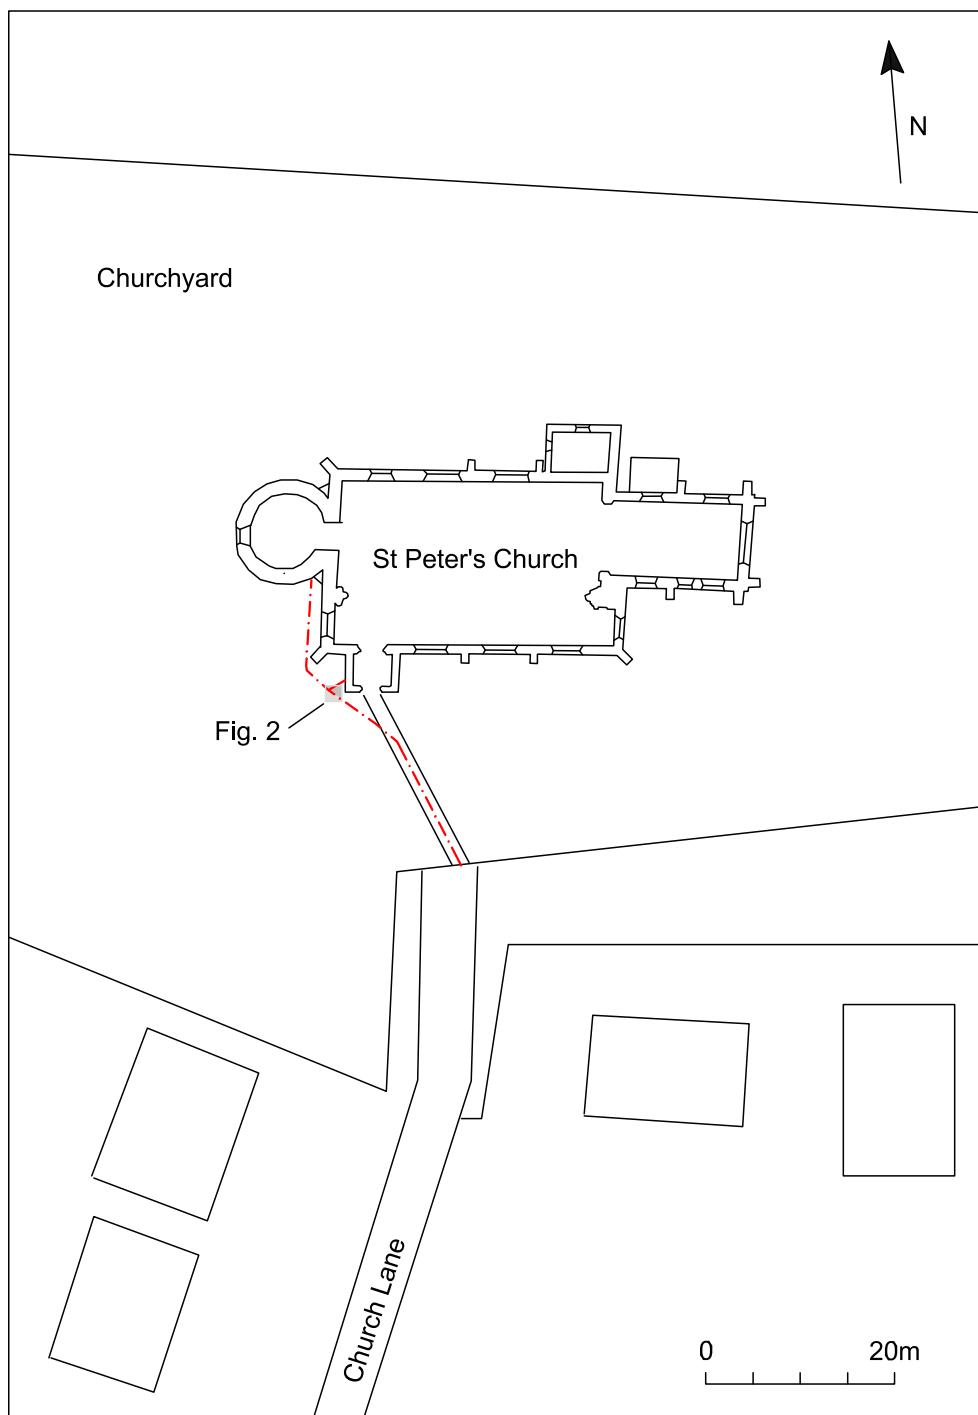
Figure 1: Location of trench, Scale 1:800

The trench for the electricity cable ran from the south side of the tower southwards and roughly parallel with the west wall of the south aisle and, along this length, was 0.50m deep [1]. The trench then turned to the south-east running at approximately the same depth towards the south-west corner of the south porch (Fig. 1, Plate 1).

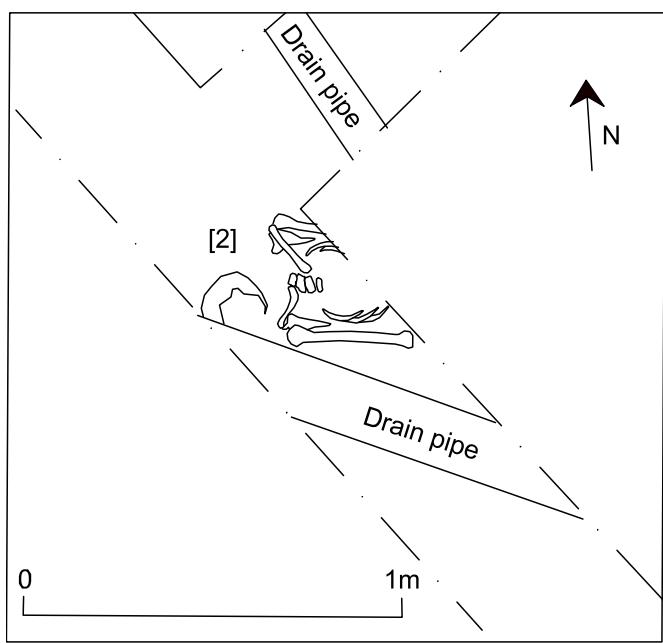
Figure 2: Burial [2], scale 1:20, for location see Fig. 1

Immediately to the north of the latter mentioned drain pipe, and at a greater depth, part of a burial was exposed in the bottom of the trench. The skull and the bones of the upper/right part of the torso of an individual was recorded [2] (Fig. 2, Plates 2 and 6). It was carefully excavated from the trench. The rest of the skeleton extended outside the trench was left *in situ*.

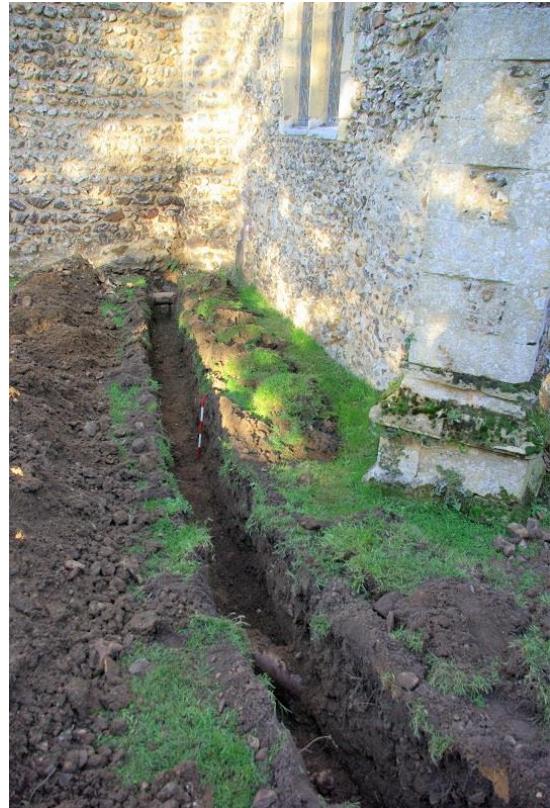
Plate 1: Trench W of S aisle; looking N, 0.5m scale

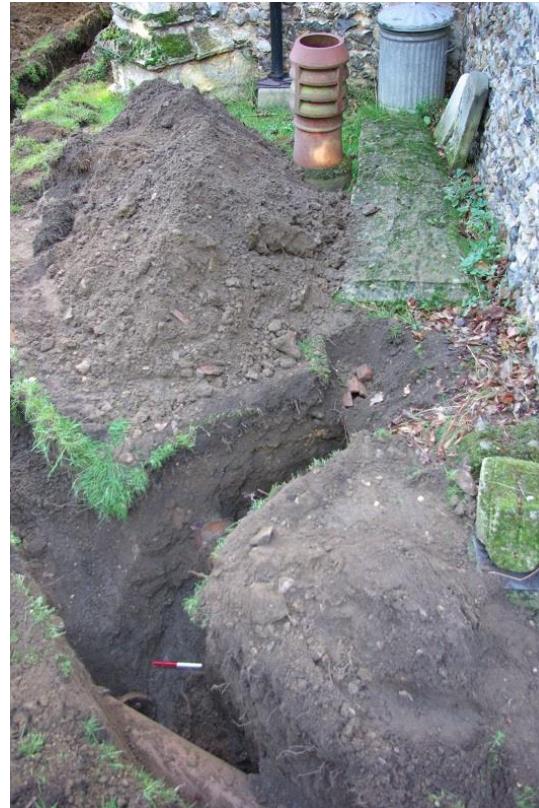
The trench for the water pipe ran from the west wall of the porch near its south-west corner and at a depth of about 0.70m (Plate 2). This joined the trench for the electricity cable and, from this point, the water pipe and cable were laid in the same trench, with the water pipe at a depth of 0.70m and the electric cable at 0.45-0.50m. The trench ran, approximately centrally, along the length of the south path to the gate with both services to be connected outside the churchyard entrance (Plates 3 and 4).

Plate 2: Trench W of porch; burial [2] visible below drain pipe, looking N, 0.5m scale

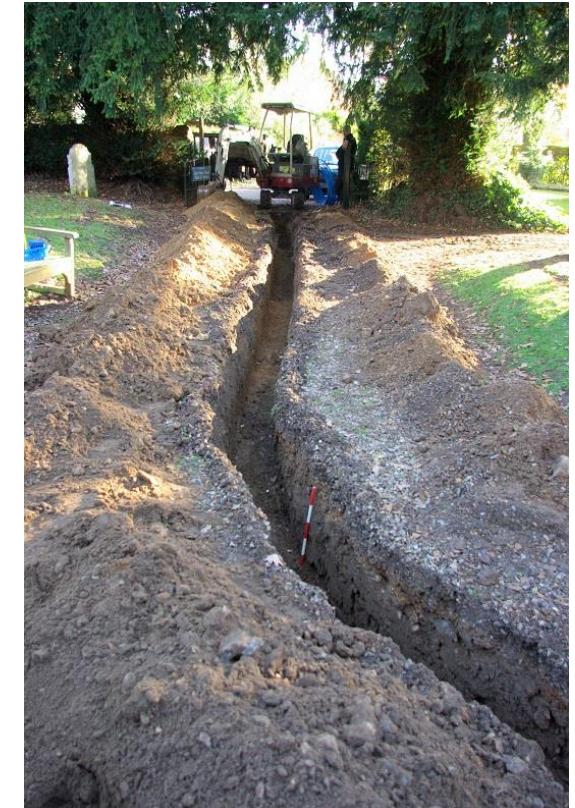
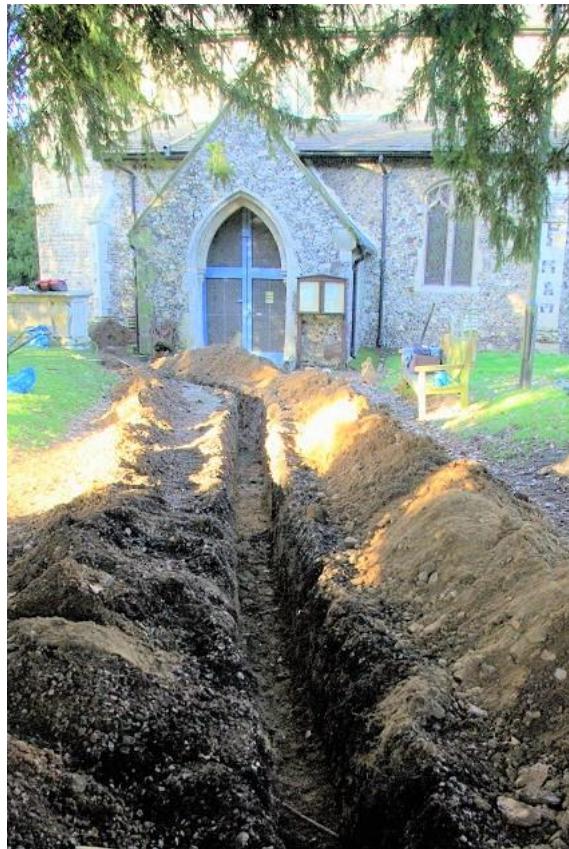
Plate 3: Trench in S path, looking S, 0.5m scale

Plate 4: Trench in S path, looking N, 0.5m scale

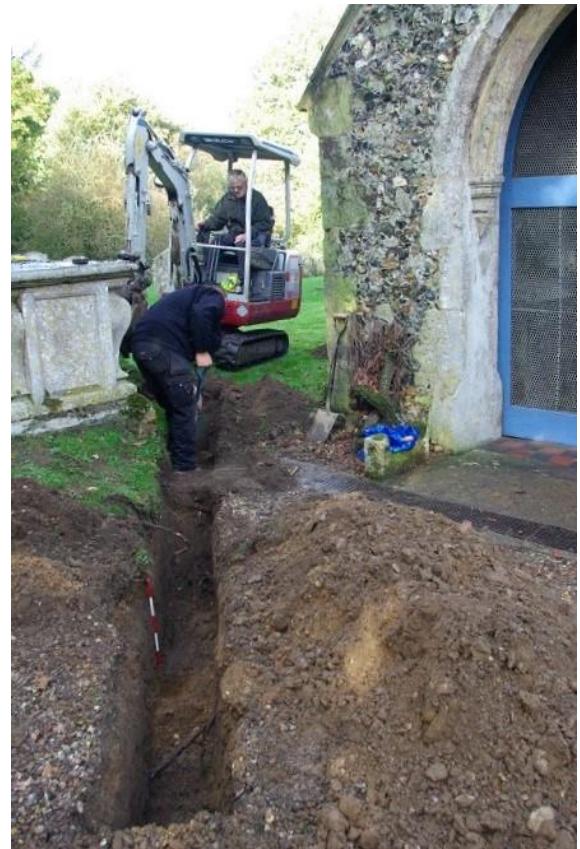
Existing (or former) drain pipes were exposed immediately south of the tower, in the trench for the water pipe beside the south porch, and immediately to the south-west of the porch. An electric able in an iron duct was exposed running south-to-north just south of the south porch (Plate 5).

Plate 5: Trench S of porch, existing electric cable visible, looking NW, 0.5m scale

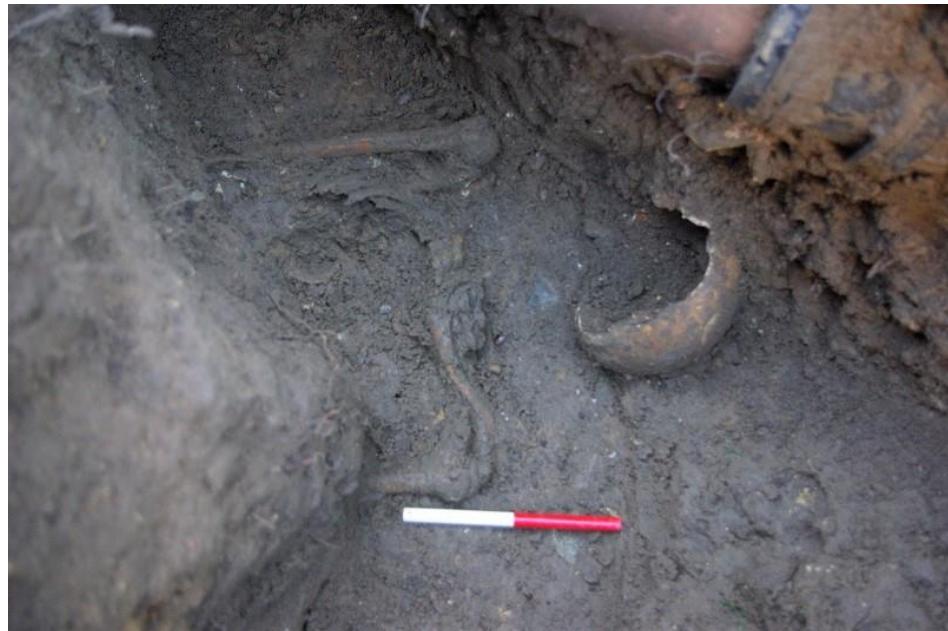
Plate 6: Burial [2], from above, looking S, 0.2m scale

One burial was exposed during the work and the bones present within the area of trench were excavated and removed to enable the laying of the water pipe. The remains were reburied in the trench by a church official.
