#### Warmley Brassworks, Siston, Bristol NGR 366927 172821

#### SAM no. 28518

#### Archaeological Recording Exercise

Project No. 5176

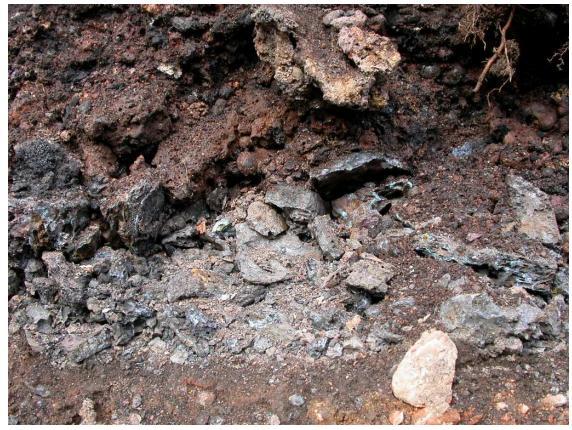
Figure 1. Context [002]

| Context | Description | Notes |
|---|---|--|
| [002] | Layer | Extensive layer of slag and clinker (see Figure 1). The slag |

The extensive layer of slag and clinker [002] appears to represent dumping of waste material from the mid to late 18th-century copper smelting. The presence of slag and clinker in the same context is entirely to be expected from smelting in a reverberatory furnace. The microstructure of the slag is largely that to be expected from smelting Cornish copper ores. The chemical composition is close to that expected but the presence of zinc is unexpected and merits further investigation. The fact that this context contains slag and clinker with little or no other material or sediment suggests that it is not a re-worked deposit and that it represent 18th-century activity (probably c.1747 to 1761).

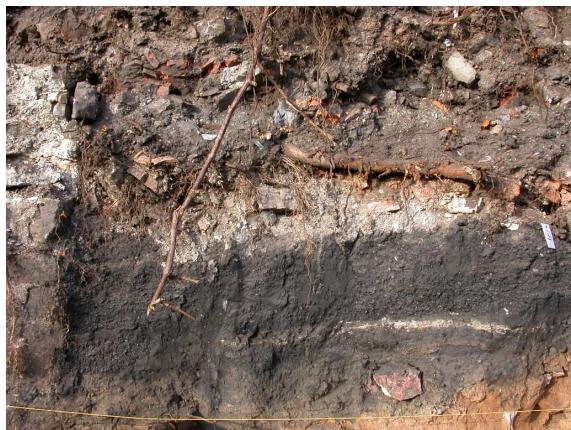
Figure 2. Contexts [004], [005], [006] and [007]

- 4.5.7. East of wall [005] was context [004], a series of tapering deposits of coal slack, a mixture of coal fragments and coal dust. This deposit, which had a maximum depth of 0.75m, tapered for some 3.70 to the east, and clearly accumulated in stages against the wall front.

Context [004] (see Figure 2) appeared in the field to be composed almost entirely of small fragments of coal and coal dust. This was confirmed by exposing samples to a flame: the coal burnt.

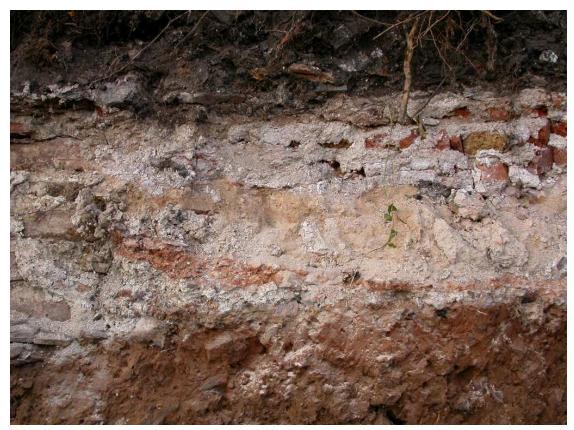
finally [011], a 0.13m thick deposit of sandy mortar. Samples of these surfaces were removed for analysis, and were found to be composed of lime mortar. Lime mortar would not survive the temperatures needed to smelt zinc or copper or those needed for brass cementation. Therefore, although these structures are almost certainly part of the Champion factory, smelting and other manufacturing practices did not take place within them.

Figure 3. Contexts [009], [010] and [011] Figure 4. Contexts [012] and [013] List of samples

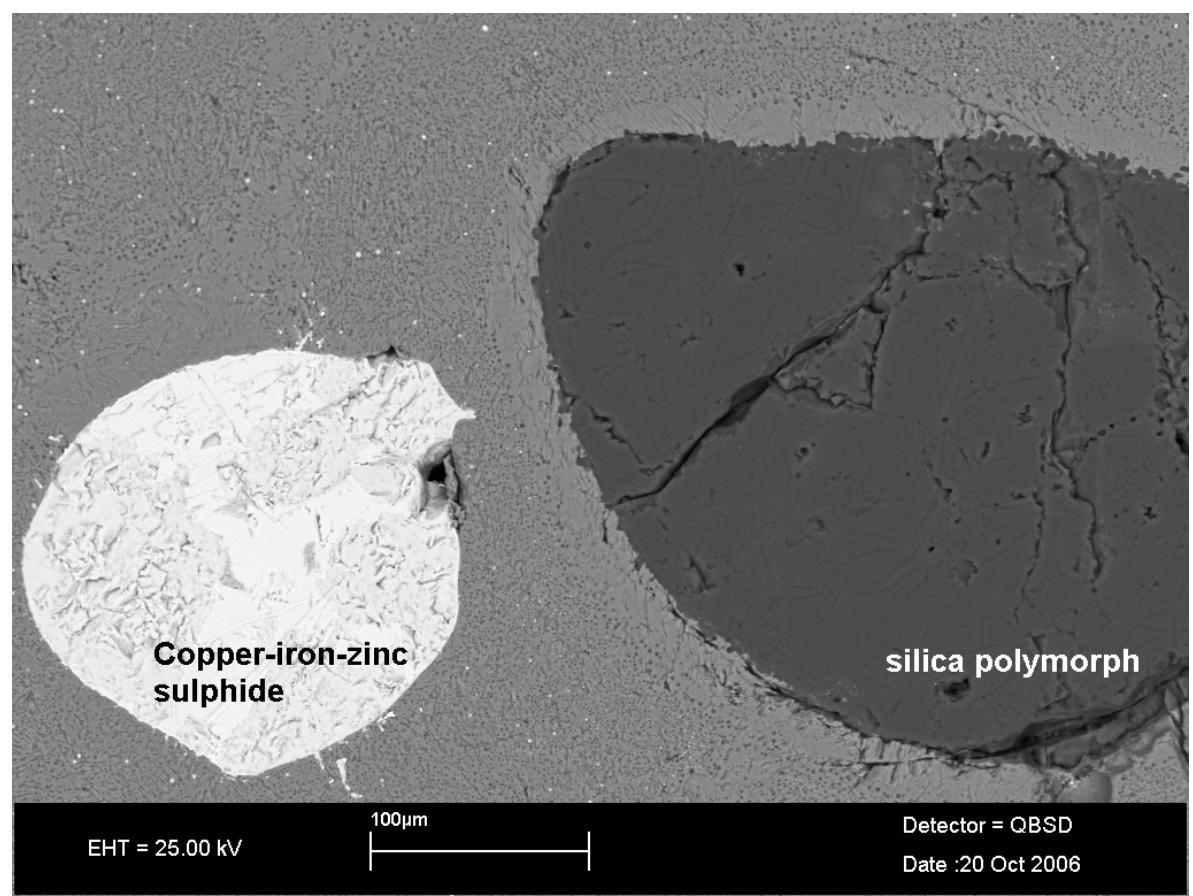
The three samples of copper slag (the capping from the culvert/drain [001] and two samples from [002] all shared very similar characteristics and are dealt with together. The slag is an iron-calcium-aluminium-silicate slag typical of the post-medieval period. It contains two types of inclusions which may shed light on the sorts of process that produced it, namely silica polymorphs (SiO<sub>2</sub>) and copper/iron/zinc sulphides (Figure 5). The presence of the sulphide inclusions suggests that it was principally sulphide ores that were being smelted. This is in agreement with the documentary evidence which suggests that the Bristol copper smelting industry principally used sulphide ores from Cornwall (Day 1973; Percy 1861). Quartz, and some lime, were commonly added to Cornish copper ores during the smelting process to help produce the slag. The presence of zinc in this slag is unexpected as zinc is not usually found in Cornish copper ores (see Appendix for chemical composition). It is possible that the Warmley copper smelters blended ores from different sources; it is known that they obtained some copper ores from North America.

Figure 5. SEM photograph of sample 01 (copper slag block from culvert [001]).

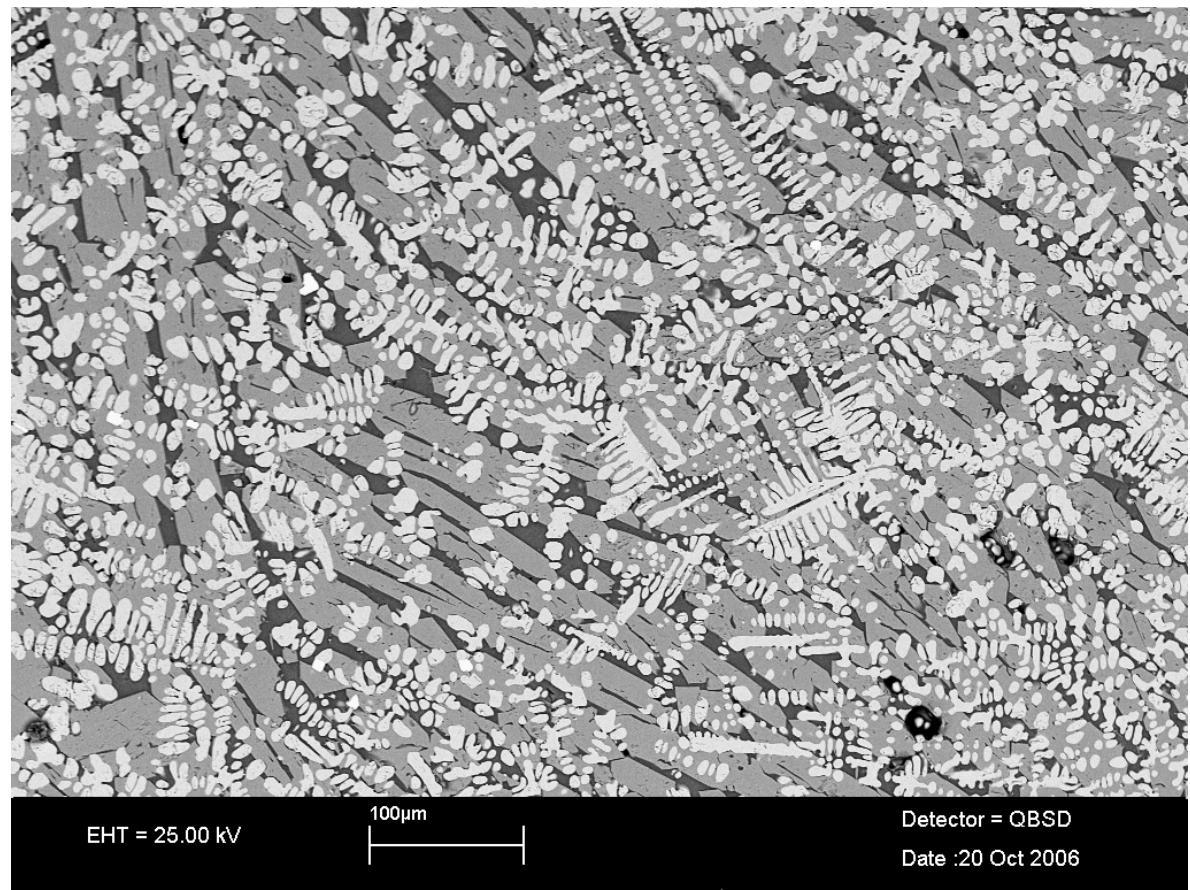
The two samples of tap slag from the make-up layer below the large building have compositions and microstructures (see Figure 6) which correspond to bloomery iron slags (Morton and Wingrove 1969; 1972). The closest parallels are the bloomery slags from the Forest of Dean Carboniferous and Bristol–Mendip area (Paynter 2006): these slags were clearly produced in the region. The bloomery iron smelting process originates in the Iron Age and continued to be employed in England until the 18th century, however, it started to decline from the early 15th century with the introduction of the blast furnace. It is likely that this bloomery slag was produced long before Champion moved to Warmley and is probably residual in this context.

Figure 6. SEM photograph of sample 07 (tap slag from [008]).

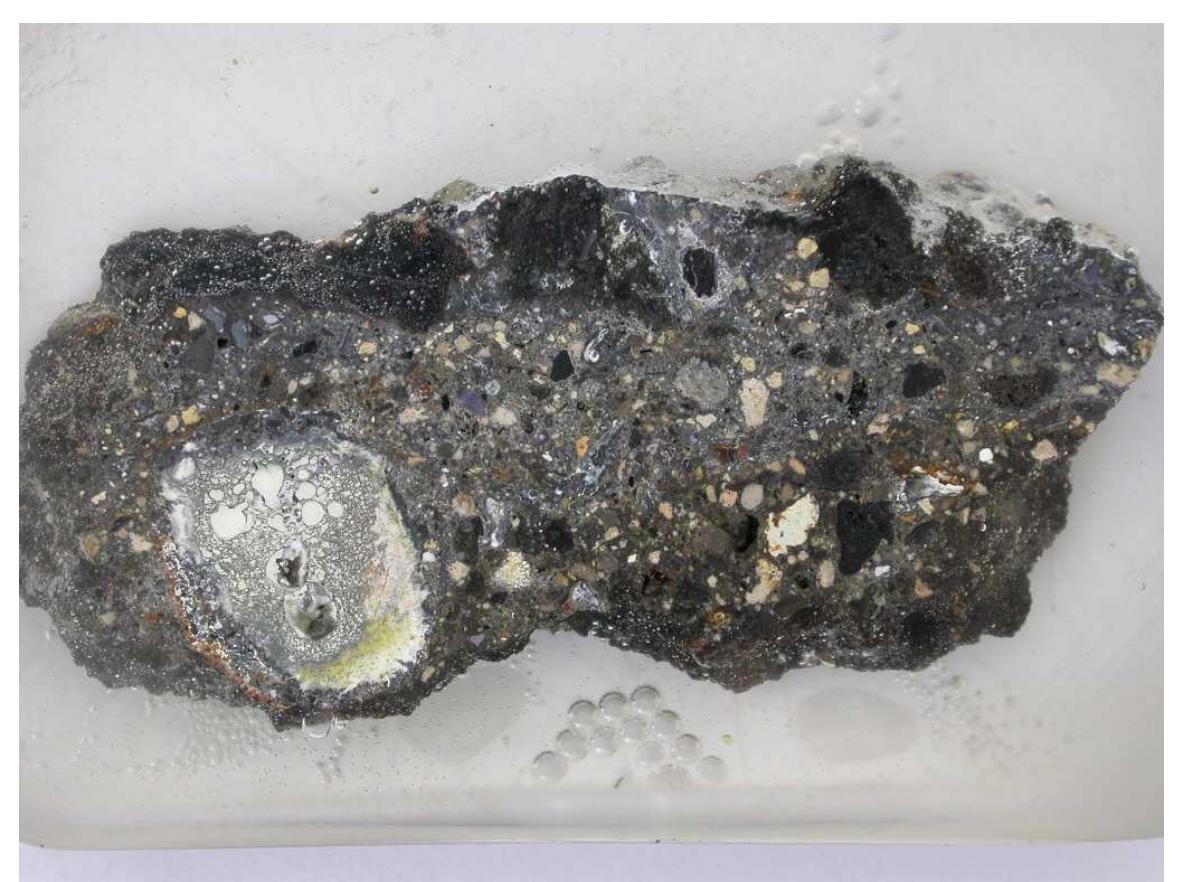
This is a complex deposit, containing droplets of metallic zinc (0.01–2mm in diameter), fragments of coal, fragments of charcoal and fragments of refractory material, in a zinc compound matrix. The nature of the zinc compound forming the matrix is uncertain, however, no sulphur was detected and so it is not zinc sulphide ore. The metallic zinc droplets are in many cases very small and finely dispersed throughout the material. It is possible that this material is the 'residuum' left inside a zinc-smelting retort mentioned by Percy (1861, 558).

Figure 7. SEM photograph of sample 09 (zinc-rich material from [012]).

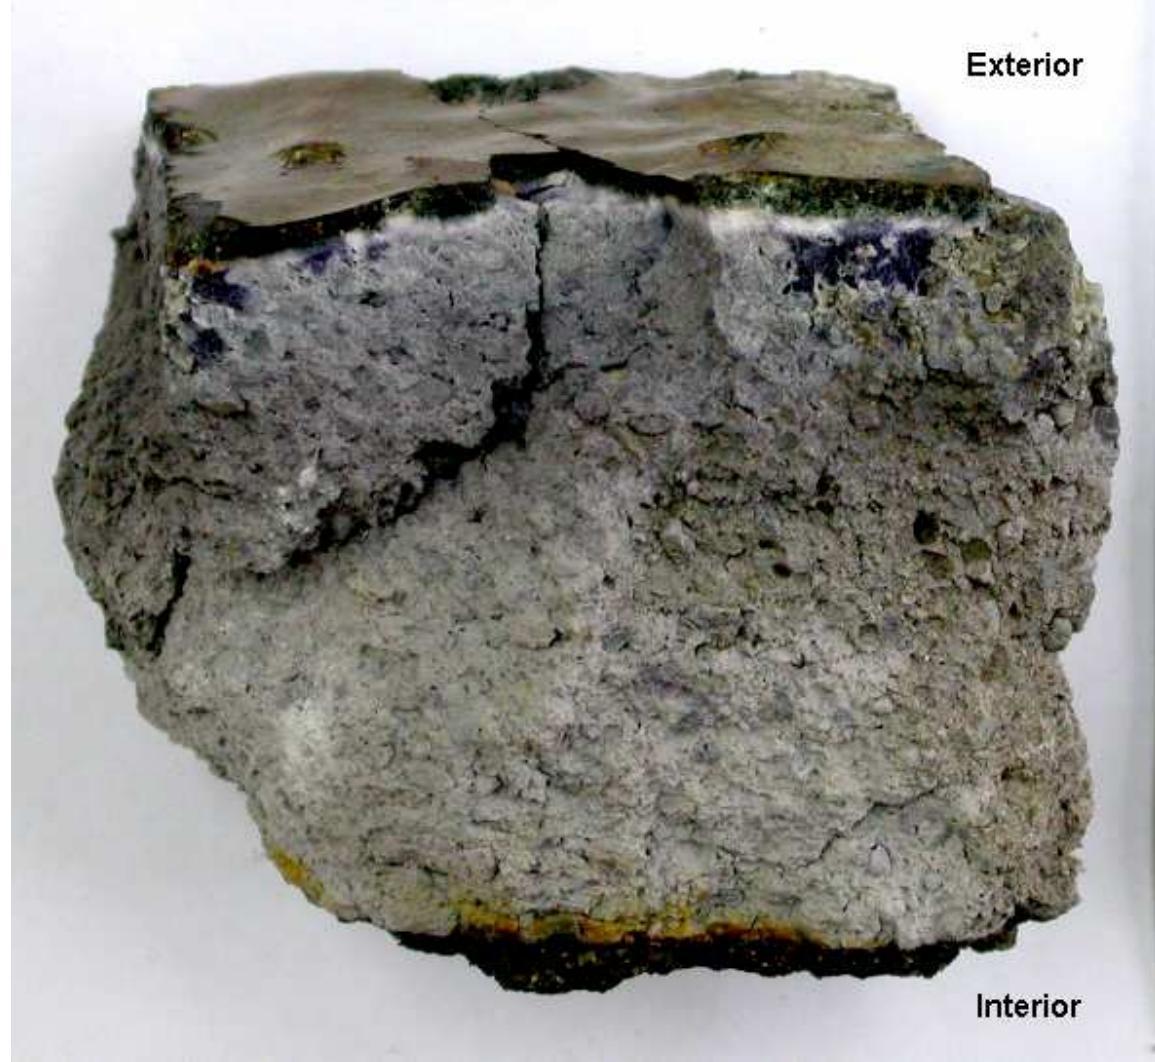
Figure 8. Unstratified refractory material (sample 05)

An unstratified fragment of refractory material was identified as deriving from either a brass cementation crucible or a zinc retort (figure 8). This is approximately 48mm thick (not including the vitrified layers on both surfaces),

which would be more in keeping with a zinc-smelting retort than a brass cementation crucible. The vitrification of the outer surface resembles that seen on the exterior surface of crucibles used in the coal-fired glass industry (eg Dungworth 2003), and is probably due to the action of coal fumes and ash (with some zinc vapour). The vitrification on the exterior surface is heterogeneous and vesicular. The chemical composition (see appendix) and microstructure, eg presence of zinc-aluminium spinels, of the ceramic core are similar to those reported by Freestone (1988). The absence of copper (see appendix) indicates that this is a fragment of a zinc smelting retort rather than a brass cementation crucible. The vitrification on the interior surface contains a variety of phases and may be the 'residuum' left after zinc smelting (Percy 1861, 558).

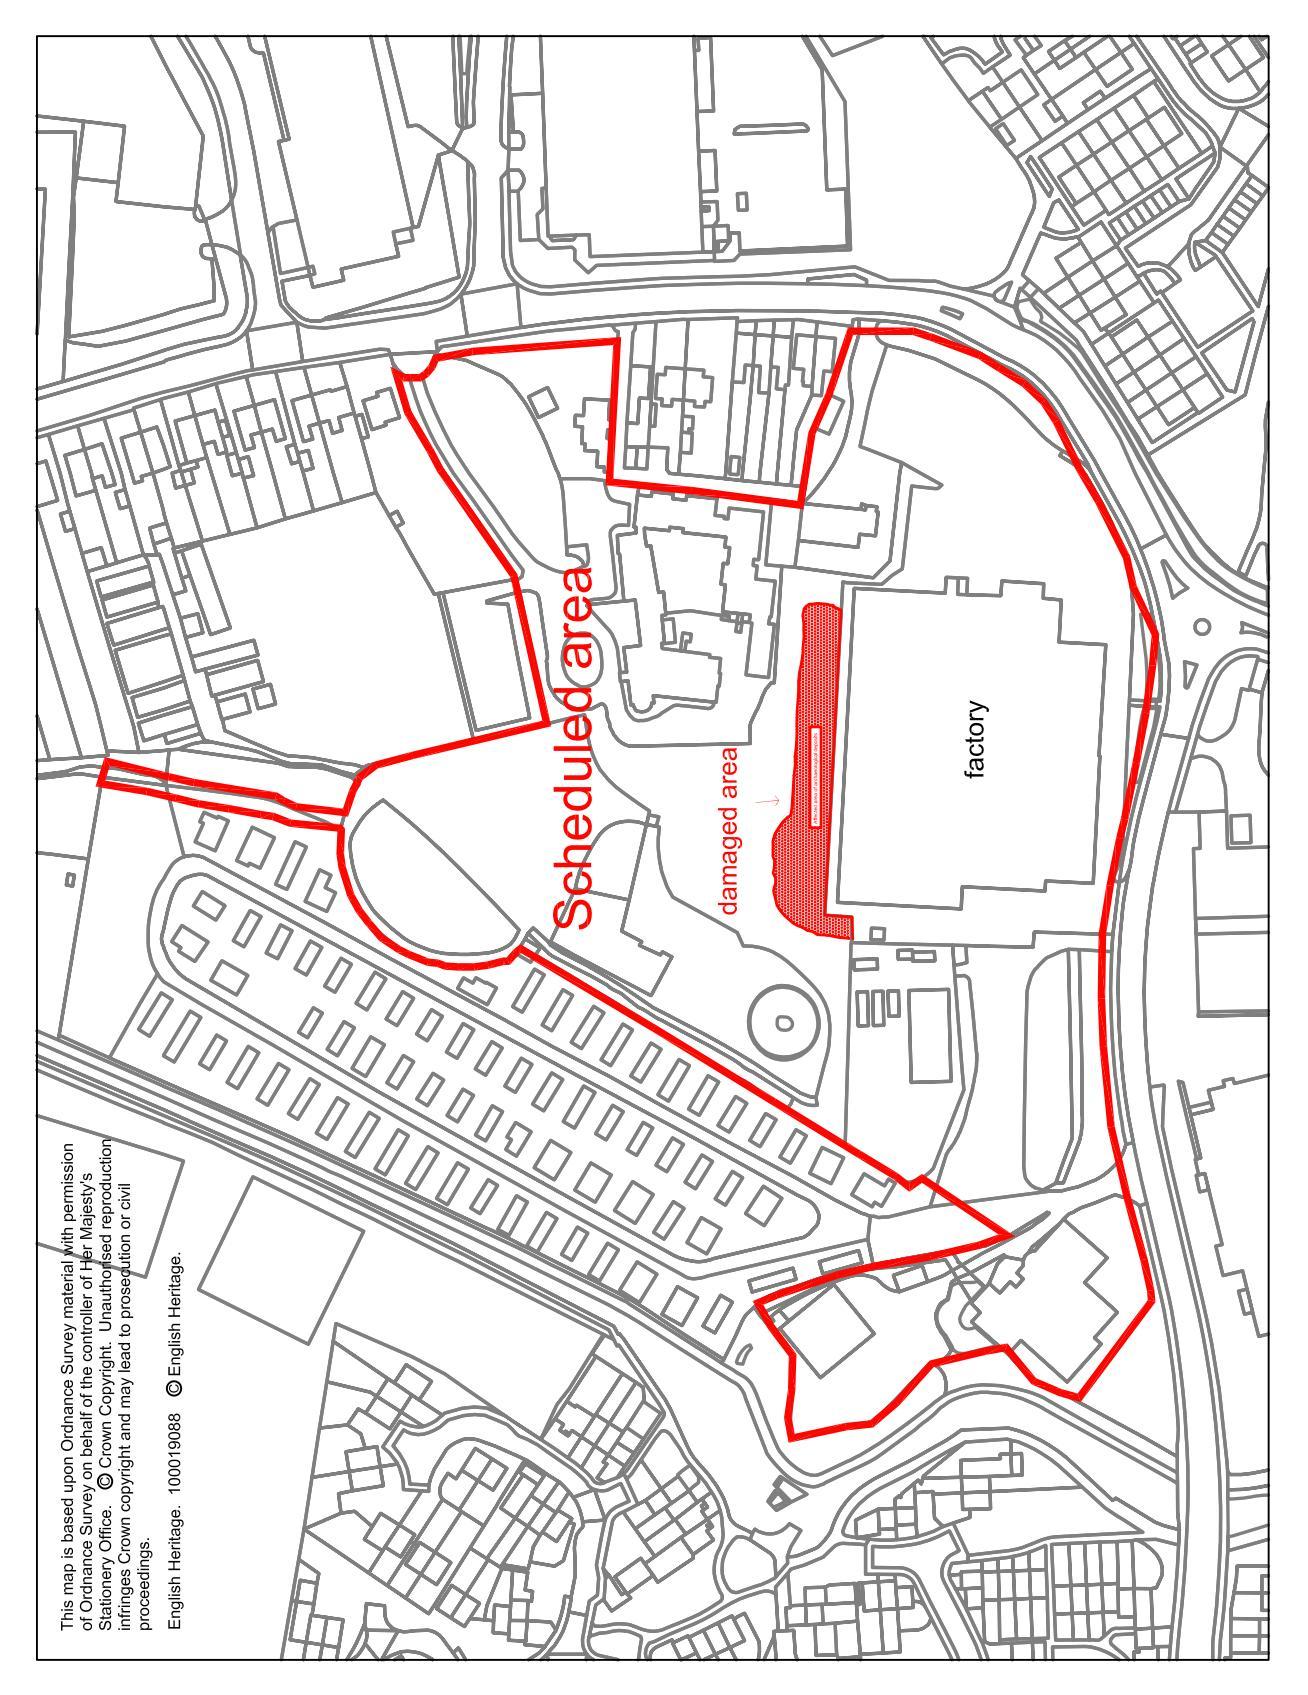
- 1.2. The area of the damage was to the north and west of a lightweight industrial building, known as the Former Lindmans Works, off Tower Lane. A large swathe of land had been machined away by a tracked excavator using a toothed bucket from the rear of the building up to the adjacent property boundary, to a depth ranging from 10 22m from the building. The section was 88m in length, and at its apex over 5m in height. Approximately 1000 cubic meters of soil is thought to have been removed, although not all of this would represent archaeological deposits, as the truncation had cut into the natural geological deposits.

Fig 1: SAM and site location showing affected area.

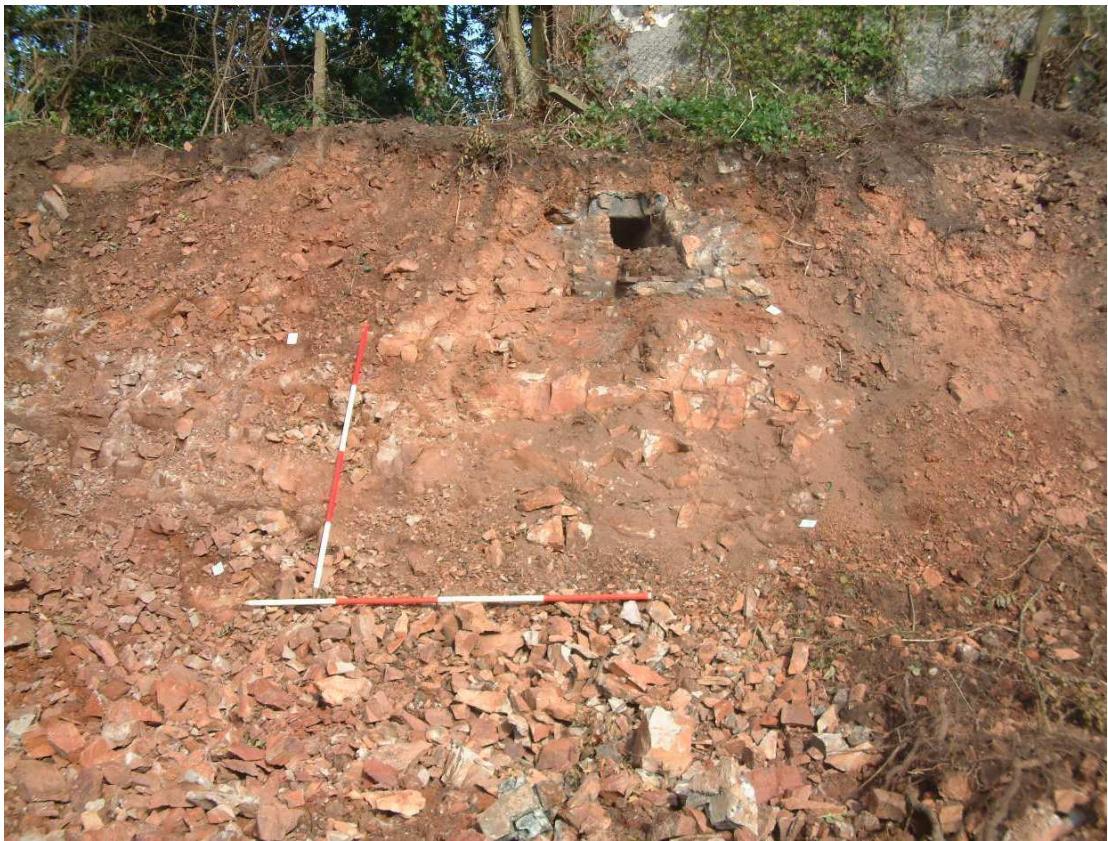
- 4.3.1. The first archaeological structure encountered from the west was a small culvert, approximately 2.40m long x 1.60m high (Section 1). The culvert was constructed by excavating through the natural sandstone [018], then reusing the excavated material bonded with a cement mortar to form the walls and floor of the culvert [017]. The floor was capped with slate bedded in cement, which was also used to render the interior. The top of the culvert was capped with a single course of cast slag blocks [001], which was sampled for its composition and is discussed in the appendix.
- 4.3.2. Approximately 0.30m to the east of the culvert was a second cut, [014]. This measured c. 1.30m across, and was at least 3.0m deep, at which point it continued below the section cut. It was backfilled with redeposited natural sandstone [015]; it was suggested by the Kingswood Museum that

Figure 5: Detail of culvert

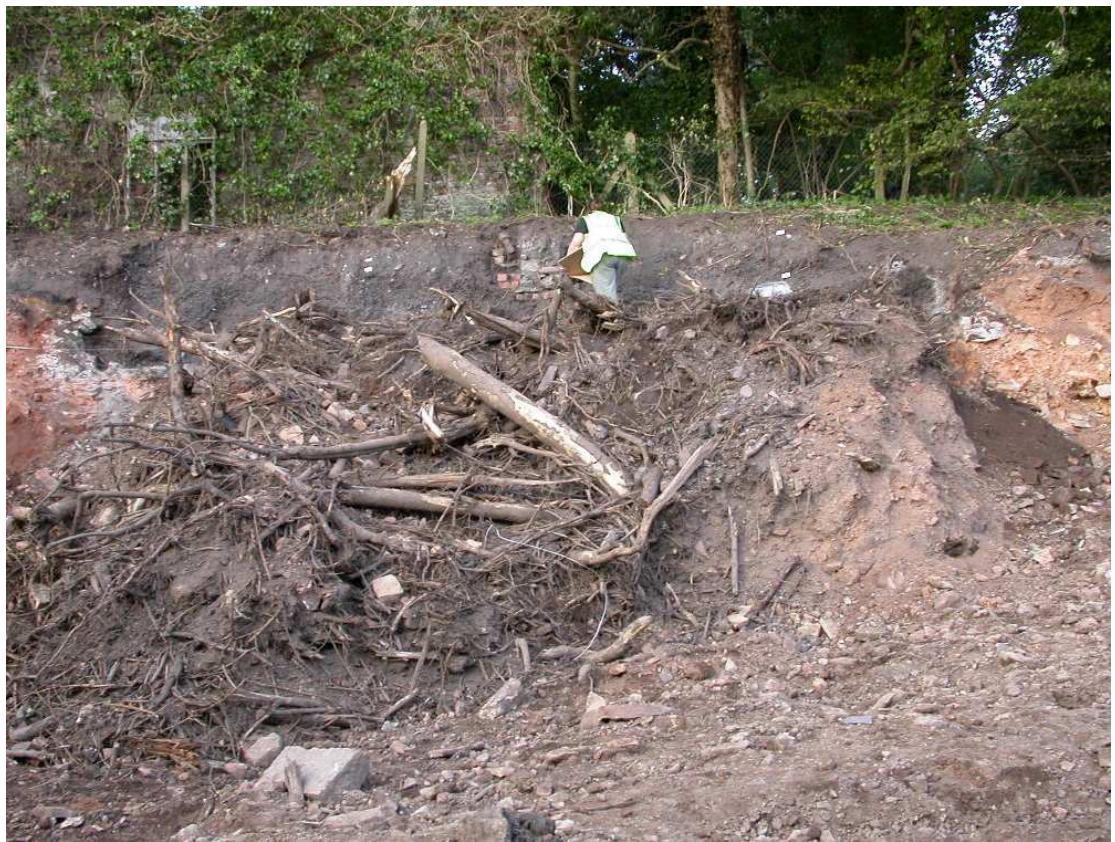
- 4.4.2. The western wall [022] was set into cut [021], which measured 0.60m wide x 1.20m high. The wall was constructed of irregular sandstone blocks bonded with a chalky mortar and the cut backfilled with redeposited natural [023]. Remnants of a mortar floor were seen abutting the wall on the western side of the structure only ([051]). The wall on the eastern side of the building was of a similar size and construction, but was more severely damaged by machining.

Figure 6: Western building, showing damage and timber debris
