ARCHAEOLOGICAL DESK-TOP
ASSESSMENT OF
MUCKNELL FARM
STOULTON
WORCESTERSHIRE

WSM 38291

Archaeological desk-top assessment of Mucknell Farm, Stoulton

WSM 38291
October 2007

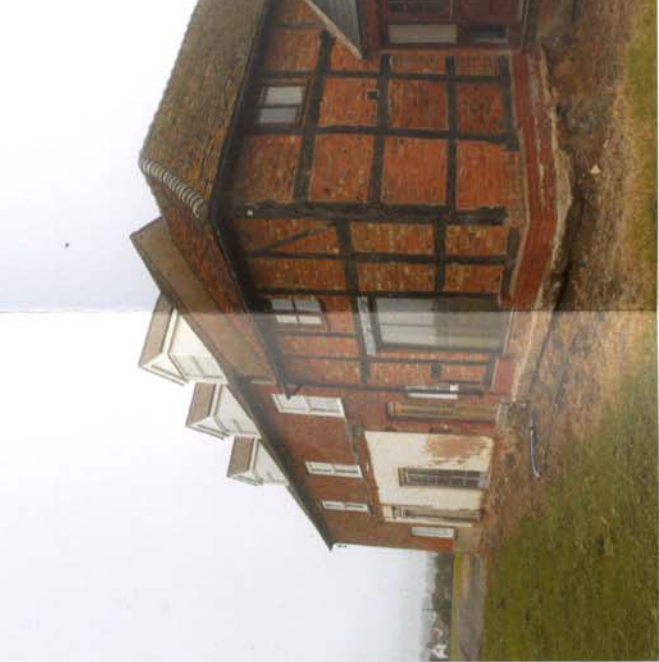
- 7.1.8 The present condition of the building is poor, and there is some evidence that the recent brickwork infilling is contributing to the decay of the timber framework as the cement used does not expand and contract with the timber, exacerbating water penetration around the panels. Other than the remnants of the timber frame no other original fabric appears to survive.

Former "dairy"- note modern concrete base, and depth of recess

- 8.3 The timber-framed former "dairy"/farm office building is presently in poor condition, and has been drastically altered since original construction, possibly also moved. It is not adaptable to re-use without very extensive replacement of the surviving decayed timbers, and the past loss of perhaps 50% of the original framing elements has left it as an uninterpretable fragment. It appears to fall outside the criteria for selection as a designated agricultural or vernacular building (English Heritage Selection Guides, March 2007), and therefore is not protected by current legislation. It is recommended that following recording it is carefully dismantled and elements of the frame re-utilised where possible in the restoration of the remaining farm buildings and replacement farmhouse. The present brickwork infill is mainly laid in recent Portland cement, and it is unlikely that much can be salvaged economically except from the eastern elevation which has not suffered so drastically from 20th C cement repairs.

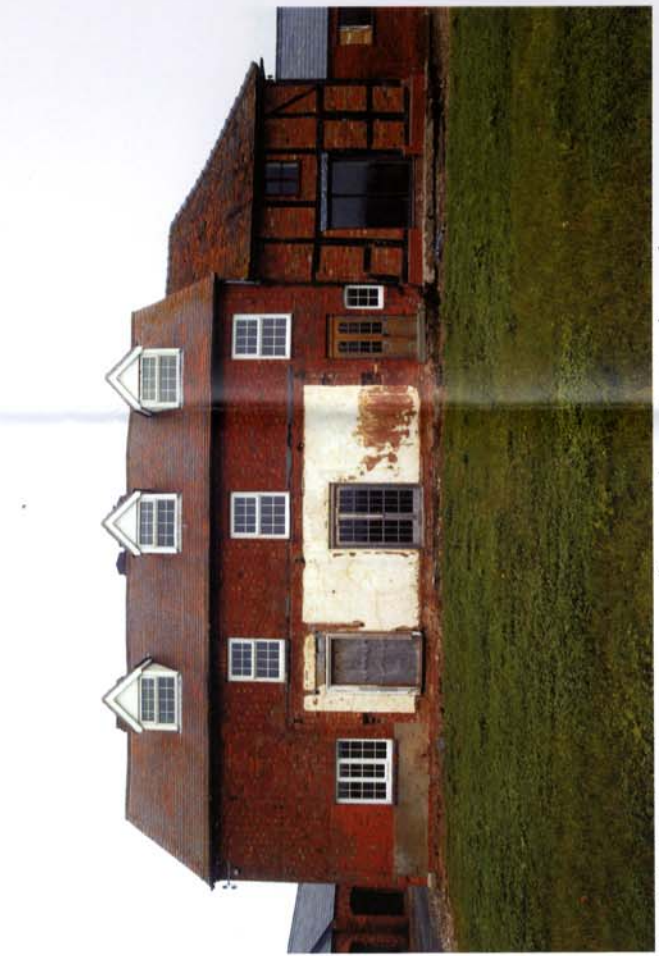
South facing elevation- note scar of removed recent extension and modern plastic windows and dormers

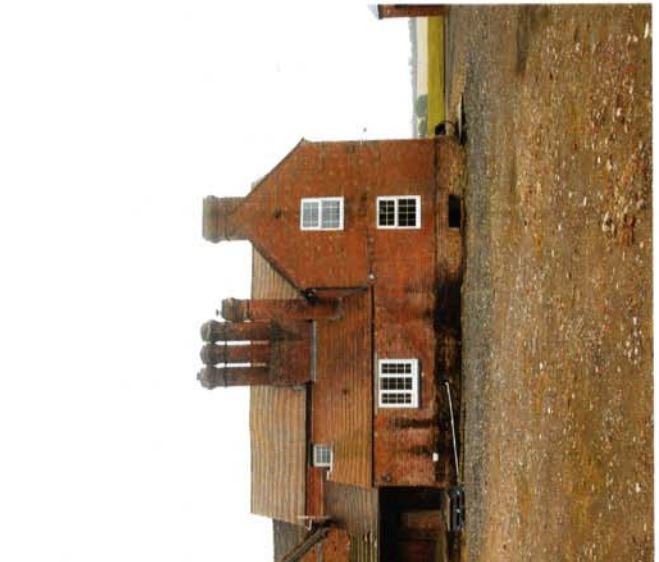
Former "dairy" and farmhouse - all visible fabric on this (number roof truss) is 19th C or later

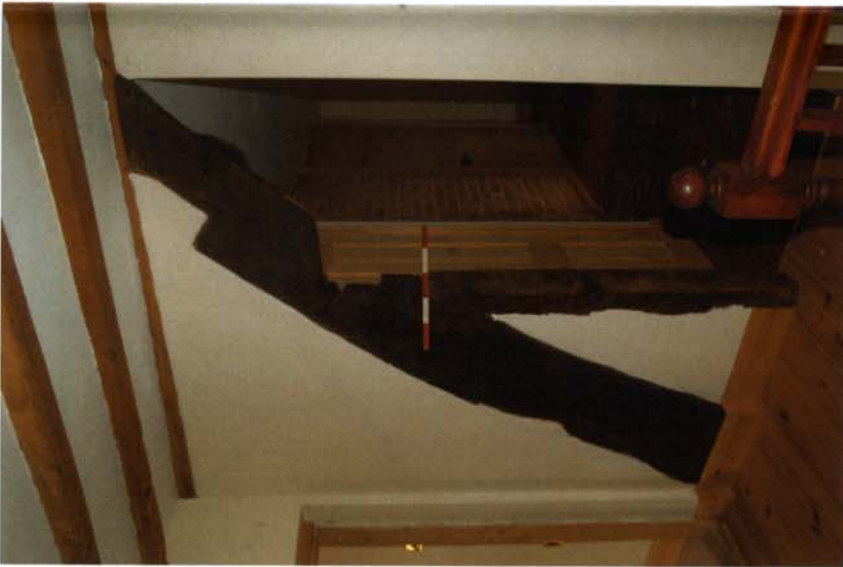
7.2.2 The earliest surviving elements are the two opposed blades of a probable “upper cruck”, or possibly “eaves blades” between the second and third bays at the western end of the house (Fig 6). Both blades are badly damaged due to later openings having been cut through them. The blades are now incorporated in an internal wall of largely modern construction (of concrete block at ground-floor level), and truncated at attic level by tie beam of the late 18th C roof truss. There are no immediately apparent datable characteristics in the present crucks. Recent research in Shropshire has suggested that the majority of surviving “true” cruck frames date from the 15th and 16th Centuries, and similar dates have been identified in several other counties (Mercer, 2003 p131). Upper crucks have been considered a later development of the “true cruck”, as they provide substantially greater headroom, and several examples are known from the 17th Century in Herefordshire (RCHME). There is no evidence that crucks pre-date box-framing, but it remained in use for a long time, as late as the eighteenth century on the North York Moors (English Heritage Vernacular Houses Selection Guide (Domestic Buildings 1) March 2007). A particularly late local example of “upper cruck” construction of 19th C date has been identified at 21 Friar Street, Worcester by Richard Crook in advance of alterations to this listed 17th century building (WCM 100724). The blades here cannot be precisely dated without detailed examination, but are probably of late 17th or early 18th C date. The survival of the blades appears to have occurred by chance, as they appear to now serve little useful structural function. They possibly marked the western end of the original building. There are some remnants of framing below the crucks surviving at first floor level only, and this may be possibly be contemporary with the crucks. The crucks have been treated as a decorative feature in a 1980s renovation scheme, and prior to detailed examination caution is required in interpretation as some of the timbers may be decorative recent additions.

Northern cruck-blade (from Bay 2)

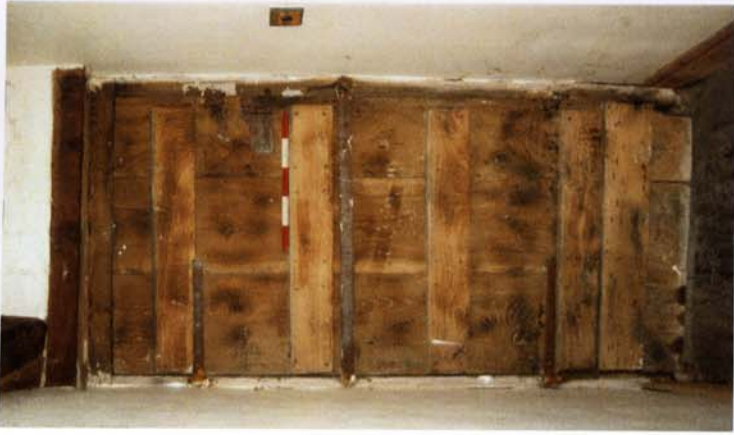
- 7.2.6 At ground floor level the only probably pre 19th C door is that which was formerly the door to the farmyard (Fig 6). It is now an internal door between the side lobby and the "lean-to" kitchen, but is clearly an external door which has suffered decay at the base (neatly repaired), and internally has a swivelling security door bar locked (when in place) by a gudgeon pin. The door and its contemporary frame have few closely dateable characteristics, but are (on the evidence of the door-bar and hinges) probably 18th Century. Interestingly the drop handle of the 19th C exterior door to the "lean-to" kitchen also may possibly be of mid-late 17th C date (vide Hall, 2005 figure 2.78 for similar examples), and if so is certainly re-used in its current location.

Door to "lean to" kitchen - a relatively rare example of a plain ledged external plank door of probable mid 18th Century date, together with contemporary frame and door furniture, including a thumb-latch, swivelling iron door-bar, staple and gudgeon pin. Possibly the most interesting feature in the house. **Recommendation: Retain for reuse, preferably within new house.**

Original door to farm-yard - note surviving door-bar and L 18th C latch

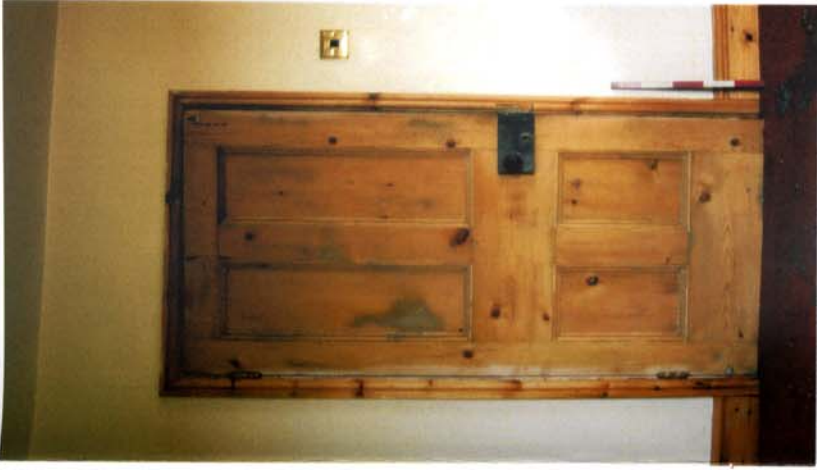
Typical 19th C 4 panel door (Bay 1)

*Doors from Bay 2 are mid 19th Century four panel softwood doors, both with planted bolelection mouldings to panels. Door furniture appears slightly later (1870s-80s). Both damaged by sand blasting, but re-usable if sanded thoroughly. In common with the subsequently listed 19th C panelled doors these are mass-produced items and far from rare - they do however have some historical value **Recommendation: Retain for possible reuse on site.***

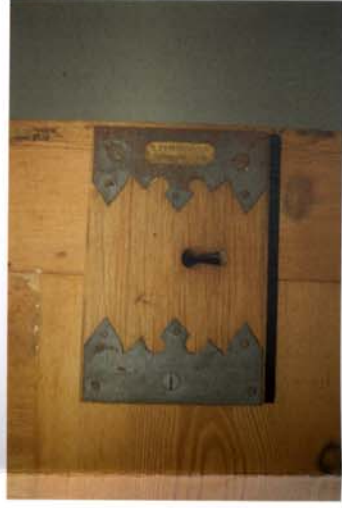
*Door from Bay 2 is plain mid-late 19th Century four panel softwood door. Door furniture appears slightly later (1870s-80s). Damaged by sand blasting, but re-usable if sanded thoroughly. Nb door from front door lobby to Bay 3 is missing. Door to china pantry is plain mid 19th Century four panel softwood door with 1850s-60s wooden boxlock with decorative stamped metal plates Manufactured by H.Symmonds & Co Birmingham. **Recommendation: Retain for possible reuse on site.***

Mid 19th C box-lock by Symonds of Birmingham
