**Barn at  
East End Road,  
Stonham Aspal, Suffolk  
SAL 031**

**Historic Building Record**

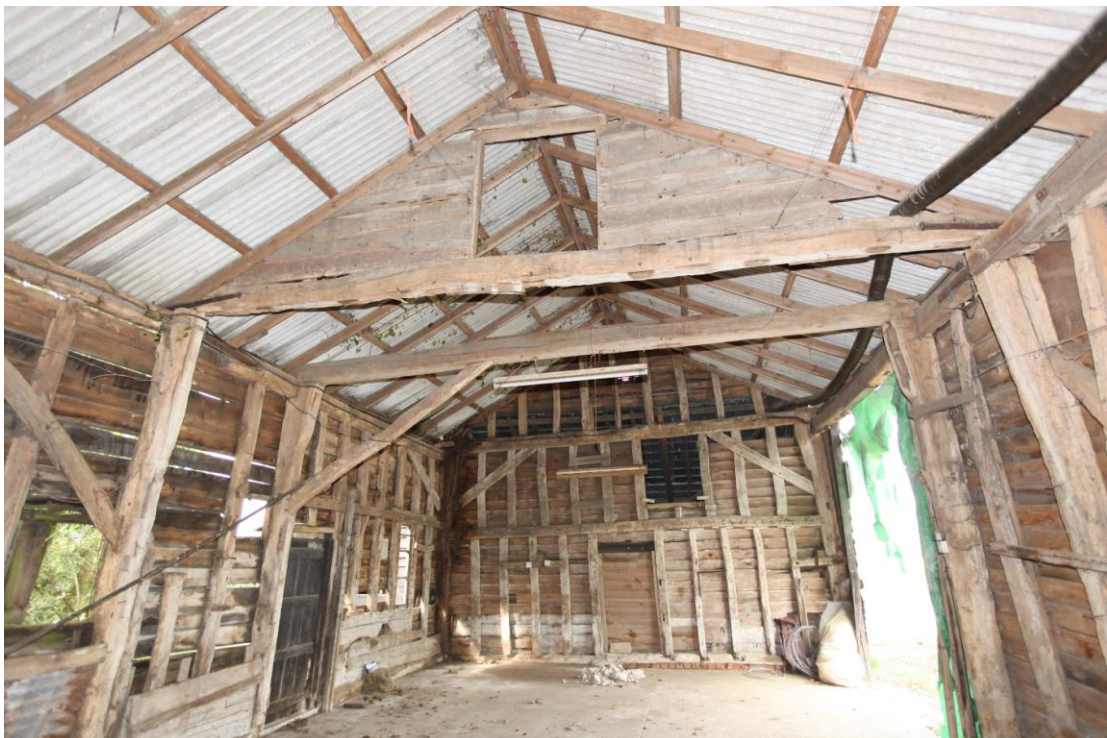
**Illus. 12.** The remains of the internal northern gable of the 16<sup>th</sup> century barn (1) showing empty mortises for missing studs and corner braces but no mid-rail. The southern gable, in contrast, contained a mid-rail. The boarding above the tie-beam retains a loading hatch that served the missing hay loft of the stable bay (1b) beyond.
