**Barn at Glebe House,
1 Old Street,
Haughley, Suffolk
HGH 049**

Historic Building Record

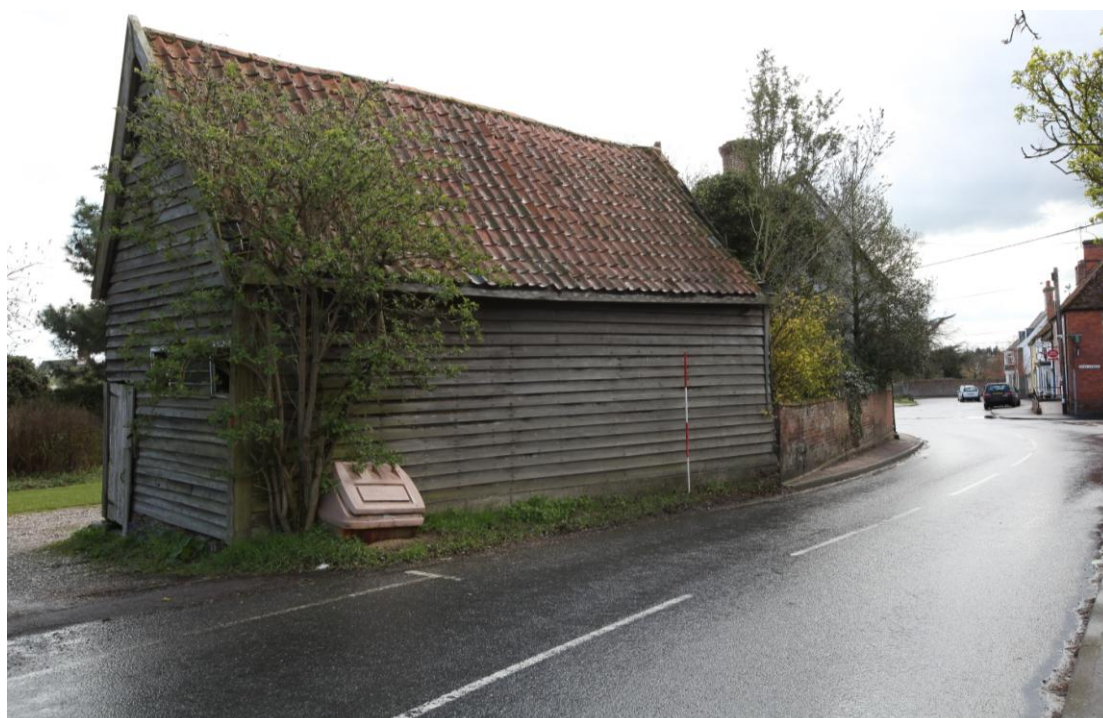
Illus. 2. The barn from Bacton Road to the north showing its proximity to the site of the medieval market place (in the rear to the right). The weatherboarding of the western elevation and the northern gable was renewed in the 20th century, and the pantiles are likely to have replaced thatch. There is evidence of an original narrow door in the central bay of the roadside elevation.

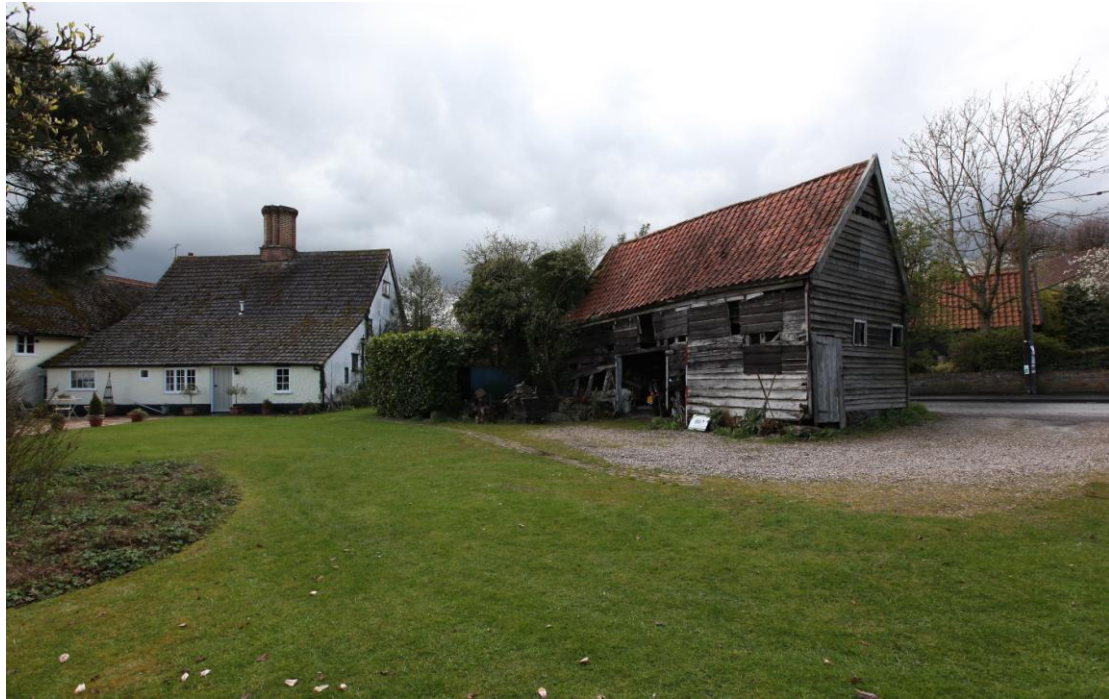
Illus. 3. A general view from the garden to the east showing the distinctive rear lean-to of Glebe House to the left and the site entrance from Bacton Road to the right. A similar lean-to formerly adjoined the eastern elevation of the barn.

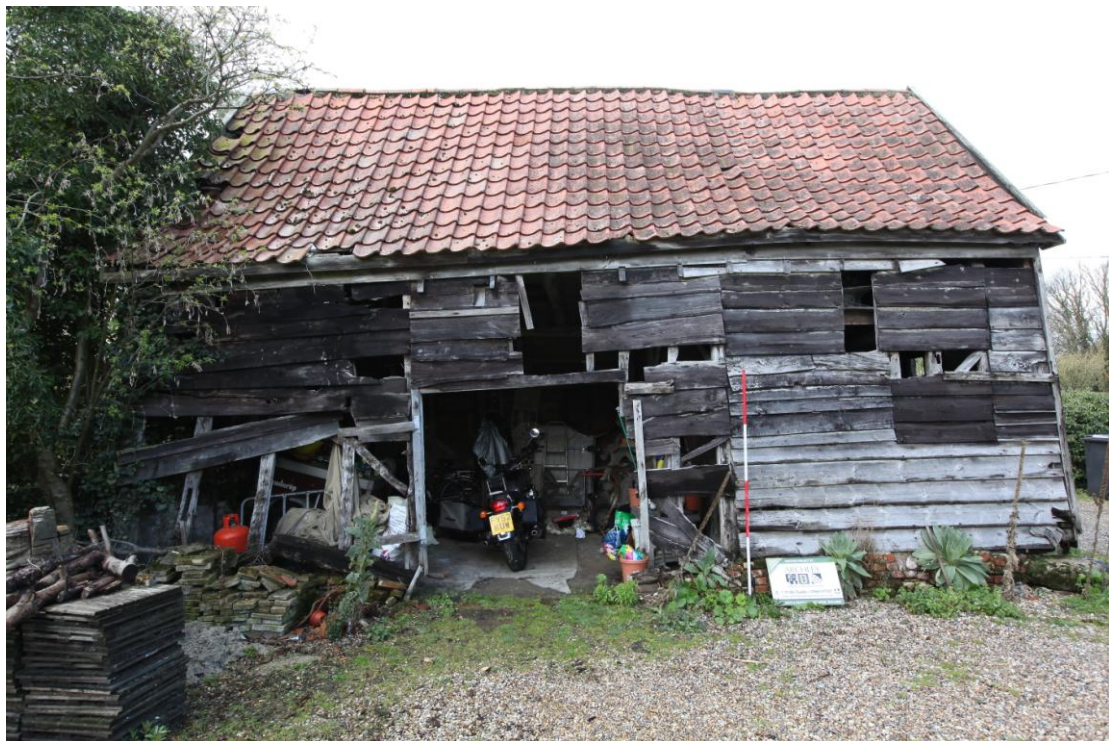
Illus. 4. The eastern exterior of the barn showing the 19th century tarred weatherboarding that escaped replacement in the 20th century as it lay within a recently demolished lean-to (as indicated by the stubs of rafters beneath the eaves and shown on the current Ordnance Survey in figure 1). The upper boards are unusually large, at 28 cm (11ins) in width, with neatly chamfered lower edges, and respect an original full-height entrance in the central bay (reduced to its present proportions in the 20th century). The blocked window apertures are secondary.

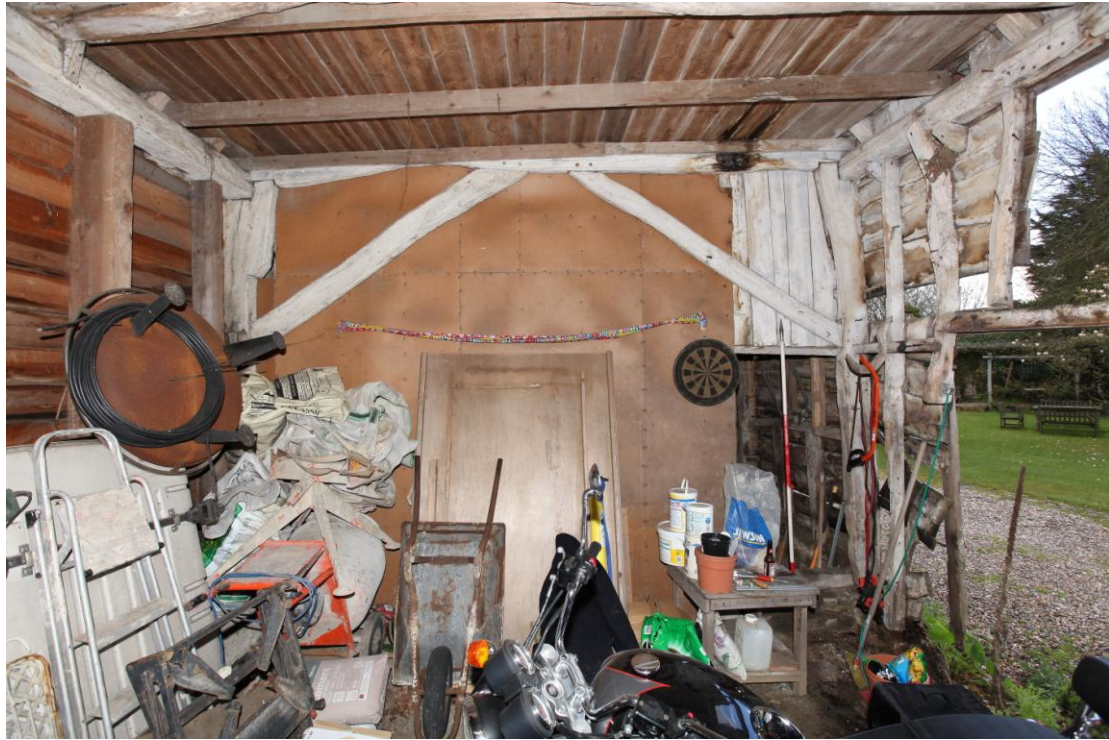
Illus. 5. The interior of the central bay (B) from the south showing the intact arch-braced open truss adjoining the secondary partition of the northern bay (C).

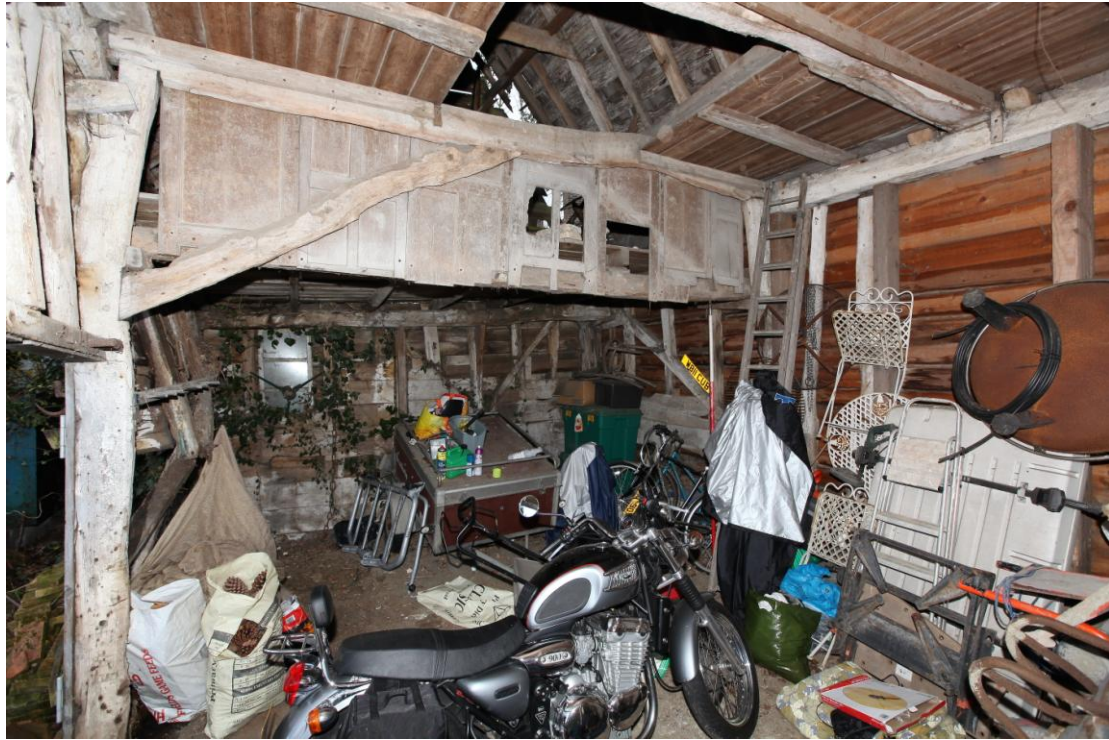
Illus. 7. The interior from the north showing the open truss to south of central bay (B) with an intact arch-brace to the left the empty mortises of its missing counterpart to the right. The partition of the secondary loft consists of re-used 17th century panelling.

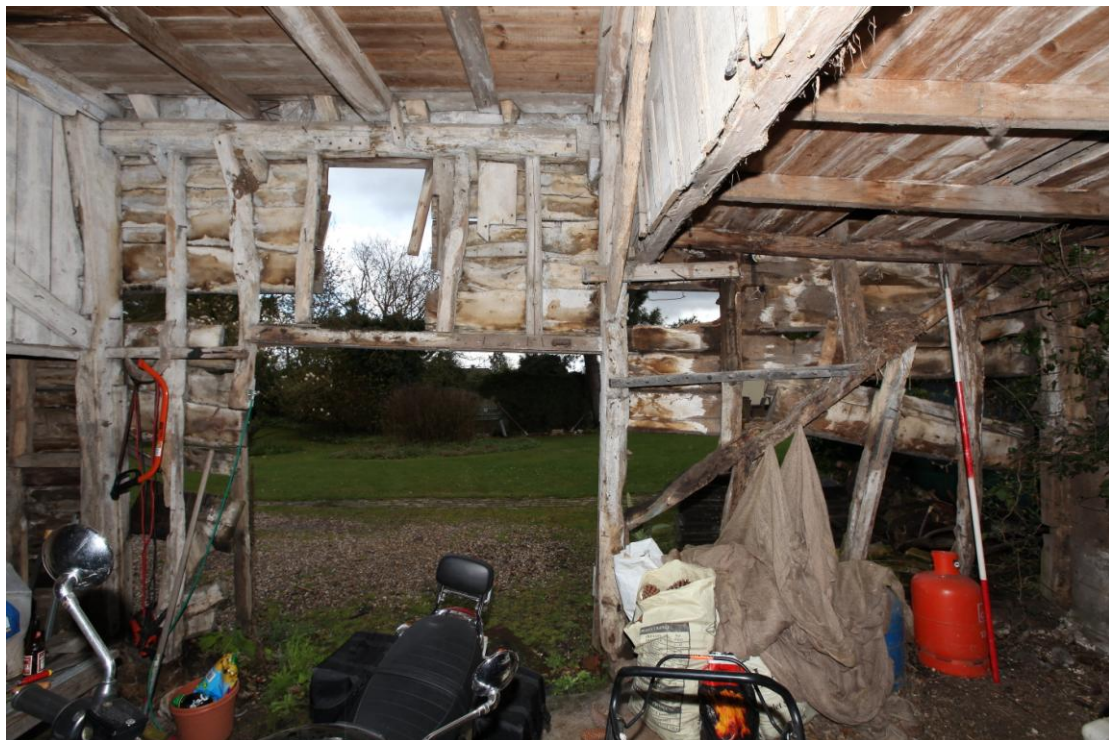
Illus. 8. The eastern interior of bays A (right) & B showing the low 20th century doorway in the position of the original full-height entrance to the left and the 20th century softwood joists of the southern loft to the right.
