## ARCHAEOLOGICAL MONITORING REPORT

SCCAS REPORT No. 2012/182	Parish: Nayland with Wissington
<b>Loretto, 6 Church Lane</b>  <b>NYW 053</b>	Planning Application No.: B/12/00053/FHA/JD
	HER Event No.: NYW 053
Address: Loretto 6 Church Lane Nayland with Wissington	Grid Reference: TL 9761 3429
	Number of Site visits: 1
	Date of visit: 19th November 2012

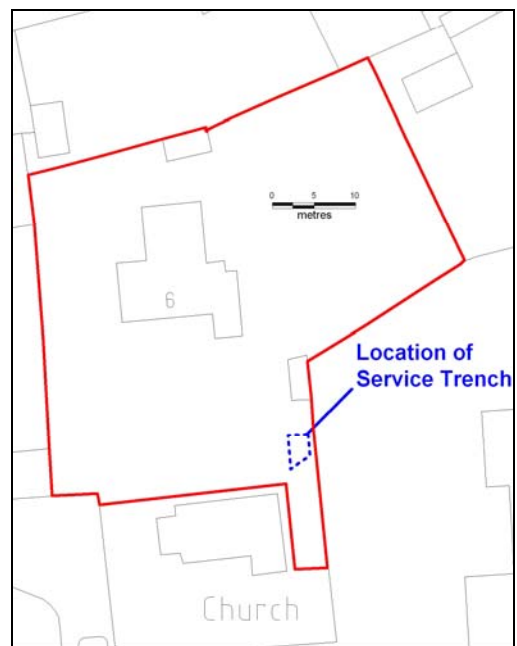
Figure 2. Site plan showing location of service trench:

Unfortunately the Archaeological Service was not contacted during the digging of footings or service runs (PIs 1 & 2). A short segment of service trench associated with an adjacent property (but within the garden of Loretto) could be viewed however and this was recorded (Fig. 2).

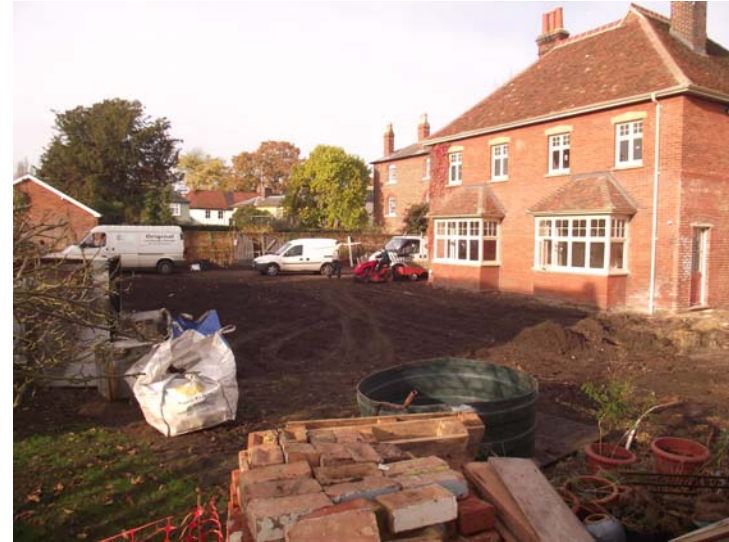
Plate 2. View showing disturbed ground to the south of Loretto where septic tank, drain runs and other services were located

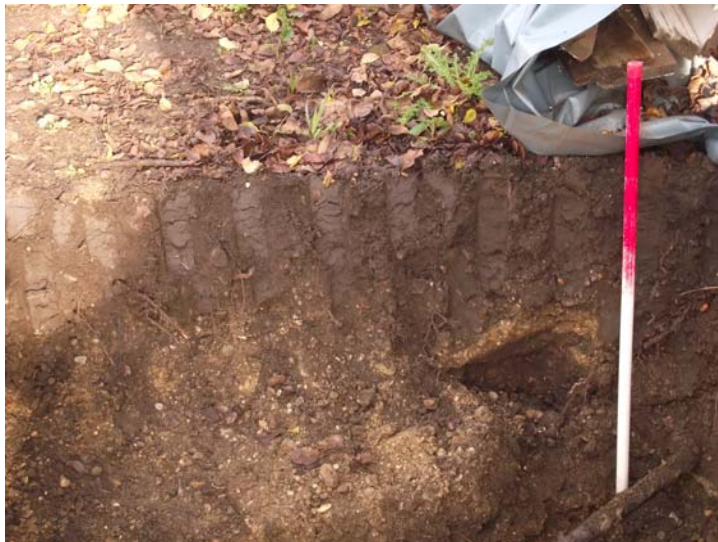
The service trench observed had been excavated along the line of an earlier service so that the ground was highly disturbed. The northern edge of the trench however appeared to cut undisturbed deposits and these were recorded and photographed (PIs 3 & 4).

The deposits consisted of dark brown humic topsoil (0.3m thick) directly over clean (probably truncated) yellow sand and gravel. No archaeological features or finds were recognised. The surrounding trench edges and associated spoil were checked for finds but none were found.

Plate 3. Section against north side of service trench showing sharp contact between topsoil and underlying natural (suggesting truncation)

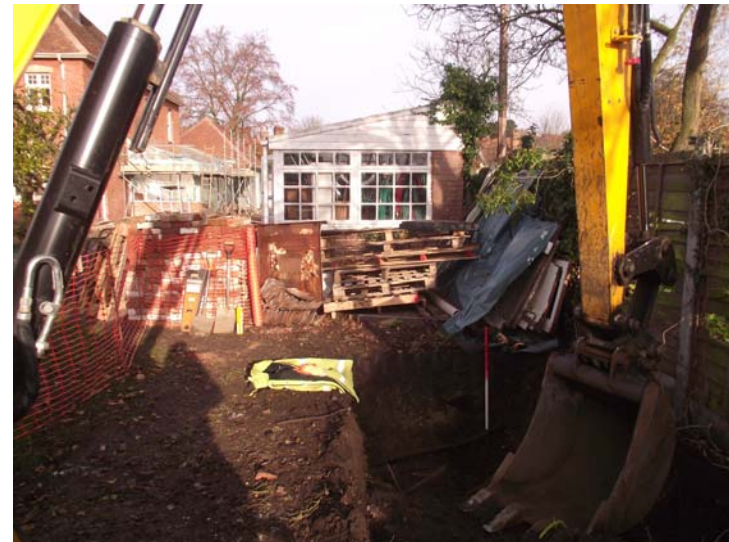
Plate 4. General view looking north showing location of edge of service trench recorded (see 1m ranging rod)
