Pottery Cottage, Wattisfield WSF 061

Historic Building and Archaeological Monitoring Report

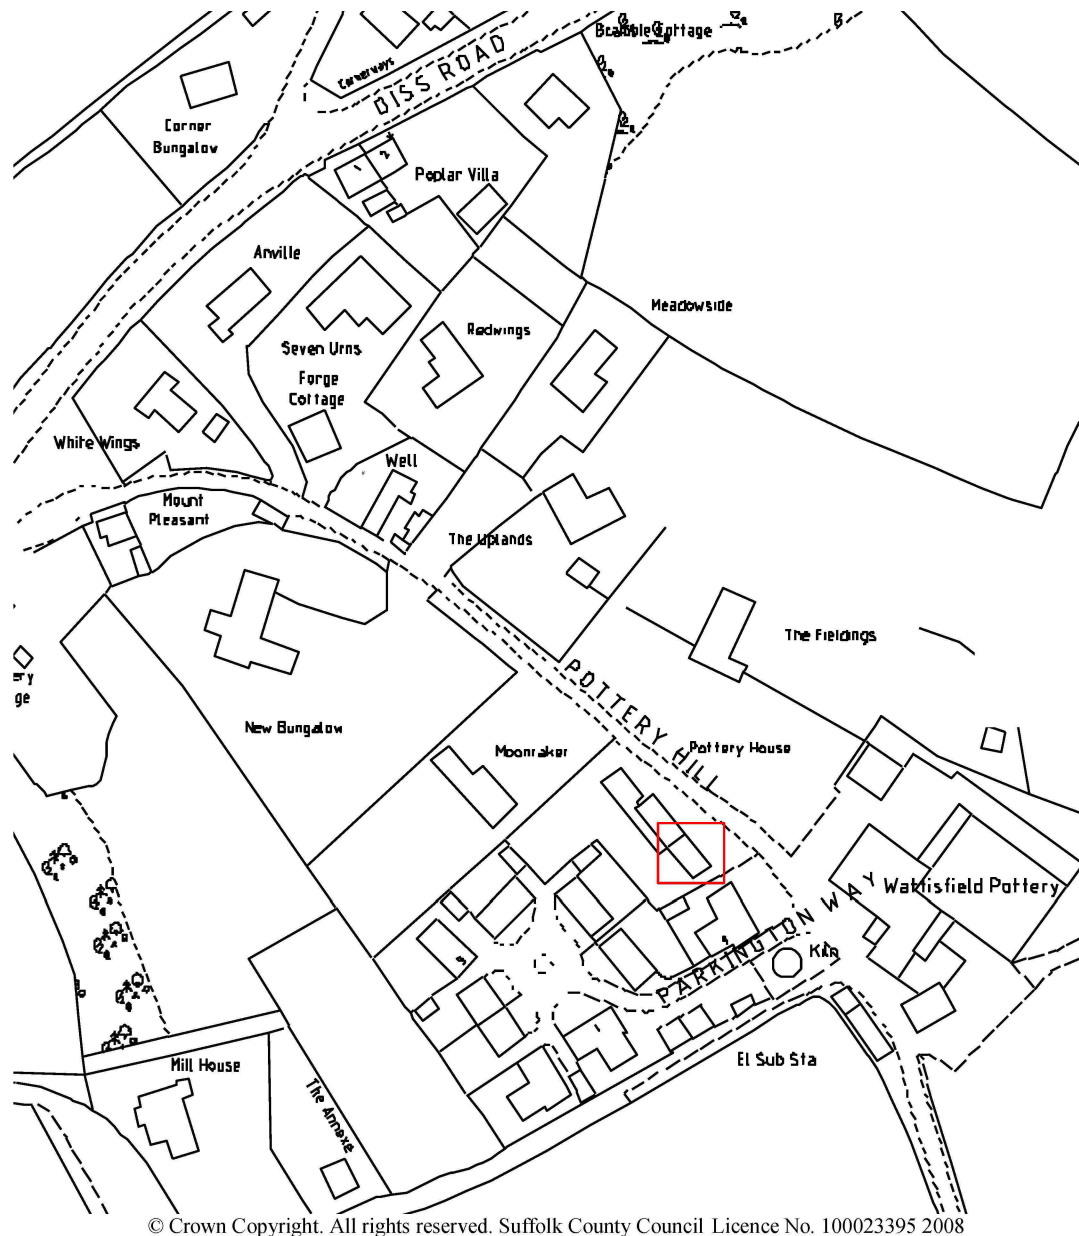
Figure 1. Current Ordnance Survey Site Plan.

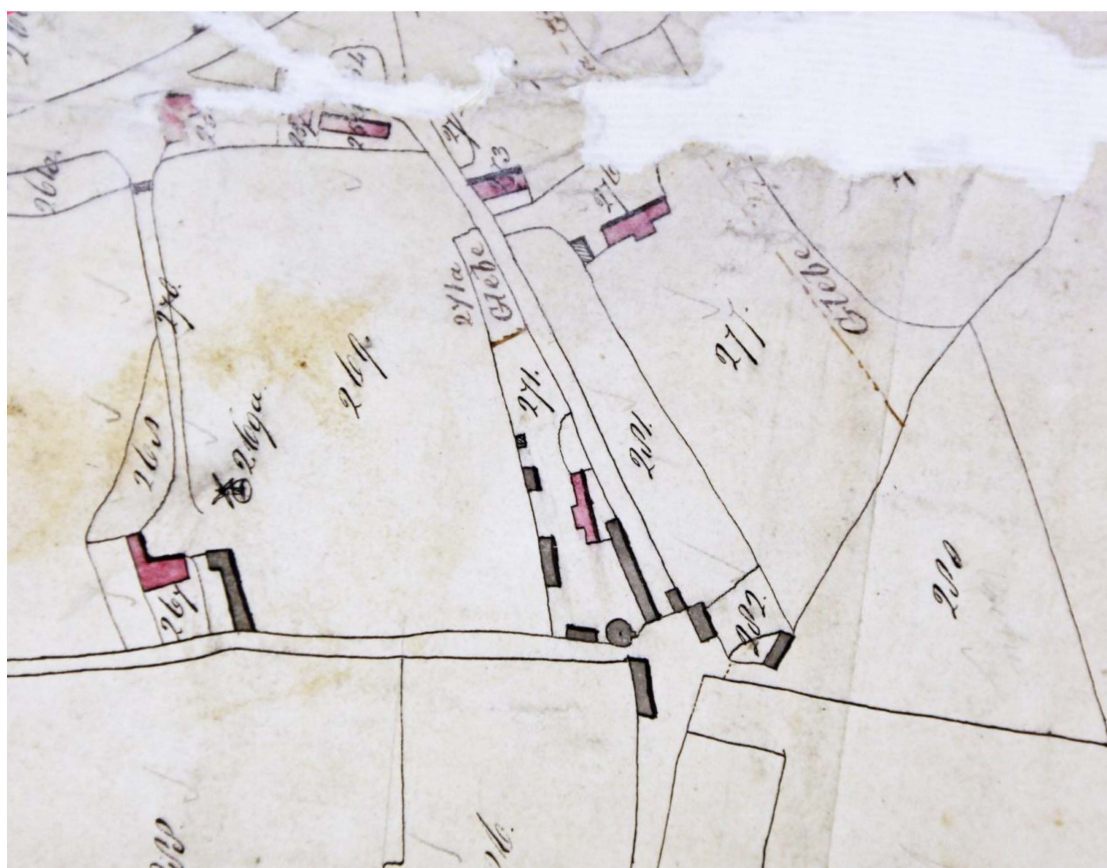
Figure 2. The Wattisfield tithe map of 1838 (Suffolk Record Office.) The pottery complex occupies the southern end of a long, triangular half-acre plot of land (271) adjoining the junction of three roads with a section of church glebe land to the north. This configuration is highly characteristic of ancient tyes or greens, and suggests Pottery Cottage may have been built on a medieval common.

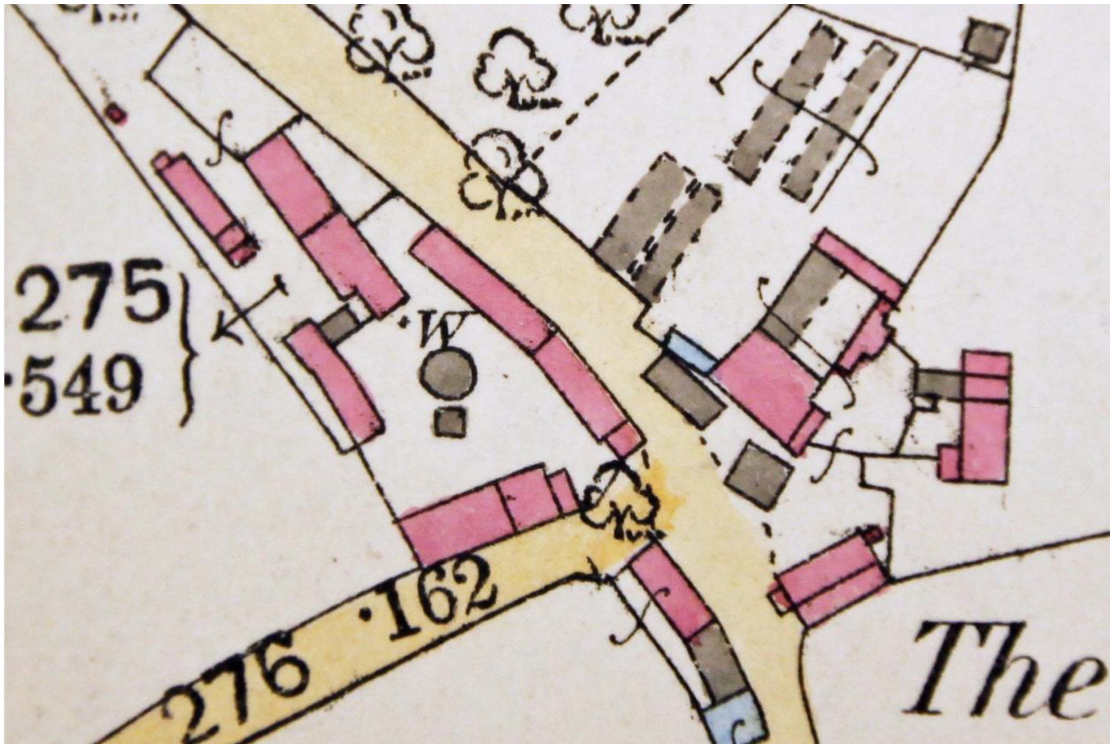
Figure 3. The First Edition 25 inch Ordnance Survey of 1885. Since 1838 a new kiln had been built in closer proximity to Pottery Cottage, with a well between the two buildings, and the wider current proportions of Pottery House had replaced the narrower range shown in figure 2. The narrow southern section of Pottery Cottage was replaced by the present brick garage after the fire of 1963. The two houses are now delineated as separate dwellings. Note the open-sided drying sheds and other new buildings on the eastern side of the road. The entire complex is labelled The Pottery (bottom right).

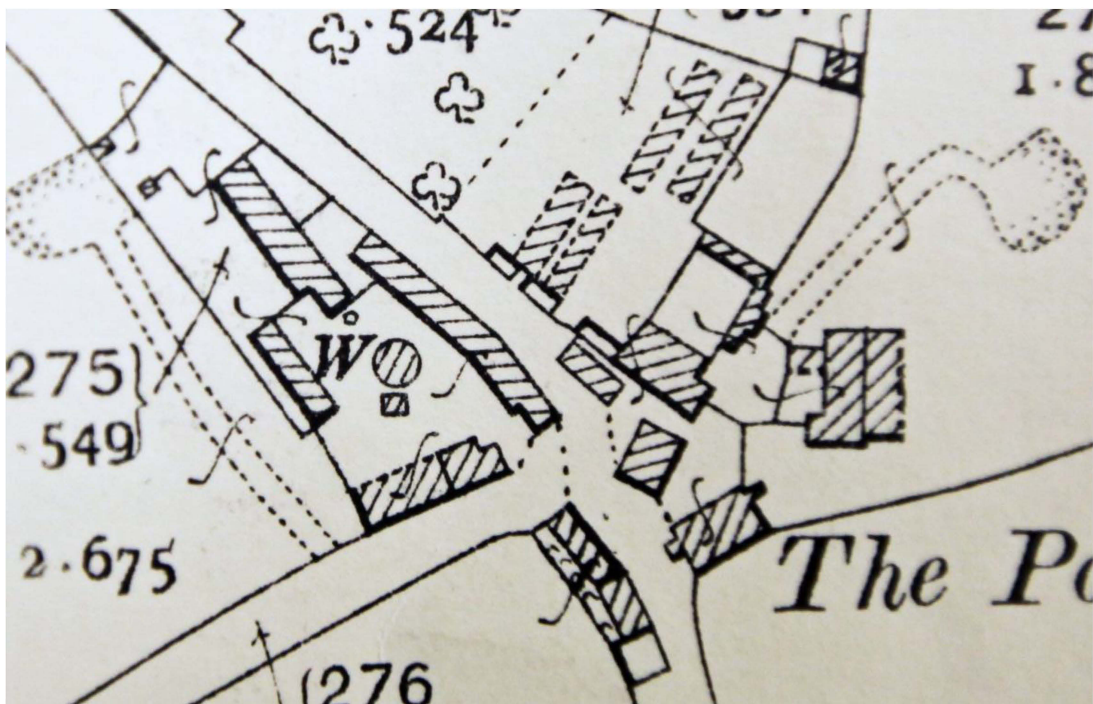
Figure 4. Second Edition 25 inch Ordnance Survey of 1904. Pottery House and Cottage are no longer shown as separate dwellings, but other internal partitions have also been omitted.

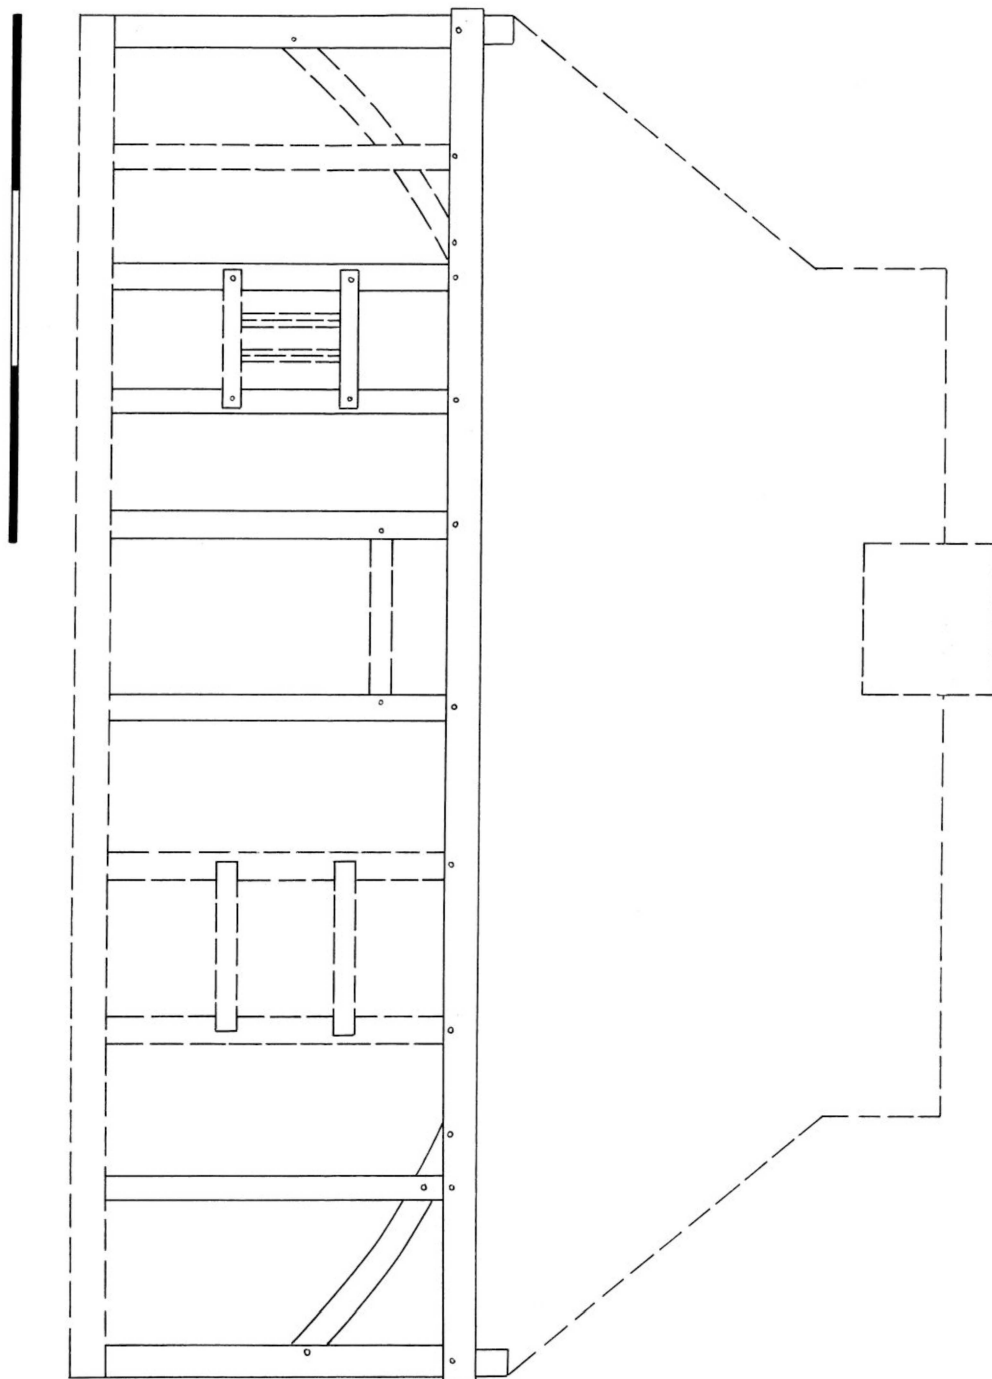
Original ground plan showing the 17th century chimney which may have replaced a timber-framed predecessor. The back (southern) edge of the fireplace appears to have been rebuilt in the 18th or 19th century. Solid lines indicate surviving timbers and broken lines those which have been lost. The smaller southern room (A-B-D-E) could be interpreted as a service (storage) area rather than a parlour, although the latter is more likely.

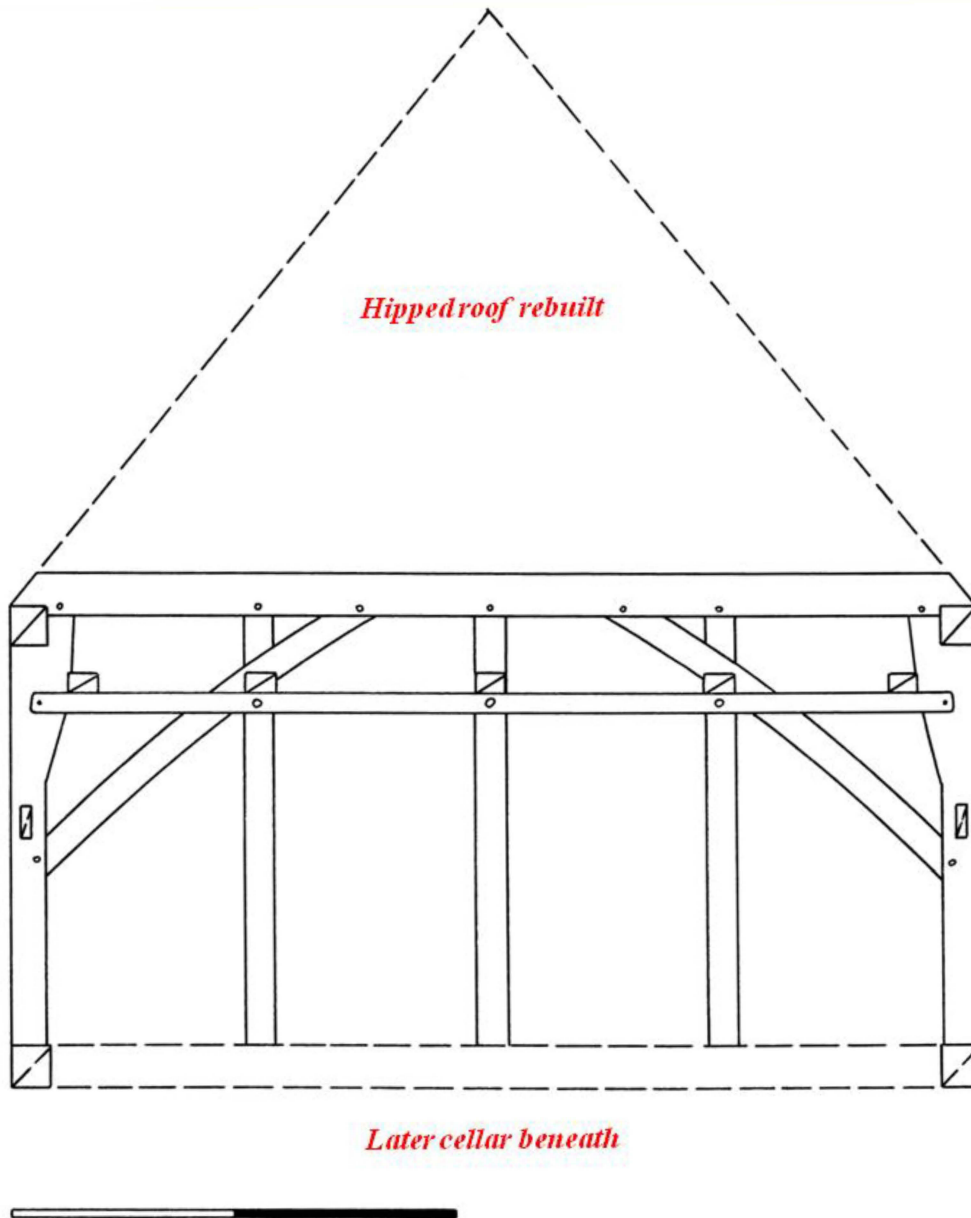
A reconstruction of the original eastern facade (D-F) showing the surviving window lintel to the left. The hipped roof was replaced in the latter part of the 17th century. The framing would have been concealed by external render, with only the door and window lintels and sills exposed.

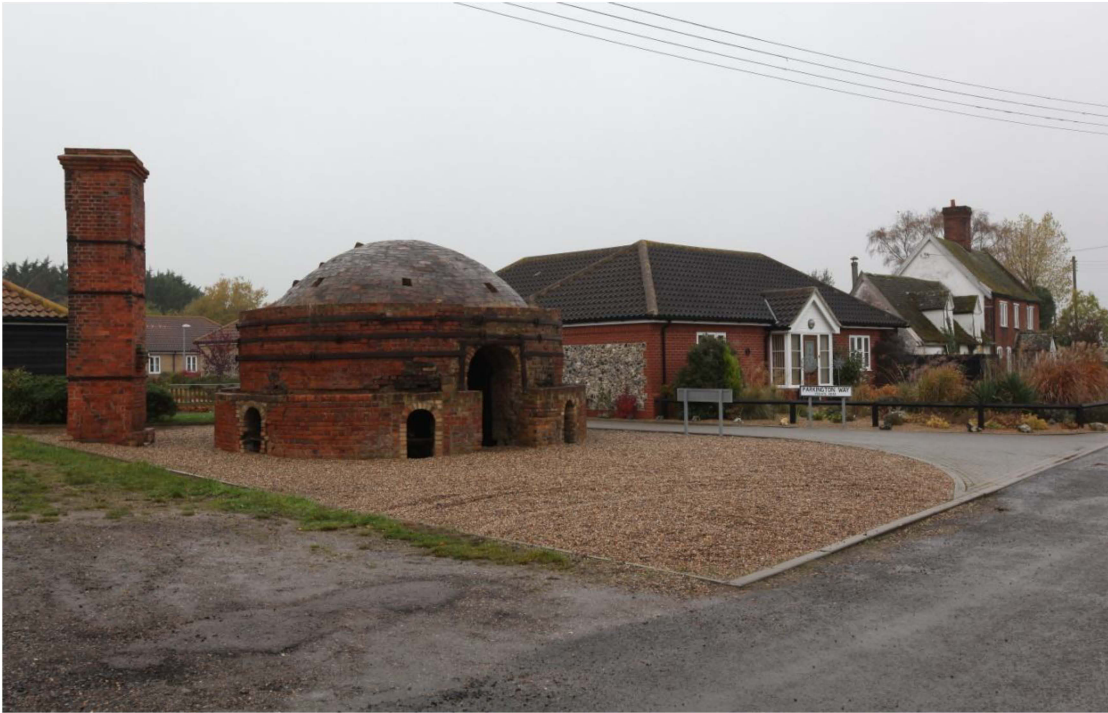
Illus. 1. A General view of the site from Pottery Hill to the south-east showing the disused down-draught kiln and chimney of 1940-41 with the new housing development which replaced the old pottery complex in 2006/7. Pottery Cottage and Pottery House are visible to the right.

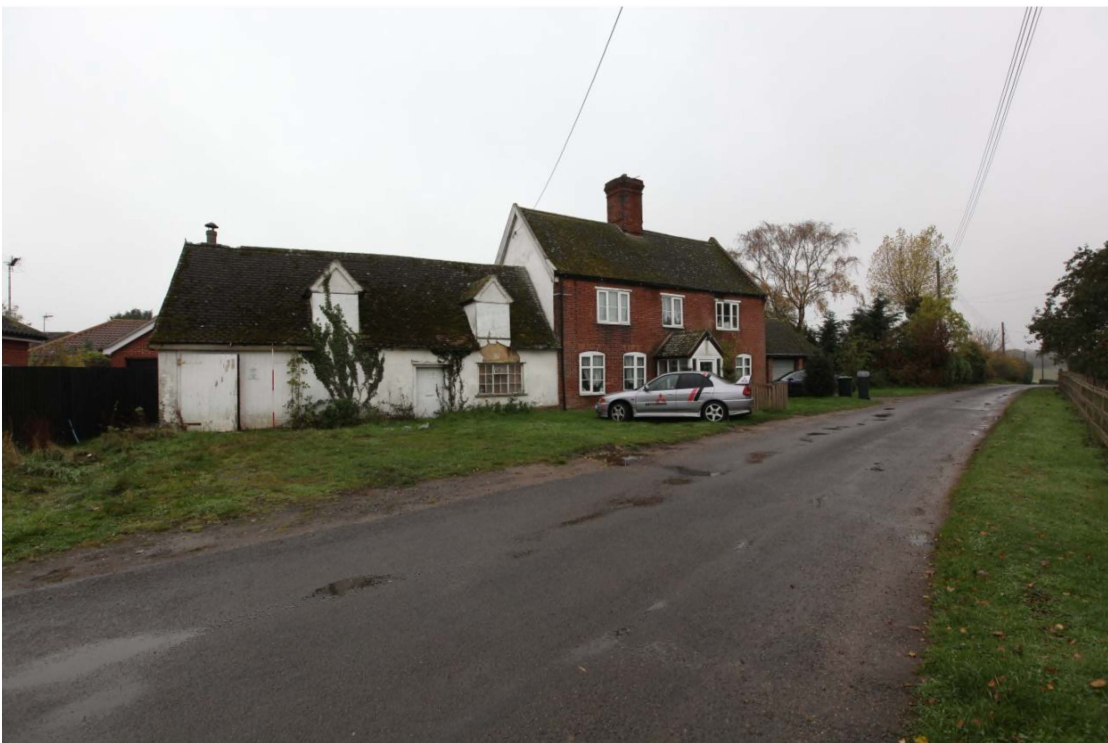
Illus. 2. The site from the east showing the rendered structure of Pottery Cottage to the left and the brick structure of Pottery House to the right. The two were linked internally at least until the mid-20th century and formed the potter's residence in the 19th century.

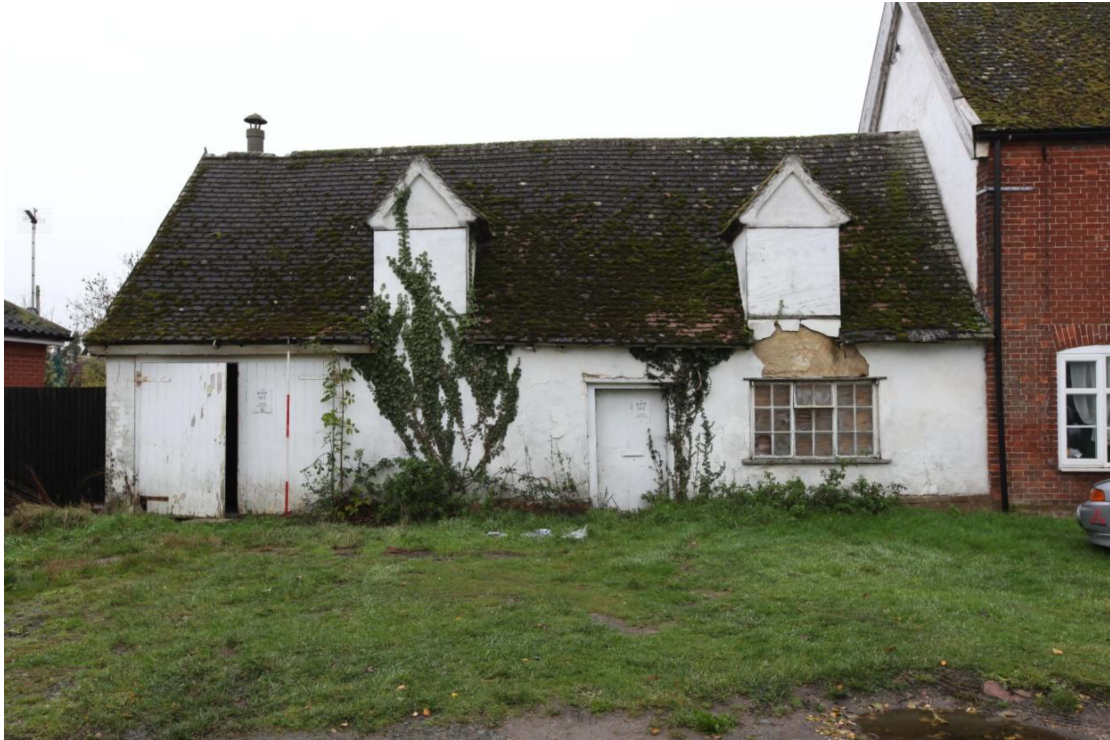
Illus. 3. The eastern facade showing the building's mid-20th century cement tiles and rendered timber-framed walls. The double doors to the left open into a brick garage (G) that probably replaced a 17th century extension damaged by the fire of 1963. The diminutive original structure may have formed the dwelling of the potter who is understood to have worked on the site as early as the 16th century.

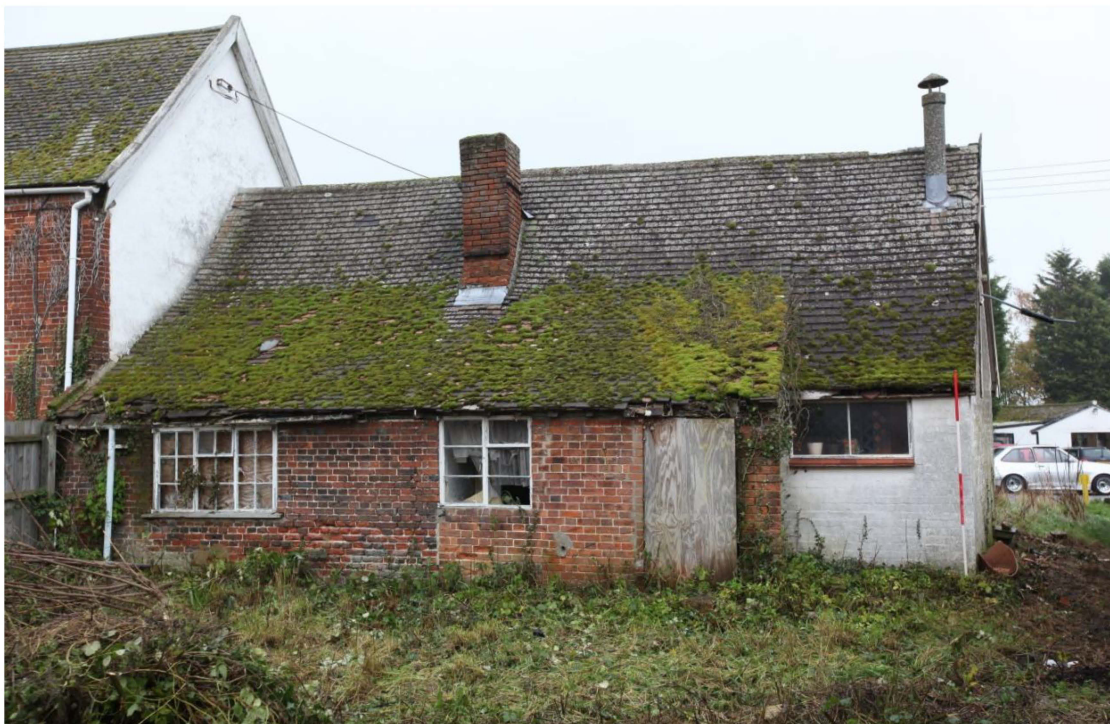
Illus. 4. The rear (western) exterior showing the 1960s brick garage to the right with a brick lean-to extension adjoining the original timber framed structure. The lean-to was built in two phases, with 18th or early-19th century English bond brickwork to the left and 19th century Flemish bond to the right of the central window's left-hand jamb.

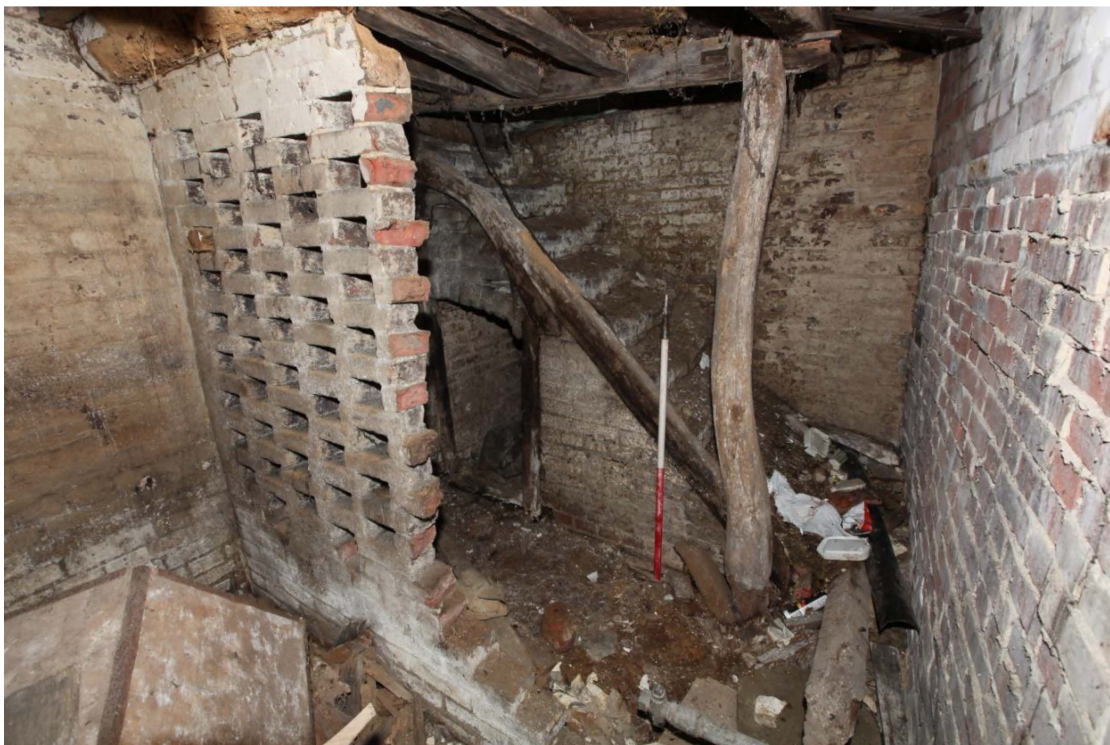
Illus. 8. The cellar stair from the west showing an arched recess beneath the brick steps with the remains of a later perforated brick partition beneath the original axial ceiling joist. This cellar is a 17th century addition that extended beneath a contemporary extension to the south which was probably replaced by the present garage after the fire of 1963. The section of cellar beneath the garage survives beyond the right-hand brick wall but was inaccessible at the time of inspection.

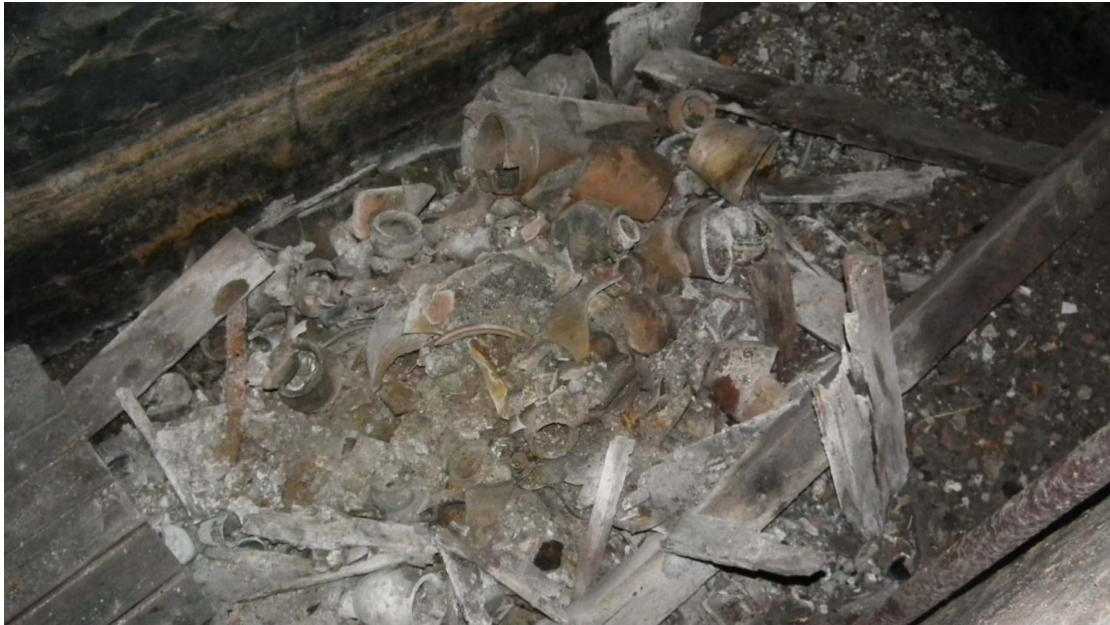
Illus. 9. Miscellaneous pottery on the floor of the inaccessible southern section of the cellar beneath the modern garage (G). This photograph was taken from the northern section through a small aperture in the dividing brick wall (formerly occupied by the axial ceiling joist which had rotted away). This pottery was presumably abandoned after the fire and appears to represent a diverse assemblage of vases, flower pots and chamber pots – some of the latter resembling medieval cooking pots.

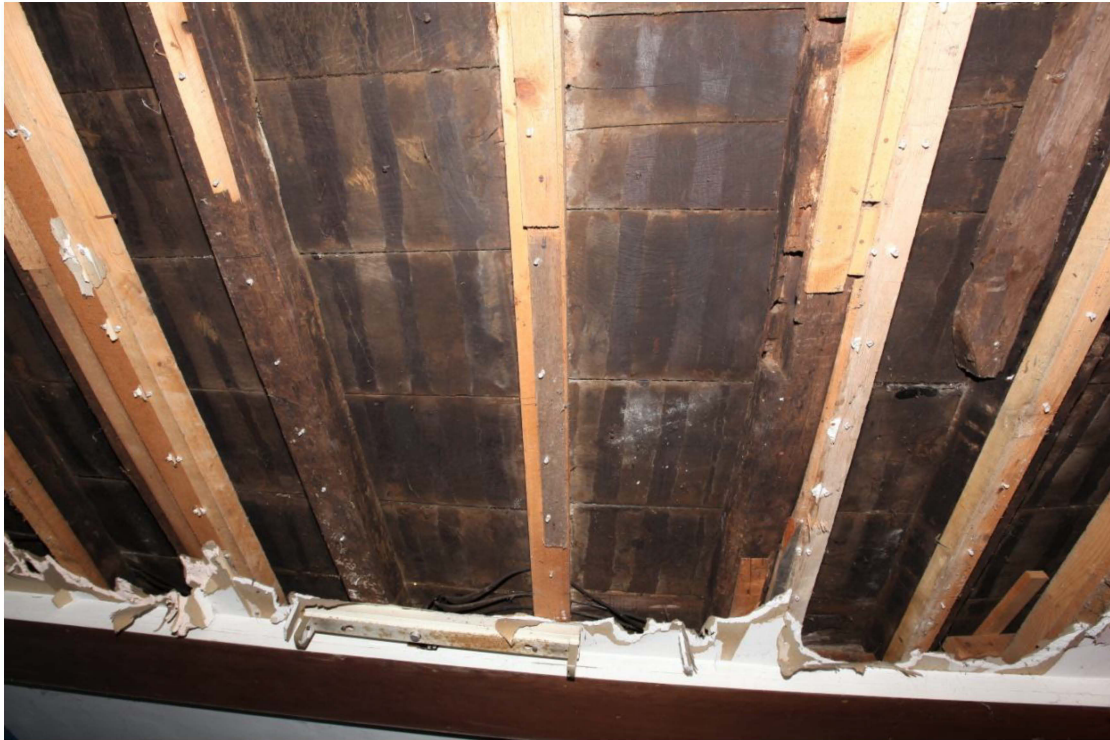
Illus. 11. The hall ceiling from the rear (west) showing a number of recent softwood joists inserted to strengthen the original oak joists which survive largely intact and in good condition along with the original rebated oak floorboards. Both joists and floorboards were heavily and abnormally smoke stained before the application of render to the undersides of the floorboards as indicated by the distinctive pattern of stripes.

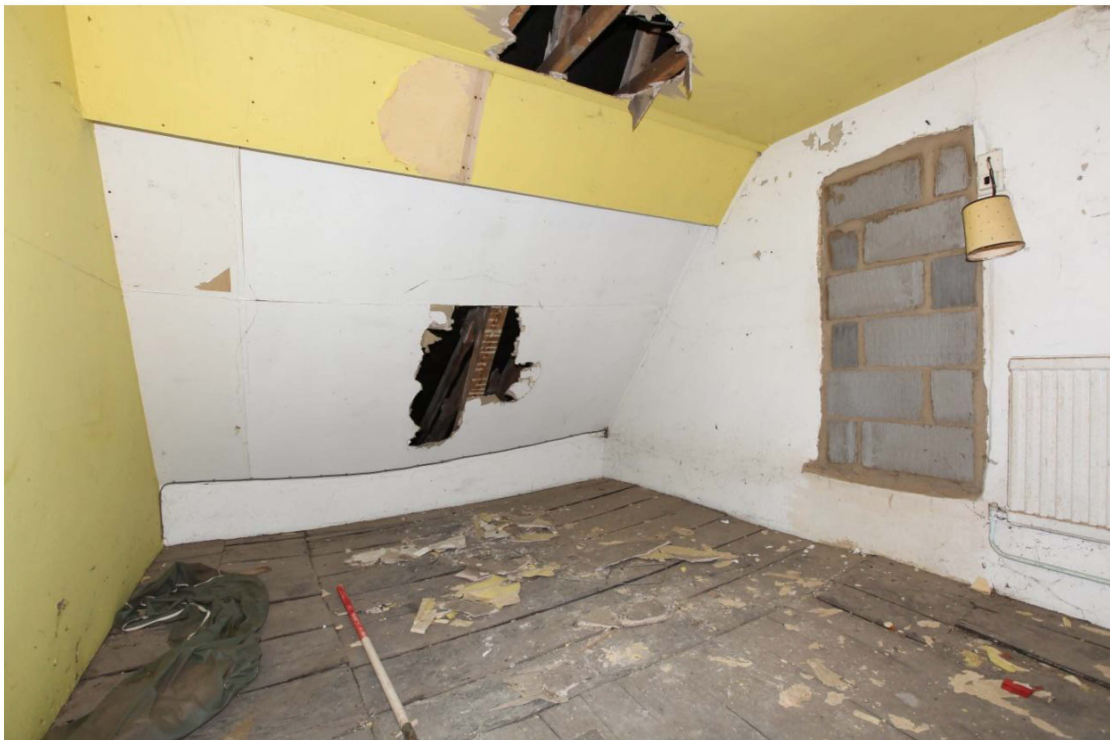
Illus. 12. The northern bedroom from the east showing a blocked door to Pottery House on the right and the unusually complete floor of rebated oak boards. The framing is hidden by late-20th century dry-lining.

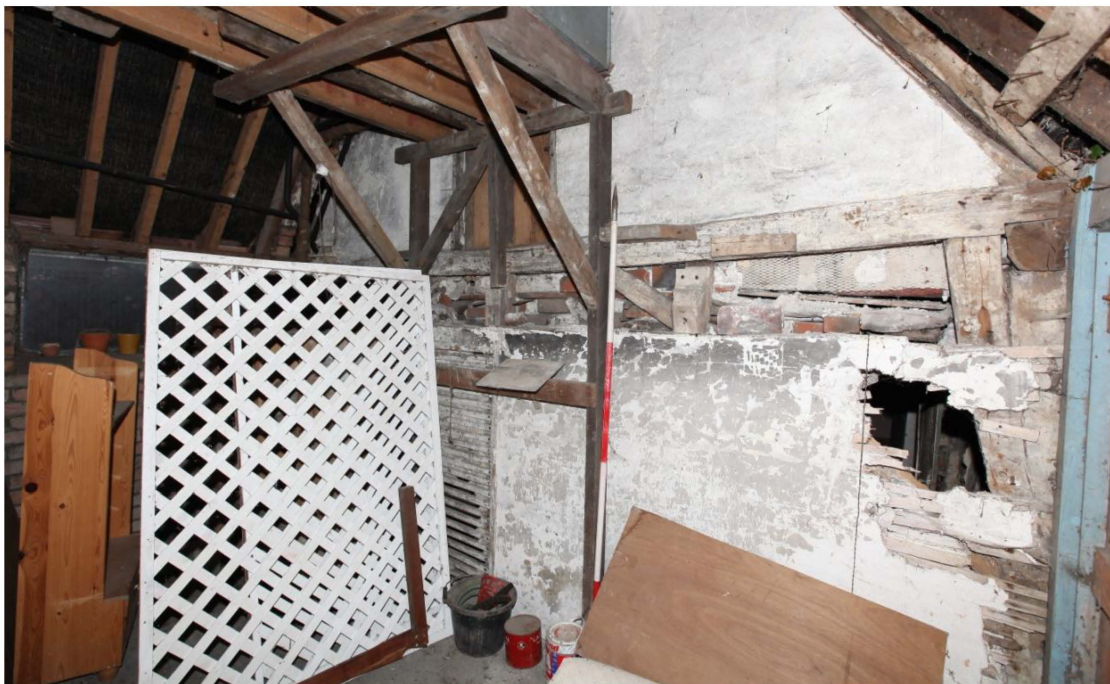
Illus. 14. The garage (G) showing the intact framing of the original southern external gable with pegged plank-sectioned braces rising from the heavily jowled corner posts to the tie-beam. The original gable is likely to have been hipped as there are no obvious stud mortises in its upper surface. A series of nailed wooden corbels beneath the tie-beam supported the ceiling of an extension which was probably damaged in 1963 and replaced by the present garage. The inaccessible section of cellar lies beneath this space.

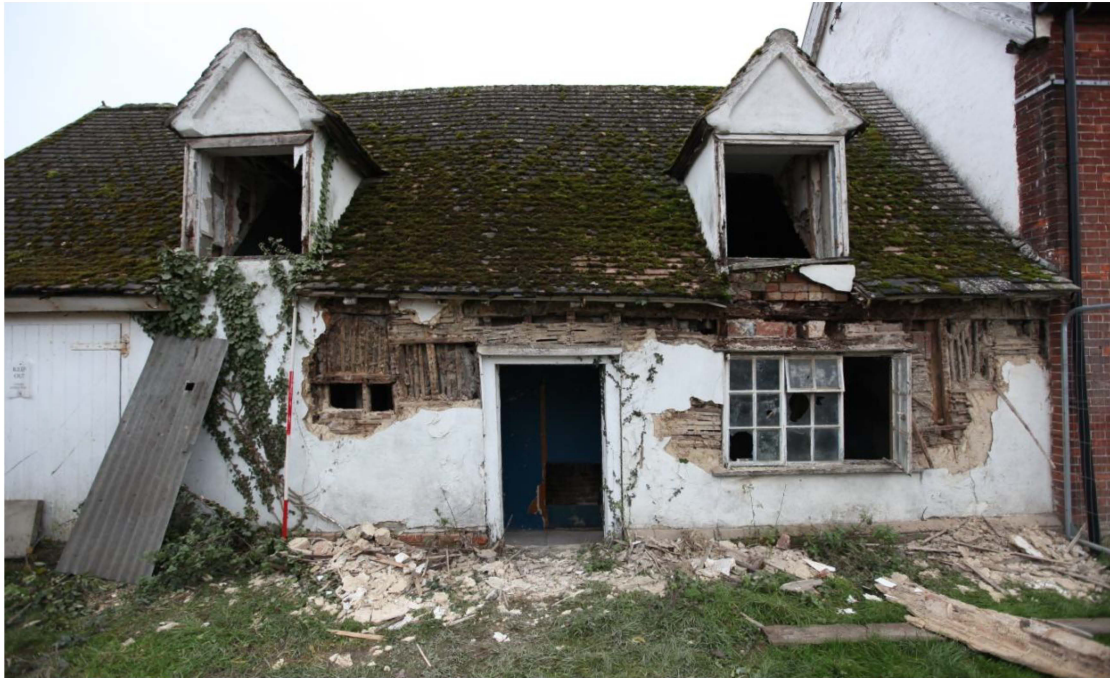
Illus. 15. The eastern facade photographed on 3rd December 2013 after the partial removal of the render shown in illus. 3 above. The original roof-plate, studs and internal braces proved to be largely intact with substantial areas of wattle-and-daub. Note the window lintel to the left of the entrance.

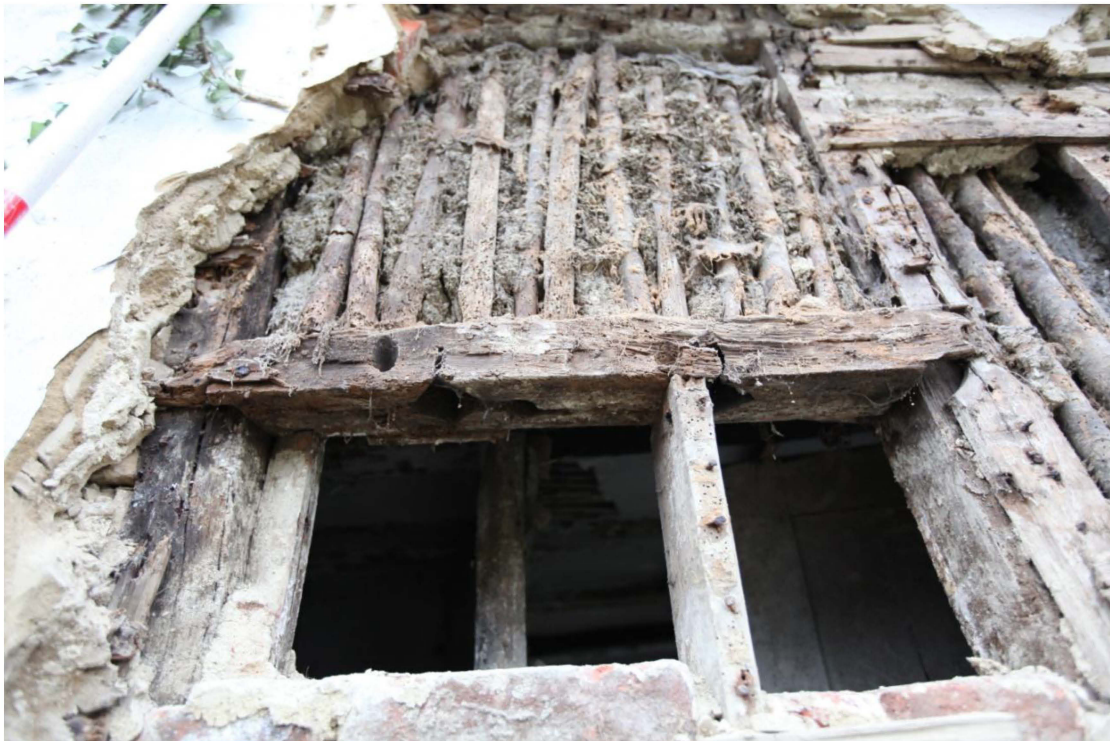
Illus. 16. A detail of the original window lintel to the left (south) of the entrance door in the eastern facade with two diamond mullion mortises in its soffit. The sill has been removed but its pegged mortises remain in both jambs. The lintel has been damaged slightly but still overlaps these jambs and would have projected through the original external daub. It contains two dowel holes angled upwards at approximately 45 degrees that may have supported an external drip board or hood to exclude rain in the absence of glass.

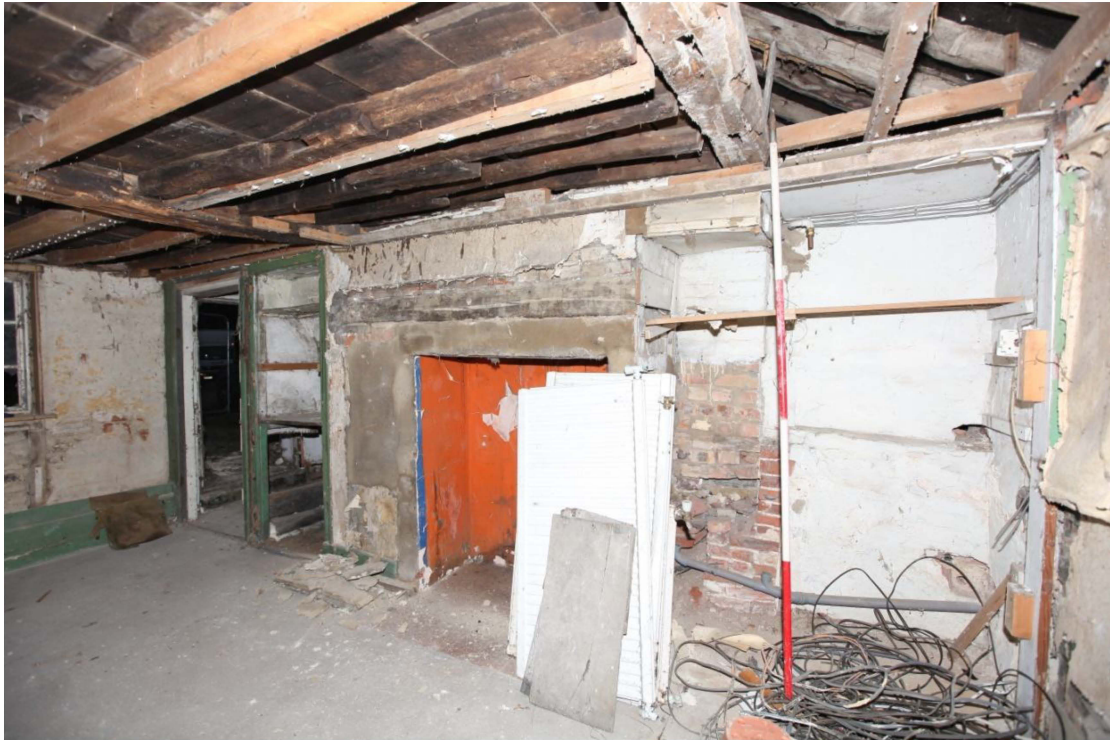
Illus. 17. The newly exposed fireplace in the hall with a large timber lintel that formerly extended to the rear wall – the position of which is indicated by the scale rod. The timber supporting the original ceiling joists was inserted when the lean-to extension was added and the wall removed; it contains stud mortises but has been re-used from elsewhere. The original roof-plate survives immediately above.

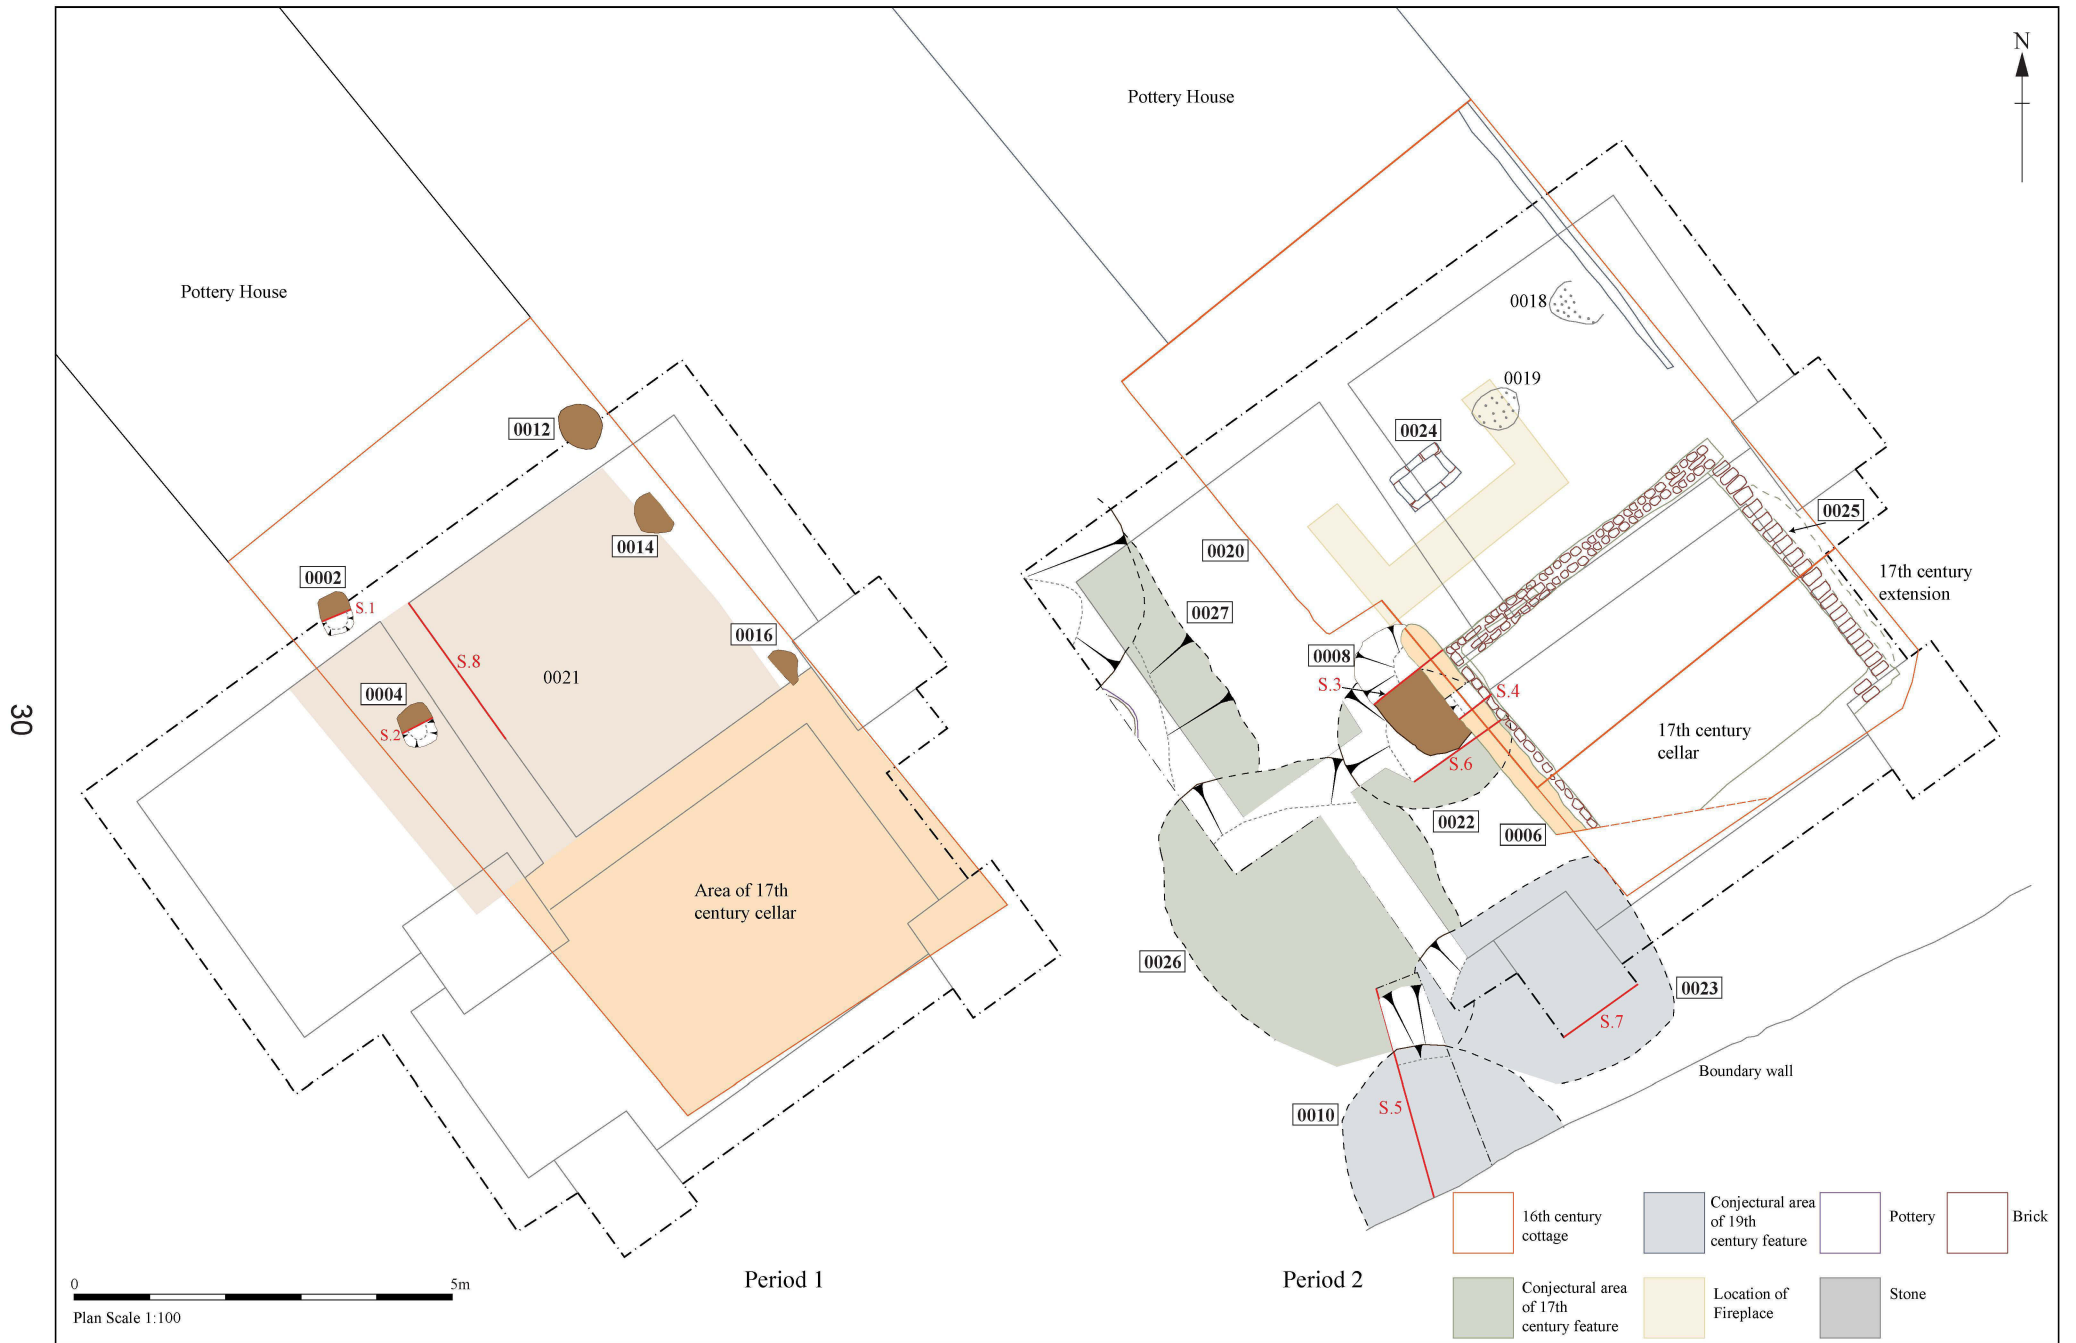
Figure 9. Site plan, showing (left) Phase 1 features (pre 16th century) and (right) Phase 2 features (post 16th century).

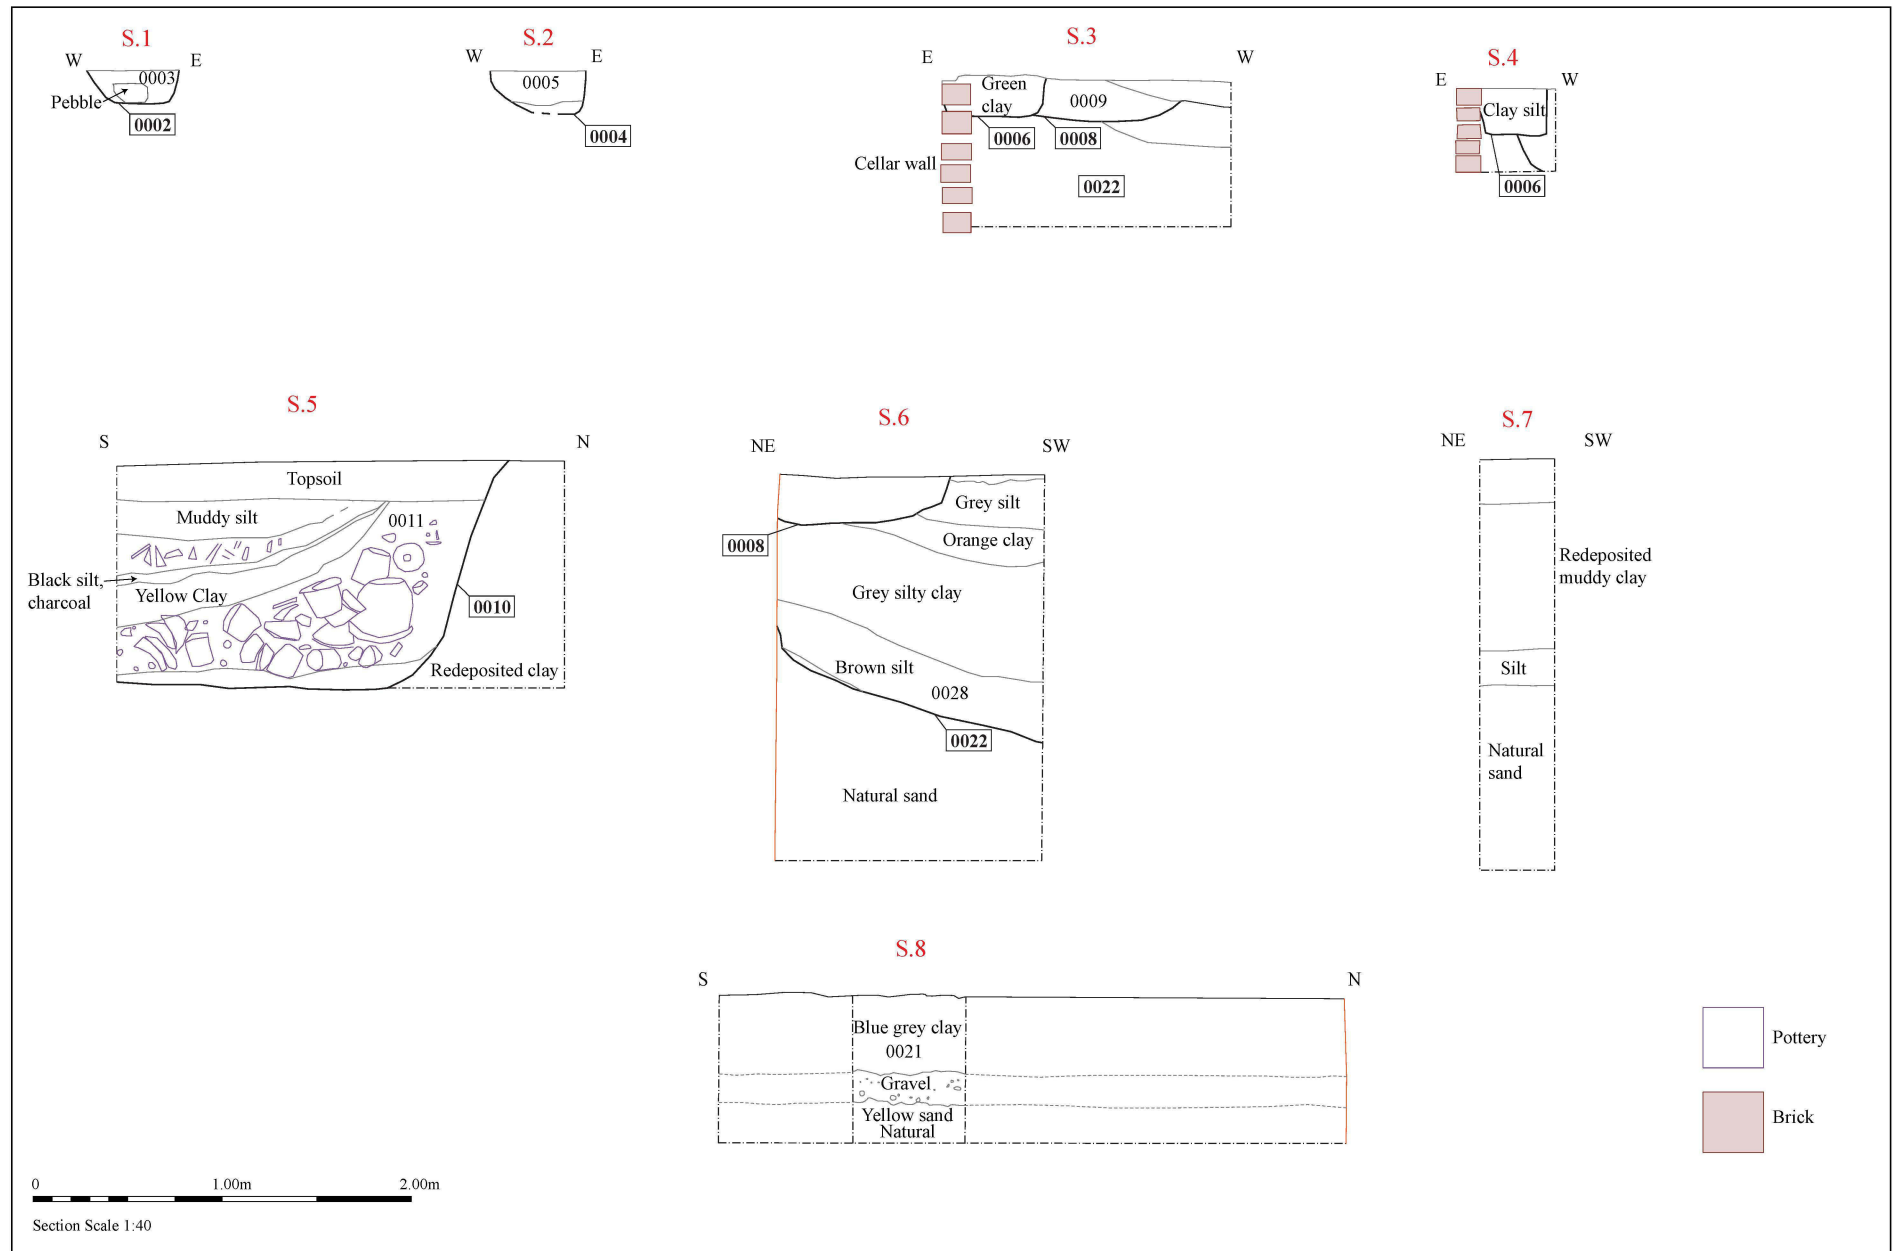
Figure 10. Sections of excavated features and foundation trenches
