Pottery Cottage, Wattisfield WSF 061

Historic Building and Archaeological Monitoring Report

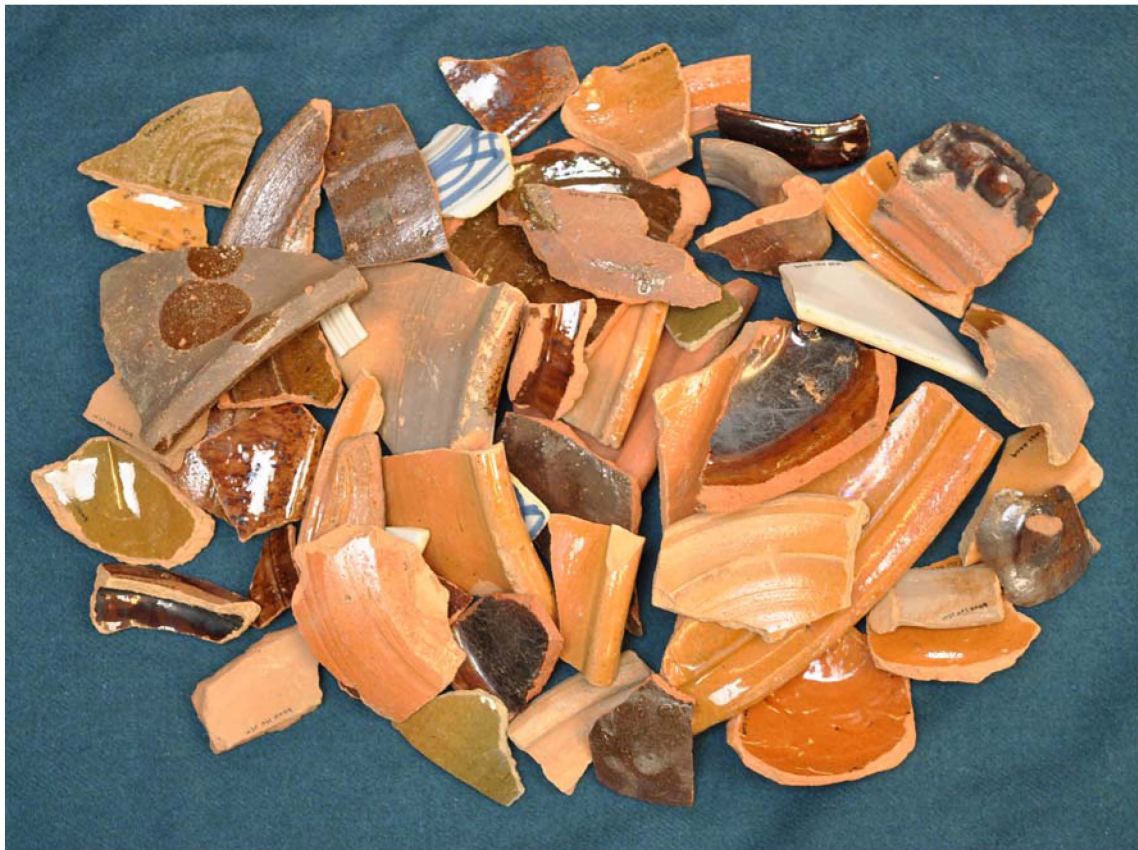
Assemblage of late 17th-early 18th century pottery from pit 0008 (context no 0009)

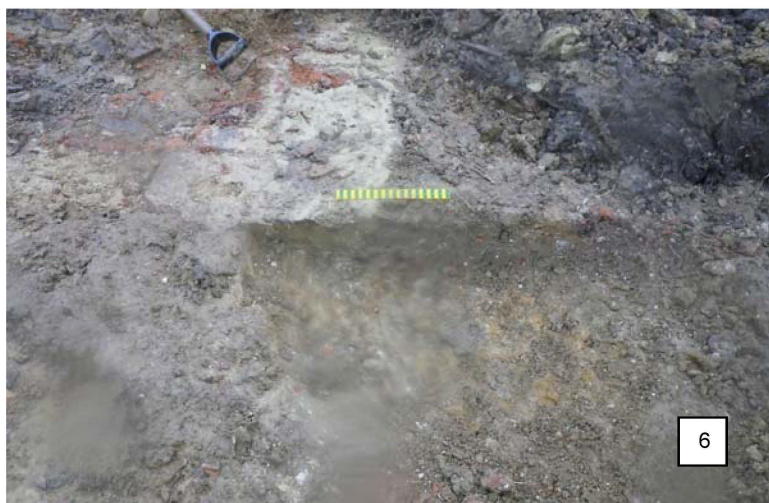
6) Excavated pit 0008 and the clay filled slot 0006. The slot was part of the foundation to the timber-framing and part of the modifications to the south end of the cottage at the end of the 17th century. The clay butted against and partly covered the NW corner of the cellar wall. The pit which produced a large assemblage of late 17th century pottery was cut by the slot.

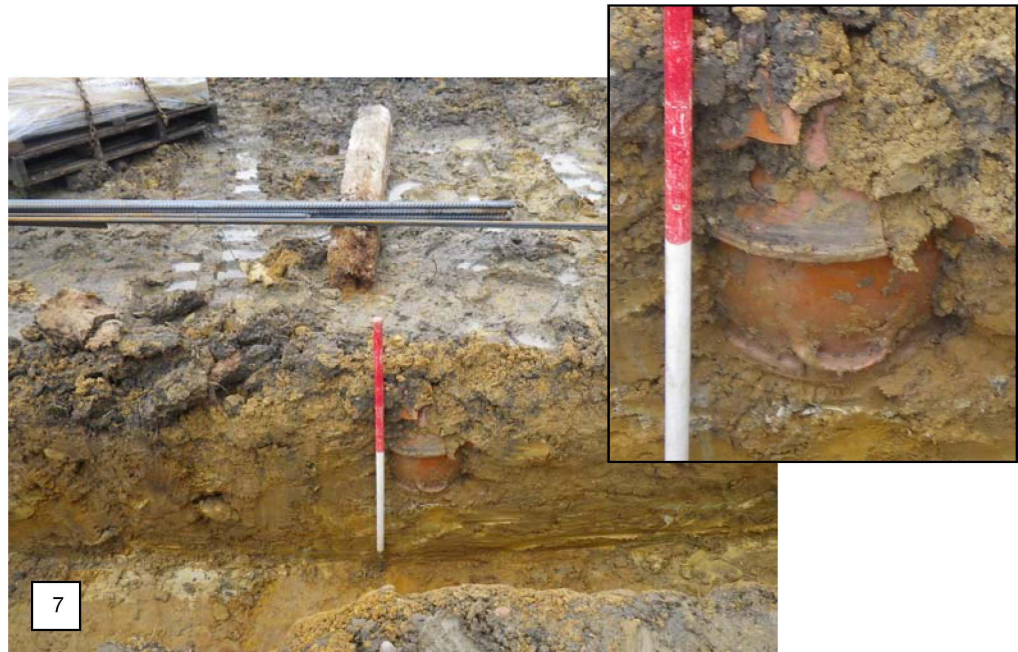
7) Section 9 showing redeposited clay and silts backfilled the top of the sand extraction pits with a stack of 19th century glazed vessels; the whole of the footing trench is excavated within redeposited material. Scale 1m

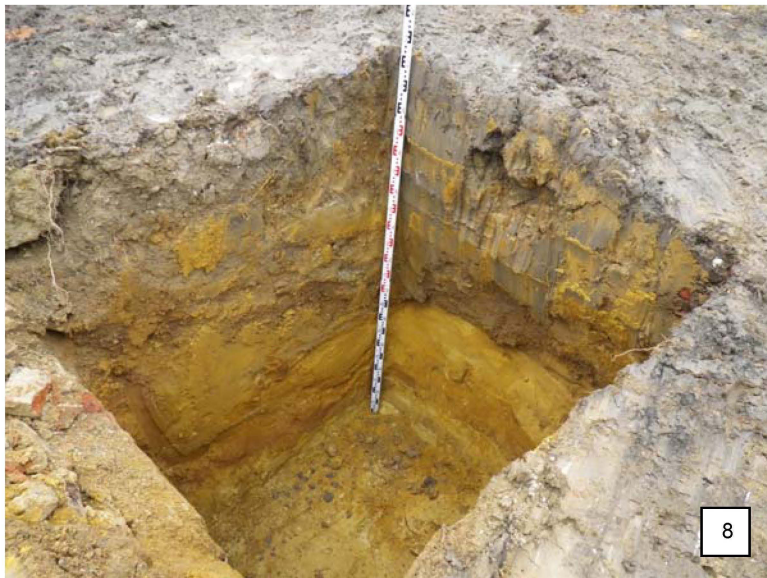
8) Section 6 looking SW showing the cut of a 17th century sand extraction pit, backfilled with debris from the clay quarries, and the natural sand at the bottom of the hole. The NW corner of the cellar wall can be seen bottom left. The total depth of the excavation 2.25m.

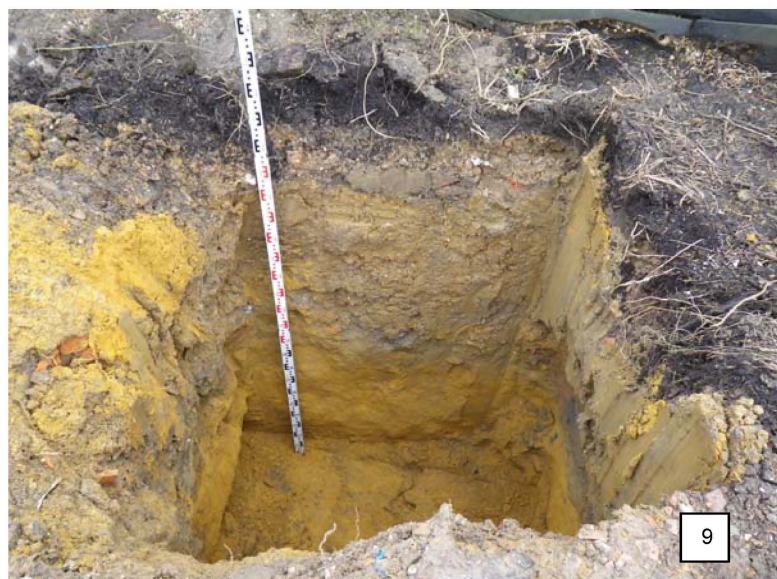
9) Section 7 looking S. Extraction pit similar to above with clay debris infilling most of the pit with grey and burnt sands at the base of the cut. The total depth of the excavation was 2.3m.

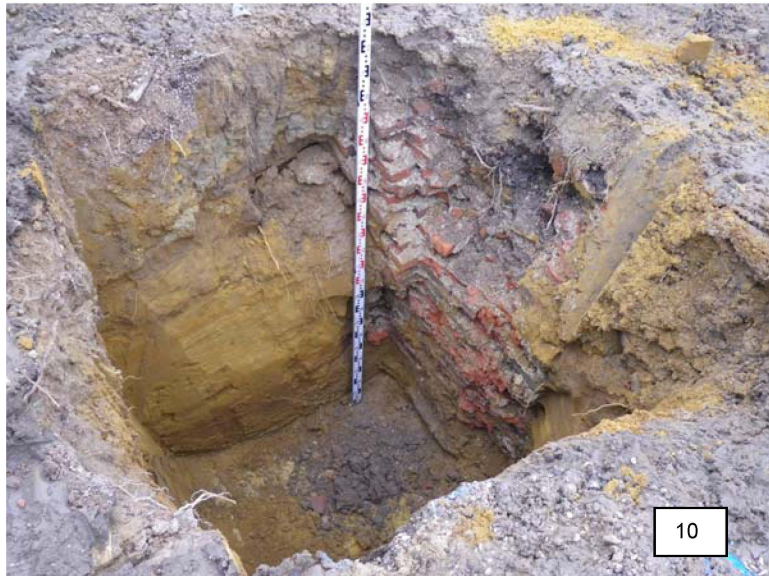
10) Section 11 rear face of the 17th century cellar showing the absence of a construction pit for the cellar. The disturbance at the top of the section to the left of the scale includes a layer of grey/green clay possibly a continuation of layer 0021. Hole depth 2.6m

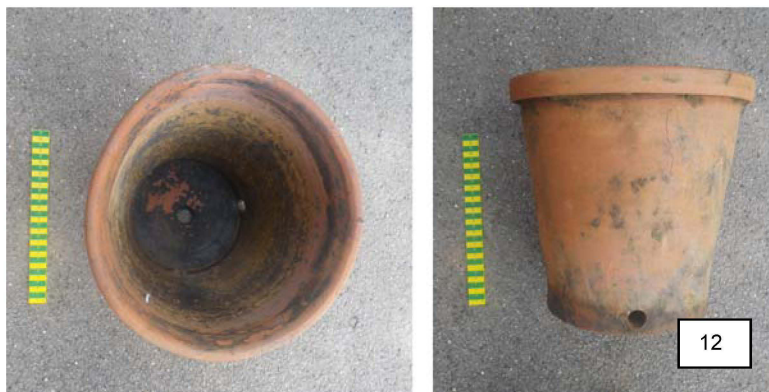
12) Large flower pot with drainage hole in the sides and base. The pot is a second that was used as some form of kiln furniture that caused the inside of the pot to be coated with soot from the coal-fired kilns.
