**The Marquis of Cornwallis,
Upper Layham, Suffolk
LYM 036**

Historic Building Record

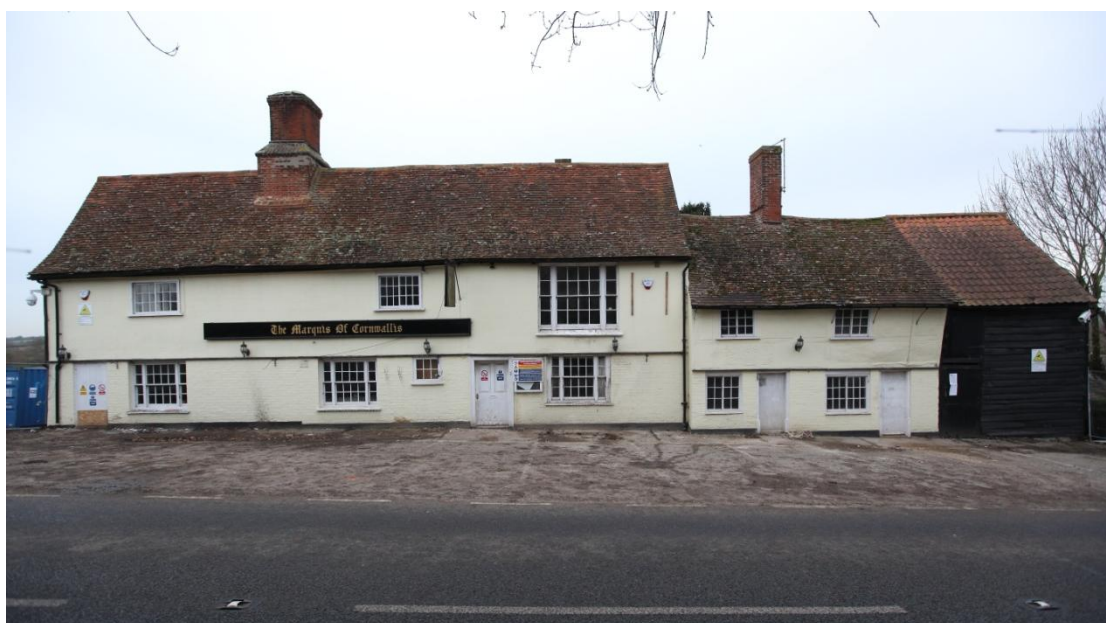
Illus. 1. The eastern facade showing the separately listed early-19th century ‘Cottage’ (4) to the right. The weatherboarded and pantiled stable to the extreme right (4c) is part of the same timber-framed structure. The taller range consists of a mid-17th century hall and parlour with an original central chimney (1) to the left and a disguised mid-19th century section of ‘infill’ including the large first-floor window and the door beneath (5) to the right. This replaced a low, narrow range depicted in 1839 (fig. 2) and the 17th century pargeted northern gable is hidden in its roof above the left-hand jamb of its door (roughly coinciding with the projecting inn sign). This roof also preserves early-19th century pargeting at the apex of the Cottage roof.

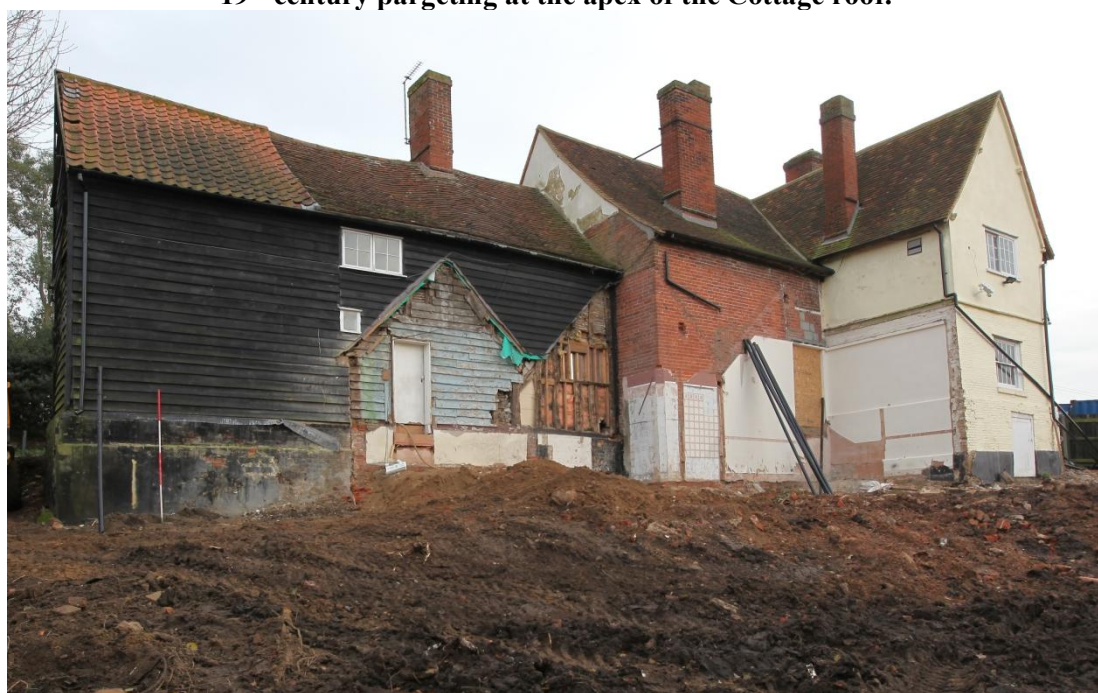
Illus. 2. The rear view from the north-west showing the scars of recently demolished extensions to the weatherboarded ‘Cottage’ (4) on the left and the central section of red-brick infill (5). The projecting gabled wing to the right (3) is contemporary with the 17th century hall and parlour on the street (1). Note the considerable slope of the ground.

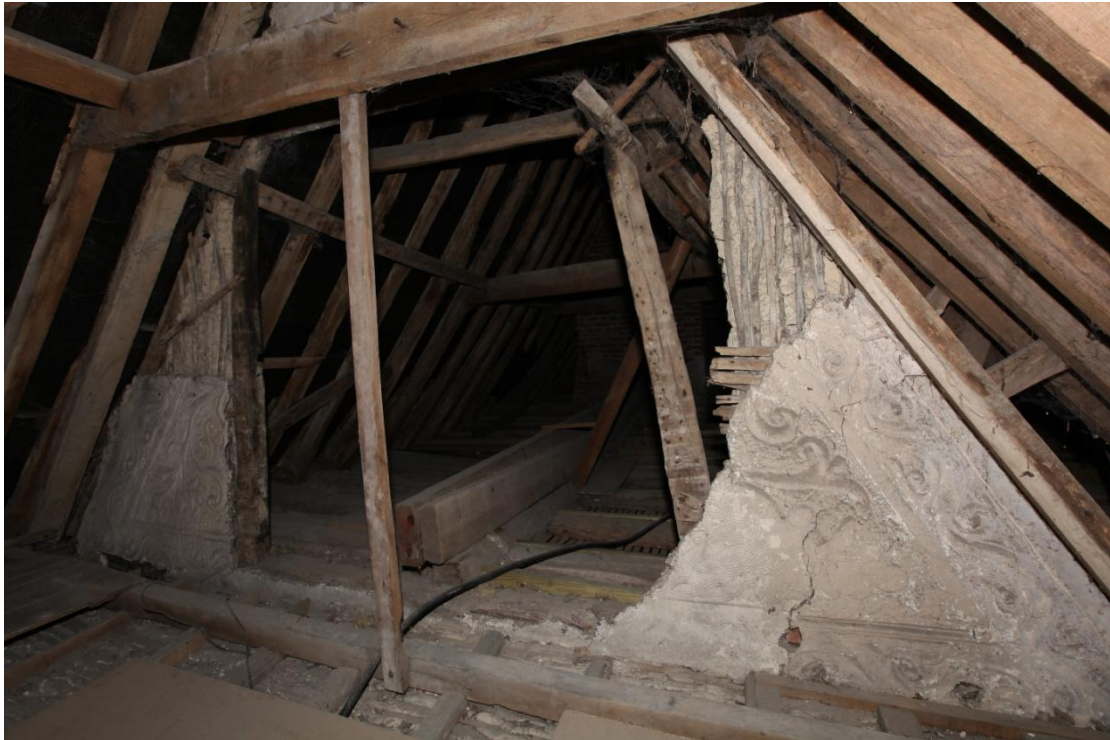
Illus. 9. The remains of the rare 17th century pargeting to the southern gable of the 17th century structure (1bf) seen from the roof of the 19th century brick infill to the north (5f). The foliate design is in bold relief within a broad triangular border. A repair section of late-18th or early-19th century combed pargeting is visible to the left of the right-hand section.

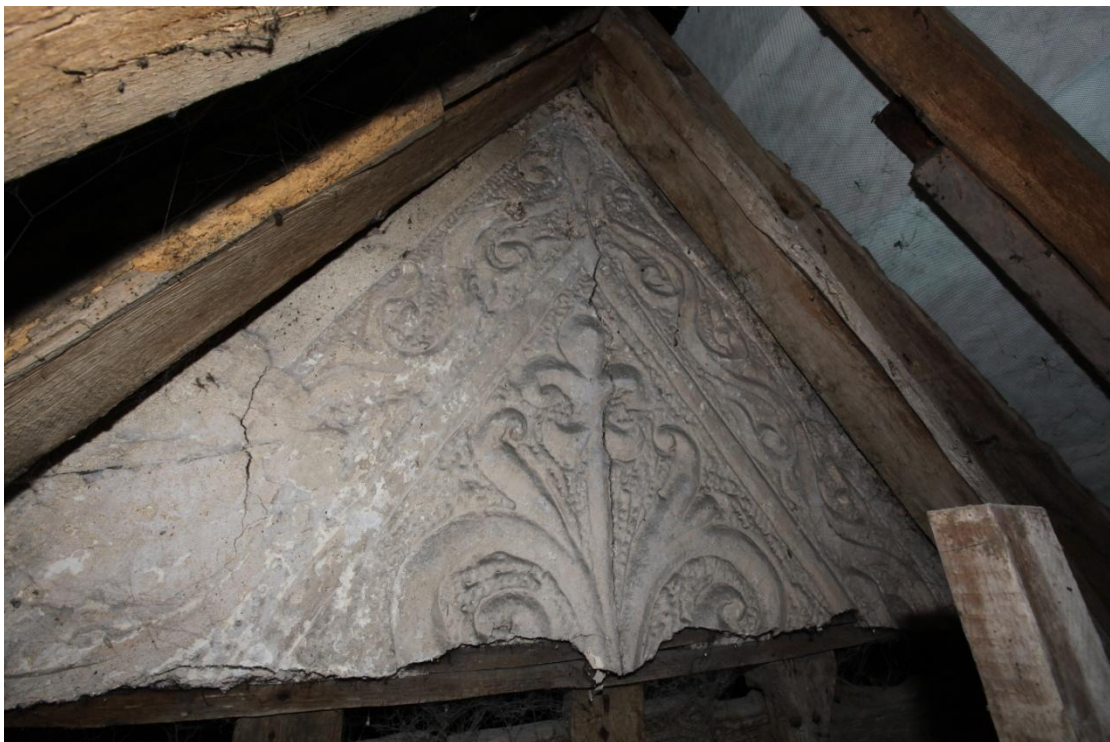
Illus. 10. The apex of the 17th century whitewashed foliate pargeting shown in illus, 9. Note the fleur-de-lis at the top of the central device. The plaster is secured by horizontal laths nailed to the studs, with wattle-and-daub between the timbers.

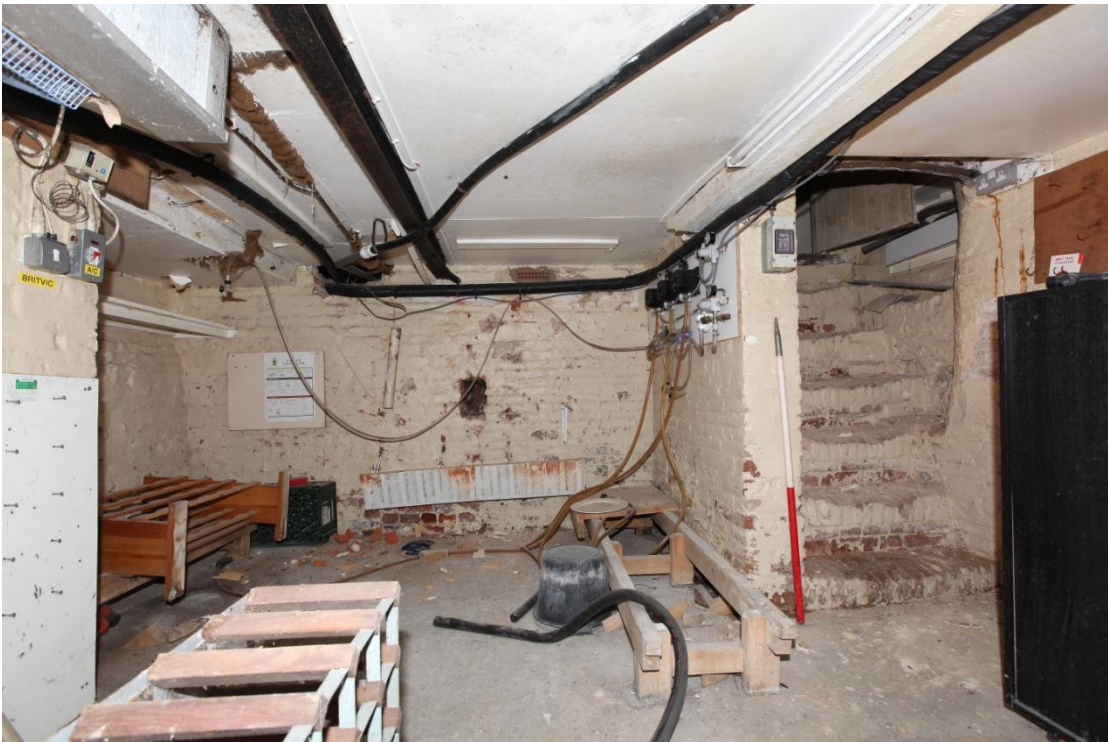
Illus. 16. The brick cellar beneath the 17th century rear wing (3), viewed from the west and showing the worn original internal steps to the right.
