# ARCHAEOLOGICAL MONITORING REPORT

## **Ballington Bridge, Sudbury. BCB 012**

A REPORT ON THE ARCHAEOLOGICAL MONITORING, 2002

Suffolk C.C. Archaeological Service

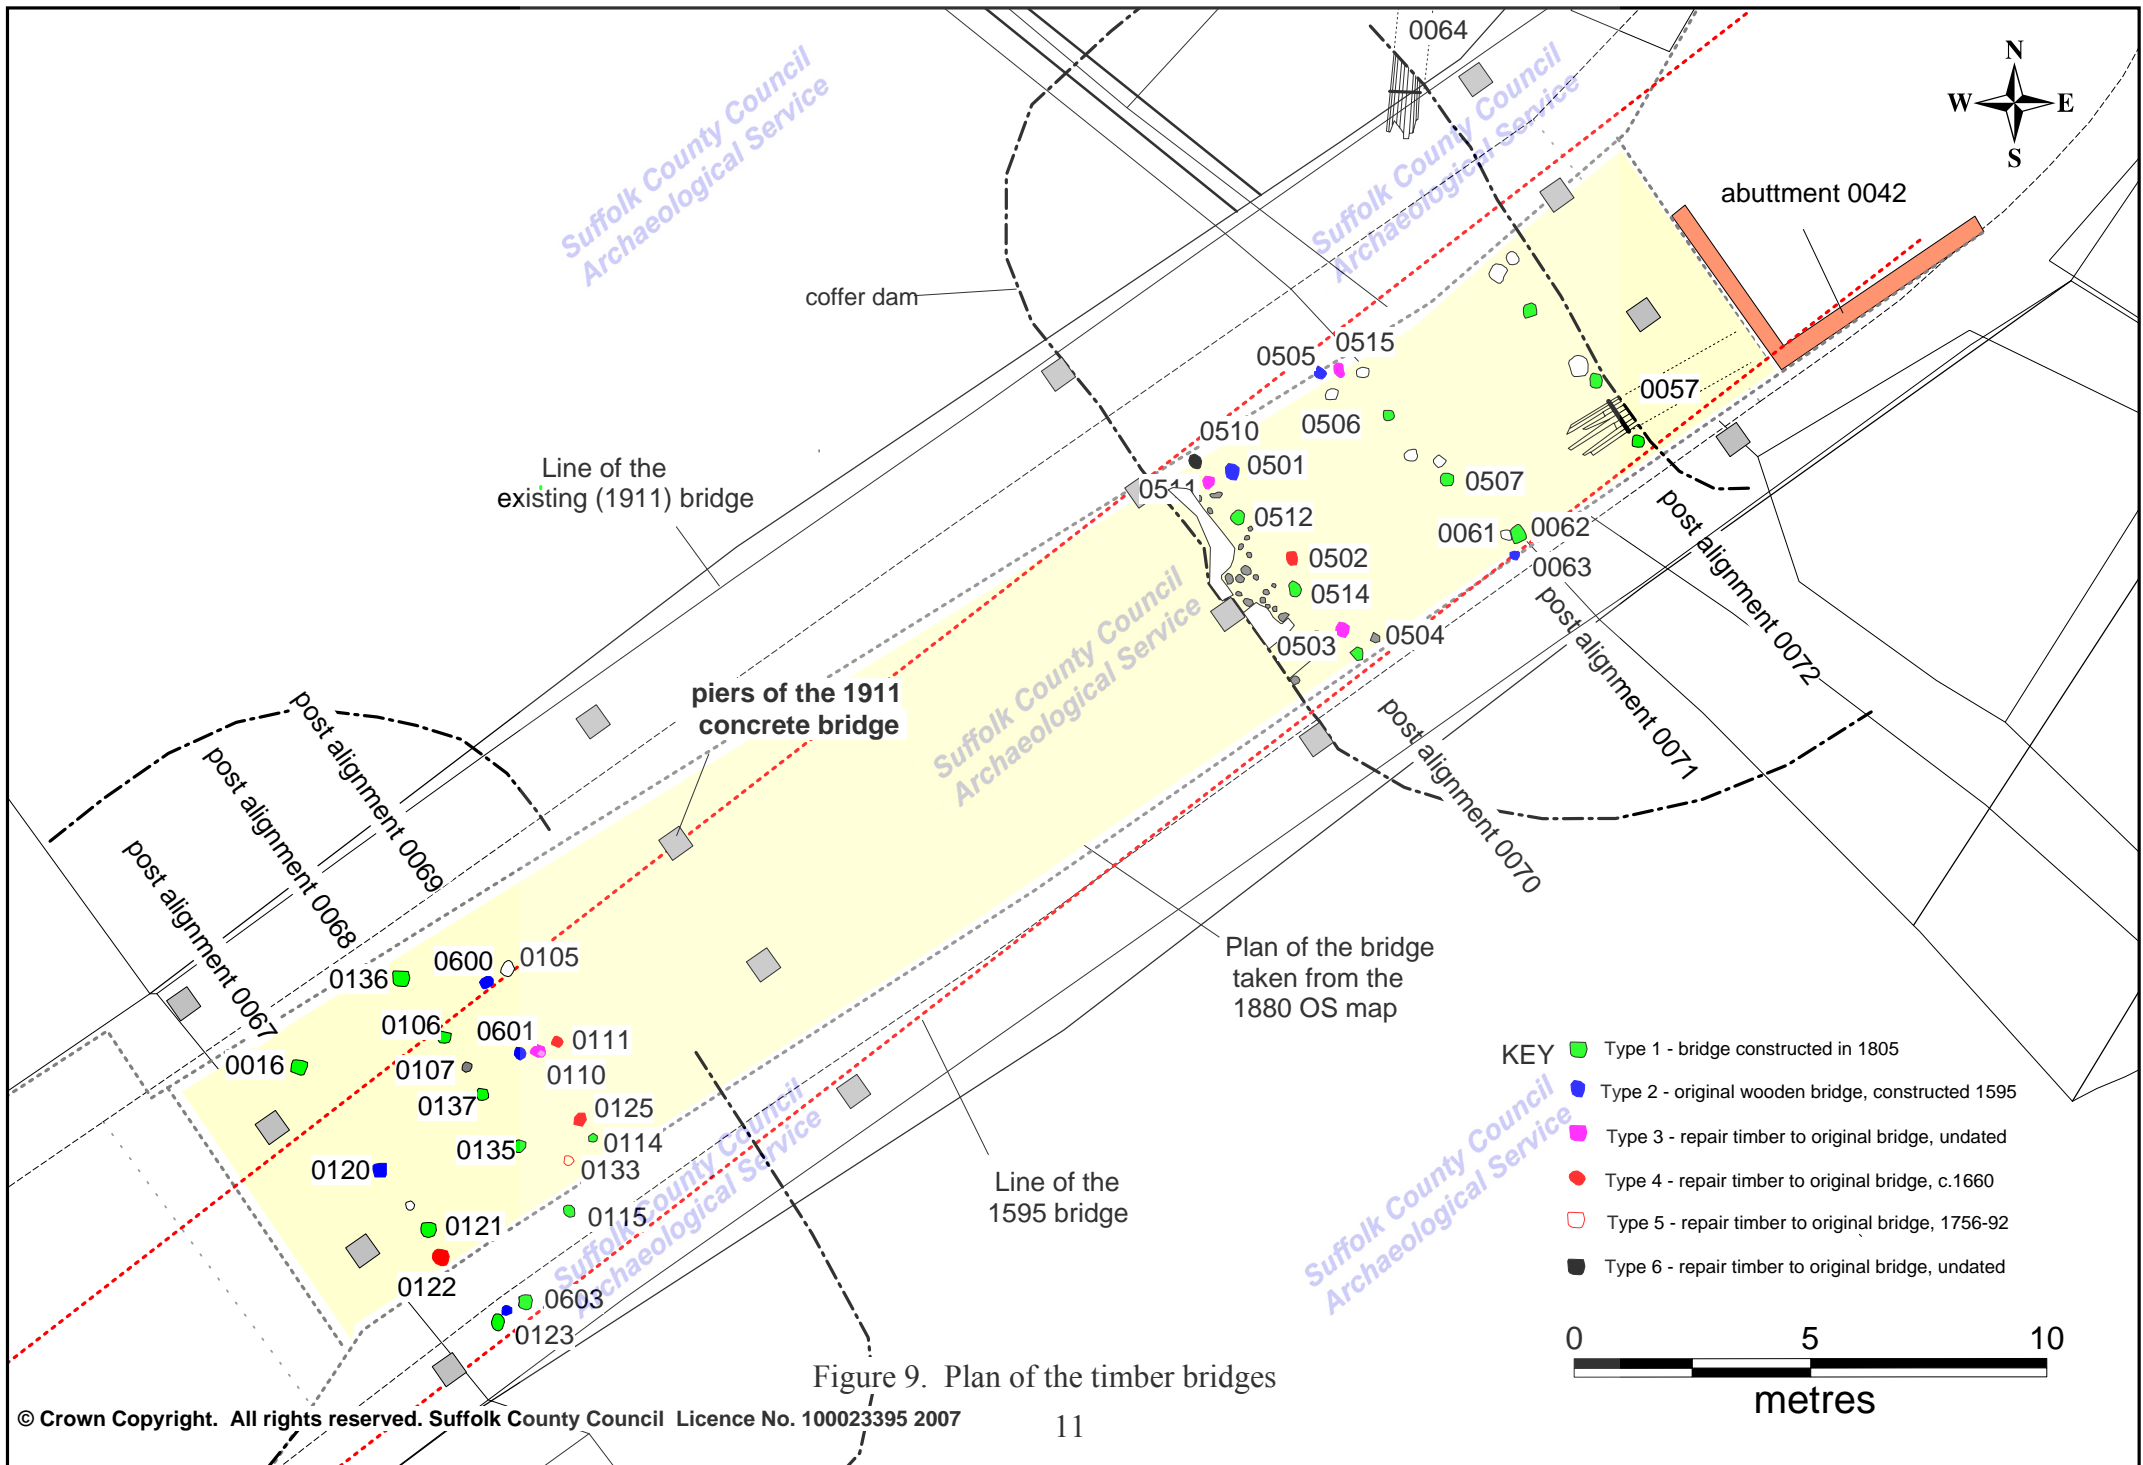
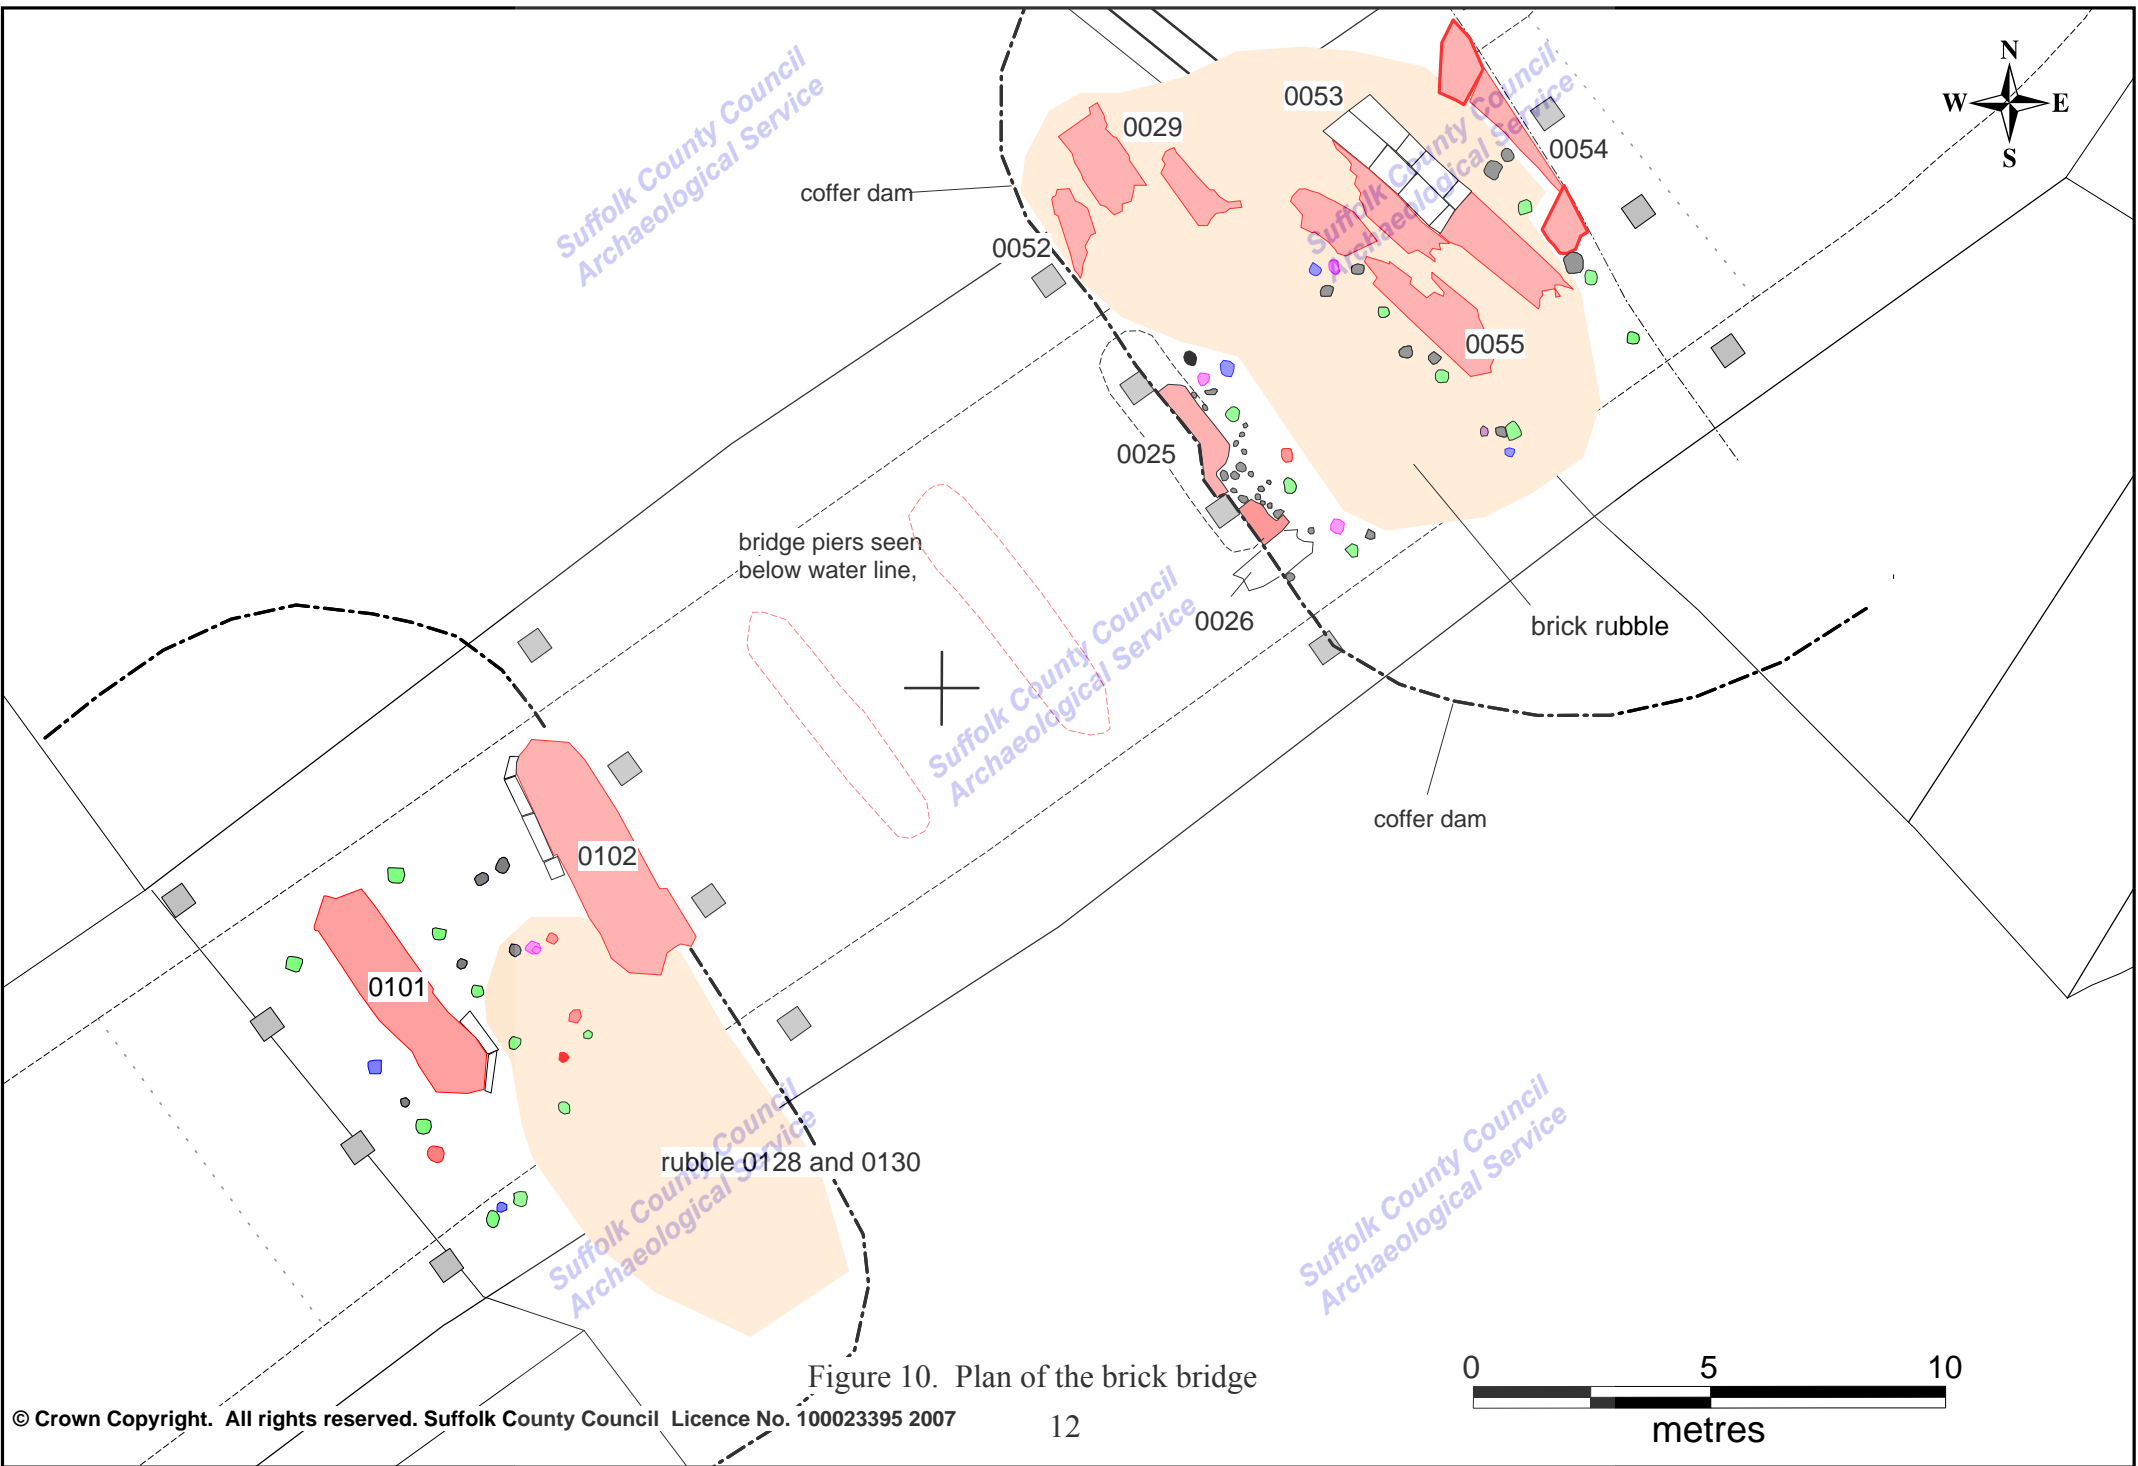
Figure 10. Plan of the brick bridge

The remains of a brick built bridge and evidence of an earlier mortared flint and stone bridge were found spread across the riverbed (Fig 10). The bases of six brick piers could be seen truncated just below the water surface and dense rubble, including large bonded fragments of the above water structure, was recorded in the east bank and clogging the Sudbury half of the stream. Of the six piers, four were within the areas of the cofferdams and two, well preserved, examples visible in the centre of the river just below the water surface.

Of the six piers, four (0101, 0102 and two unnumbered) were part of the original structure and *in situ*, one had turned over onto its side (0053) and one (0025) was a replacement (Fig.10).

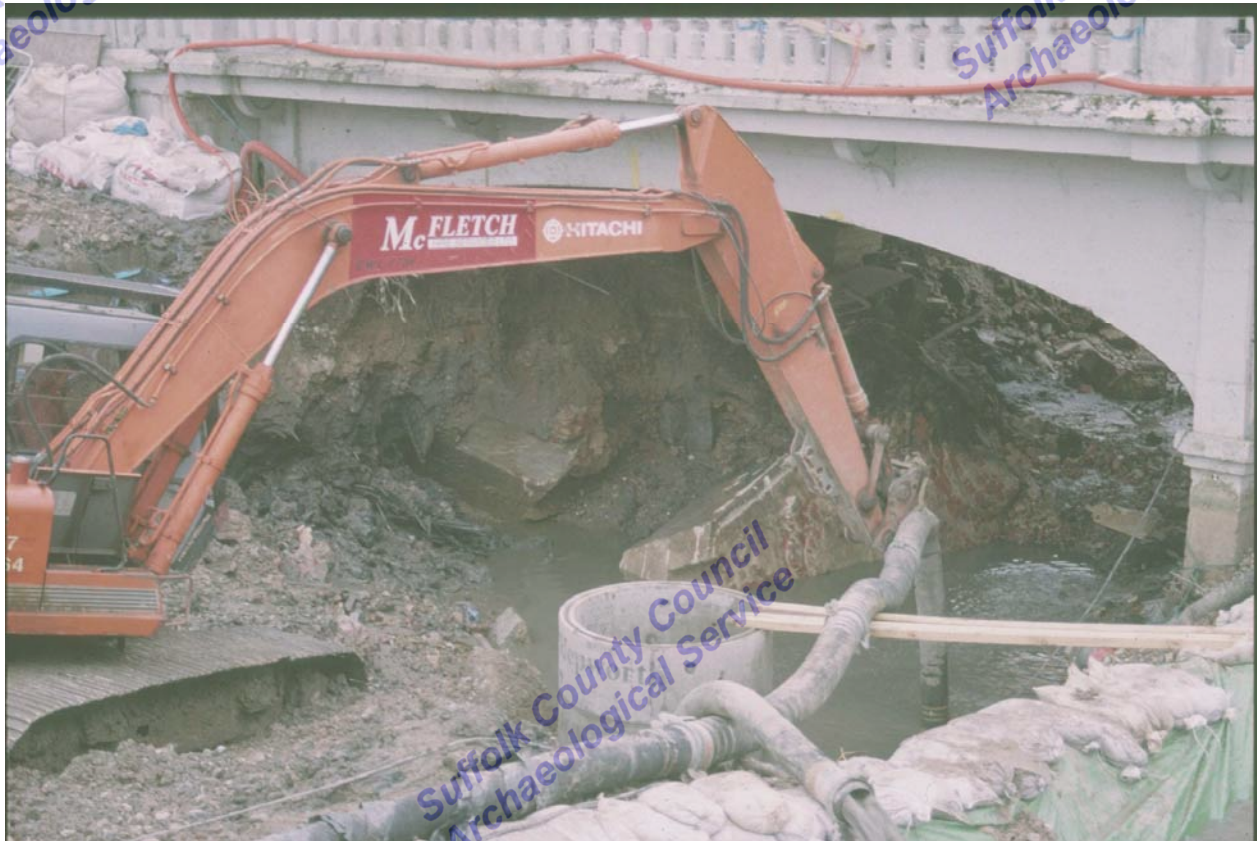
On the Sudbury side the piers were not immediately apparent. The fabric of the collapsed bridge lay where it had fallen slowing the flow of water and causing an accumulation of silts so that what had been the first two arches of the bridge had become a muddy sloping foreshore to the bank. With the silt cleared away (see *Non bridge features*) the enormity of the debris pile was revealed.

Figure 11. Remains of the brick bridge being excavated adjacent to the Sudbury bank

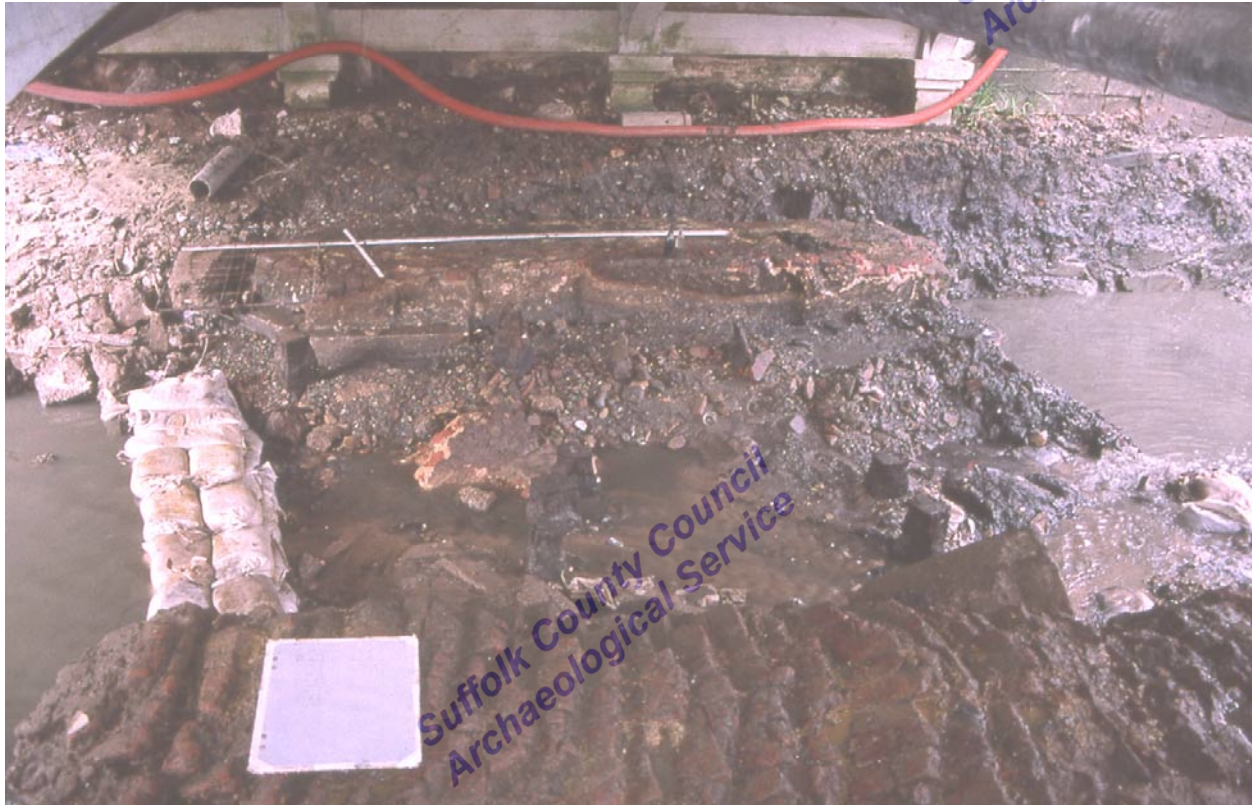
Figure 14. Piers 0101 and 0102. Slump of pier 0102 evidenced by the angled brick courses in foreground

The south end of the adjacent pier 0101 had sunk, the north end was pitched above the level of the reduced water line and the coursing of the brickwork and limestone facing were steeply angled at  $c.20^\circ$  from the horizontal. The pier had been truncated level with the water's surface so that the surviving top of the pier was a surface of pitched brickwork (Fig.14). At the more deeply submerged south end, the pier existed to the height of the arch springing point and showed the complex change in coursing needed to form the arch itself. Dredging of the riverbed suggested that a deep hole existed on the south side of the bridge and that the pier had subsided into it and the hole had become filled with rubble from the collapse. Brick, stone and building flint pulled up from well below the known level of the riverbed suggested that the hole was at least 2m deep.

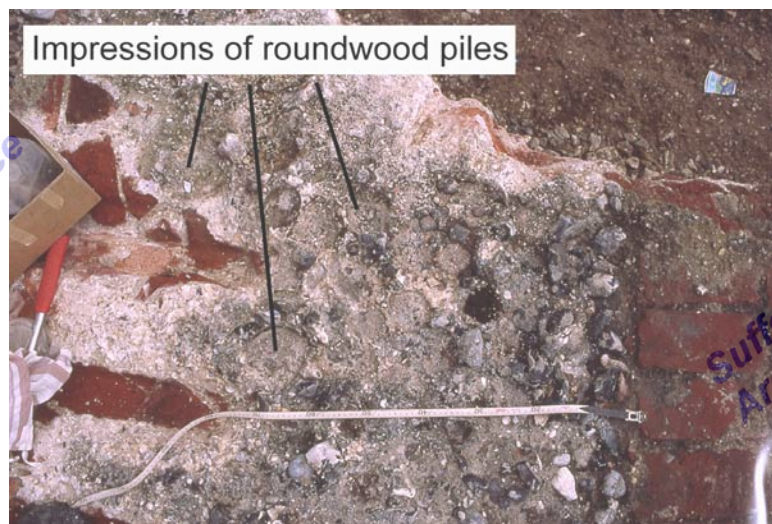
circular impressions in the bedding mortar on the base of the pier and were revealed when the piers were lifted (Fig. 15). Fragments of the piles, softwood poles 60-100mm in diameter, were collected from the water after the piers were disturbed. Pier 0102, closest to the Ballingdon bank was the best preserved and is recorded in Figure 14.

Figure 15. Underside of pier 0101 showing impressions of piles

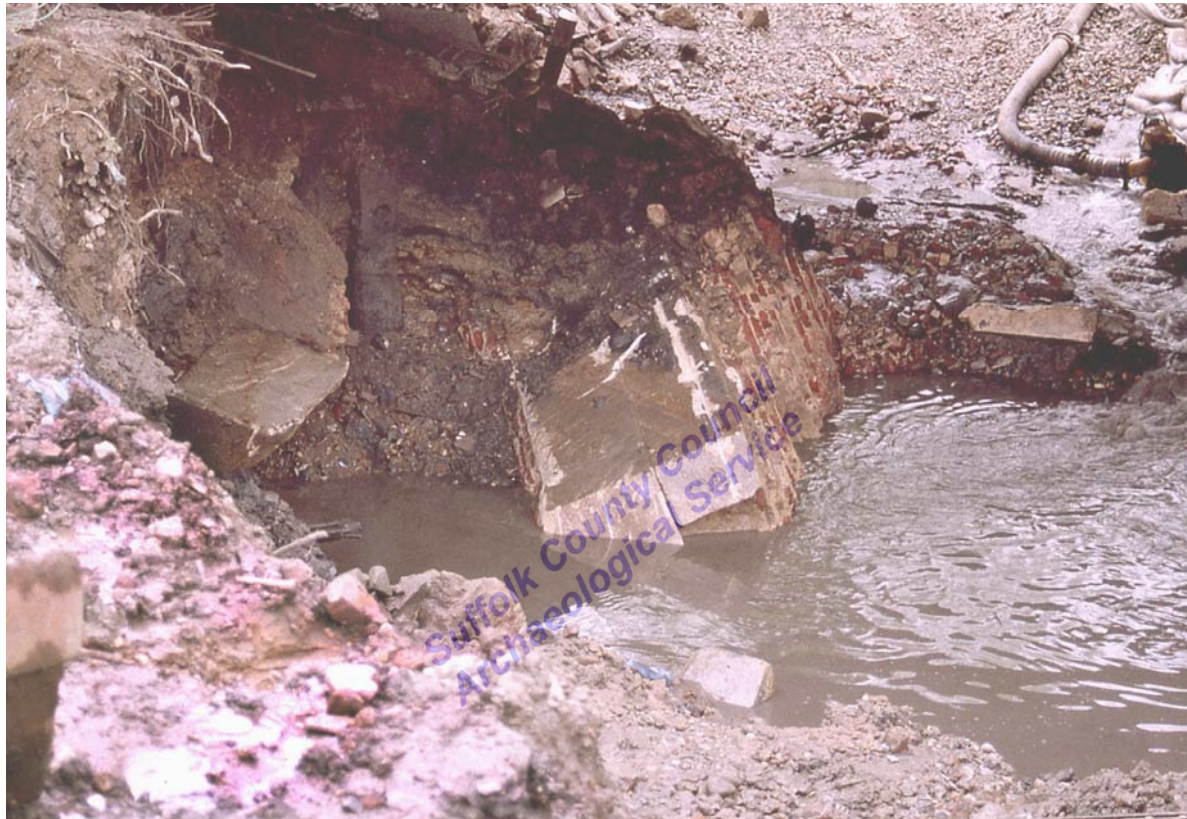
Figure 16. Inclined pier, 0053

No original piers remained in situ on the Sudbury side. The first pier from the Sudbury bank, 0053, had rolled over  $70^\circ$  to vertical and was resting on its western side with the dressed limestone of the east side now uppermost (Fig.16). The pier base had lost the bottom course(s) of brick but there was enough to indicate the step footing below the limestone and that these were the bottom courses of facing stone but damage to the bricks above the stones suggested that an upper course of limestone had been lost. At its north end the tapered cutwater could be seen.

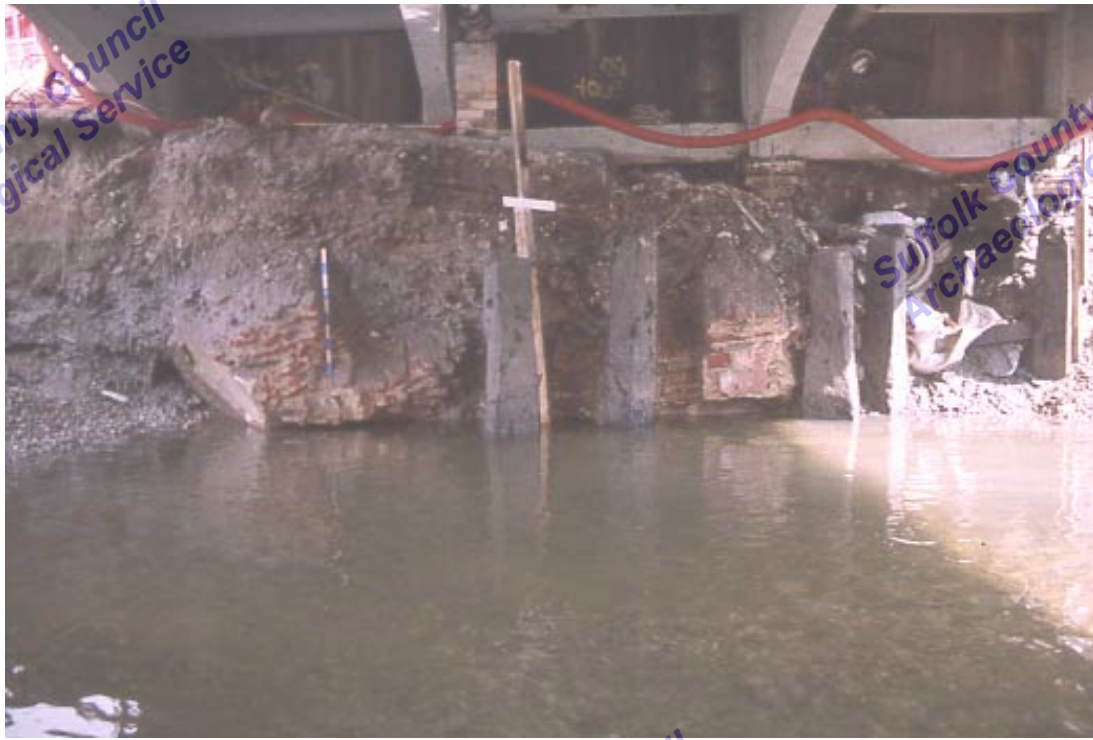
Figure 17. Cross-section of the brick bridge, 0054, behind timber pile of the later bridge

The north elevation showed the angled projecting cutwater extended to the full height of the parapet. The top of the cutwater had been truncated removing possibly a limestone capping stone but the indications were that the line of the leading edge of the cutwater did not extend further than the base of the parapet. The facing stones that protected the cutwaters at river level were not continuous above the water line but were alternated with areas of exposed brickwork for decorative effect.

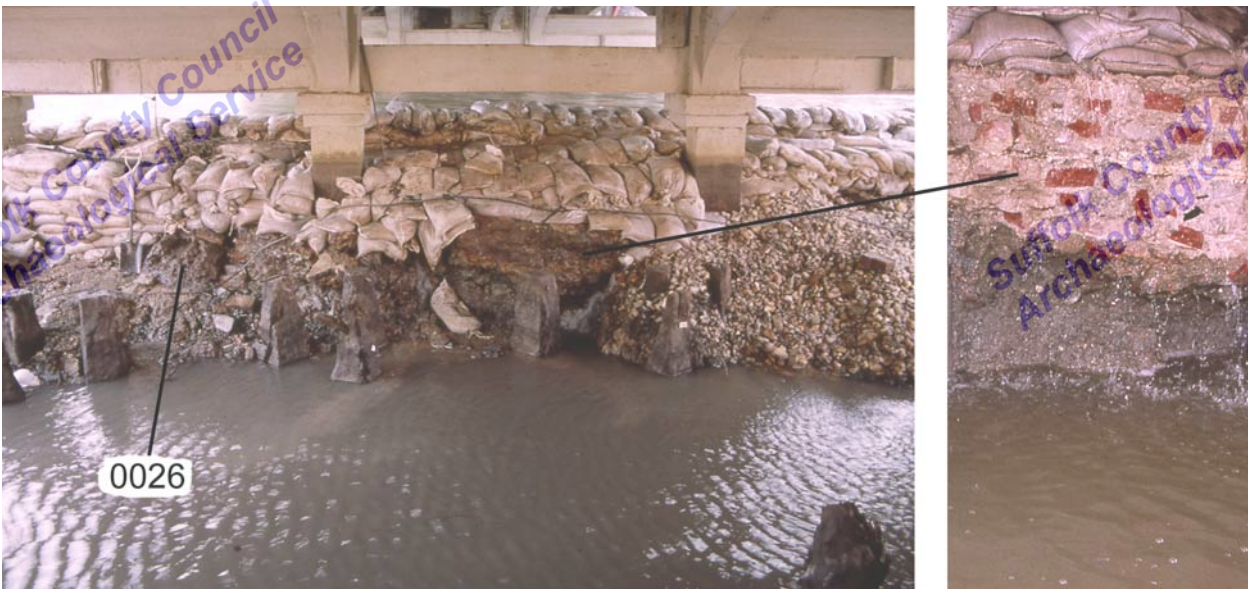
Pier 0025 was in the correct position but was constructed using a method unlike the other piers. This difference was interpreted as an indication that pier 0025 was not built at the same time as the others and was a repair to the original structure. The pier was cast, apparently *en bloc*, in a very hard-setting hydraulic lime mortar with large chalk inclusions and tempered with brick and tile rubble. Voids within it and its general appearance suggested that it had been wet poured which left the impression of uncoursed brick, and tile stuck flat against its surface. It was cast over unbonded rubble held within a framework of narrow softwood piles (contexts 0032-40) driven into the riverbed. At its south end the pier was a single row of coursed hand-made narrow 'Tudor bricks' 0024, dated to the 16th century. Butting against the bricks and supporting the pier was a large unworked log, 0026, (probably walnut, identified by the twisted burred grain) lying horizontally east west across stream. The log sat above the softwood piles but the pier followed its contours suggesting that the pier was cast against it. The log was wedged in place either to help anchor the pier or to break up the water's flow and counteract the scouring effect – alternatively it might just have become stuck.

The pier had broken up where an oak pile passed through it. The pile was not part of the timber alignments associated with the later wooden bridge but may have been an internal frame, an impression of a similar internal timber support was seen in the adjacent block of detached brickwork 0052 and was thought to relate to the two components.

Figure 18. Pier 0025 showing detail of fabric and position of log 0026. In front of 0025 are the timber piles from the later wooden bridge

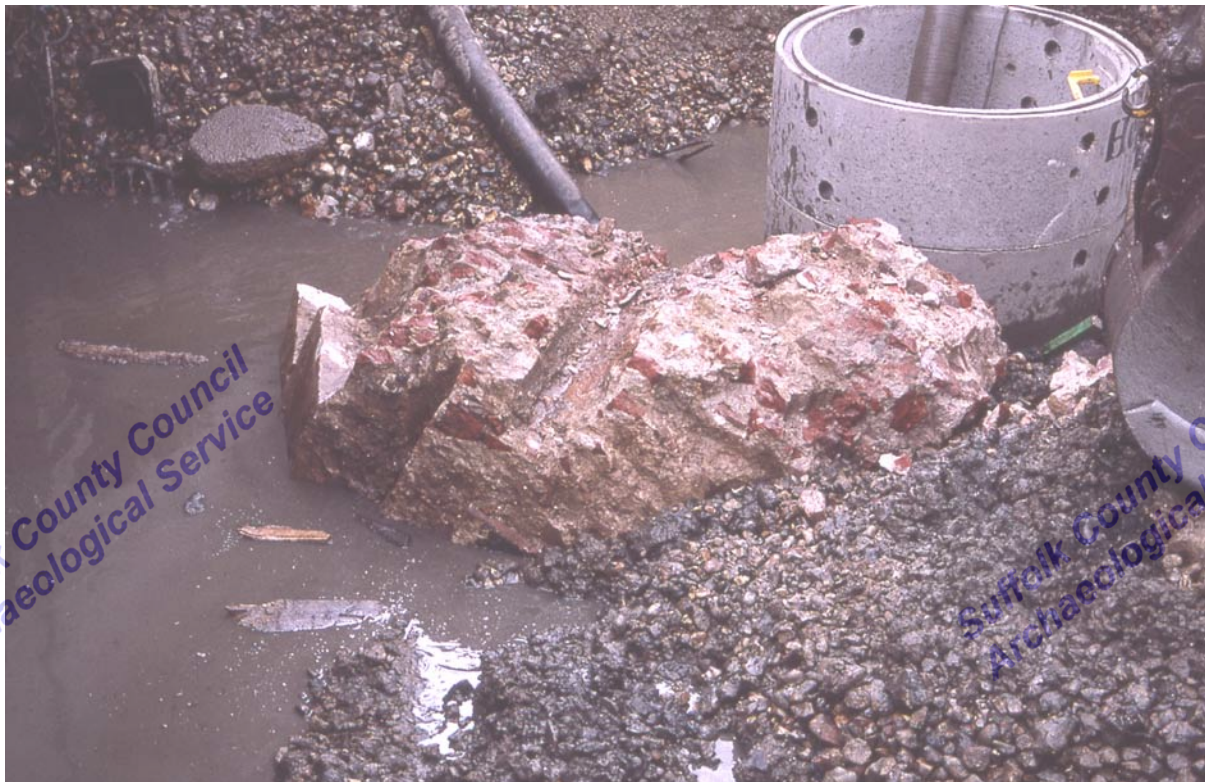
Figure 19. 0052 showing impression of internal timber

formed around an internal skeleton of wood. This tied in with evidence from the repair pier 0025 suggesting that the two were co-joined. There were two distinct mortar mixes within the core of 0052 and the change coincided with the joint between two courses of the limestone facing. The lower mix was a darker lime mortar similar to 0025, whereas the upper mix was a very hard (harder than the bricks) white mortar with distinct quartz inclusions and this was similar to the mortar that bonded 0029.

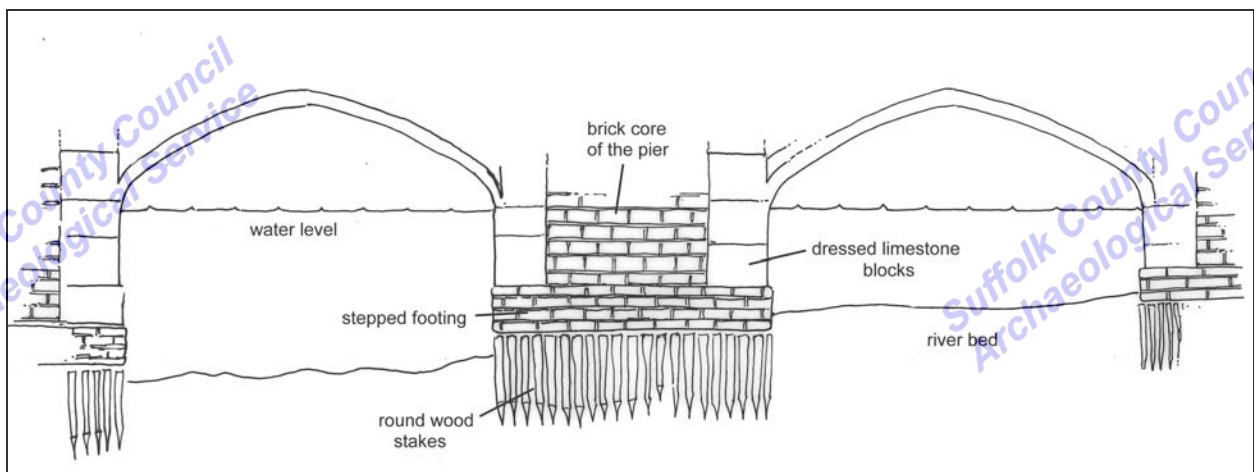
The bridge was broken for a second time during a flood in September 1594 and the effect on the structure put it beyond repair. The archaeological evidence demonstrates that this failure centred on the second pier from the Ballingdon bank, which subsided into a deep hole that had developed on the riverbed. The hole was thought to be the result of eddying water scouring away the riverbed gravels immediately downstream of the pier and the cause of the collapse may have been exacerbated by the bridge's construction. The piers were built off narrow sectioned piles driven into the riverbed (Fig. 27). This created a level base for laying the bricks and keyed the bridge into the ground without the need to excavate foundations under the water. It is possible that little or no brickwork was actually set into the riverbed. The bridge engineers may have used the increasing load of the bridge, as the bricks were laid, to push the piles into place and allowed the bridge to 'find its own feet'. The depth of brickwork below the water level would then be

Figure 27. Illustrative section through the bridge pier showing wooden stakes footing

dependent on the bearing capacity of the soil beneath the riverbed and could be different from pier to pier. It is even possible that the bricklayers started the brickwork on the piles above the watermark, giving the mortars time to go off before the weight of the bridge sank the piles home. This system of foundation would allow the passage of water around, and possibly even under the piers, eroding the gravel from around and between the piles resulting in the piles becoming unsecured and eventually lost leaving the pier over a void.

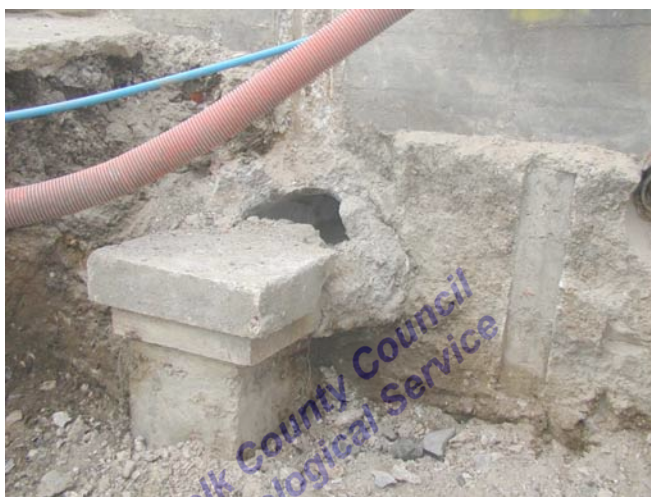
Figure 28. Explosive holes behind the piers
