# THE CHURCH OF ALL SAINTS CHURCH METTINGHAM MTT 044

A REPORT ON THE TOWER RECORDING, 2008

Tower recording: All Saints Church, Mettingham

SCCAS Report No. 2008/193

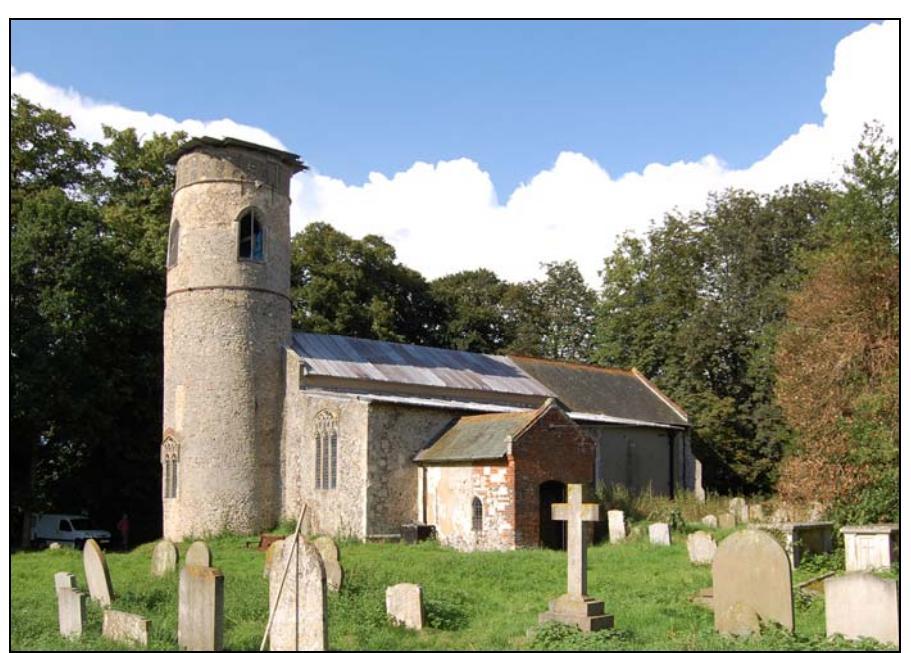
Figure 2. South view of All Saints Church.

The Church of All Saints comprises cells of nave, chancel and south aisle with a round tower at the west end of the nave (Fig.2). The porch on the south aisle was extended in the 19th century and serves as a vestry.

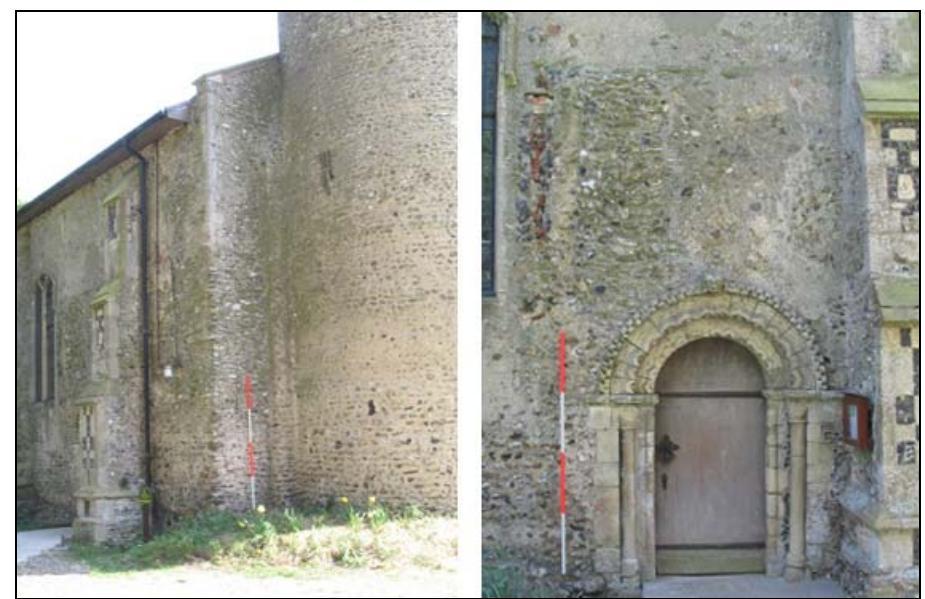
Figure 3. NW corner of the nave and nave north door

The exterior fabric of the nave includes flint work strongly coursed in horizontal layers that appear to run continuously round the tower suggesting that the two are contemporary. On the north side the nave has an ornate Romanesque doorway with engaged columns and orders of

chevron and billets in the arch (Fig.3). The flint coursing runs up to the edge of the door stones in unbroken layers suggesting that the door is a primary feature and seems to confirm a post-conquest date for the building's origins.

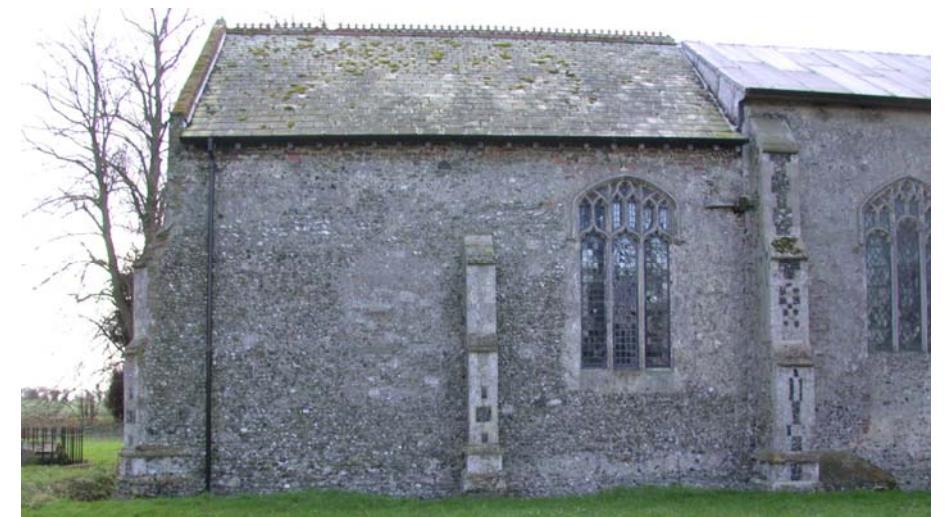
Figure 4. North side of the chancel

A south aisle and chancel were also added in the 14th century when the nave remodelled. The chancel is almost as large as the nave, the wall lines are continuous but there is a clear, full height butted joint at the junction of the two cells (Fig. 5).

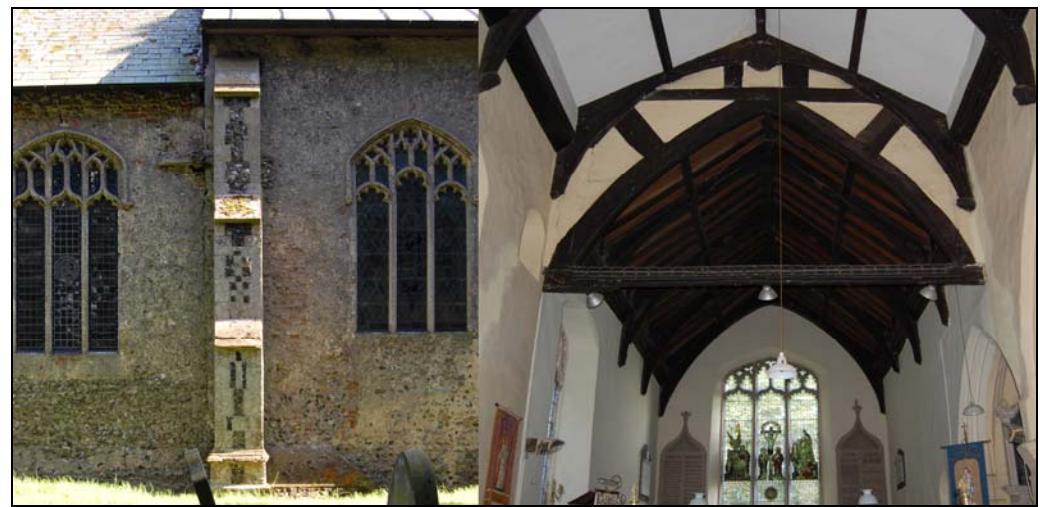
Figure 5. Junction of the nave and chancel and view of the chancel arch

The chancel was later altered in the 16th century by raising the wall heights, replacing the window with large perpendicular windows with flattened arches (the south one of which is now blocked). An original blocked window and the former wall height can be seen on the north wall and the lower wall height is reflected in the position of the buttress tops (Fig. 4). On the north side of the nave there is evidence that an external rood stair has been removed but the entrance to the loft still remains on the inside wall as does the rood beam and above it a timber arch which have survived the chancel alterations (Fig. 5).

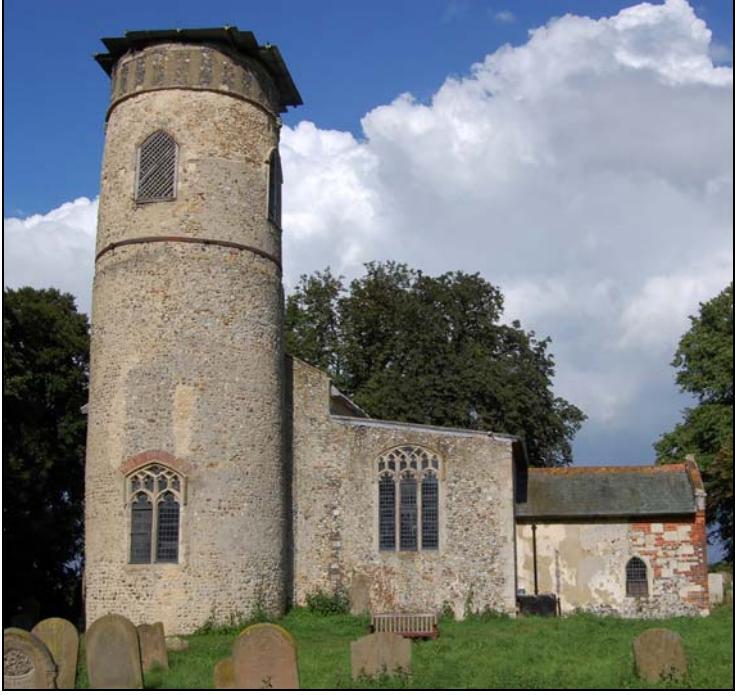
Figure 6 West view of the tower

The tower is constructed in well coursed flint similar to the nave and has a slightly irregular bulging profile. The top third of the tower is built with a smaller circumference creating a step in the wall face just below the belfry (Fig. 6). Three of the four belfry openings are framed in a mixture of limestone for the verticals, topped with brick to form a two-centre arch. The south opening is entirely in stone and re-uses the surround from a Decorated tracery window. A two light window was added at ground floor level to the west side of the tower in the 15th century and an iron band was fixed around the girth during the 19th or 20th century.

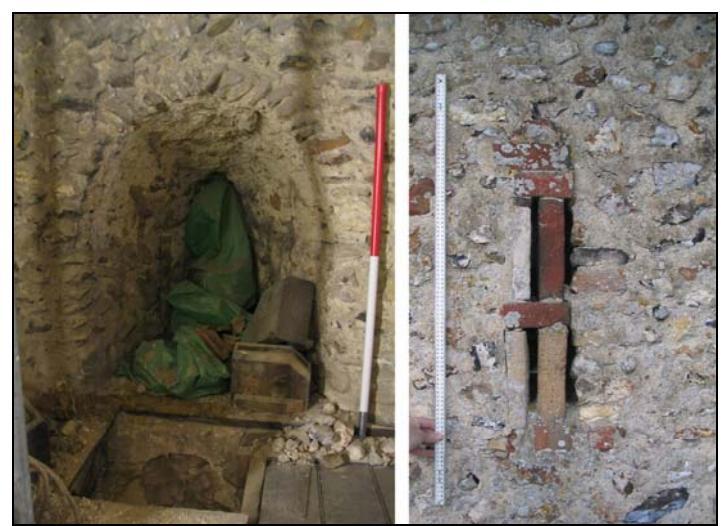
Figure 7. Interior and exterior of a tower room window

The tower room is lit by splayed windows piercing the north, south and west walls. The west window has been infilled but was identified during the first stage repair work. The round headed openings and external lancets do not have limestone frames and have been finished in flint (Fig.7). The heads of the internal arches show the impressions of shuttering boards and a clear lift line can be traced around the wall at the springing point of the window heads. There is no doubt that the windows are original features contemporary with the basic fabric.

Externally the windows have been diminished in size by later brick fillings giving an appearance

akin to vent holes in historic barns. The bricks are similar in size and fabric to those used on the later phase belfry openings and this alteration to the windows is thought to be contemporary with the belfry's re-construction in the 16th century.

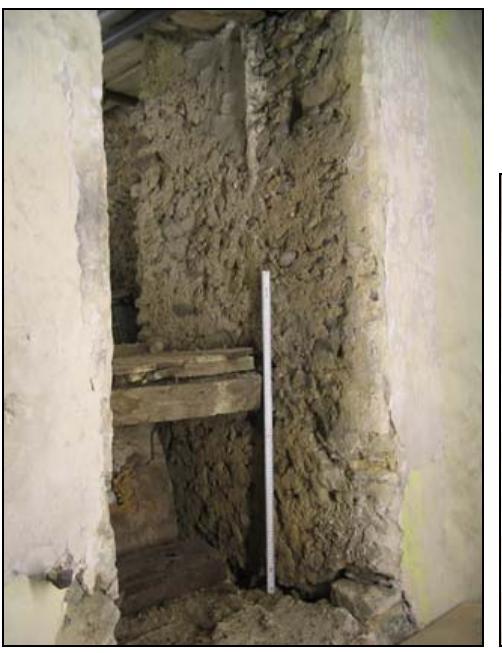
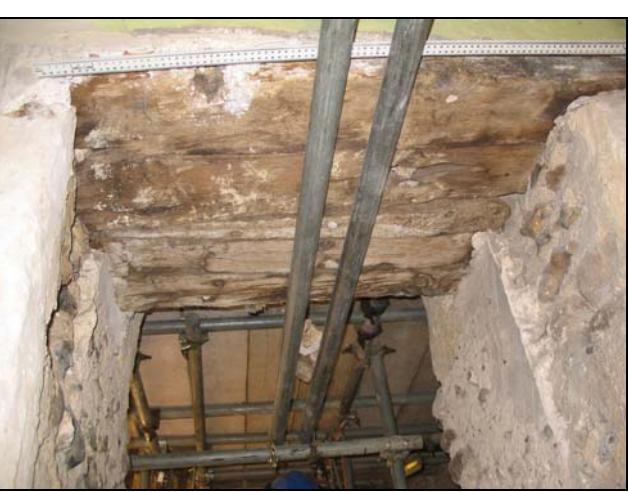
Figure 8 Tower room doorway from the nave, showing surface treatments and timber lintels

On the east side of the room a straight sided doorway gives onto the body of the nave above the tower arch. Like the windows, the opening on both faces is edged in flint. The square-headed top of the doorway is formed by a wooden lintel, the existing timbers are likely to be later replacements using reused timbers – this is to be tested by dendro-dating - but pockets cut in the side of the door opening and undisturbed core material above the door suggest that the style and height of the opening are unchanged. Within the opening, the sides have been pointed flush with the face of the flints (Fig. 8); this pointing does not exist within the tower room where the flints are left projecting. Curving around the nave side quoin, a secondary fine textured render survived beneath the current topcoat of lime plaster. The render predates the blocking in the doorway and is likely to be the original internal finish of the nave.

The present floor is later than the doorway and lies 0.77m above the original threshold. It is supported on joists that sit on the sills of the tower room windows and extends into the door opening as far as the rear of the daub infill that until recently blocked the door. The impression of the daub can be seen in Figure 8.

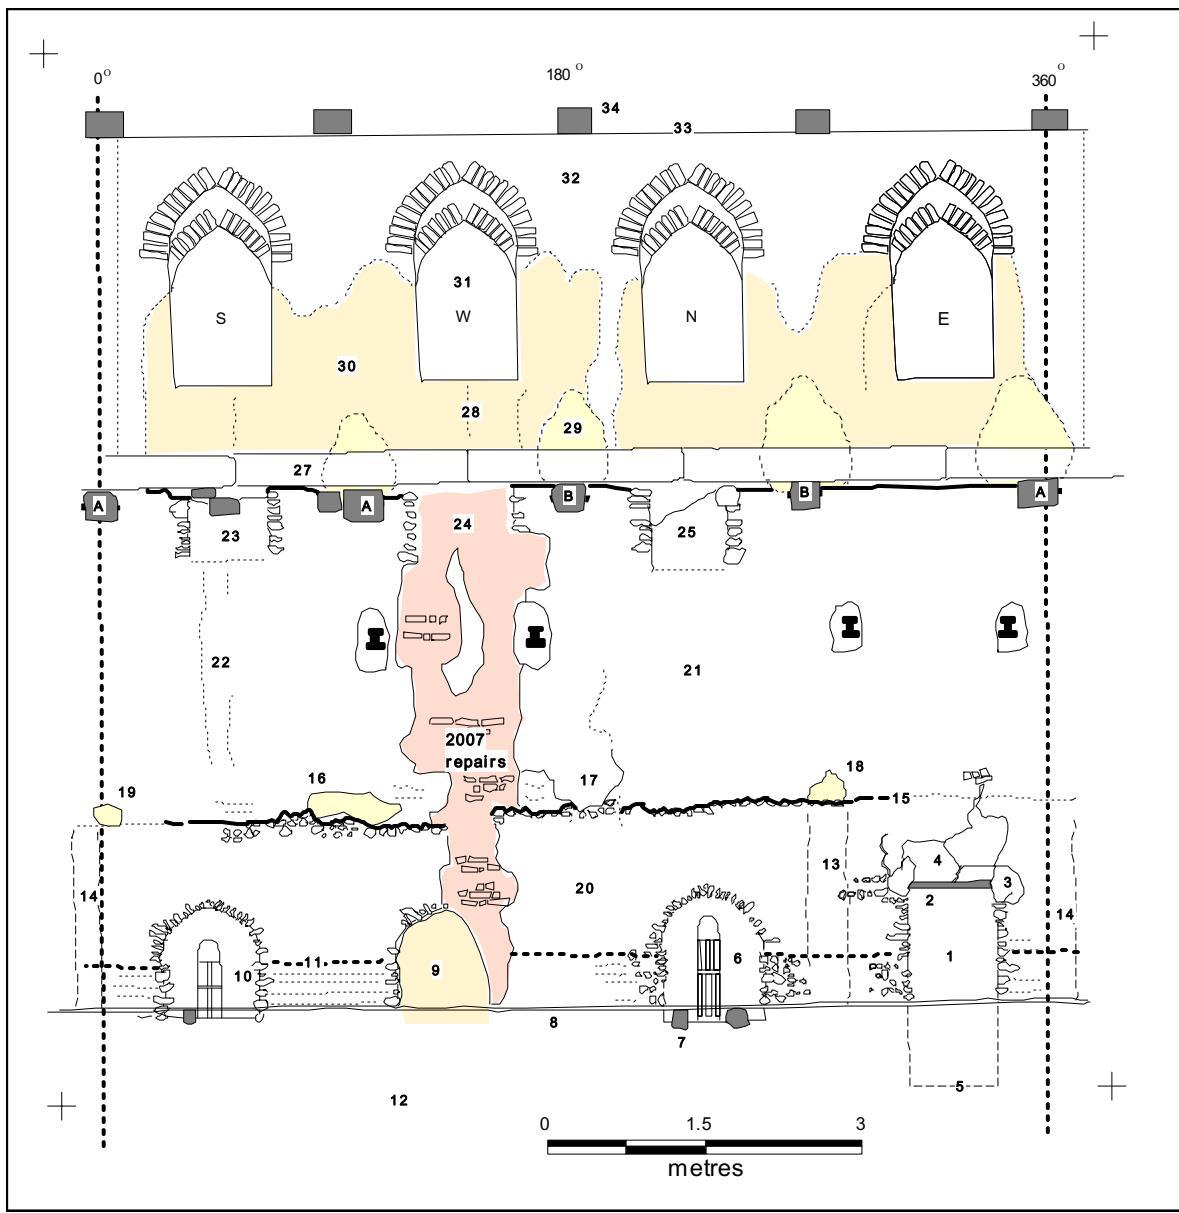
Figure 9. Internal face of the tower, unfurled.

- 1. Door overlooking the nave
- 2. Timber lintel, made up of re-used oak planks
- 3. Cob packing infilling setting for the lintel
- 4. Exposed core original masonry indicating that the original opening was square-headed and not arched
- 5. Original floor level of the tower room
- 6. Original Norman N window, splayed
- 7. Joist supporting current floor set onto the window sill
- 8. Current floor level
- 9. Infilled Norman W window.
- 10. North Norman window, shuttering impression clearly visible on underside of the arch
- 11. Lift line, distinct end to a phase of build below the springing point of the arch
- 12. Face of the tower rendered over below current floor all details obscured
- 13. Curving right angled corner where round tower joins the nave
- 14. Curving right angled corner where round tower joins the nave
- 15. Change in wall thickness, forming a shallow ledge along this line

- 16. Wide socket in the masonry, infilled with mortared flint
- 17. Repair section covering socket opposed to 16. Existence of socket evidence by a break in the coursing
- 18. Probable socket recently (2007) infilled
- 19. Probable socket unclear
- 20. Norman facing, large flints laid in well defined courses
- 21. Norman facing, mixed flints coursed wall thickness less than 20 creating ledge at 15
- 22. Impression of vertical, square post preserved in small area of render
- 23. Blocked belfry S opening
- 24. Blocked belfry W opening
- 25. Blocked belfry N opening
- 26. Inserted paired principle timbers, running N-S and supporting bell frame. A to A and B to B opposite end of single timbers
- 27. Bottom rail of the bell frame
- 28. Corners of the bell frame set into earlier belfry openings
- 29. Repair patches of mortared flint, setting for timbers

- 30. Wall face chopped away to accommodate to allow fro the timbers 26 to be let in
- 31. Belfry openings
- 32. Intact wall face, closely spaced large rounded flint cobbles, predominantly brown flint
- 33. top of the belfry wall
- 34. Timbers supporting shallow pitched roof rafters
- 35. Horizontal steel girders propping up the bell frame

A pair of square sectioned timbers (26), aligned N-S were fitted retrospectively into the tower to support the new bell frame. To fit these and the bell frame the internal face of the tower was chopped away (30), reducing the thickness of the wall, increasing the interior diameter of the space and creating a ledge all the way around the tower, just below the bell frame. In addition to this, long vertical gouges and elongated pockets (29) were cut to manoeuvre the timbers into place; and the pockets infilled with mortared flint to secure the beam. The measurement of the diagonal of the bell frame is greater than the internal diameter of the tower, it was therefore necessary to turn the bell frame at an angle of 45° to the axis of the tower in order that the corners of the frame could sit in redundant opening of the earlier belfry (Fig. 16). So close is the fit that the infilling of the earlier belfry windows is little more than one flint thick at the corners of the frame. Beneath the frame secondary timbers have since been added to augment the main cross beams (26), these are shorter than the tower diameter allowing them to be fitted from below and run from tower edge to mid-beam.

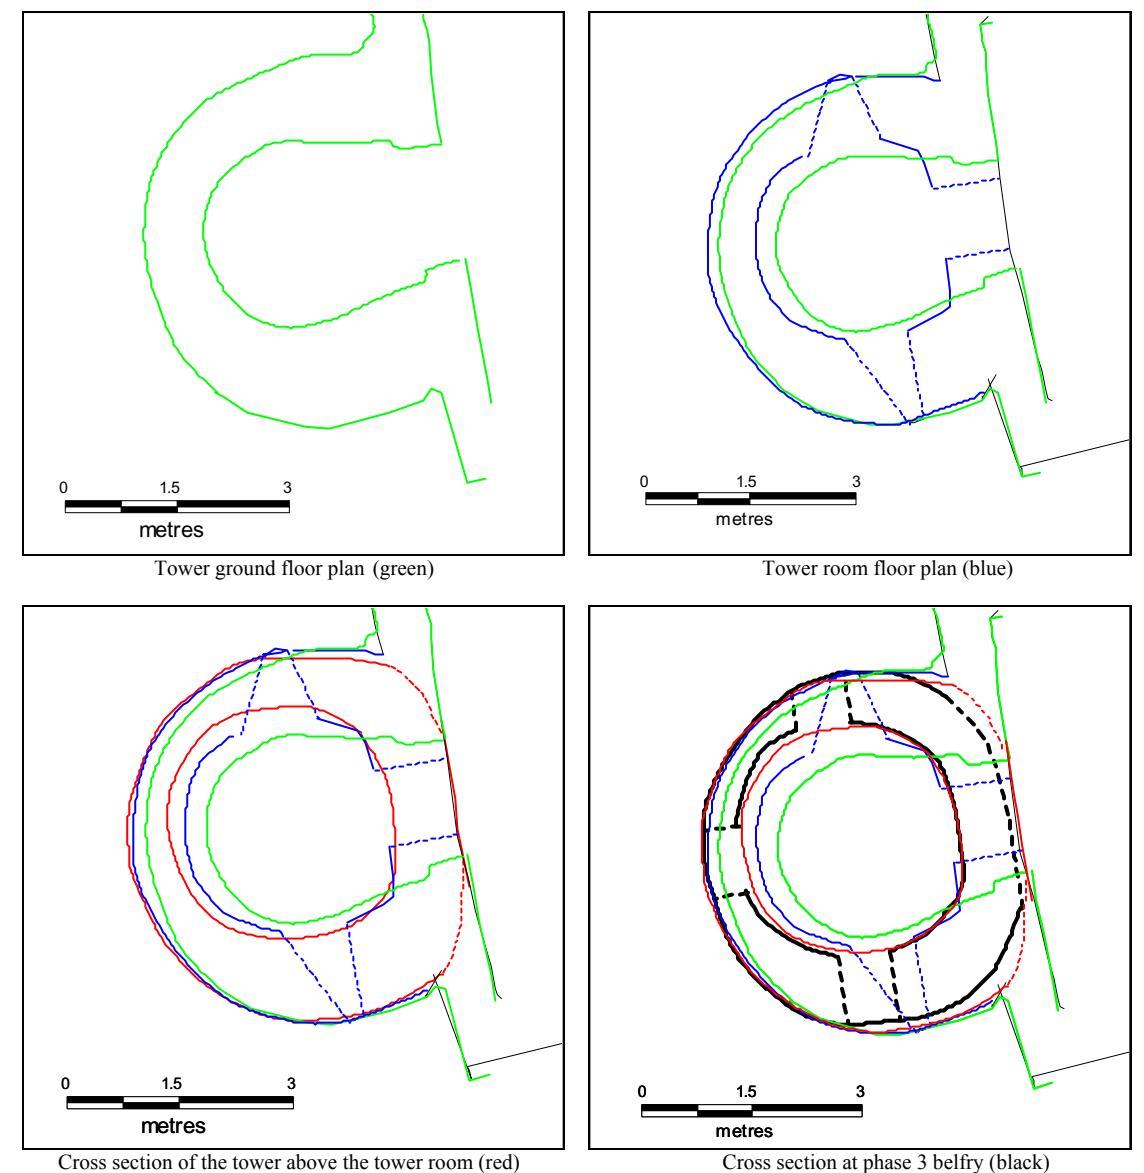
Figure 11. Tower room from the belfry.

As a result of being constructed off the reverse of the nave wall, the tower room is not circular or entirely symmetrical in plan, but is sub-square with readily discernible SE and NE corners (Fig. 10). Below the tower room, the floor plan has been altered by the addition of the tower arch and it is not until it is above the tower room, where it is clear of the nave, does the tower become circular.

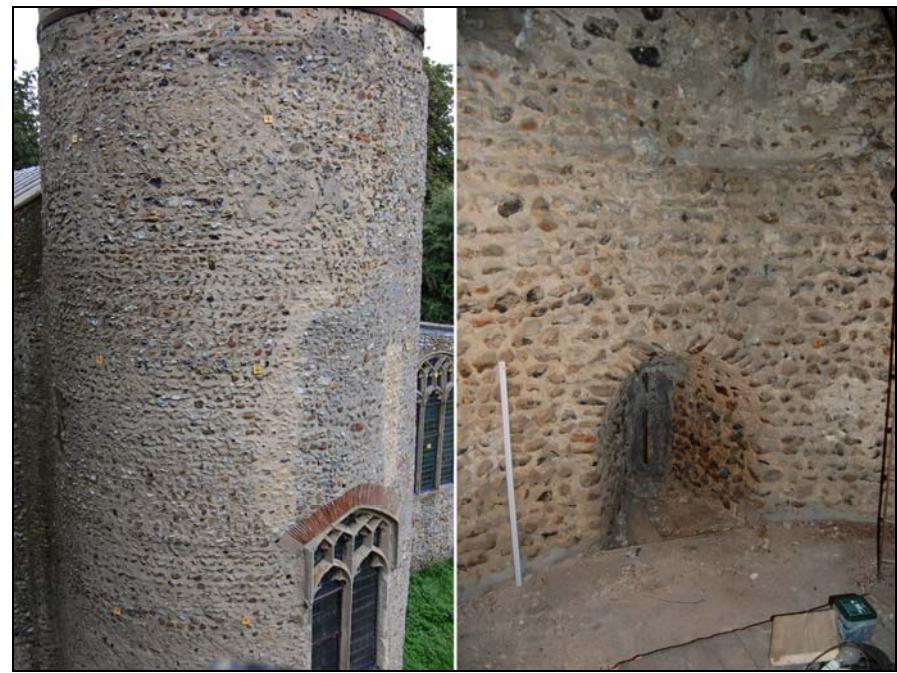
Figure 12. Changes of build and ceiling level within the tower room

The tower has been re-pointed flush with the face of the flints and in places this becomes almost a render and obscures the coursing. The tower has been re-pointed on several occasions but what appears to be the earliest, a high chalk lime mix, extends over the nave and south aisle gable suggesting that this, at the earliest, is a post-15th century treatment of the surface and the tower's original appearance is likely to have been one where the flints stood proud. Because of the re-pointing it is difficult to identify the junction between building lifts (the amount the tower was raised is a single episode of construction before it had to be left to allow the mortar to 'go off'), but there are distinctive lines of flint which occur at regular intervals of between 0.8 and 1.2m. The top of the first phase of the construction of the tower can be identified at a height

approximately 7m from the ground surface (Figs. 12 and 13) at which height the flints are no longer clearly coursed. This division is a distinct horizon and can be followed right around the circumference of the tower and coincides with the shallow ledge on the internal face of the tower which distinguishes the ceiling height of the tower room (Figs. 12 and 13). It is also at this height that the gable wall of the Norman nave becomes the same width as the internal diameter of the tower. The coincidence of these factors suggests that this was deliberate and because of this it is possible to project the supposed ridge and pitch of the original Norman roof over the tower in an uninterrupted line (Fig. 14). The existence of the sockets for timbers in the tower indicate that a ceiling or a roof structure certainly occurred over the tower at this height, and it could be assumed that the masonry at this point was calculated to accommodate this. Roofing the building at this stage would suggests that the tower remained at this height for some time and may explain why, when building resumed that the Phase 2 structure had such a different appearance.

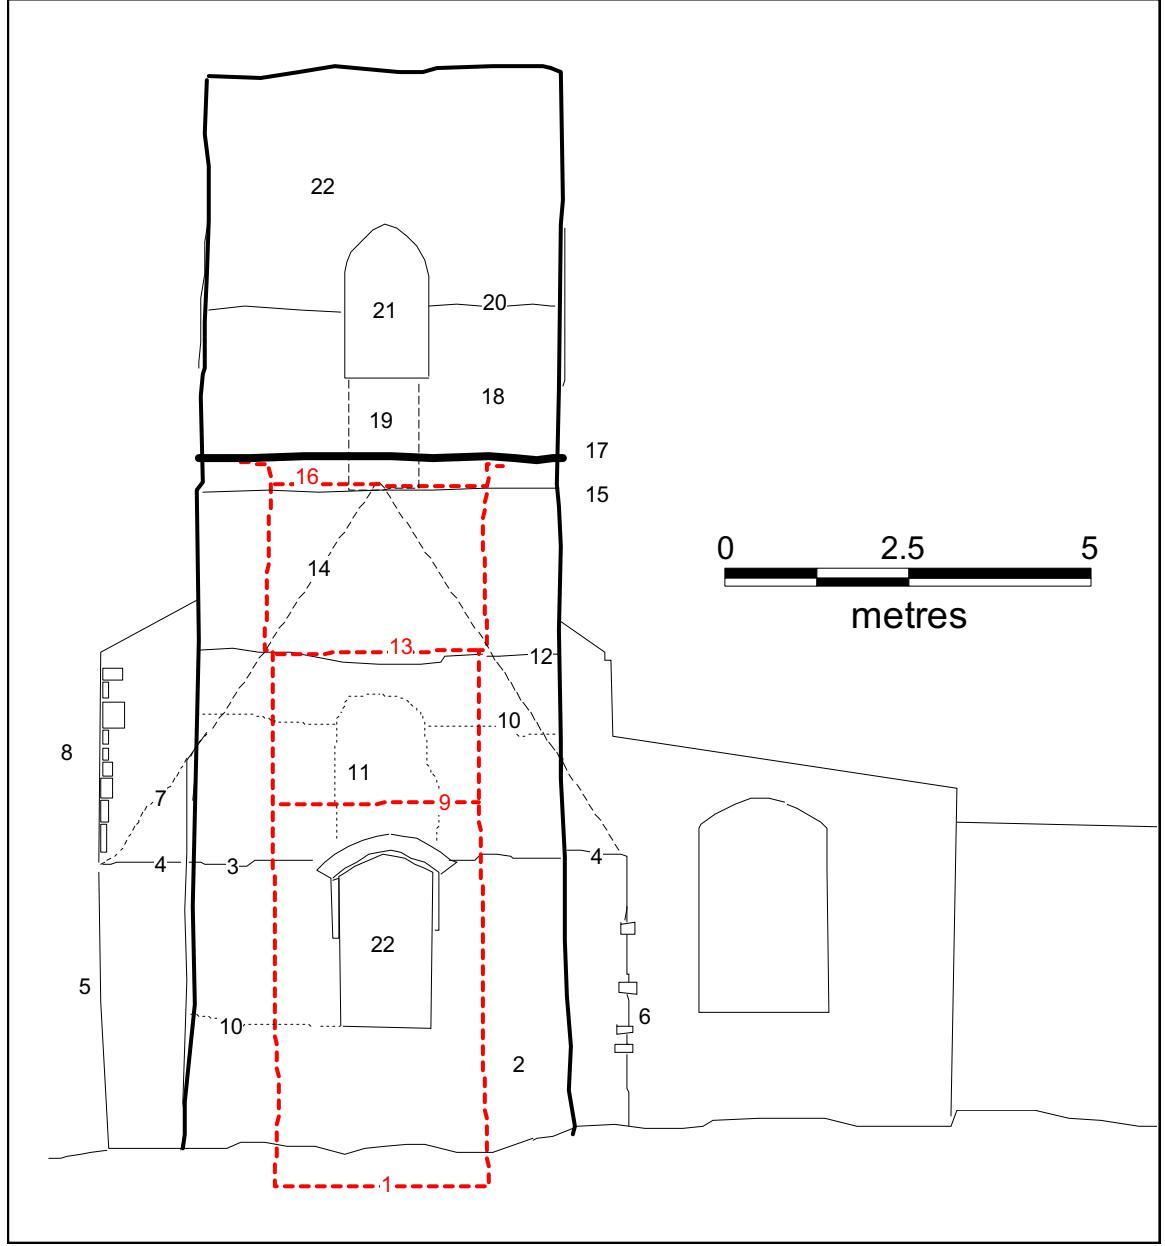
Figure 13. West elevation of the tower

- 1. Ground floor inside the tower
- 2. Flint laid in horizontal courses

- 3. Lift line on the tower, continuous with original Norman eave level
- 4. Norman eave height and lift line in gable

- 5. Flint cobbles on corner to eave height
- 6. South edge of Norman nave. South aisle stitched into nave with limestone blocks
- 7. Top of the gable line of Norman roof
- 8. Limestone quoins, nave height raised during C14-15th
- 9. (red) Inserted floor; current floor level in the tower room
- 10. Lift lines
- 11. Repair patch, infilled tower room window
- 12. Distinct change in build, top of the Phase 1
- 13. (red) top of the tower room inside the tower
- 14. Projected line of the Norman nave roof

- 15. Top of phase 2. Distinct change of build step in the external face of the tower where the external; diameter becomes smaller
- 16. Planned cross-section of the tower drawn at the base of the original belfry openings
- 17. Iron band
- Phase 3 build. Heavily point/rendered face although suggestion of coursing to the flint work
- 19. Position of original belfry openings
- 20. Top of the phase 3 build. Level of large, closely spaced putlock holes circumventing the tower
- Late medieval 15-16th<sup>th</sup> century belfry openings
  Phase 4 top of the tower constructed after the installation of the bell frame

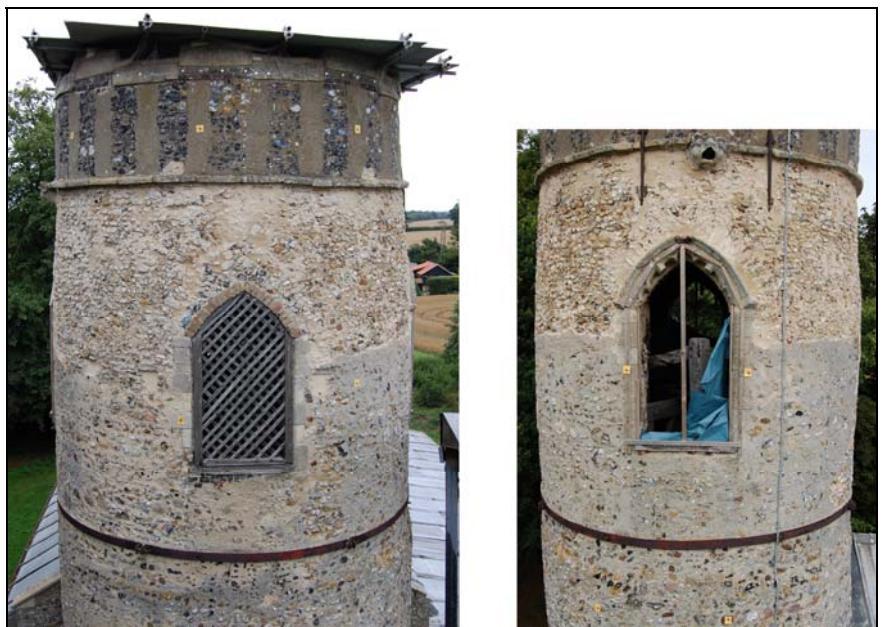
Figure 15. Belfry west and south openings

The earliest material evidence of a belfry is found within Phase 3. The evidence consists of the wide openings, now blocked, that were added in the lifting of this phase. Because of their size it seems likely that these are openings to a former bell chamber, rather than windows and these occur just below the current bell-frame. Like the tower room windows the sides of the openings are edged with flints, larger than those used in the body of the wall and are easy to see. The edges of the opening all started at the same level however the sills were not defined by masonry and it was impossible to indentify the base of the openings as the flint and mortar with which they had been later blocked, was near identical to wall material below. There was no evidence of an opening on the east side, overlooking the nave roof. This could be because the position of the projected ridge line of the early nave would have been at or very close to the base of the belfry openings. This may indicate that this phase predates the remodelling of the nave and the

The current belfry openings are directly above, and probably slightly overlap, the Phase 3 ones and were constructed when the current bell-frame was fitted into the tower. The heads of the openings are two centre arches; internally these are stepped with a recessed lower arch, the lower arch forming the external opening. On the inside the openings are in flint and the heads both internally and externally are constructed of brick. The bricks are plain handmade, sandy reds measuring  $9\frac{1}{2}x 4\frac{1}{2}x 1\frac{5}{8}x$  suggesting a 15th century date; a similar brick is used to reduce the tower room windows. Externally the belfry openings are edged in Barnack stone which is likely to have come from elsewhere on the building and, on three of the openings, the arch heads are constructed in brick similar to the interior ones. On the south side however, the head of a Decorated tracery window and a drip hood have been used (Fig.14). The shape of the window suggests that it dates to the 14th century, it is a two-centre arch and the remnants of the tracery indicate it is the same pattern as the south aisle window just to the east of the porch.

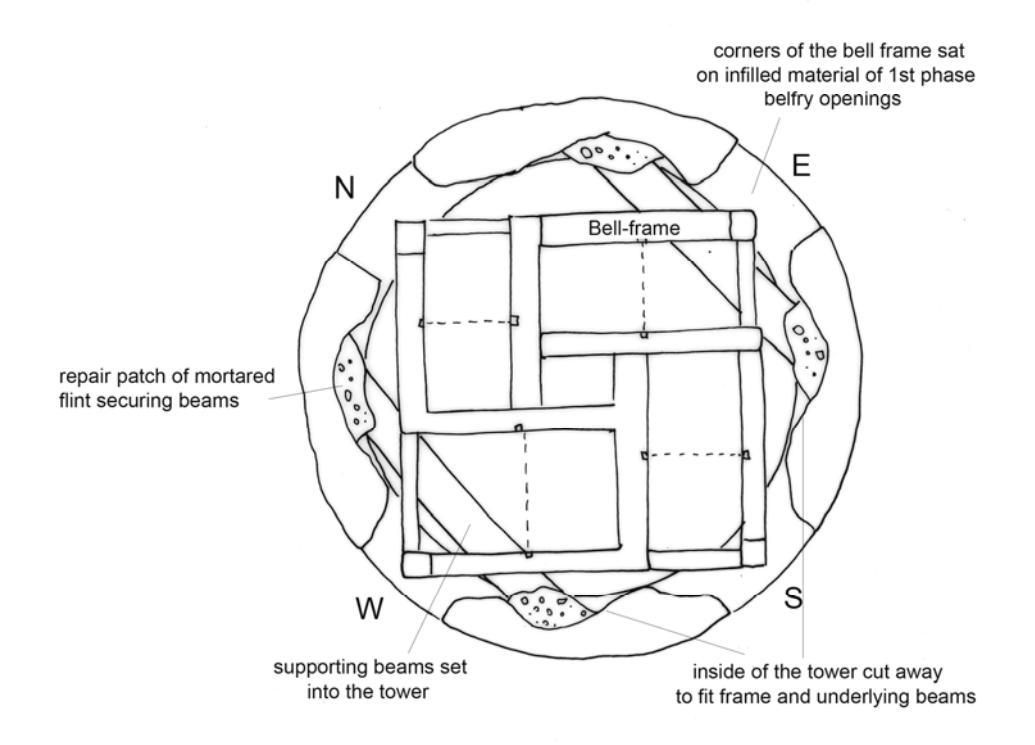
Figure 16. Sketch of bell frame

In the recent past an iron band was fixed around the outside of the tower. The level at which this is fixed is the same as the cross timbers that underpin the bell frame. There are metal straps fixed to each side of the cross beams and these correspond to the four wrought iron threaded fixings that hold the band in place. The ends of the timbers are decayed and not securely fixed into the flintwork. It seems, therefore, that the iron band is not counteracting a bulge in the masonry, but appears to be there to hold the timbers in place.

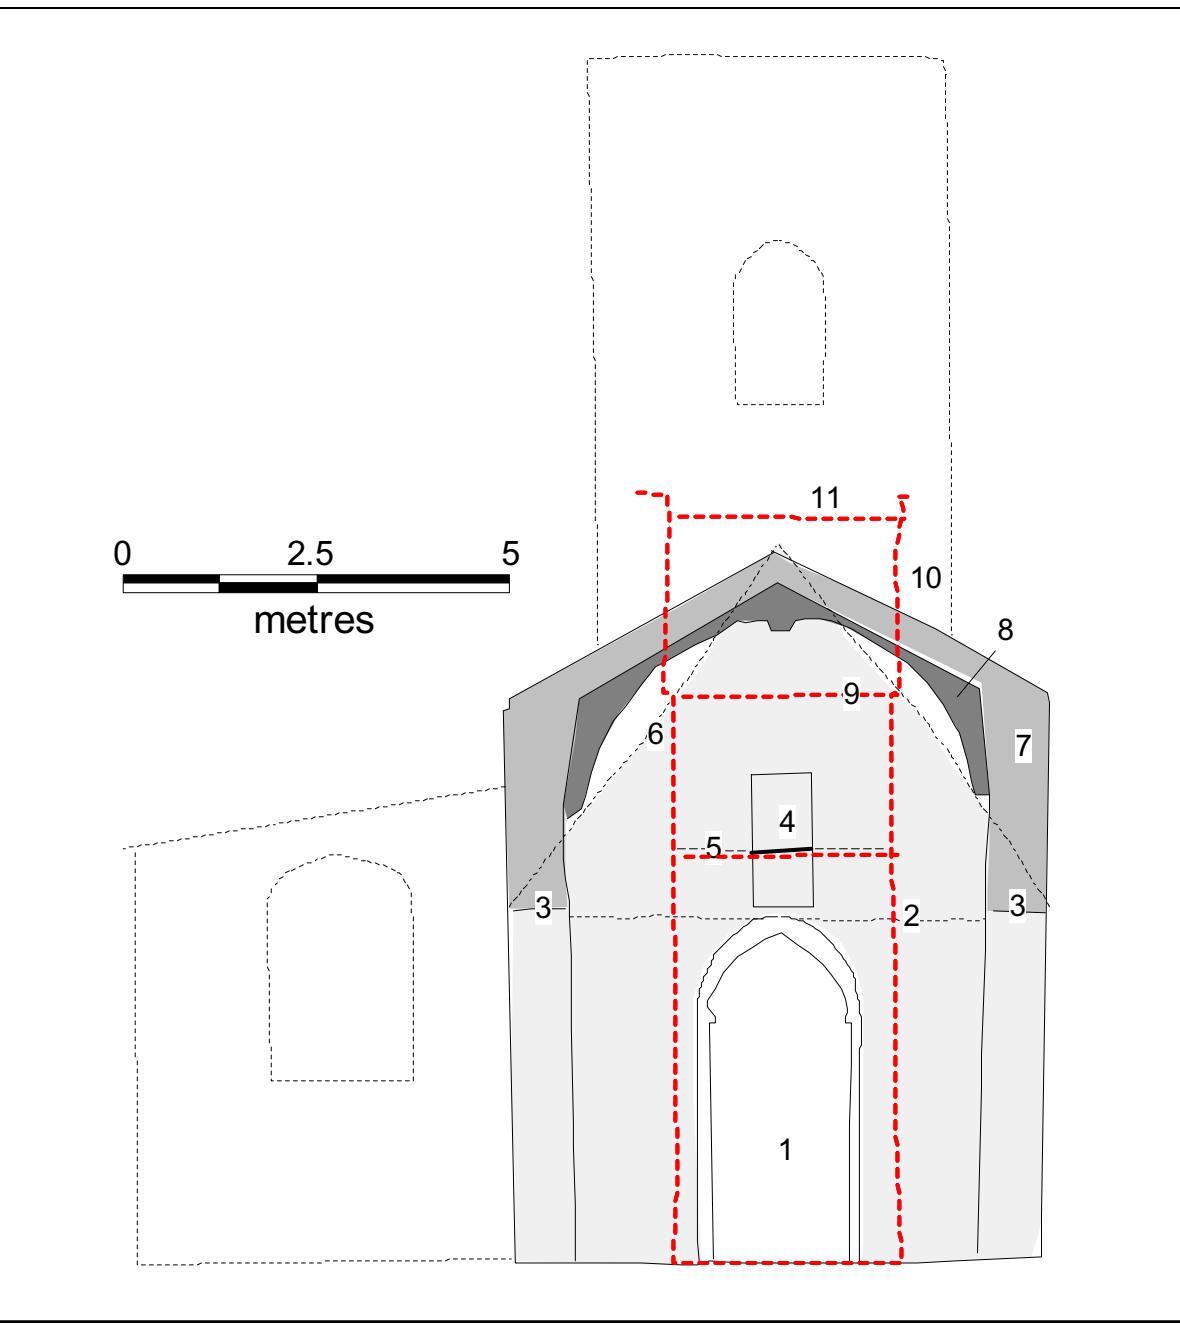
Figure 17. West wall of the nave, internal elevation.

- 1. Tower arch 13<sup>th</sup> century
- 2. Change in build, identified by slight change in the plane of the wall
- 3. Change in the face 13<sup>th</sup> century
- 4. Tower room entrance
- 5. Inserted floor
- 6. Norma Nave roof line, identified as a shadowy line
- 7. Wall height raised in the 14<sup>th</sup> century
- 8. Truss form the Arch braced roof
- 9. Top of the tower room, as surveyed from within the tower
- 10. Line of the tower internal wall
- 11. Sill height of the former belfry openings

The elevation illustrates the relationship of the 13-14th century tower arch and the entrance to the tower room. The crown of the arch partly cuts away the threshold of the door into the tower room and this suggests that the two were never open at the same time

Combining the surveys confirms that the slight step in the plane of the interior wall aligns with the top of Norman build on the exterior of the north nave wall. This level is the top of the eave and demonstrates that a phase of construction of the early building finished here. This level is also the just below the level of the original tower room floor as suggested by the threshold of the entrance and would have been the level at which the floor joist would have had to have been inserted.

It is also just possible to pick out the line of the original roof but this less clear and may be influenced by the knowledge of where it is on the exterior of the building. A large crack is developing in the north corner of the building; probably as a result of the thrust of the roof which is forcing the side and gable walls apart.
