Suffolk County Council
Archaeological Service

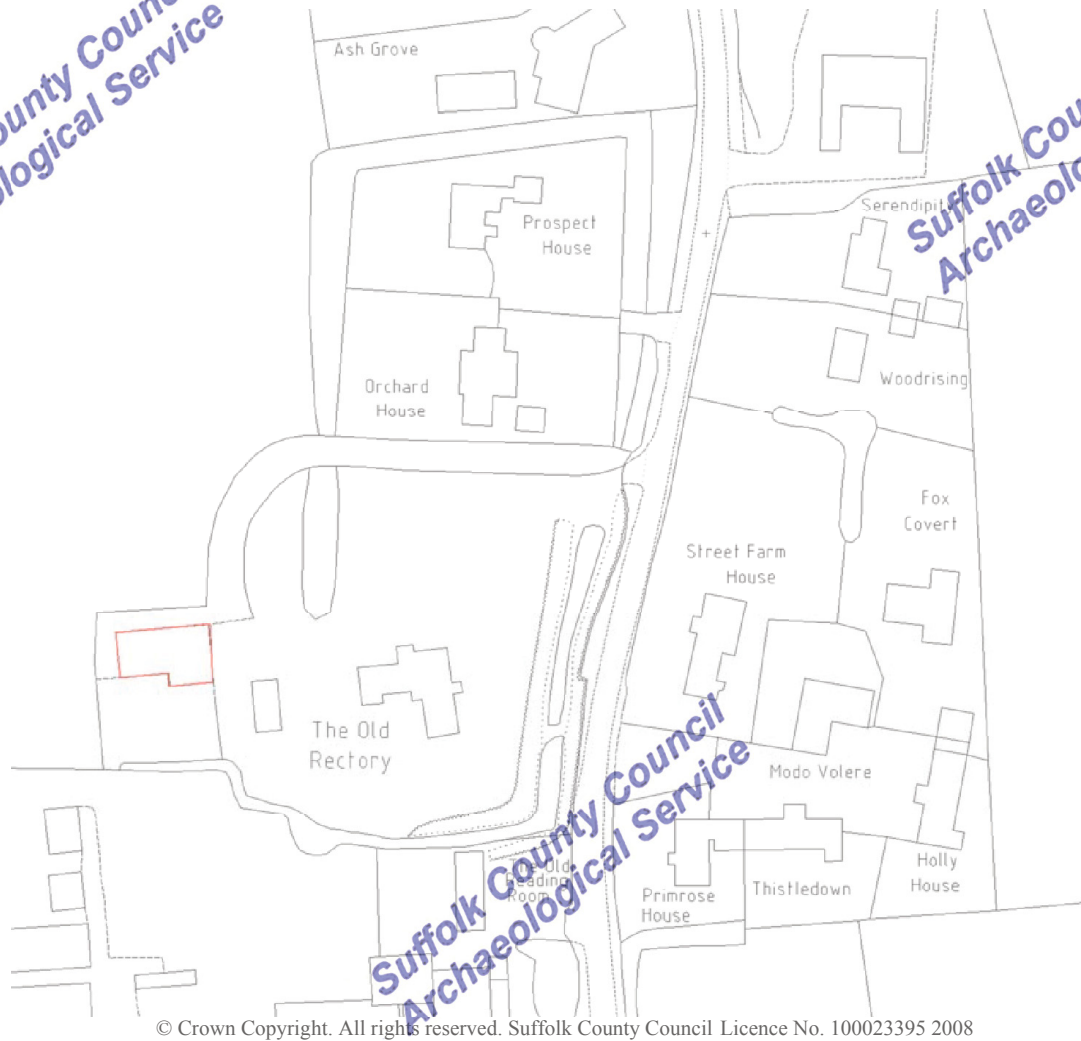
Figure 1
Existing Ordnance Survey Site Plan
Outlining the barn in red and showing the dedicated grass track which links it to the High Street

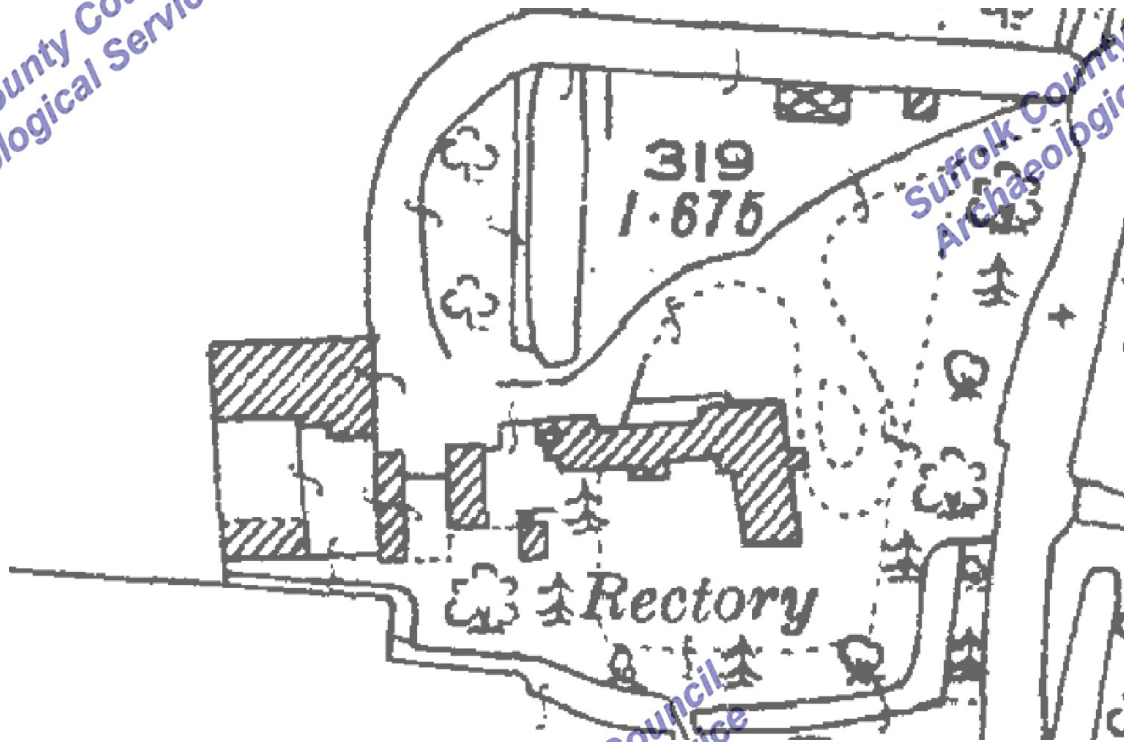
Second edition 25 inch Ordnance Survey of 1904, showing the unusual moat complex
