**Barn at Grange Farm,  
Hepworth,  
Suffolk  
HEP 028**

**Historic Building Record**

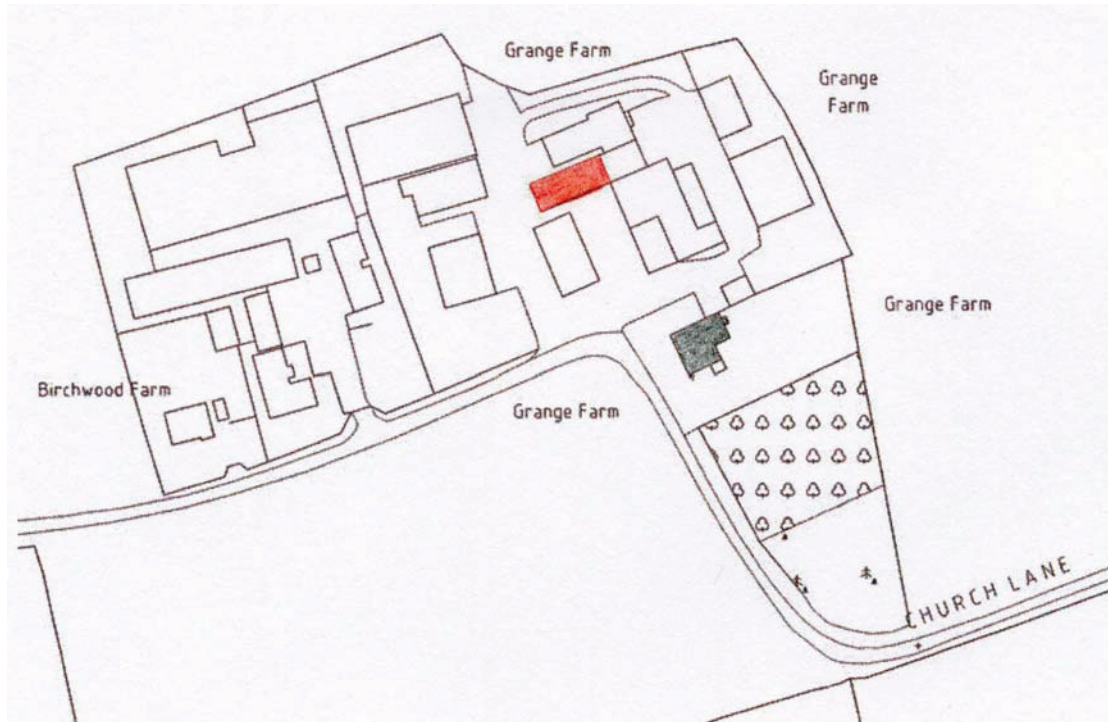
© Crown Copyright. All rights reserved. Suffolk County Council Licence No. 100023395 2008

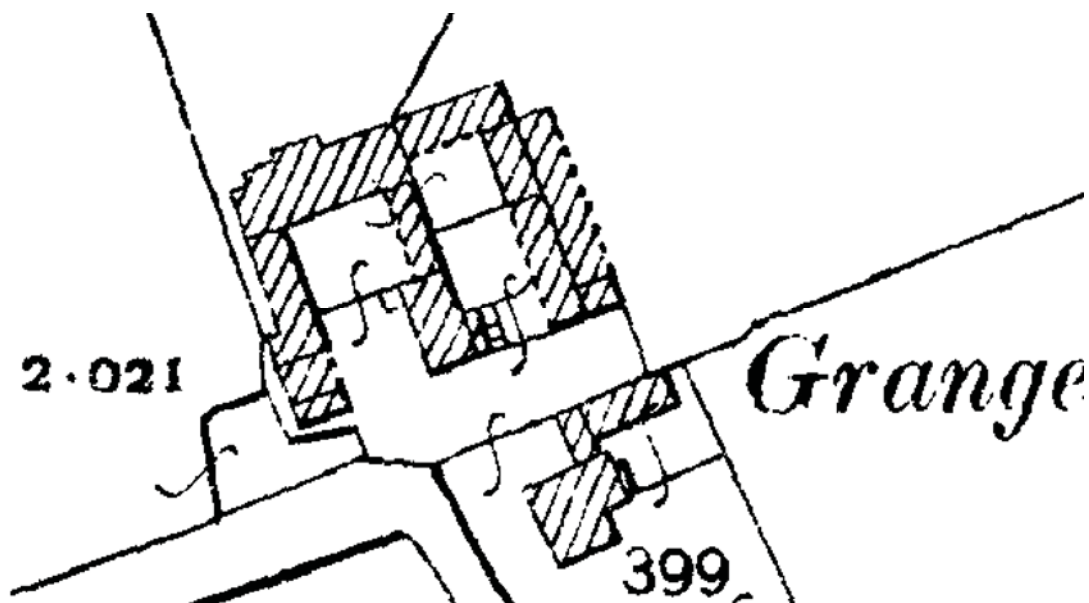
The barn is again shown with a central porch or shed to the north and a yard flanked by two sheds to the south. The eastern shed is significantly narrower, and is identified by the broken line of its western elevation as an open-sided animal shelter. Since 1845 an extensive complex of animal yards and sheds had been built to the east and south (none of which now survive), and the existing farmhouse had appeared to the south. The open-sided circular feature north of the barn was probably a horse mill.

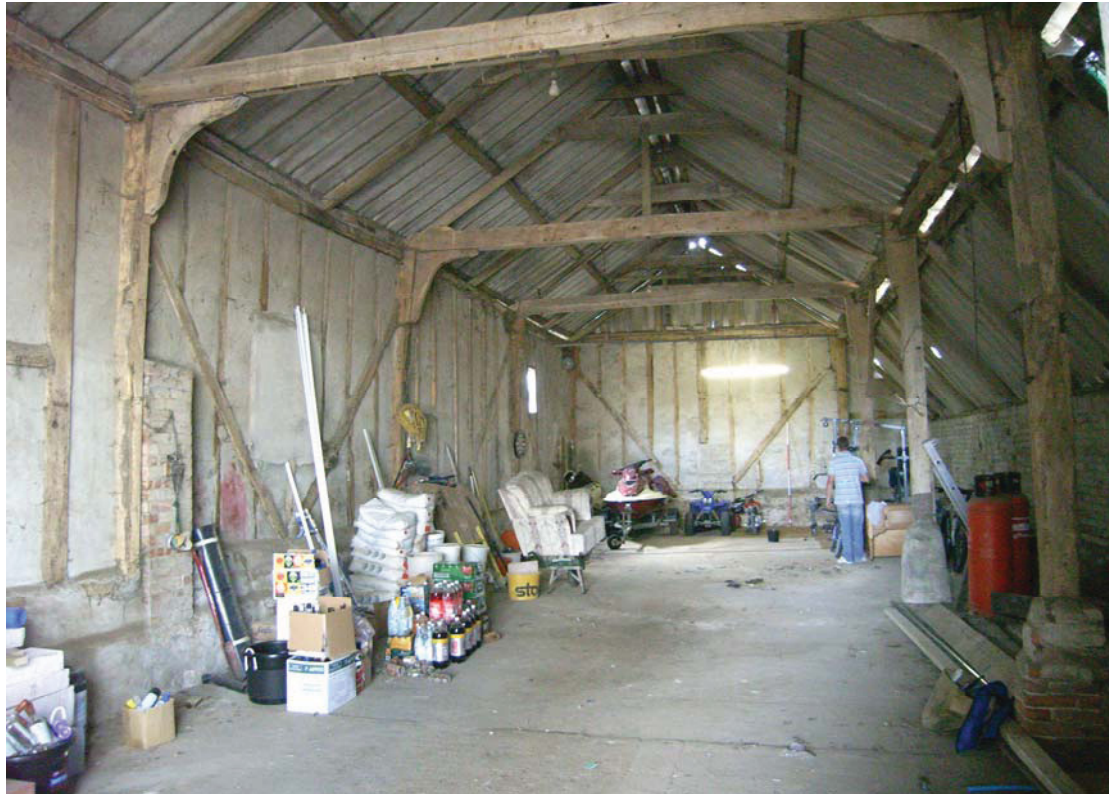
A2.5 General view of barn interior from eastern gable showing mid-20<sup>th</sup> century roof structure and the 19th century knee-braces which replaced the original arch-braces. The eastern bay in the foreground was originally partitioned as a stable as shown by empty stud mortises in the upper tie-beam

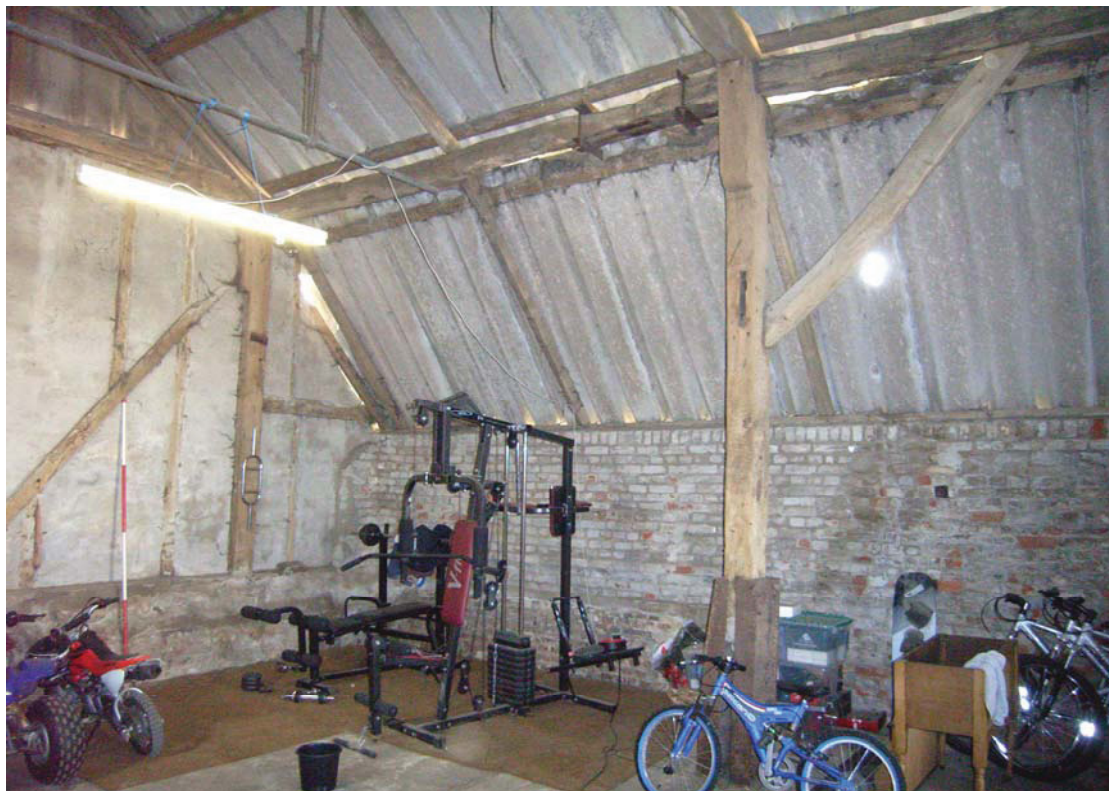
A2.6 North-west internal corner of barn showing the rebuilt rear (northern) aisle with the only original arcade brace to right
