ARCHAEOLOGICAL MONITORING REPORT

SCCAS REPORT No. 2010/002

The Chantry, Rougham
RGH 060

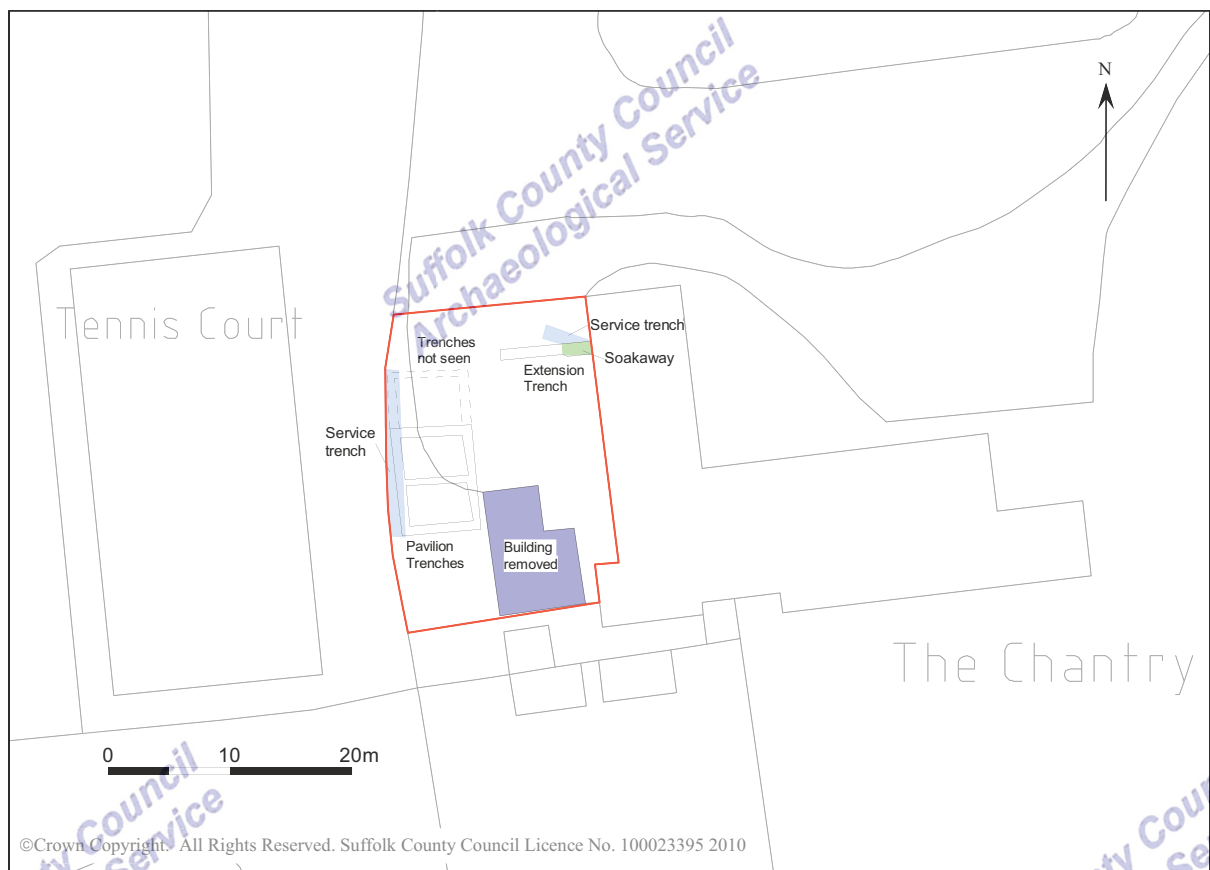
Figure 2. Location of foundation trenches

Topsoil, demolition debris and driveway surfaces were stripped over the footprint of the pavilion to the top of the subsoil. The subsoil was at approximately 73.5m OD. This layer was mid brown orange silty clay approximately 0.3m in depth. A wide north to south oriented electricity service trench was observed cutting the subsoil on the west side of the stripped area extending beyond the limit of the development area (Fig. 2).

The pavilion foundation trenches contained no archaeological features. The modern electricity service trench ran obliquely across its western side on a north to south alignment. The natural geological horizon was light bluish yellow clay with frequent small rolled chalk nodules. This was overlain by 0.3m of mid brownish orange subsoil. This had been sealed by topsoil, demolition debris and the remains of the gravel driveway which variously formed the modern ground surface. These upper layers were mechanically stripped prior to the excavation of the footing trenches.

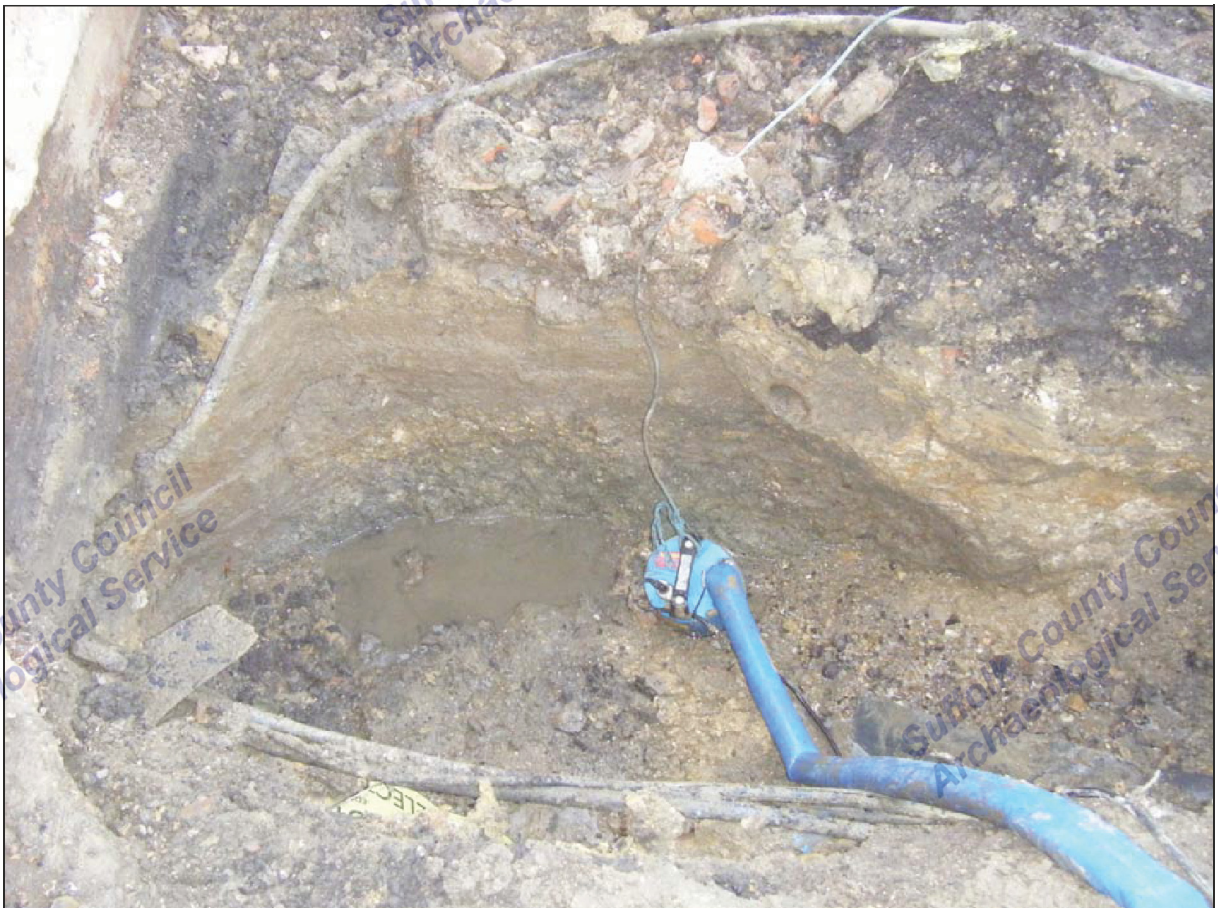
A brick-lined, possibly octagonal, soakaway was encountered at the east end of the extension foundation trench (Plate 1). It was sited immediately adjacent to the west wall of the present house. It measured 1.5m east to west and was approximately 1.25m in width north to south. It appeared to continue below the base of the foundation trench, although slumped material obscured the base of the trench. Ceramic pipes entered the feature from both the east and west sides of the foundation trench. These pipes were still active and water flooded the trench. A modern service trench entered the foundation trench from the north-west and electricity cables ran through the soakaway into the building (Plate 2).

Plate 1. Soakaway in extension foundation trench showing ceramic pipe, looking south

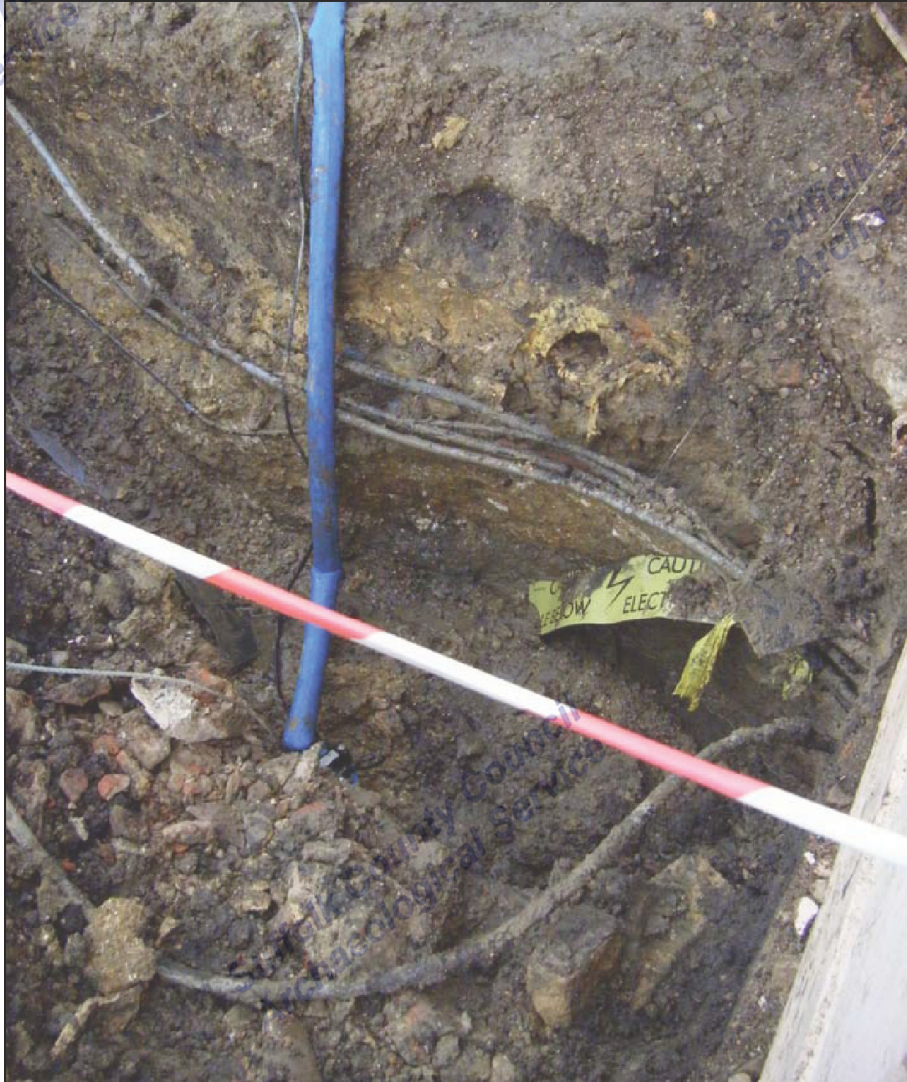
Plate 2. Service trench running into soakaway in extension foundation trench, looking north-west
