**The Farm Buildings,
Red House Farm,
Elmsett, Suffolk
ETT 020**

Historic Building Record

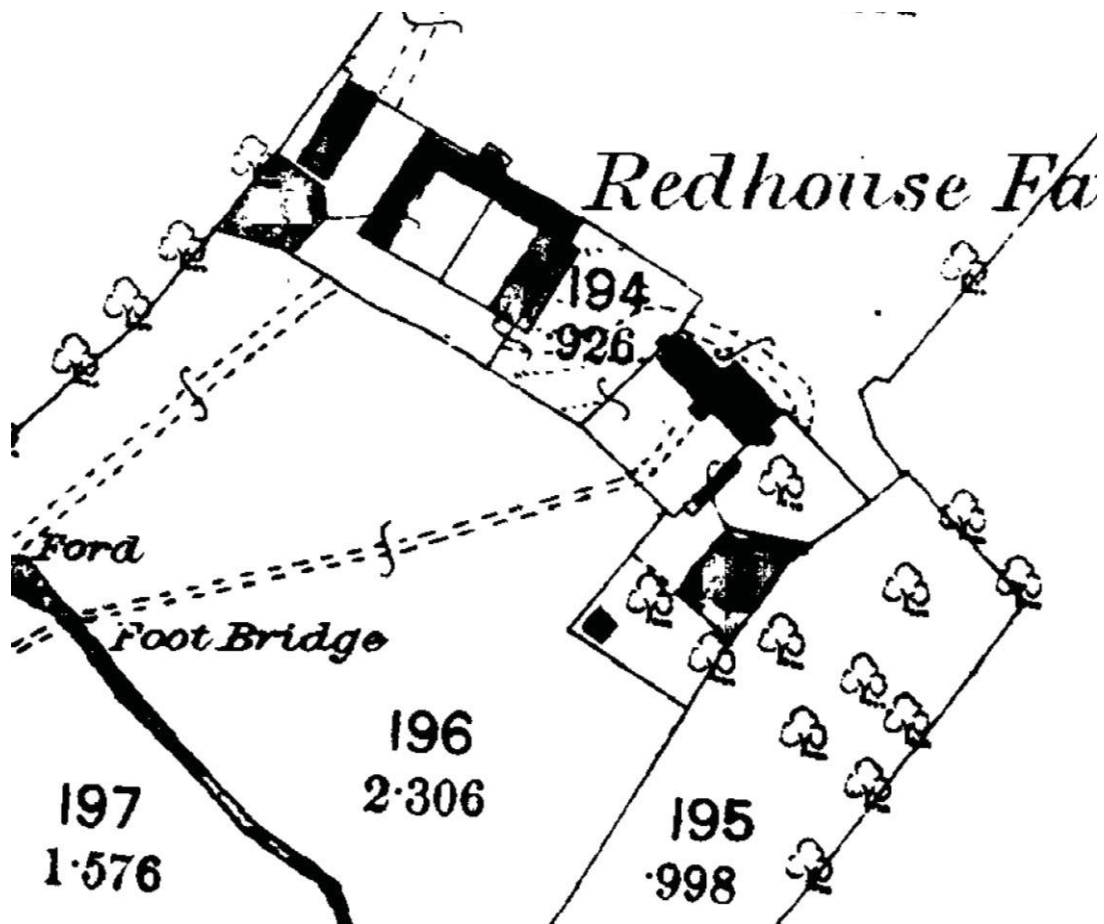
The scattered layout of the farm in 1842 was typical of the 18th and early-19th centuries and probably included a separate stable and granary. The unified yard complex shown on the first edition Ordnance Survey of 1886 reflects the mid-19th century movement towards intensive mixed animal husbandry known today as 'Victorian High Farming'. The old, inefficient disorder was swept away in favour of newly fashionable integrated farm complexes containing a barn, animal yards, stable, granary, shelter-sheds and feed-sheds in a single block. The maps of 1886, 1904 and 1926 use broken lines to indicate the new open-sided shelter sheds of the yard much as they remain today (although the yard was divided in two by a central partition which no longer survives), while a separate building adjoining the track to the west was probably a cart lodge but has been demolished.
