**Outbuilding at
Wood Farm,
Gipping, Suffolk
GPP 009**

Historic Building Record

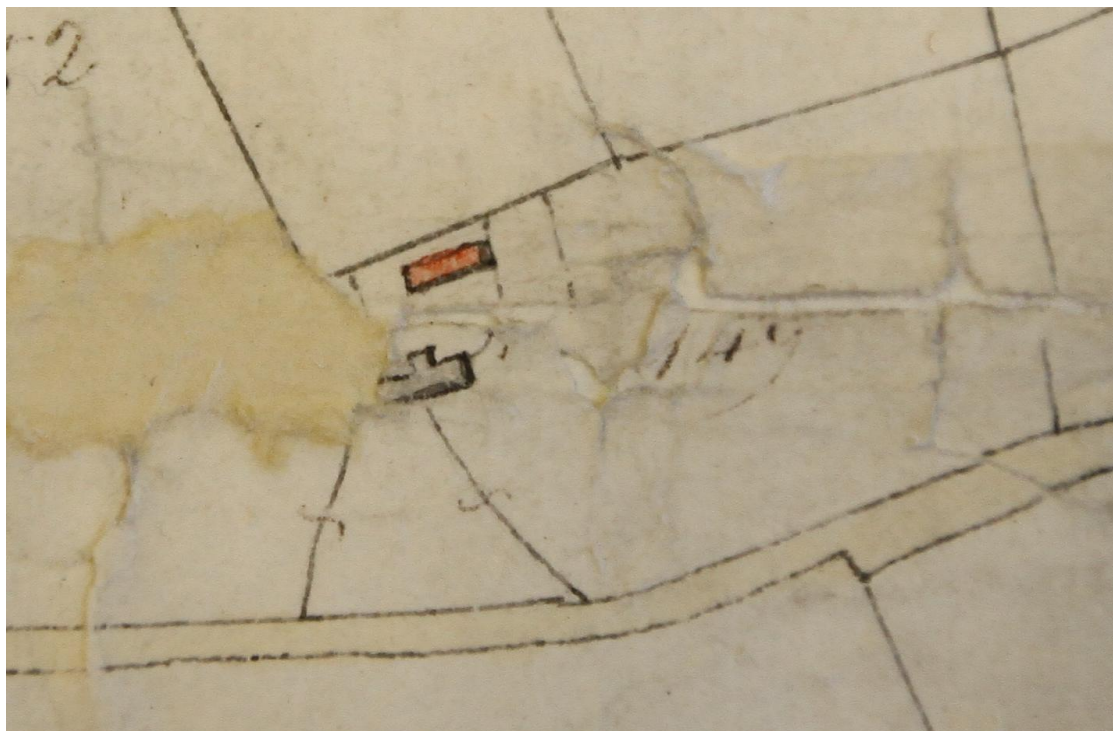
Figure 2a.
Detail of the slightly damaged 1846 tithe map showing the rectangular farmhouse in red and what appears to be a barn with a central porch to the south. The clay-lump outbuilding had not yet appeared. The linear pond to the rear of the house is also conspicuous by its absence, although smaller ponds are depicted elsewhere on the map.

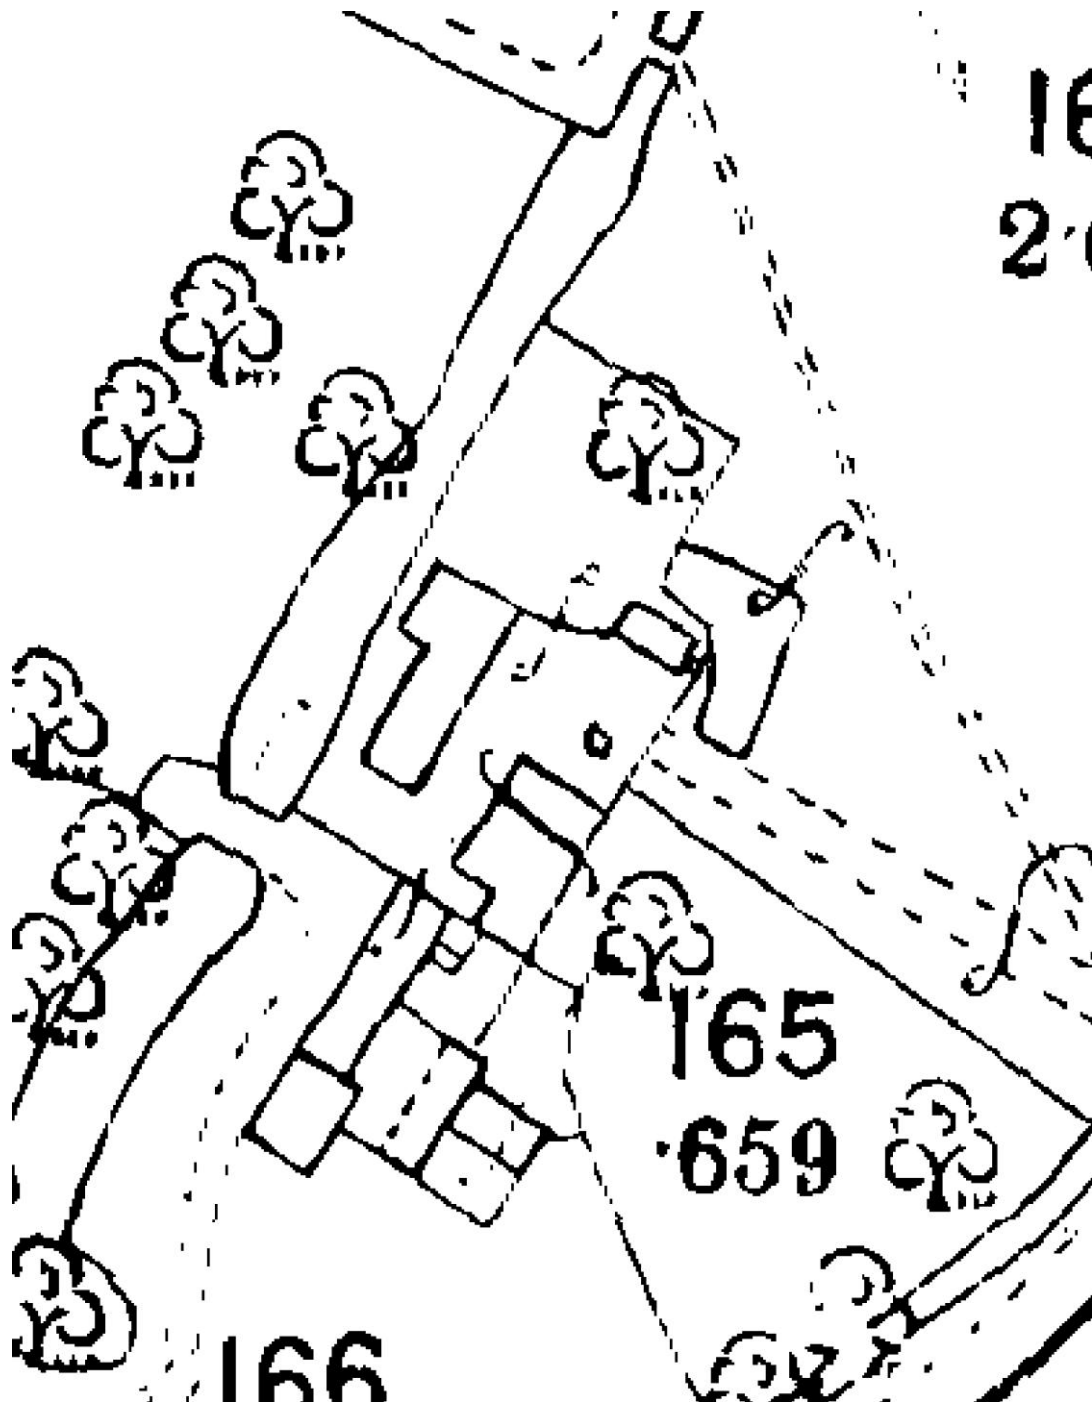
the mid-16th century but was not inspected internally for the purpose of this report. Its rear elevation abuts the linear pond, into which it has been recently extended. A group of former farm buildings to the south-west includes an ostensibly mid-19th century single-storied stable which has been newly converted but retains an original hay rack and brick manger. A new timber-framed extension designed to resemble a large weatherboarded barn now adjoins the stable and flanks the approach to the house on the south. The single-storied clay-lump outbuilding which forms the subject of this report lies on the opposite side of the same approach.

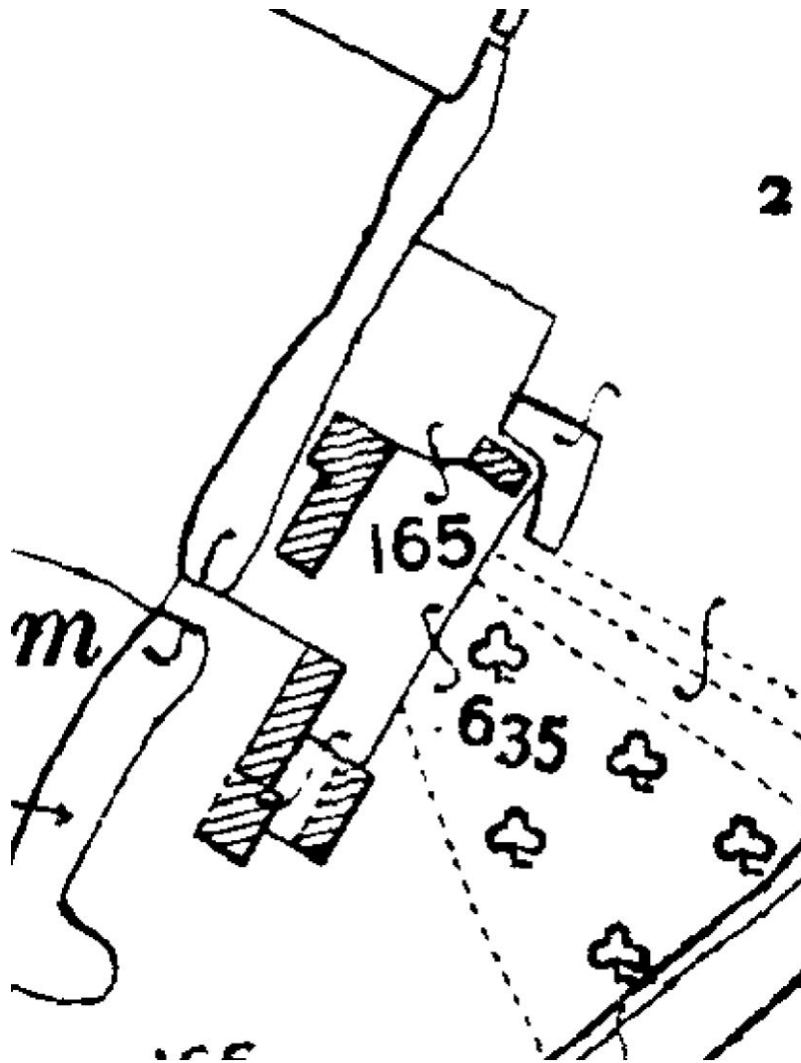
Wood Farm on the First Edition 25 inch Ordnance Survey of 1886, showing the linear pond and the present clay-lump outbuilding adjoining another L-shaped pond (the latter now indicated only by a declivity). The barn of 1846 had been replaced by a new complex of farm buildings which included the surviving stable.

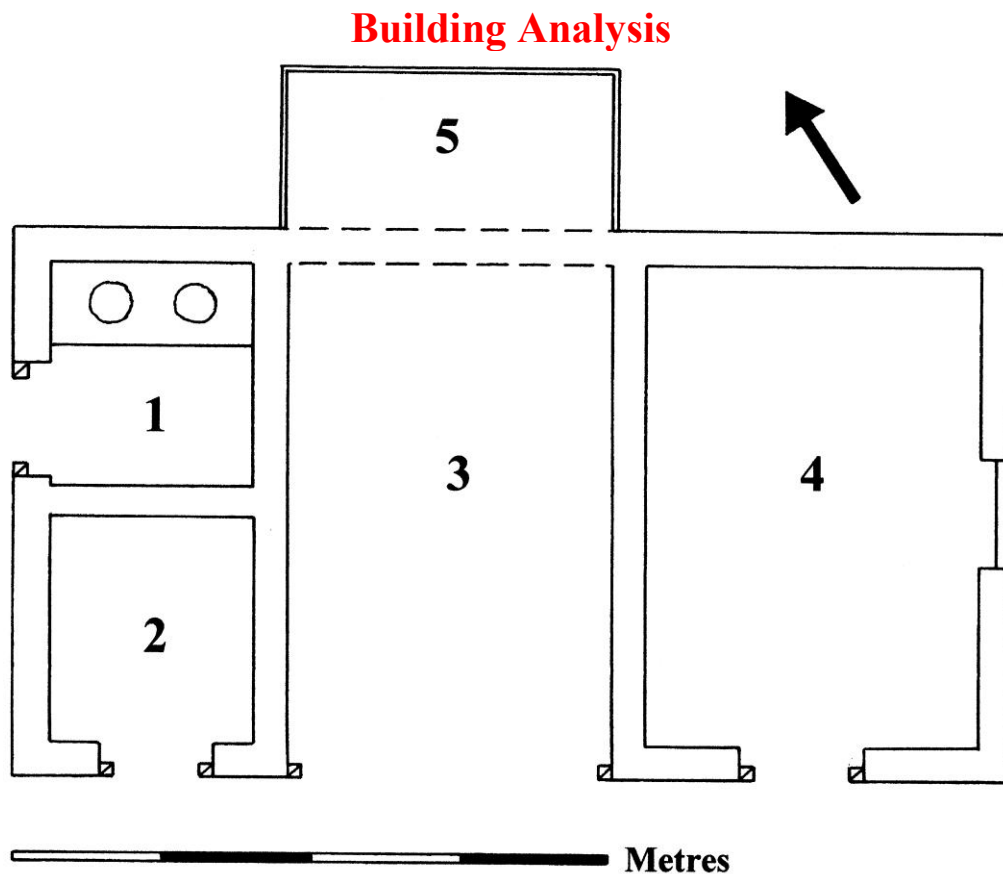
Figure 5
Block plan of the clay-lump outbuilding identifying each compartment with a number for ease of reference in the text and photographic record.

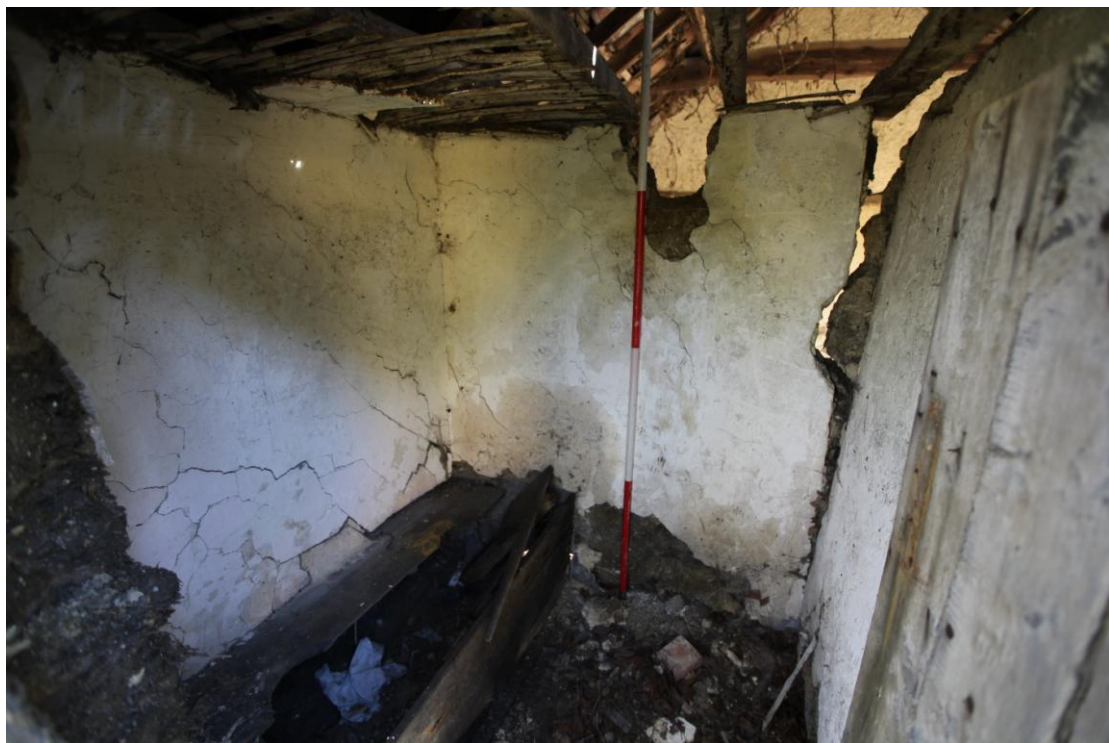
Illus. 8. The interior of the privy (1) from its western entrance showing the whitewashed walls and decayed lath-and-plaster ceiling with the remains of two chamfered circular apertures in the damaged boarded seat to the left.

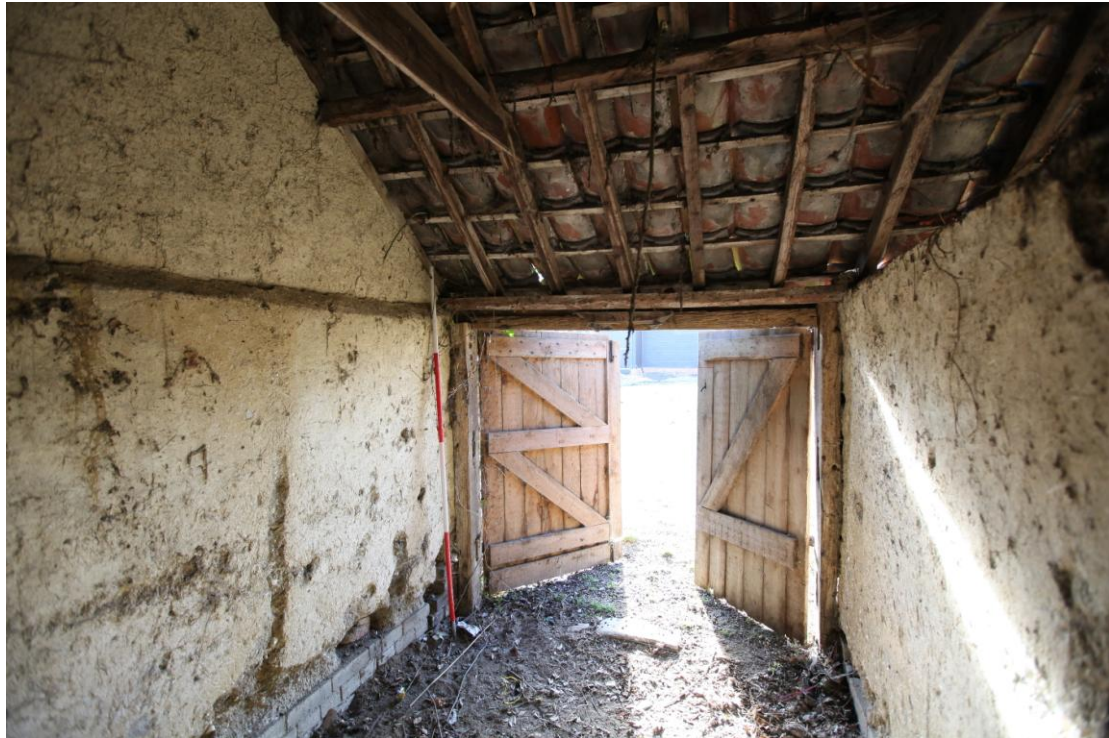
Illus. 9. The interior of the central vehicle shed (3) from the north showing the daub-rendered clay-lump internal partitions to left and right. The original jambs of the southern double-doors consist of re-used timber but the doors themselves are 20th century replacements.

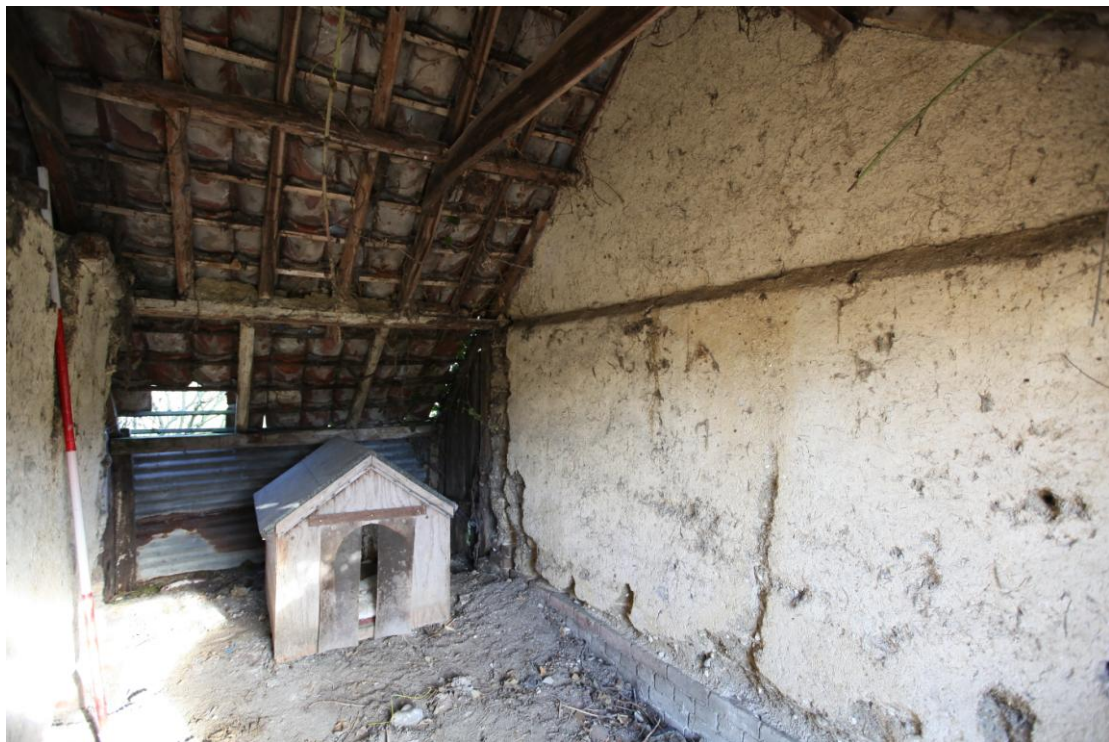
Illus. 10. The interior of the central vehicle shed (3) from its southern entrance showing the 20th century lean-to extension (5) and the position of the removed original clay-lump northern elevation.
