**An archaeological investigation by  
trial trenching at Grace Dieu  
Priory Pond, Belton, Leicestershire**

**(SK 434 182)**

Scheduled Monument No. 17074 [SMC Case No. S00086043]

**ULAS Report No 2014-155**

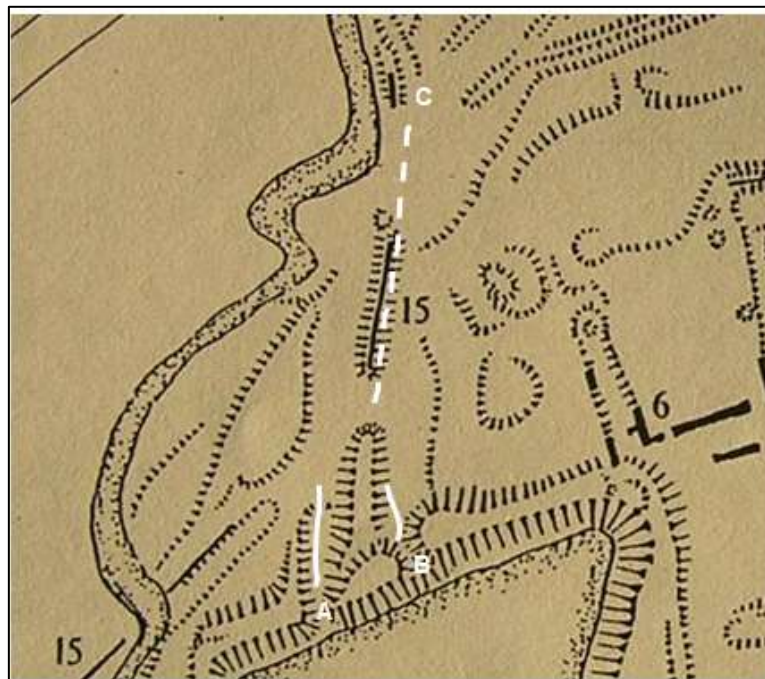
Hydrological research conducted during winter 2013 suggests that water is being lost from an historic outfall which apparently breached during a flood in 2002, destroying parts of the pond's northern retaining bank (SCWM 2014). Works are needed to repair this structure to retain water inside the pond, and also to install a spillway at a second location in order to regulate water levels.

Figure 3: Grace Dieu priory pond and outfalls A & B east of priory ruins (6).

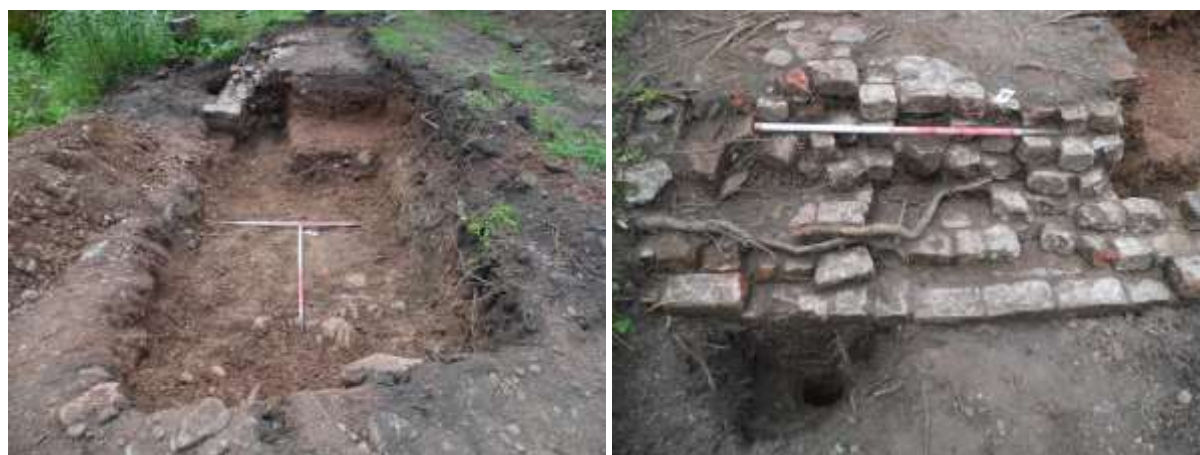
On excavation, (12) proved to form a large platform of brickwork built into or against the pond bank (Figure 6). The bricks measured c.240mm x c.120mm x c.90mm, typical of handmade late 19th-century 'Imperial' bricks, and were laid in at least sixteen courses. The platform was orientated north-east to south-west, parallel with the pond bank, and measured at least c.2.26m in length by c.1.5m, continuing beyond the trench to the south-west but appearing to stop within the trench to the north-east where the brickwork butted up against greenish-brown sandy-clay (18). The platform's core was roughly built and only partially bonded with lime mortar, also incorporating some sandstone and slate, but its south-eastern side, along the pond edge, the platform was once neatly faced, most likely using a simple 'stretcher bond' although the brickwork is now too badly damaged from bank erosion and root displacement to make this certain. No evidence was found to suggest that this platform was associated with water management and it seems more likely that it was constructed to reinforce the pond bank.

Erosion of this part of the bank may have been an ongoing issue. The north-eastern end of brickwork (12) was truncated by a large irregular cut [11] filled with layers of poorly-sorted sand and gravel (10). This appeared to have partially worked behind the platform's facing brickwork to remove part of its core before being filled with sand and gravel, which may have been imported to reinstate the pond bank. The gravel was c.1.34m thick, beneath which was firm greyish-pink clay (19) – seen at the base of a machined slot through the gravel – which is probably pond lining similar to (16) in Trench B1.

Figure 6: Left: Trench A1, looking west. Right: Brickwork (12) in Trench A1, looking north

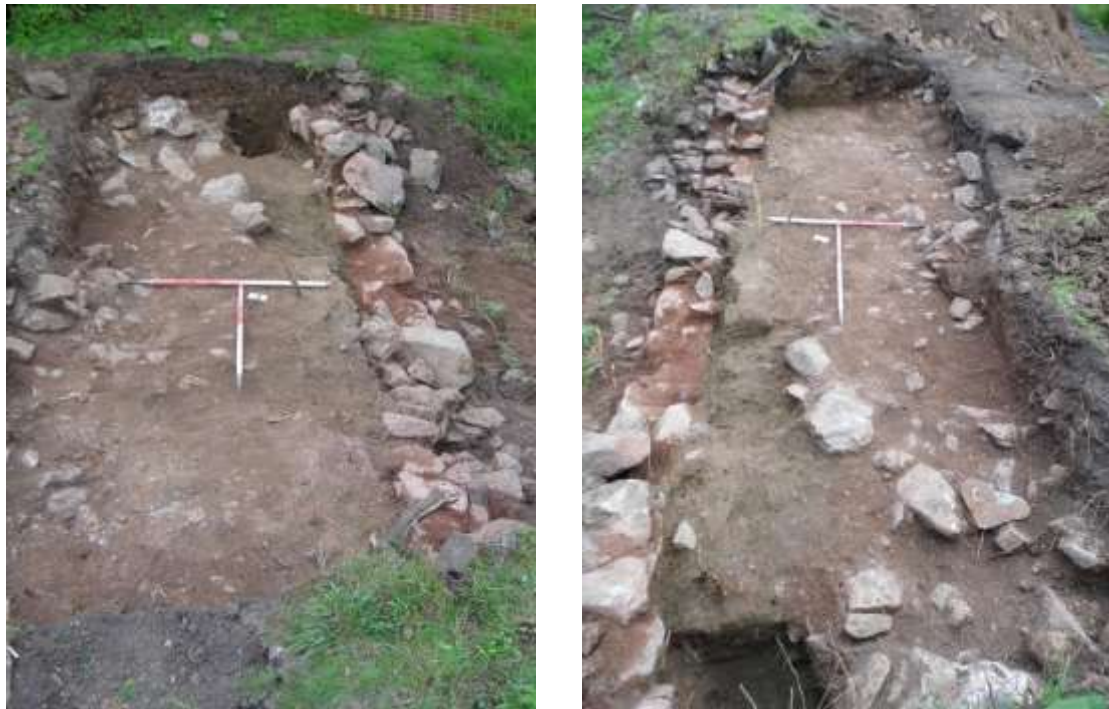
Built along the northern apex of the bank, on a north-east to south-west orientation was a narrow stone wall (5). This extended beyond the extent of the trench, was *c.*0.4m wide and still survived to a height of *c.*0.6m, with some of its upper masonry partially protruding and exposed through topsoil (1). The wall was constructed of roughly finished granite laid in crude courses and bound with pinkish-red sandy mortar. Butting up against its north face was a mixed deposit of loose building rubble and topsoil (4), forming the northern slope of the pond bank; whilst cut down the wall's southern face was a deep linear trench [3] filled with greenish-brown sandy-clay (2). This was *c.*0.4m wide and over *c.*0.75m deep and also truncated bank material (7) leaving the relationship between wall (5) and bank (7) unknown. Wall (5) had suffered badly from erosion of the pond bank

within the trench area, making it difficult to determine what it may have been originally built for but in section clay-filled trench [3] appeared to post-date it, perhaps representing a later attempt to reinforce or waterproof the wall. No clear evidence of structures associated with water management was found in this trench.

Figure 8: Left: Trench A2, looking west. Right: Trench A2, looking east

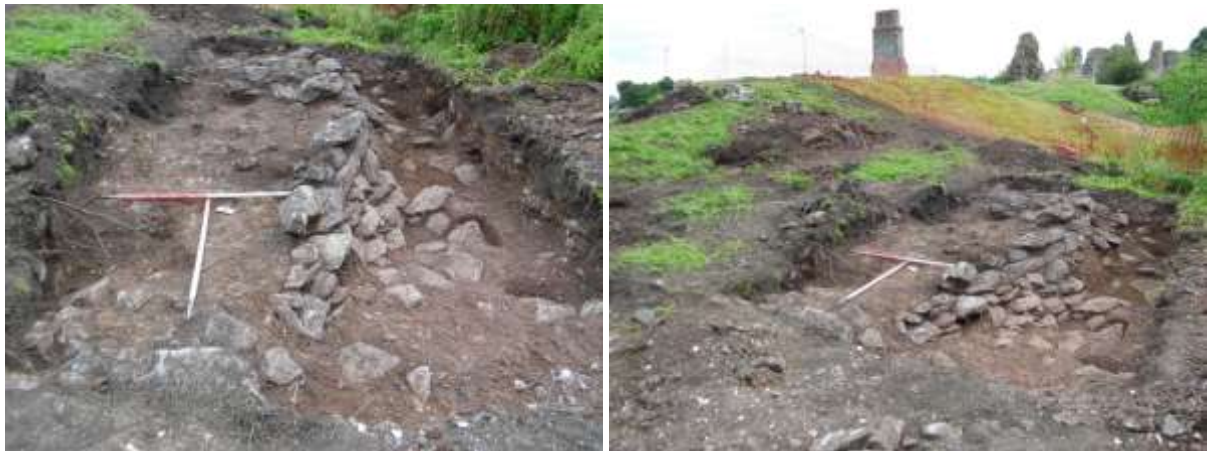
The exposed area of bank in Trench B1 (**17**) showed it to be a substantial east-west orientated linear earthwork of dark greyish-pink silty-clay mixed with frequent pebbles and large rocks (very similar to bank material (**7**) recorded in Trench A2). The bank sloped down from north to south, losing *c.*0.77m of height across the *c.*2m width of the trench. Much of this was lost in the centre of the trench where a near vertical break of slope was revetted with stonework, presumably representing the pond edge as the top of the stonework is broadly comparable with the modern pond level. The revetment was constructed from clay-bonded granite but also incorporated small quantities of sandstone, limestone and slate. In places the revetment was little more than a kerb along the top of the break in slope but in the centre of the trench it was built up in at least six rough courses of stonework creating a more solid facing. Notable, no bricks were found in bank material (**17**) and there was no evidence that the stone was recycled (no adhering mortar).

Covering the bank material at the base of the revetment was a thick layer of dark greyish-pink clay (**16**) which appeared to be pond lining. Impressed into the surface of the lining was large quantities of freshwater mussel shells which were covered with a thin layer of greyish-orange clayey-silt (**15**) mixed with domestic refuse (pottery, bone, charcoal). This was sealed beneath subsoil (**14**) and was only present 'inside' the pond along the southern edge of the trench.

A sondage cut down through the clay lining and pond bank in the south-west corner of Trench B1 discovered that there was *c.*0.4m of clay covering water-saturated alluvial sand and gravel (**18**). Little could be recorded successfully in this sondage as it flooded as soon as the clay was breached.

Figure 10: Left: Trench B1, looking east. Right: Trench B1, looking north-east

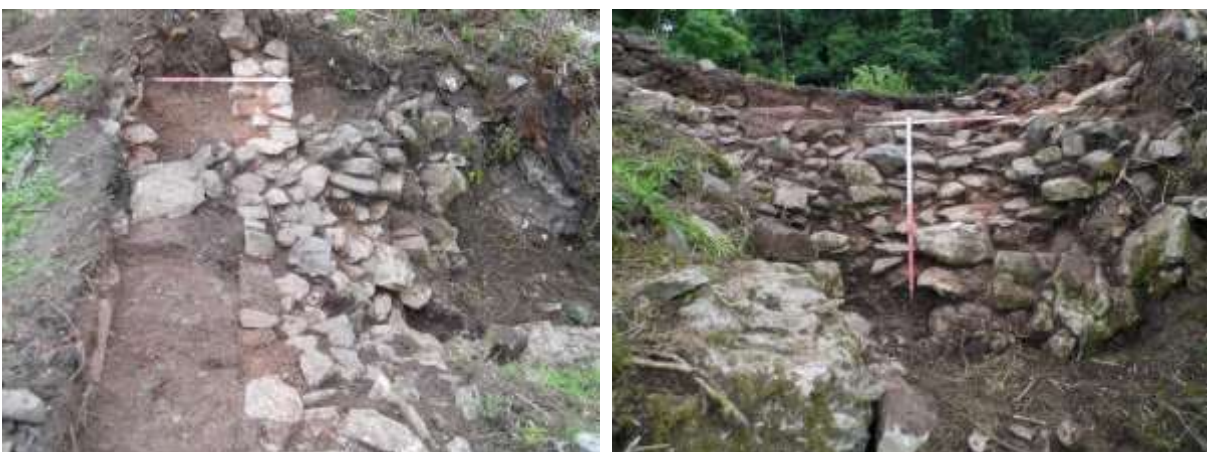
Figure 11: Left: Trench B2, looking west. Right: Trench B2, looking south

Approximately 0.1m of turf and dark grey silt topsoil (27) was removed from across the trench by mechanical digger, exposing the pond bank. Along the southern side of the trench, this was dark greyish-pink clay (26) mixed with occasional large stone fragments. Down the centre of the trench along the northern apex of the bank on a north-east to south-west orientation was a narrow stone wall (25). This extended beyond the extent of the trench, was *c.*0.45m wide and still survived to a height of *c.*0.7m, with some of its upper masonry partially protruding and exposed through topsoil (27). The wall was constructed of roughly finished granite laid in at least four crude courses and bound with pinkish-red sandy mortar. In places where the wall had been damaged or dismantled, clay (25) appeared to lie on top of the stonework. Elsewhere, the relationship between wall and clay was unclear.

To the north, excavation of the bank revealed that wall (25) was built on a massive deposit of unbonded stone rubble (24), *c.*1.89m thick, predominately comprised of granite with small quantities of slate and sandstone mixed in too. This was retained behind the remains of a substantial stone wall (21) at the foot of the bank (Figure 13). In section, this was *c.*1.2m wide constructed of granite bound with pale lime mortar. The wall was roughly

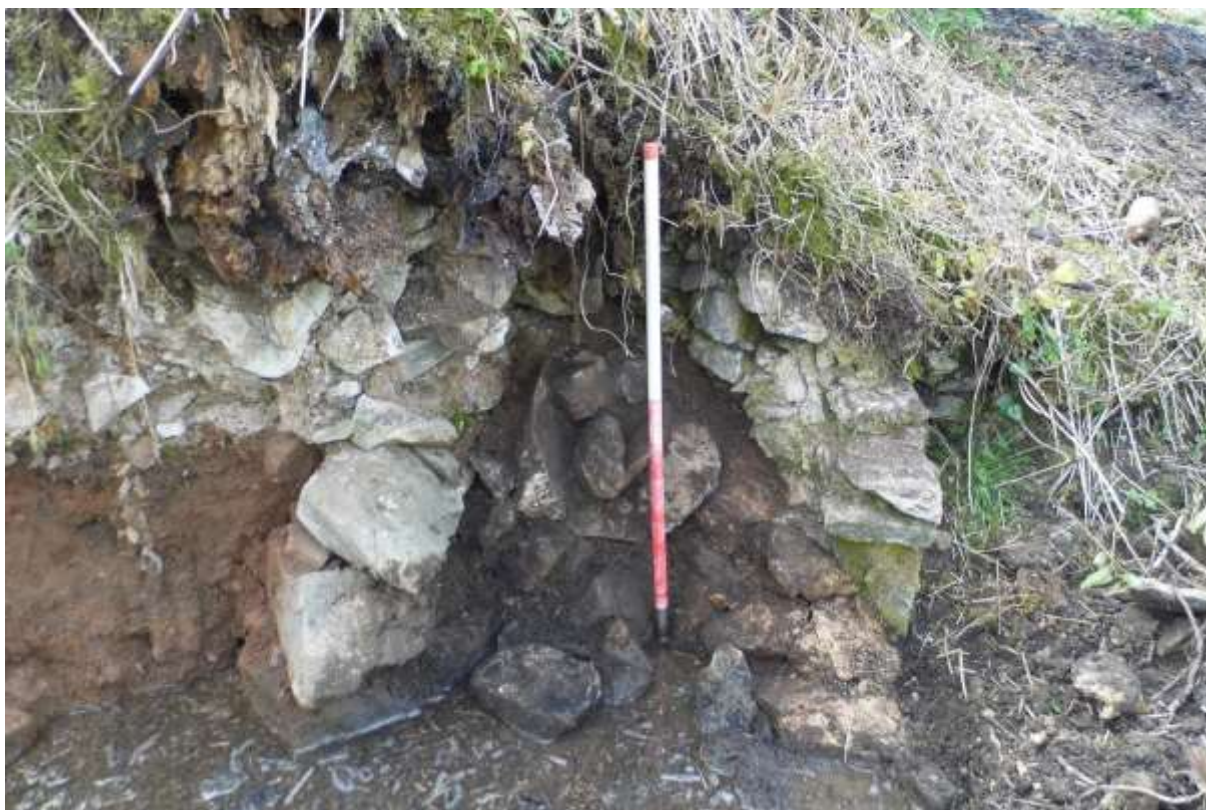
Beneath rubble (24) was a layer of orangeish-grey silty clay mixed with rubble (23) covering greyish-orange sandy clay (22). The foundation trench was wall (21) appeared to have been dug into sandy-clay (22). Investigation of the area north of the trench, adjacent to wall (21), where the bank had suffered severe erosion damage found no evidence for a culvert running beneath the bank. Rather, the rubble-filled foundation trench for wall (21) was waterlogged and as soon as its top course was cleared of soil the trench flooded.

*Figure 13: Wall (21) in Trench B2, looking west*

Overall, the pond bank appeared largely intact and in good condition in Trenches B1 and B2. Although Ground Penetrating Radar (GPR) transects carried out inside the pond in the winter of 2013 tentatively identified a subsurface outfall (SWCM 2014), possibly a narrow culvert running beneath the bank at outfall B, the 2014 excavation discovered that water loss was apparently occurring beneath the bank, not through an old culvert, but by exploiting sand and gravel beds beneath the pond and weaknesses in the internal structure of the pond bank, notably the unbonded foundation of wall (21). Measurements of the water table in Trenches B1 and B2 showed that subsurface water beneath the pond was c.0.23m higher than surface water rising outside the pond to the north. Water pressure and damaged to the pond bank from flooding in 2002 has allowed a new gravity feed spring to rise through wall foundation (21) and form outside the pond.
