An archaeological investigation (test pitting) inside St Mary's Church, Melton Mowbray, Leicestershire

For: Buttress Architects Ltd.

ULAS Report No 2014-187

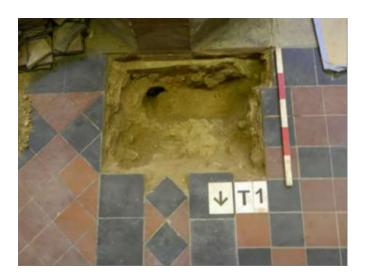
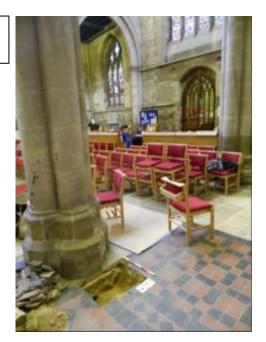
Figure 4 Test Hole 1 (below) and general location (right)

Test Hole 1 was located in the North Aisle, adjacent to the second most westerly arcade column, and measured c.0.58m x 0.46m (Figure 4). The excavation revealed that the arcade column sat directly onto the stone floor slab (c.0.07m thick) and this in turn, lay above a second limestone slab (c.0.06m thick), both presumably forming an even footing for the arcade column. Beneath the slabs was a mixed aggregate layer of limestone fragments and larger blocks within a matrix of light greyish brown mortar. A more consistent mortar deposit was revealed in the northern half of the excavated area. Both mortared layers appear to represent part of a supporting pad for the arcade column. During excavation a void appeared running beneath the column but the full scale of this hole was not able to be seen.

Test Holes 1 and 3 revealed mortared stone pads acting as solid foundations for the associated columns that sat above them. It seems likely that these are medieval in date, relating to the construction of the nave in the early 14th century and the south transept in the later 13th century. In both cases the pillar base was found to be placed directly onto the stone floor slab. The lowering of the nave floor in 1850 will have revealed this lower part of the column.

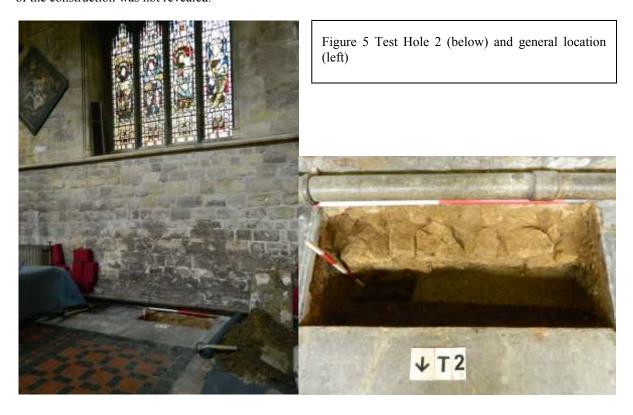
Test Hole 2 was located against the southern wall of the church in the South Aisle and was located to provide an indication of the wall foundation depth (Figure 5). The Test Hole measured $c.1.10m \times 0.56m$ and was between 0.12m and 0.45m deep.

Beneath the current floor, a levelling layer of loose, light yellowish brown mortar (between 0.08m-0.12m thick) was revealed. This overlay a mixed deposit of mid to dark greyish brown silty clay containing mortar flecks, brick/tile fragments, human bone fragments and stone pebbles. Within the confines of the Test Hole it was difficult to be too interpretive about what this layer represented but it seems likely to have been either a levelling layer supporting the floor, or infill of a construction trench for the church wall.

The stone wall foundation stepped out by approximately 0.20m at a depth of c.0.12m beneath the current floor level. The foundation consisted of a well-laid mix of ironstone and limestone blocks with occasional sandstone pieces, all bonded with a loose, silty sand mortar. A smaller sondage excavated against the wall foundation in the eastern end of the Test Hole revealed at least four courses of stonework, up to 0.30m deep however the full depth of the construction was not revealed.

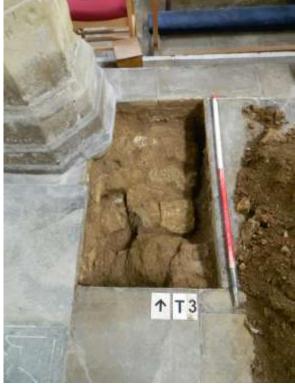
Figure 6 Test Hole 3 (left) and general location (below)

Test Hole 3 was located against the base of the north-western column in the South Transept and measured approximately $1.08 \text{m} \times 0.63 \text{m} \times \text{up}$ to 0.28 m deep (Figure 6). As with Test Hole 1 it was found that the column base was located directly onto the stone floor slab (c.0.07 m thick) of the South Transept. Below the floor slab was a c.0.10 - 0.15 m thick layer of loose and friable, greyish brown silty sandy clay mixed with mortar fragments. Underneath this was what appeared to be the south-east corner of a mortared stone pad below the column. This was similar to the deposits revealed in Test Hole 1, consisting of mixed limestone and ironstone blocks cemented together with greyish brown mortar. Clear edges to this deposit were revealed on the eastern and south sides of the test pit, suggesting that a roughly square pad of this material lies beneath this column base.

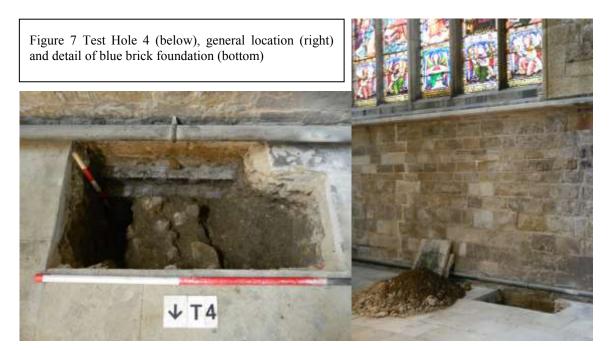
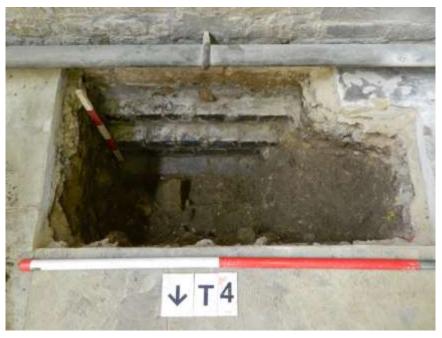
Test Hole 4 lay against the southern wall of the South Transept and measured $c.1.07m \times 0.60m \times 0.60m \times 0.30m - 0.48m$ deep (Figure 7). The main purpose of this excavation was to determine the depth of the wall foundation in this part of the church.

The stone footings of the wall continued below the level of the current floor for approximately 0.20m. Beneath the stone at least three stepped courses of blue brick were encountered, presumably relating to a later phase of underpinning. A deeper sondage in the northern part of the Test Hole showed that the brick footings carried on further than the 0.58m that was reached.

To the north of the wall footings a series of layered and intercutting deposits including possible cobbled surfaces and grave cuts may have represented *in situ* archaeological remains relating to earlier phases of the church. Within the confines of the Test Hole however, it was difficult to suggest more than this.

Wall foundations of the church were examined in Test Holes 2, 4 and 5. Stone wall footings were revealed in TH 2 in the south aisle, where stepped foundations were observed, and in TH 5. Both of these appear to be original stone footings. In TH 4, adjacent to the southern wall of the south transept, brick footings were uncovered. These were clearly a later addition and presumably relate to an episode of underpinning in 19th century, perhaps part of the work undertaken by G.G. Scott, which included the transepts, between 1865-9 (Pevsner 1984, 318).

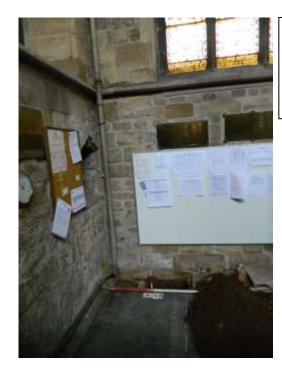
Figure 8 Test Hole 5 general location (left), detail of foundation (below) and detail of in situ human remains (bottom)

Test Hole 5 was located in the north-east corner of the church, in the Clergy & Wardens Vestry and measured $c.1.08 \text{m} \times 0.42 \text{m} \times 0.42 \text{m} \times 0.40 \text{m}$ deep (Figure 8). Some disturbance in the extreme NE corner had been caused by installation of a service pipe but the southerly 0.80m was adequate to reveal what lay beneath the floor and show the foundations to the wall in this area.

Below the stone floor slabs in this room was a c.0.30m thick layer of very loose, mid greyish-brown silty sandy clay. Below this depth the soil became more compact for the next c.0.10m that was revealed. Within the firmer soil on the western side of the excavated area a human skull was revealed that may have been *in situ*. Although slightly disturbed the skull was facing eastwards and had its lower jaw present, suggesting it had not been moved. It is possible that this represents an earlier burial that had been truncated by the construction of the eastern church wall.

The excavation revealed stone wall footings below the floor level to the full depth of the Test Hole, indicating that the wall foundations carried on beyond the depth of the Test Hole. The soil nearest to the wall footings maintained a fairly loose consistency for the full depth of the excavation, which may coincide with a construction trench for the eastern wall of the church, but this was not entirely clear

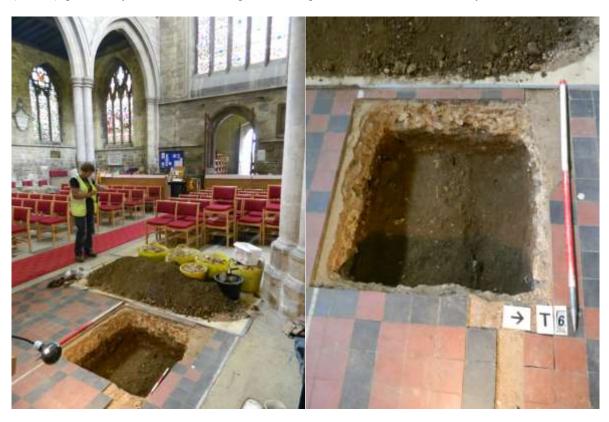
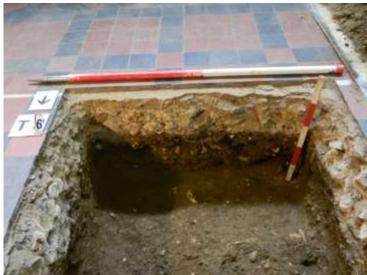
Figure 9 Test Hole 6 general location (above left), details of soil layers and human burial (above right) and detail of possible charnel pit (left)

Test Hole 6 was located on the northern side of the Nave, between the second and third arcade columns from the west and measured c.1 m x 1 m x 0.44 m deep (Figure 9). The location of this excavation was intended to examine the cause of floor sinking in this part of the church.

Below the current floor tiles was a mixed aggregate make-up layer of light yellowish brown mortar, limestone & slate fragments (c.0.20m thick). Underneath this the remainder of the trench consisted of a mixed 'fill' layer of mid greyish-brown silty sandy clay (c.0.44m thick) containing loose human bone, two ceramic floor tiles and a fragment of stained window glass. Disturbed human remains lying in the centre of the Test Hole probably represent an *in situ* burial that was affected by the earlier phase of floor lowering. To either side of this were looser areas, possibly indicating filled pits. At least one of these had been used to re-bury loose human bones (charnel), presumably also disturbed during the lowering of the floor in the 19th century.

Finally Test Hole 6, in the nave, revealed archaeological layers approximately 0.40m below the present floor level. *In situ* human remains, although slightly disturbed as a result of the 1850 floor lowering, provided an indication that further burials may have survived the Victorian renovation at a relatively shallow depth. Probable charnel pits to either side of the burial however, also indicate that some graves will have been disturbed during the renovation, and the bones re-interred within the purposefully dug pits.

No evidence of subsidence in the substrata was observed in this area and the layer of hardcore beneath the floor appeared compact and stable. It is possible that the cause of the structural damage was damp getting between the floor tiles and underlying hardcore, and lifting the tiles up, or that the tiles were laid too tightly together with little room for flexibility.
