Archaeological Attendance and Recording during groundworks at Cedar lawns, Church Road, Burbage, Leicestershire LE10 2DE NGR SP 44252 92690

Claire LaCombe Report No 2017-198 ©2017

#### ULAS Report Number 2017-198

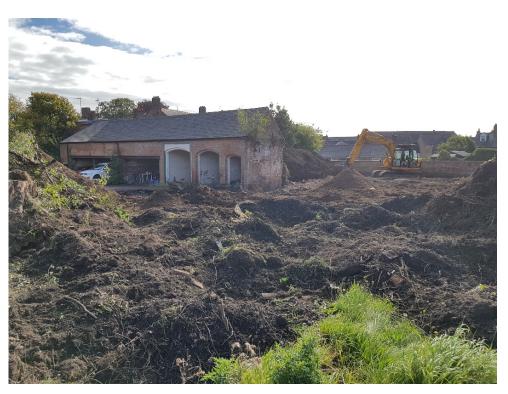
Figure 3. Visit 1, Looking from the north western corner of the site in a south easterly direction. Photograph shows some of the garden area has remained untouched.

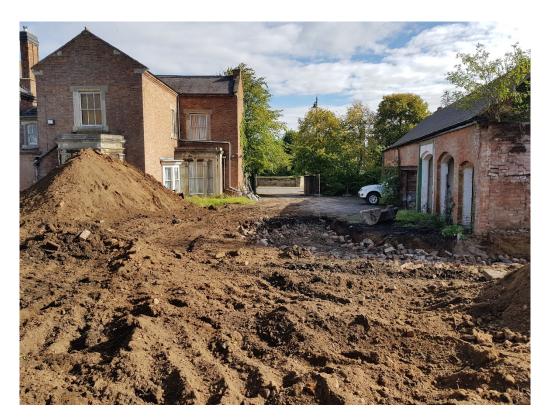
On Arrival it was noted that the area planned for vehicular access had already been excavated and was being filled with hard-core rubble. The area stretched from the south eastern boundary where there are planned car-parking spaces (Fig. 5), to the centre of the site (Fig. 6) turning towards the front entrance (Fig. 4). As a result, I was unable to monitor the excavation of this area of the site.

Figure 4: Visit 1. Looking east towards the front entrance. The area which had been excavated and filled with hard-core rubble is visible.

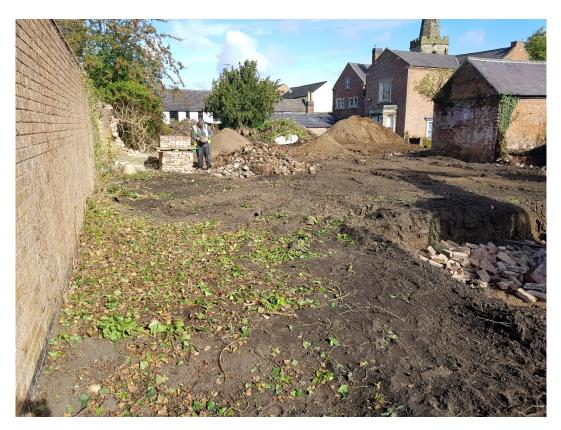
Figure 5: Visit 1. Looking along the North-western boundary from the southernmost point. The area of excavated land filled with hard-core rubble is visible to the right of the picture.

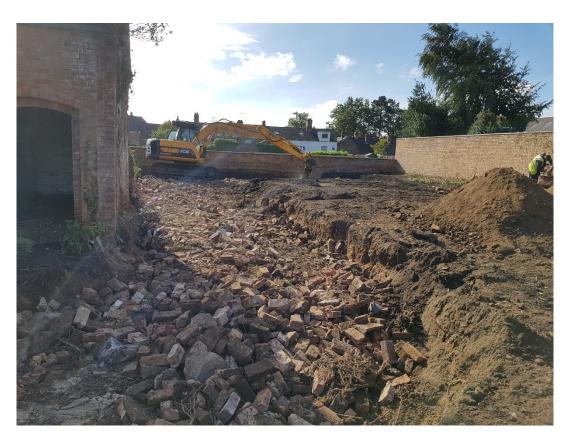
Figure 6: Visit 1. Looking south from the centre of the site at the excavated and filled area.

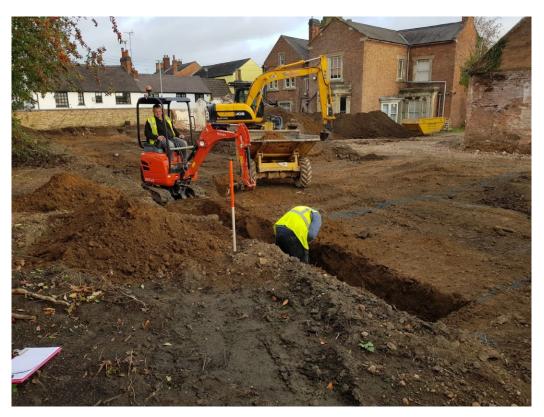
Excavation began along the south western wall line of plot 2 (Fig. 7) and continued in a northerly direction along plots 3 and 4 (Fig. 8). The ground was excavated initially with a Kubota digger with a 500mm toothed bucket and then as the day progressed and the ground got harder to the north, it was changed to a 360 JCB with a 500mm / 1m toothed bucket. Excavation continued across the northern extent of the plan, and then to the south. The area for plot 2 (Fig. 10) was excavated towards the end of the day at the south end of the site. No archaeology was discovered in any of the foundation trenches that were excavated, and there were no finds.

Figure 7: Visit 2. Work began excavating the trenches for the foundations on the marked out areas. The ground proved to be very hard in places.

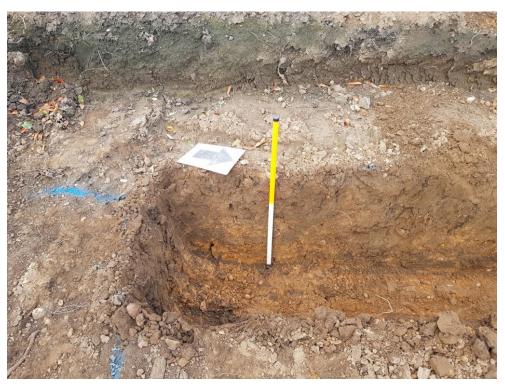
Figure 8: Visit 2. Excavation of the foundation trenches began at plot 2.

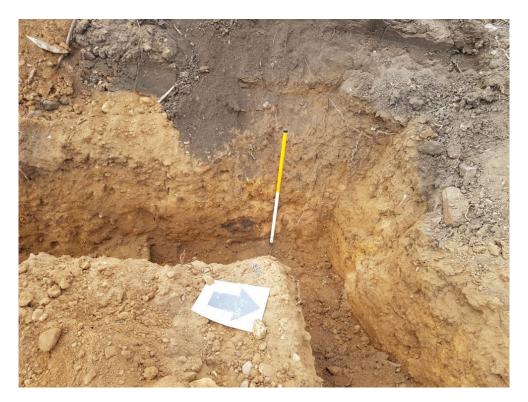
Figure 9: Visit 2. Depth of the trench at the north western corner of plot 4, the deepest part of the site.

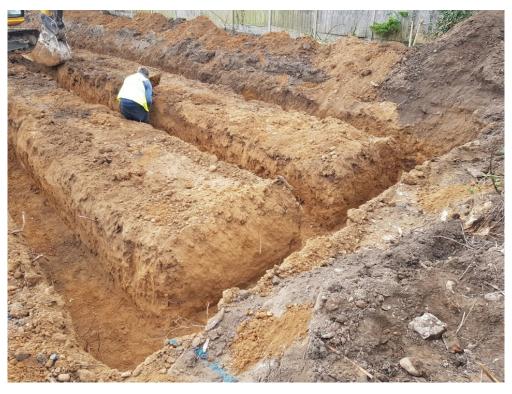
Figure 10: Visit 2. Excavation completed at the northern side of the site (Plot 3/4).

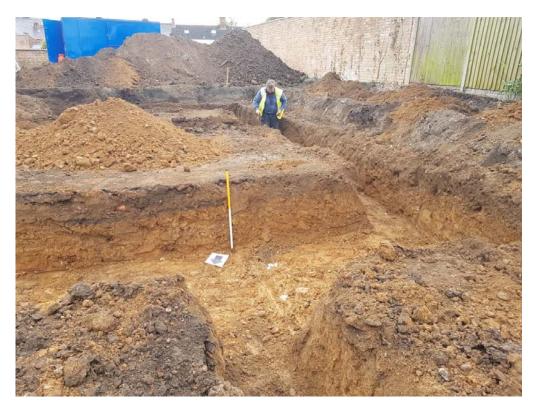
Figure 11: Visit 2. Excavation complete at the southern part of the site (plot 2).
