**An Archaeological Watching Brief during
Reconstruction of the Bottom Basin Walkway
at Foxton Inclined Plane, Leicestershire
(SP 69230 89590, Centre).**

Gerwyn Richards and Matthew Beamish

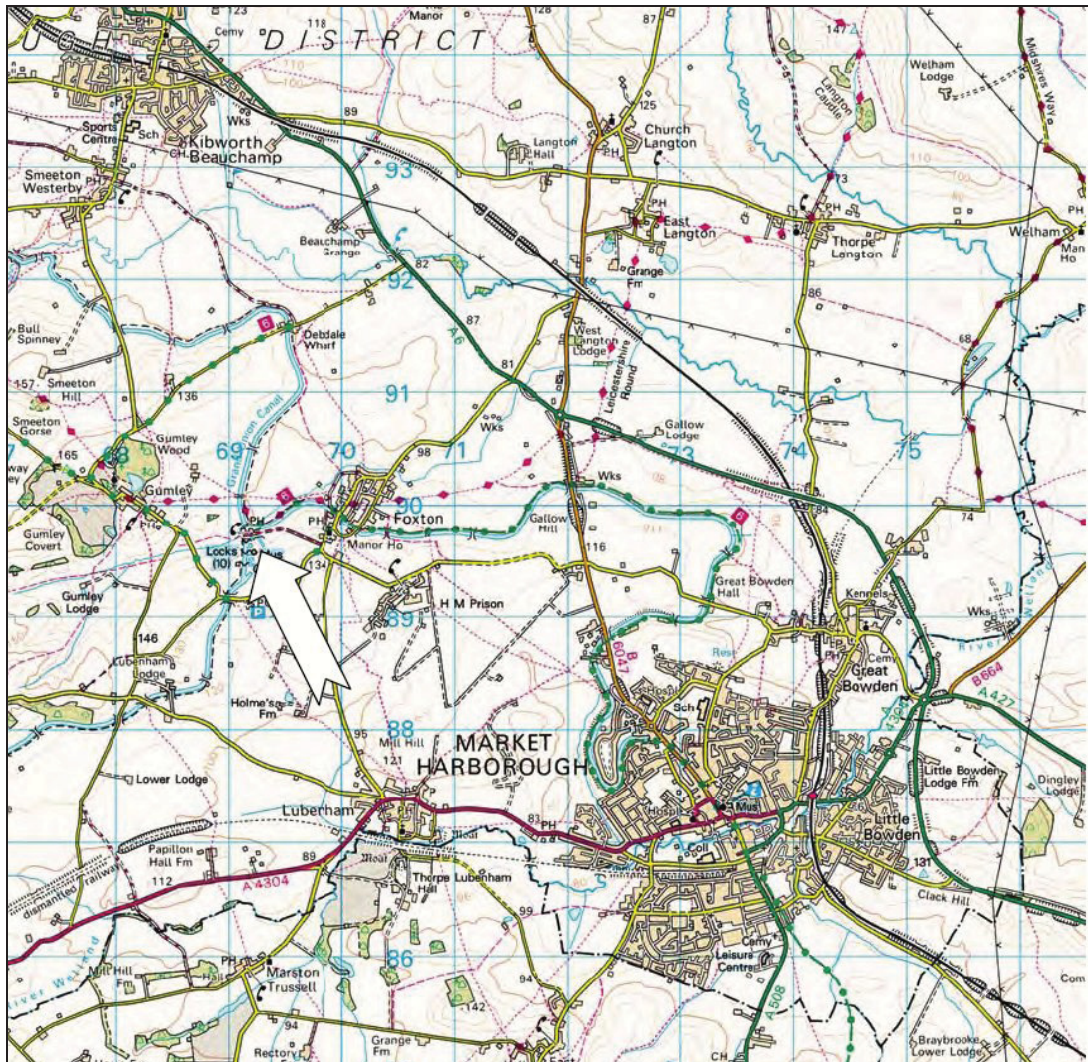
Figure 1: Site location Scale 1:50000

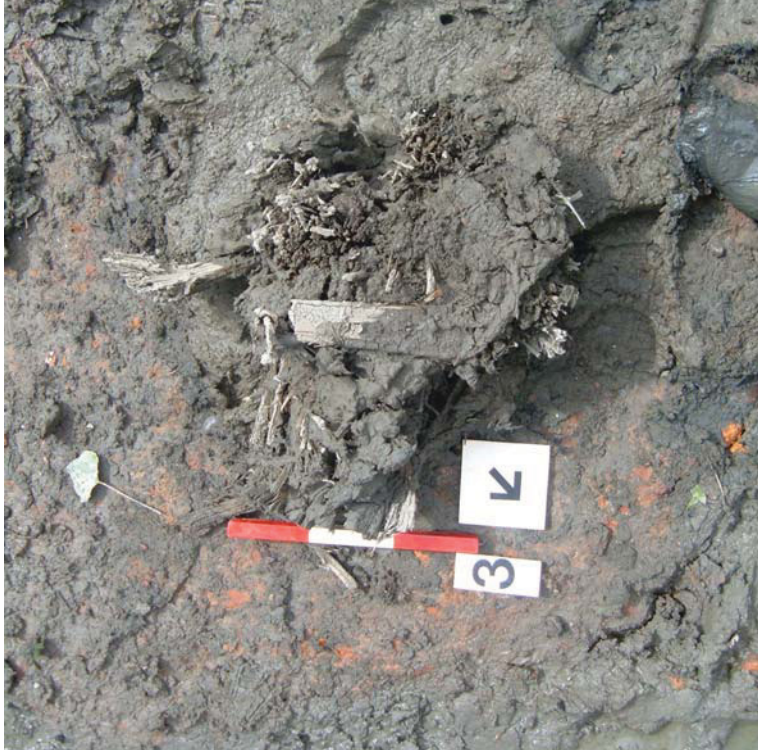
Figure 6: Condition of post 3. The timber has been badly damaged after being shortened. Part of the brick rubble and concrete plinth is visible.

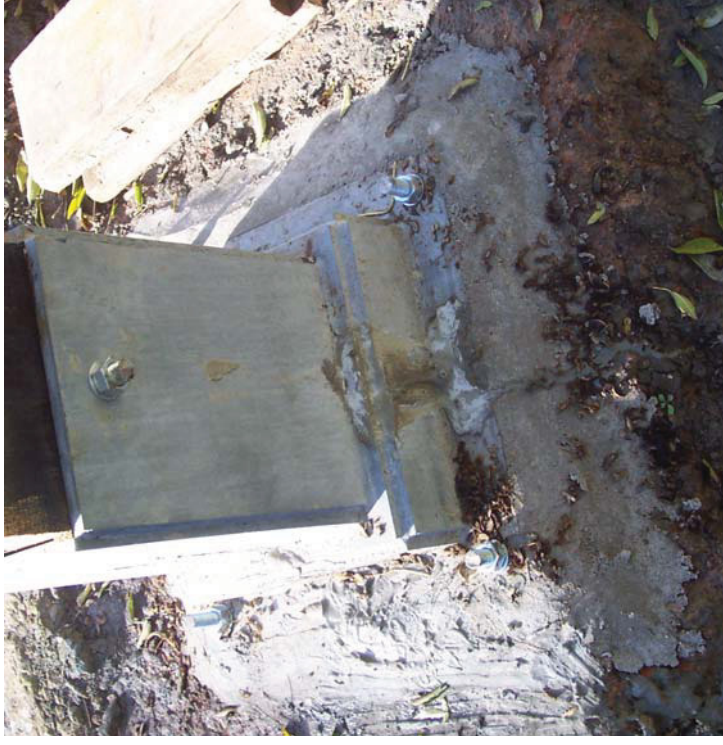
Figure 7: Custom steel collar in position above existing post. The base of the collar has been located over the existing post and a flange tied down with studding in a concrete bed (Photo: Stuart Johnson, Morrison Construction).

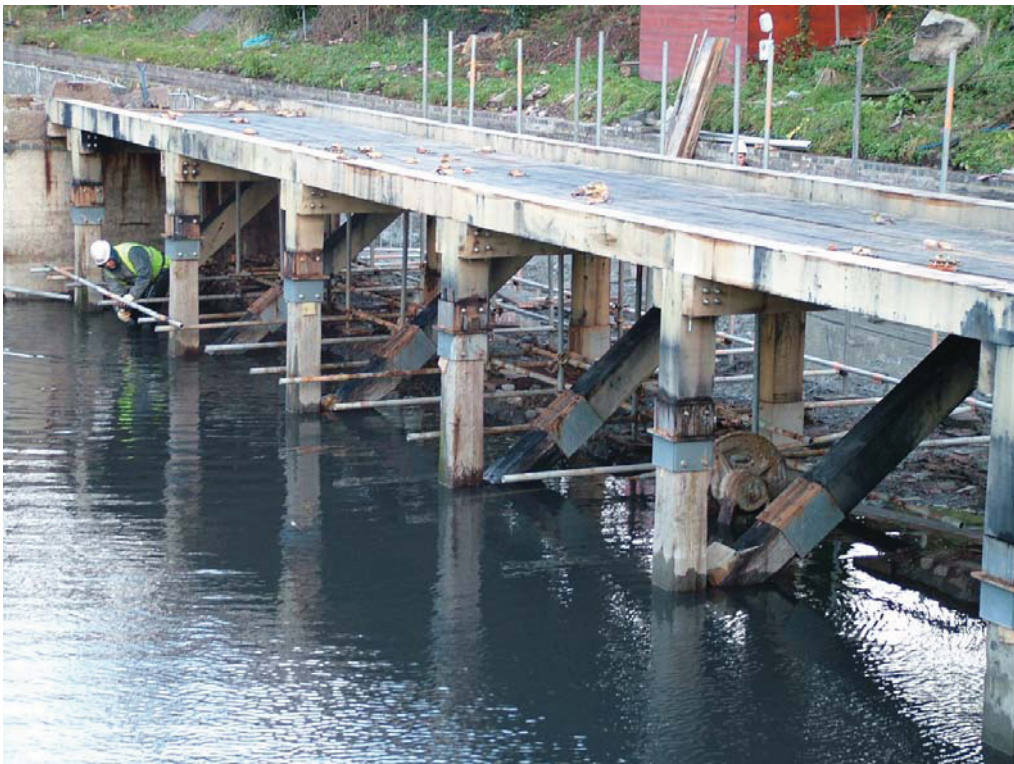
Figure 13: Completed structural restoration from south. The vertical iron wheel sits to the north of the wheel pit.

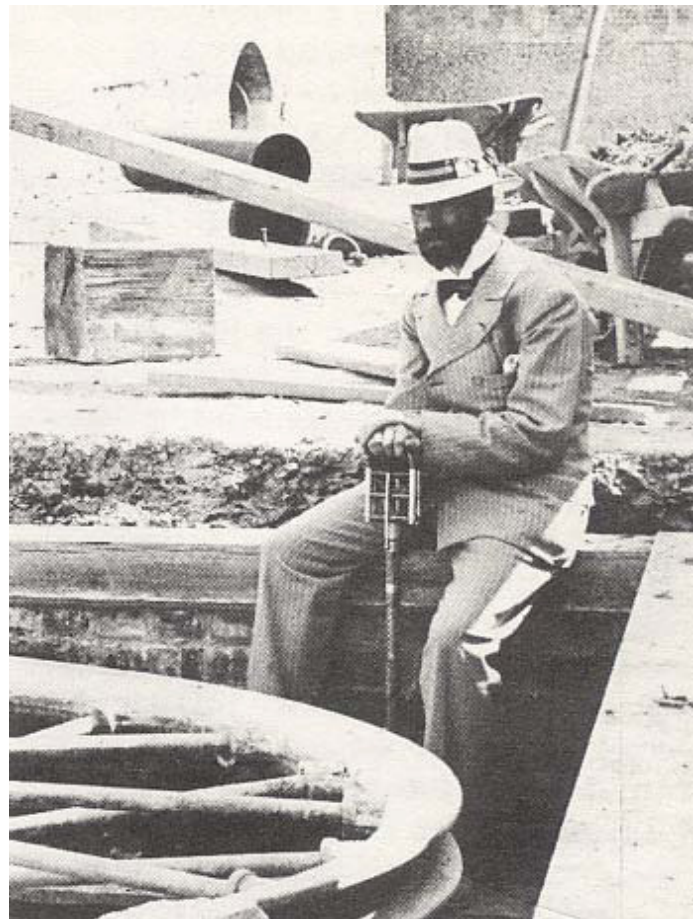
Figure 14: Gordon Cale Thomas sat within the wheel-pit.

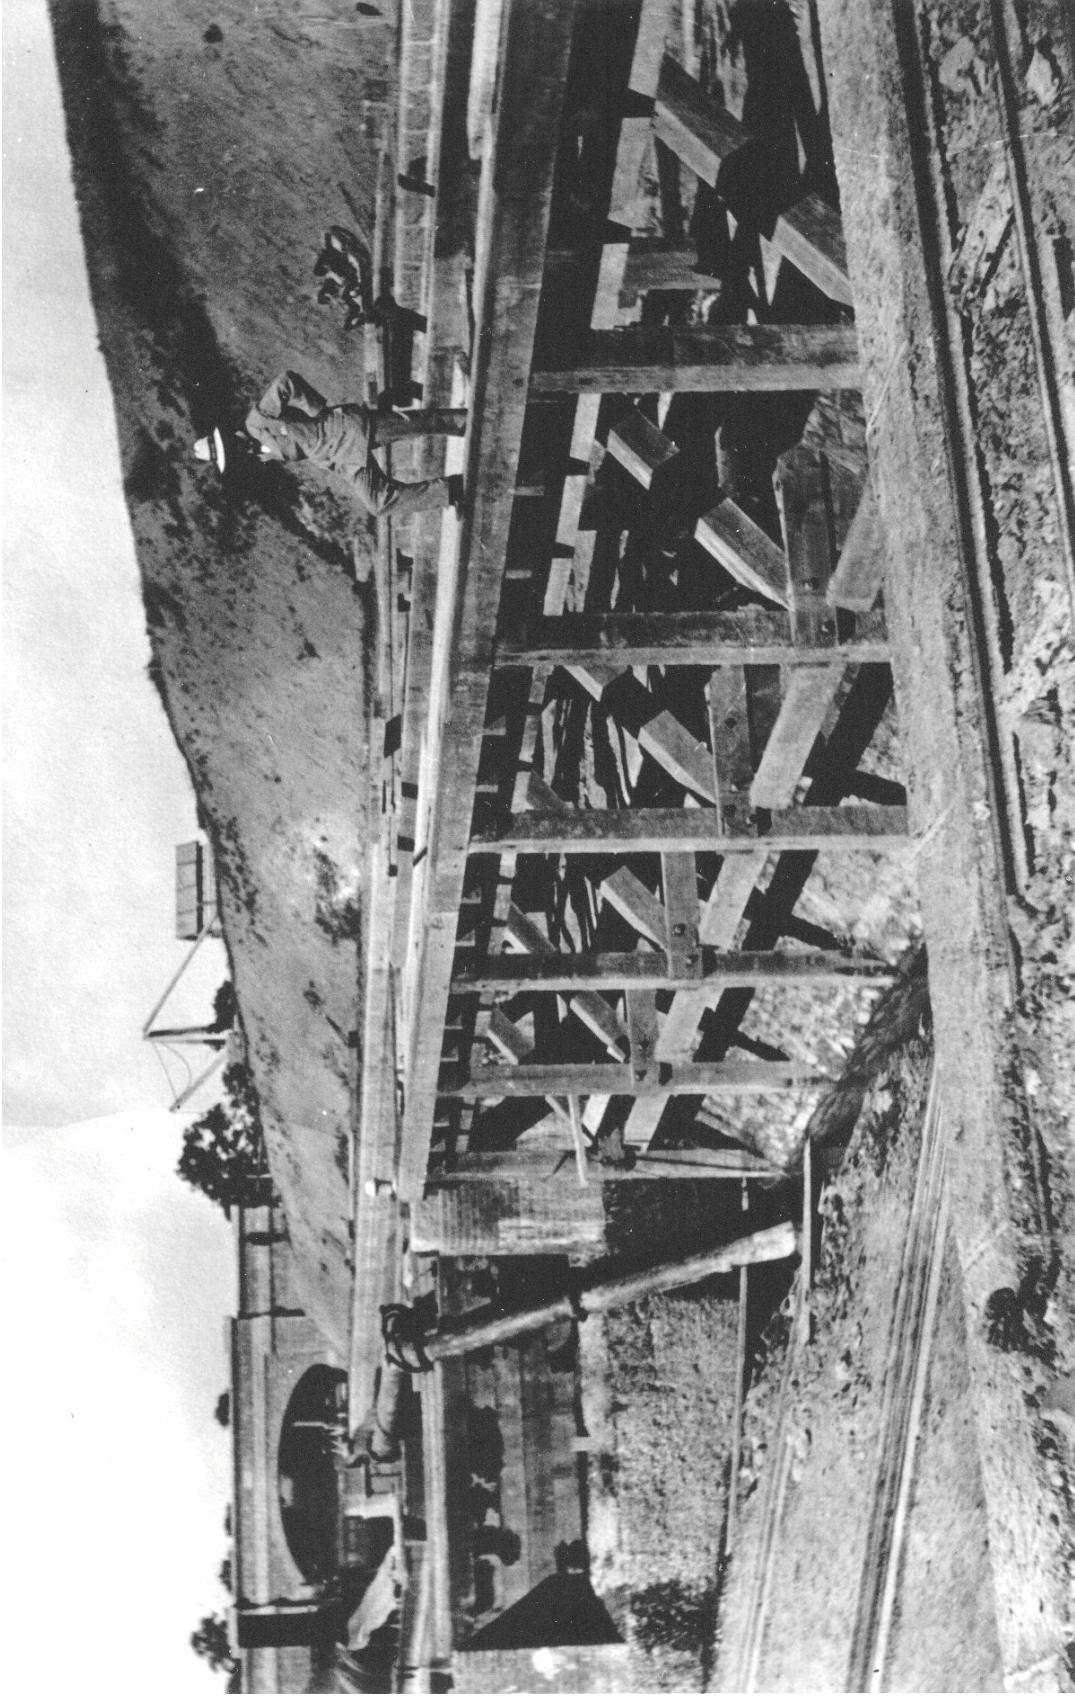
Figure 5: Gordon Cale Thomas poses on the walkway under construction in the late nineteenth century. Detail of the walkway foundations are visible (Appendix 1)

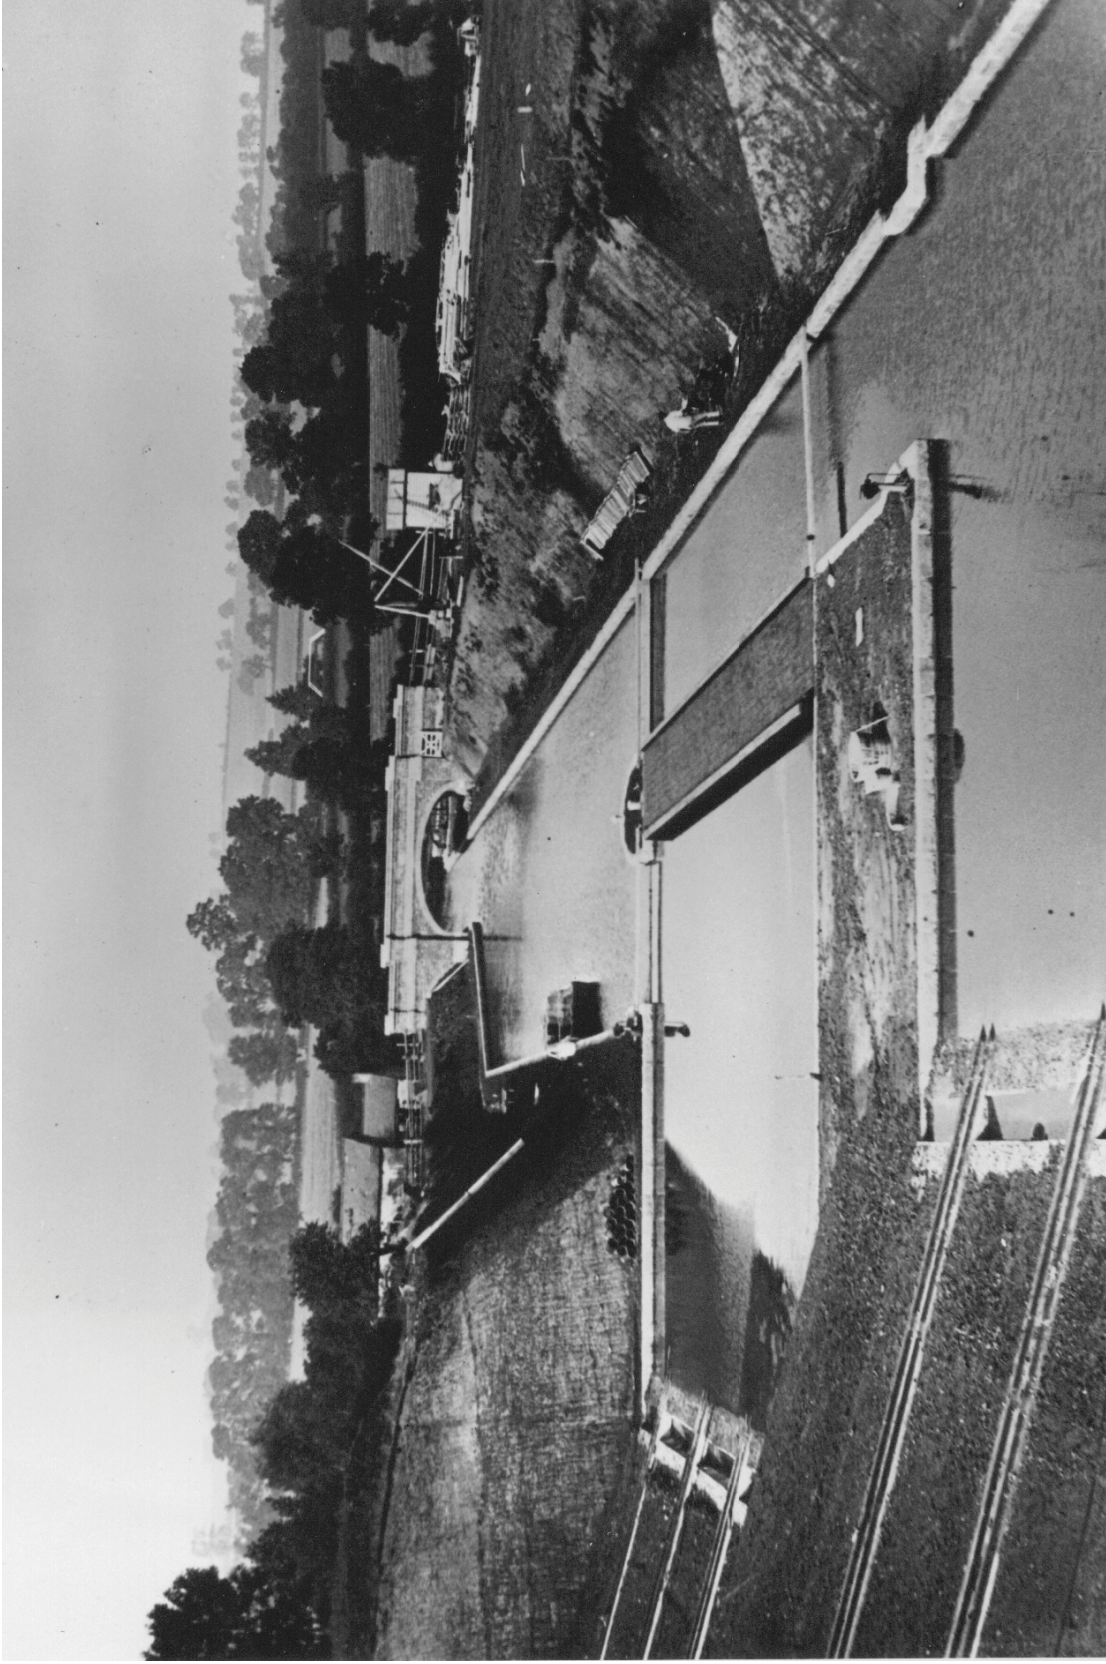
Figure 6: The bottom basin re-watered soon after construction (1899). The close planked timber walkway is central. (Appendix 1)

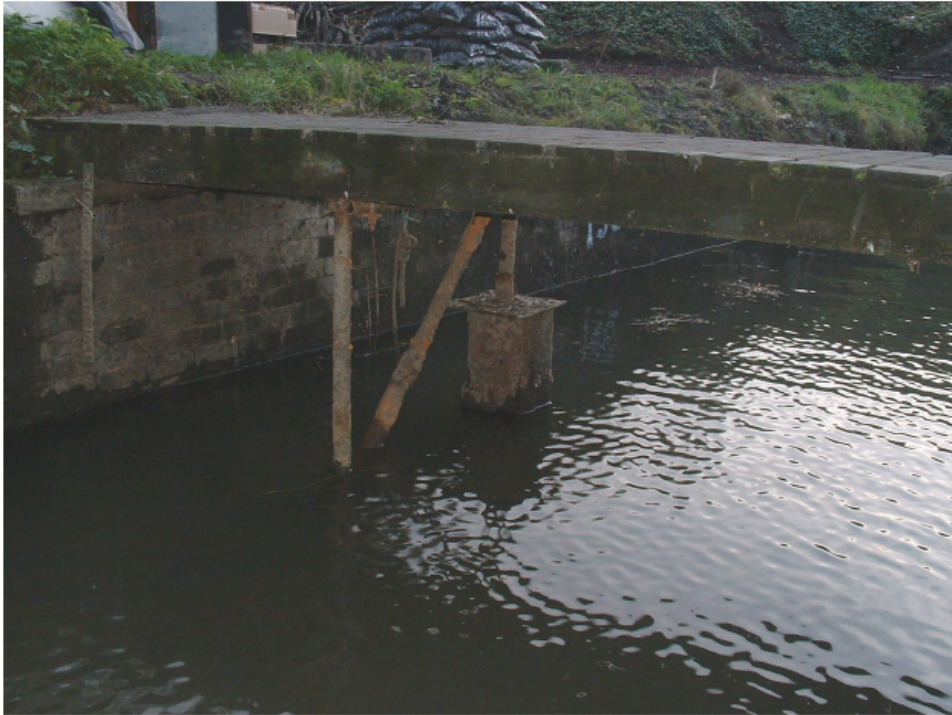
Photo 29 Typical walkway support arrangement

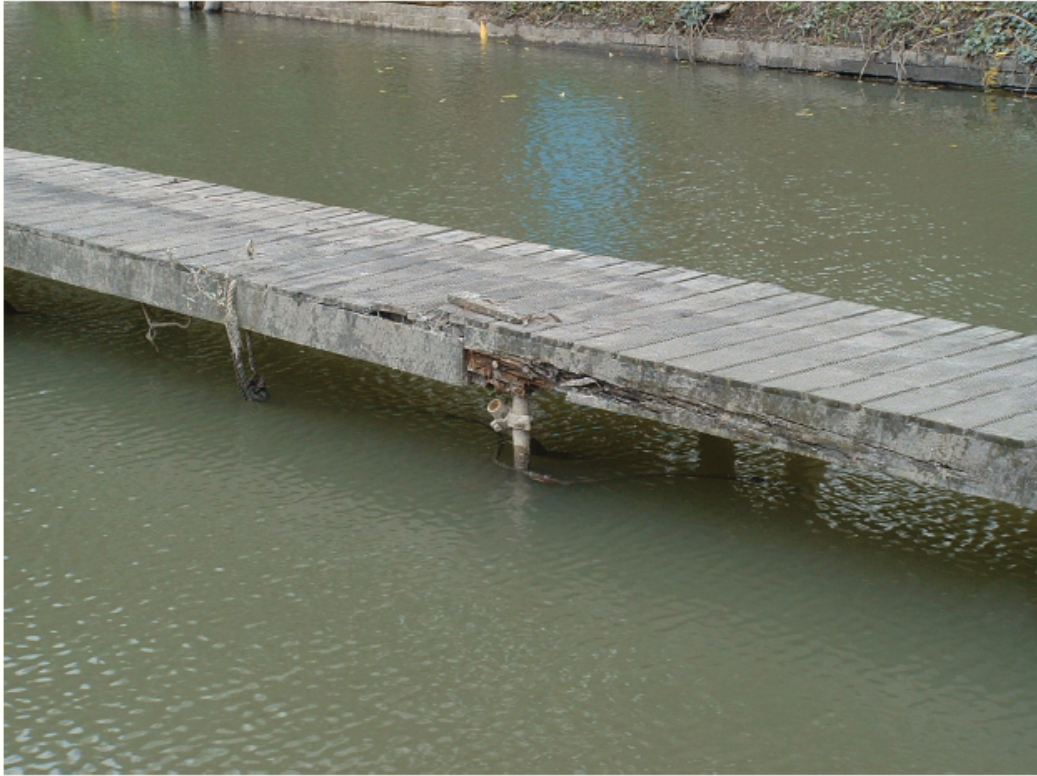
Photo 31 The timber walkway is in poor condition over the second support from the south
