**An Archaeological Investigation by
Test pitting at
St Mary's Church,
Melton Mowbray,
Leicestershire**

NGR: SK 75276 19029

ULAS Report No. 2018-153
©2018

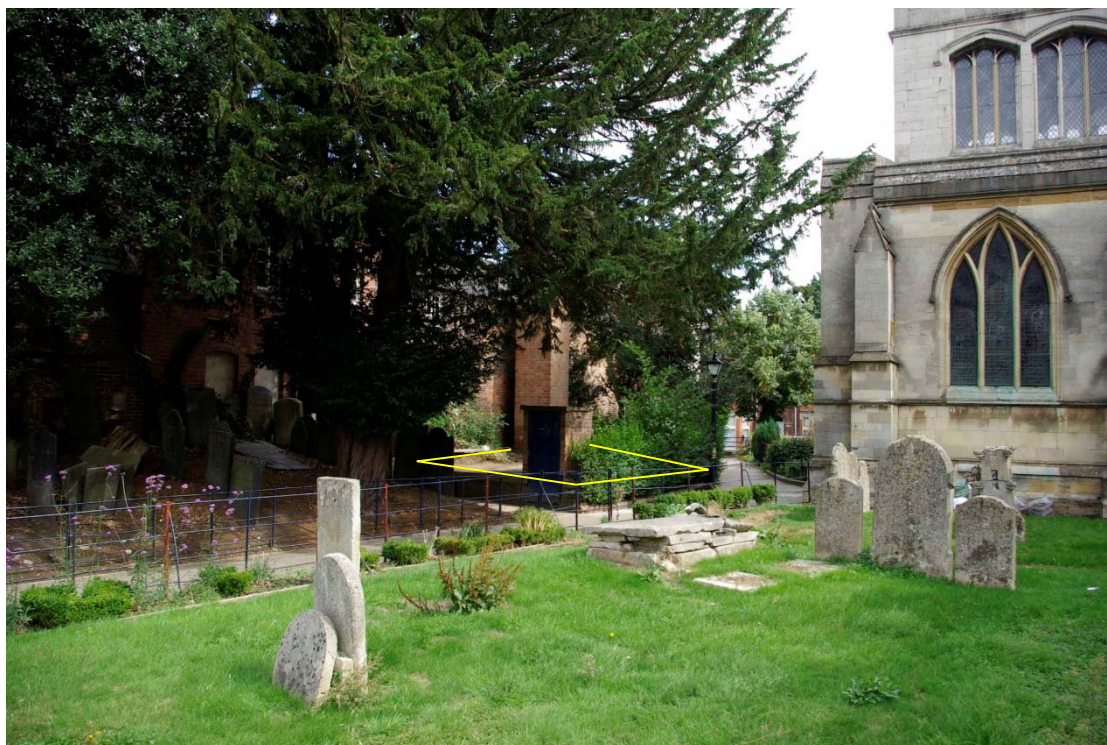
Figure 3 Proposed building location
Looking north-east. Boiler-house outlined in yellow. North transept on right

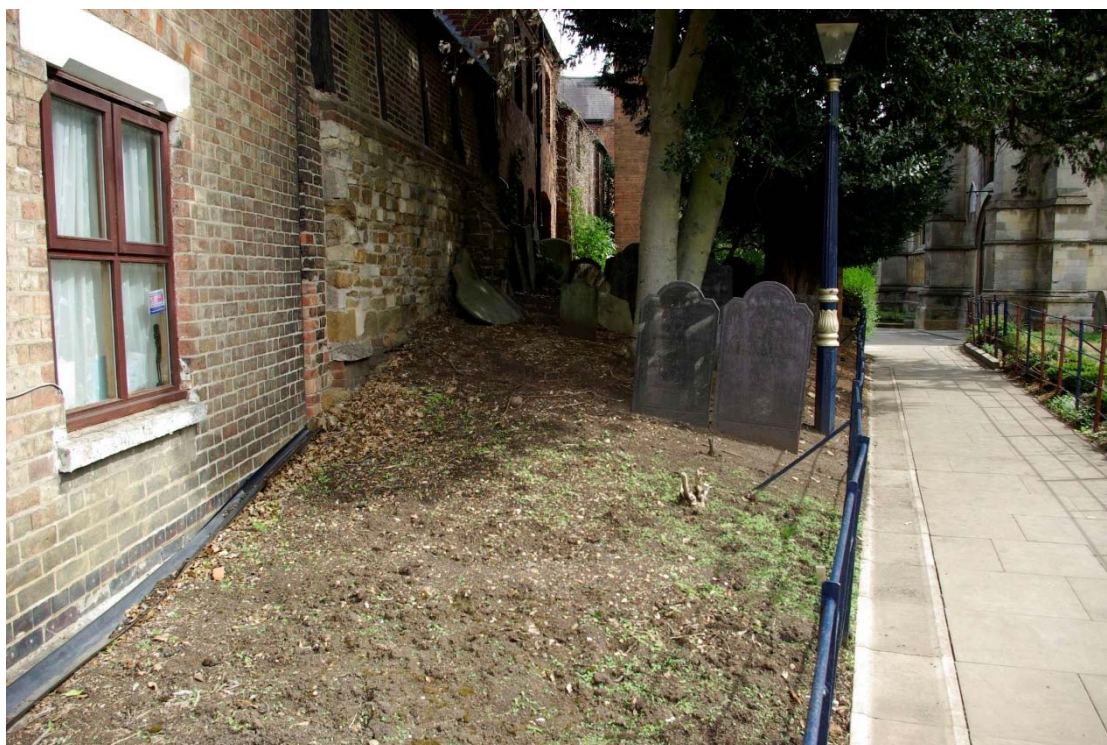
Figure 4 View of earth mound
Looking east. North transept on right

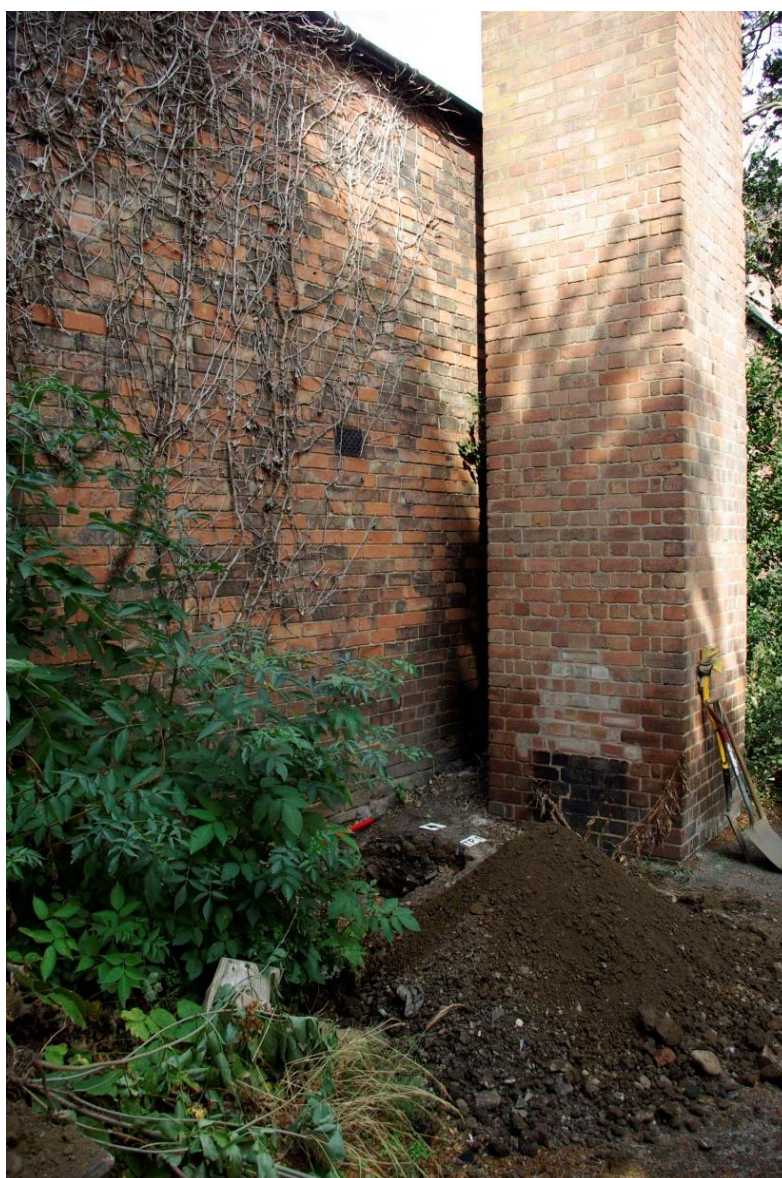
Test pit 1 was placed on the north side of the boiler-house against the brick wall. The WSI suggested that it should be to the east of the boiler chimney but a large holly bush prevented this (Fig. 6). The available space only permitted a 0.85m² pit to be excavated. The top 0.4m in the pit consisted of a layer of modern disturbance full of plastic, glass and metal debris (111) suggesting that the gap between the boiler-house and wall had been infilled quite recently (Figs 7 and 8). Beneath this layer was a dark brown clay silt layer (112) with a large amount of brick and stone building debris. Also within this

Figure 6 Test pit 1 location
Looking north-east across boiler-house roof

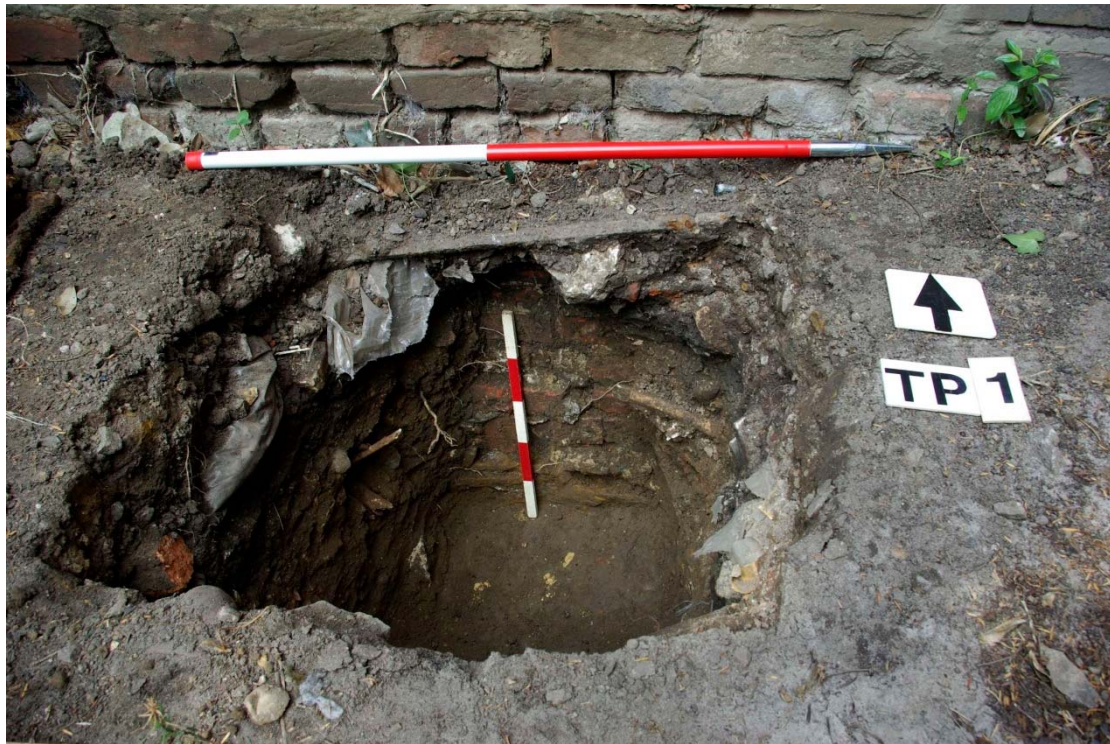
Figure 7 Test pit 1
South facing elevation. 1m and 0.5m scales

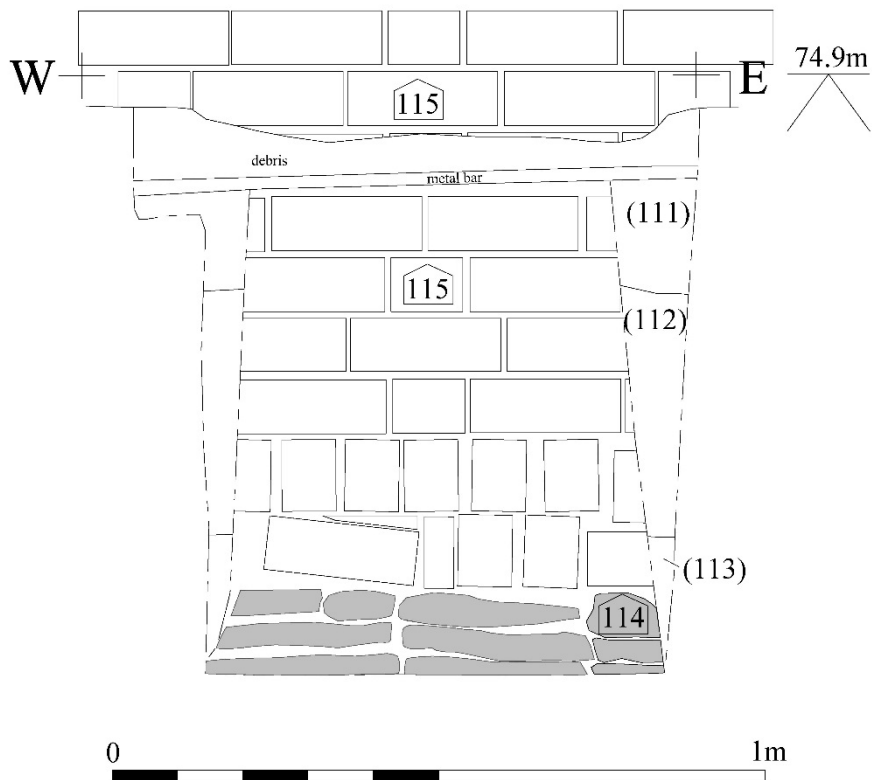
layer was a quantity of disarticulated human bone which appeared to have been deliberately placed against the Samworth Centre brick wall (115) to the north. This layer seems likely to be the disturbed material created from the excavation of the boiler-house. At 0.75m below present ground level a layer of dark red-brown silty clay with charcoal flecks (113) was encountered. This change in deposits corresponded with the lower courses of the brick wall. Partial excavation of layer (113) exposed the base of the brick wall which has been built on top of an earlier ironstone wall (114). Although no modern material was found within this layer no dateable material was recovered either. The ironstone wall (114) appears to have been laid without mortar using relatively thin pieces of unworked stone which may suggest that it forms the remnant of earlier foundations of a building following a similar alignment to the present buildings. The limited surrounding space only allowed the test pit to be excavated to a depth of 0.86m at which point the excavation was halted.

Figure 8 Test pit 1 south facing section

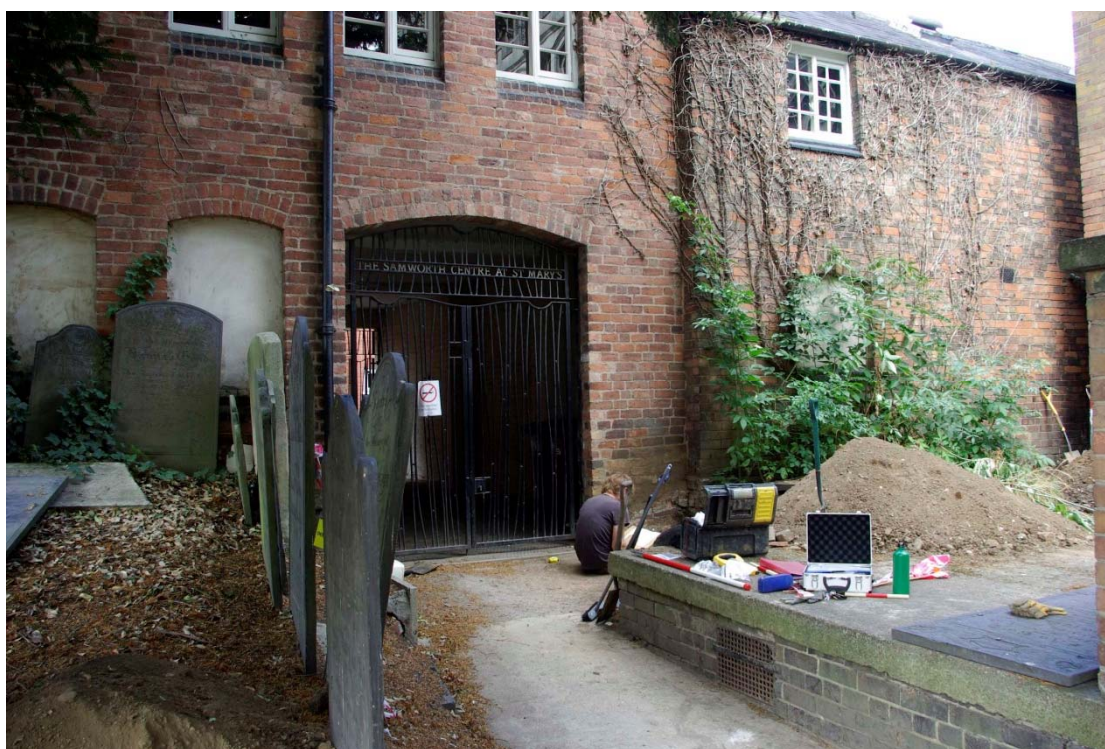
Figure 9 Test pit 2 location

Test pit 2 was located to the east side of a gateway leading northwards from the churchyard into the Samworth Centre (Fig. 9). At this point the brick wall on the north side of the pit steps outwards and the brick courses do not match which indicates a different phase of building work. As with Test pit 1 the upper layers of overburden (100) and (101) contained modern plastic and building waste. Removal of these layers exposed the base of the Samworth Centre/Crown Inn brick wall (104) showing it to have been patched or repaired in the eastern corner and also to be sitting upon an earlier ironstone foundation wall (105) (Figs 10 to 11). This east to west stone wall is very probably the same ironstone wall seen in Test pit 1. Four courses of wall (105) survive beneath brick wall (104) but, where the brick wall steps outwards, and becomes wall (102) only a single course of stone survives. The ironstone wall does not step out but continues on its east to west alignment. A clear construction cut [108] for wall (105) can be seen cutting into a silty clay layer (106). The back fill of cut [108] contained a mid-red brown silty clay (107) which is probably the same layer as (113) seen in pit 1. A single sherd of Stamford ware pottery of mid to late 12th century date was recovered from fill (107).

Test pit 2 is to the right of the gateway. Test pit 1 is on the far right of the picture.
Boiler-house in foreground on right

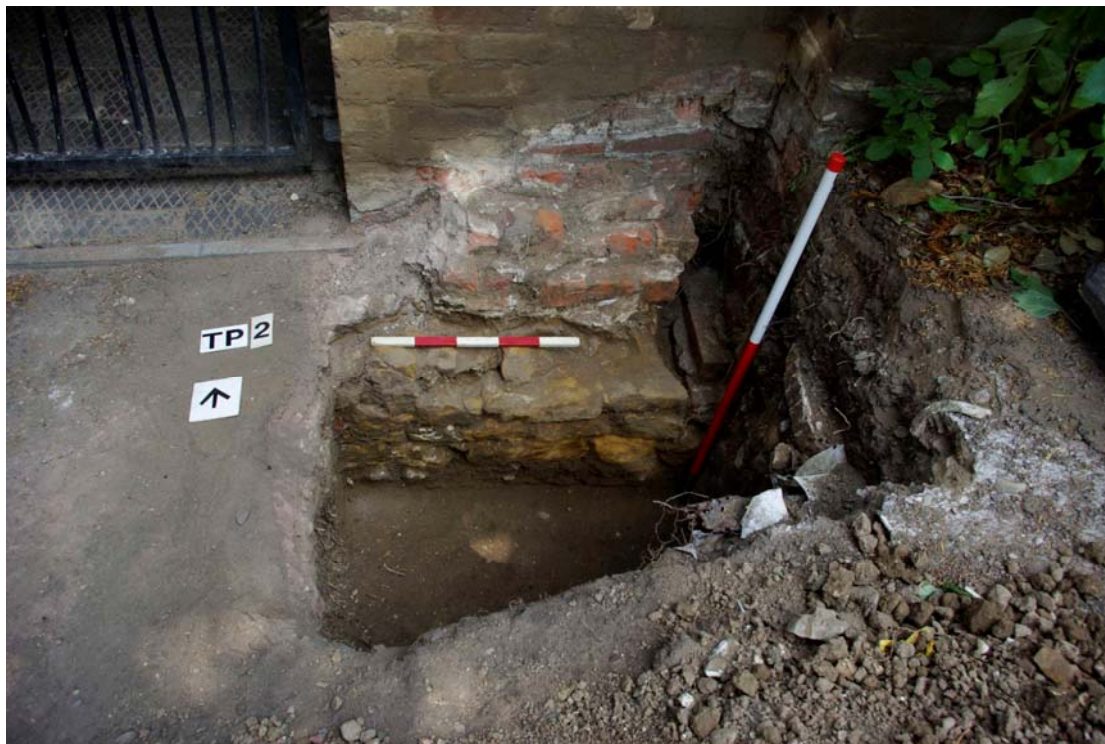
Figure 10 Test pit 2 south facing section
Looking north. 1m and 0.5m scales

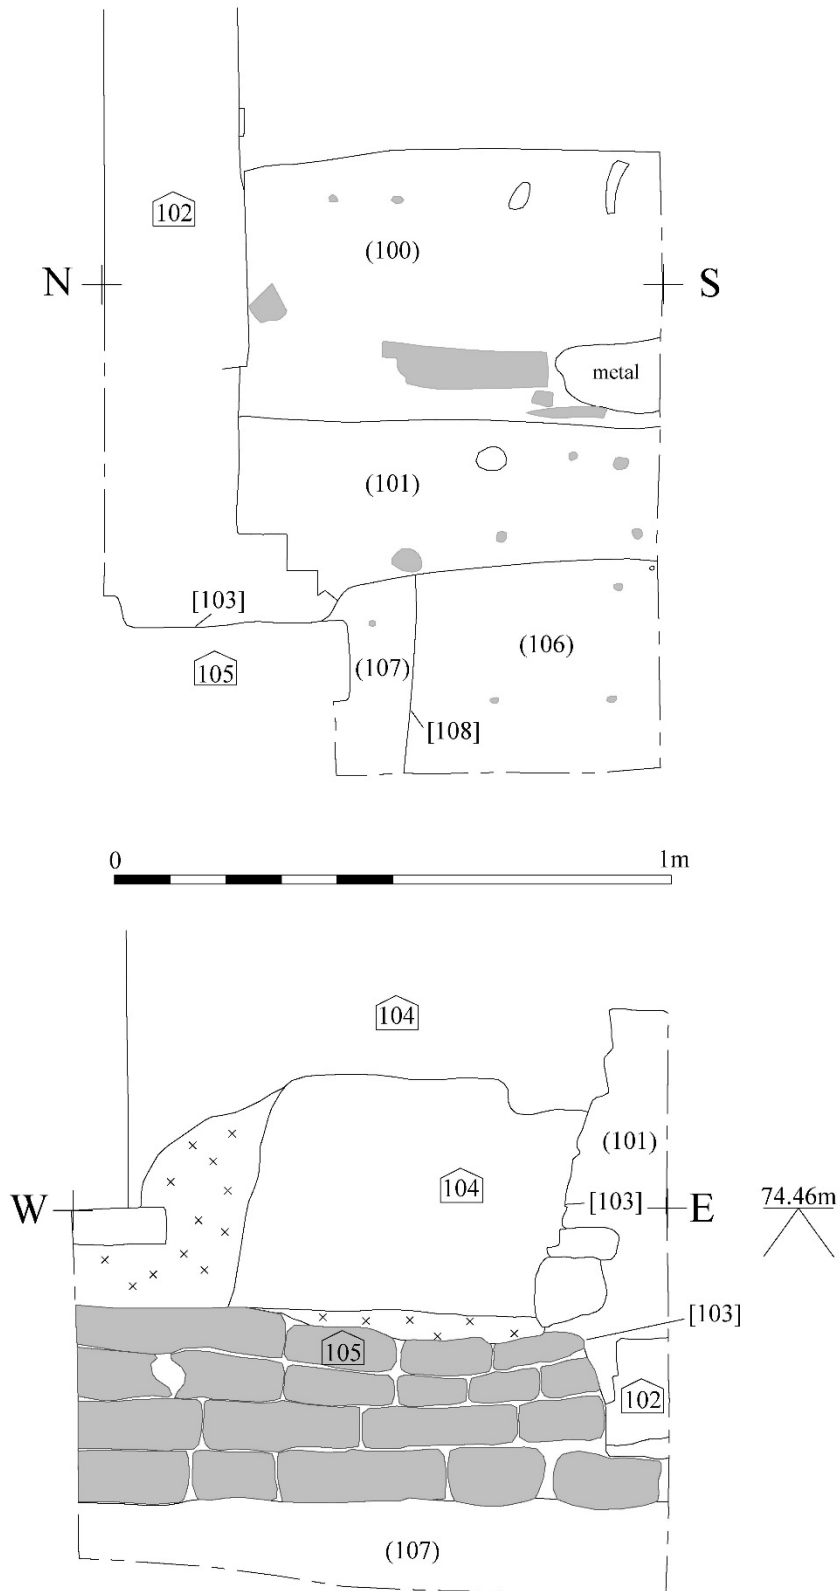
Figure 11 Test pit 2 west and south facing sections

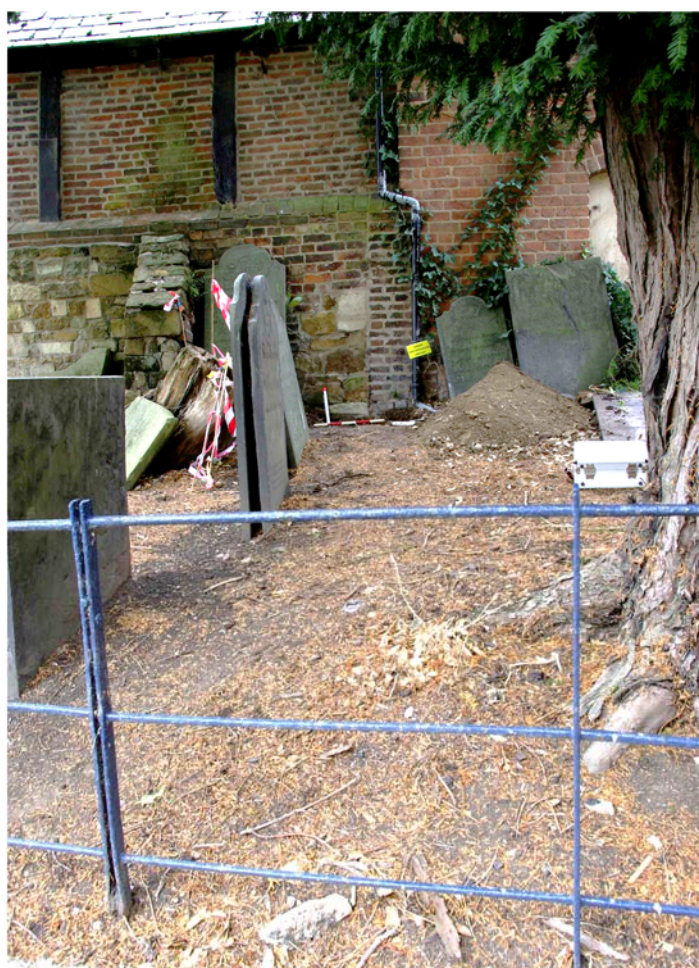
Test pit 3 was placed against the northern brick boundary wall at the highest point of the earth mound to the west of the Samworth Centre gateway (Fig. 12). At this point the red-brick wall of the Samworth Centre changes to a partially timber-framed wall which has a lower half built from a mix of brick and stone. This wall appears to have been heavily patched and repaired a number of times. A homogenous mid-brownish grey clay silt (119) was encountered throughout the entire 1m depth of this test pit which seems to confirm that the mound is likely to be made from material created from the spoil from the boiler house (Figs 13 to 14). A lot of tree roots were observed within the fill which also contained a small amount of brick rubble. A number of disarticulated human bones were observed throughout this layer.

Figure 12 Test pit 3 location
Looking north. Test pit to left of yellow sign

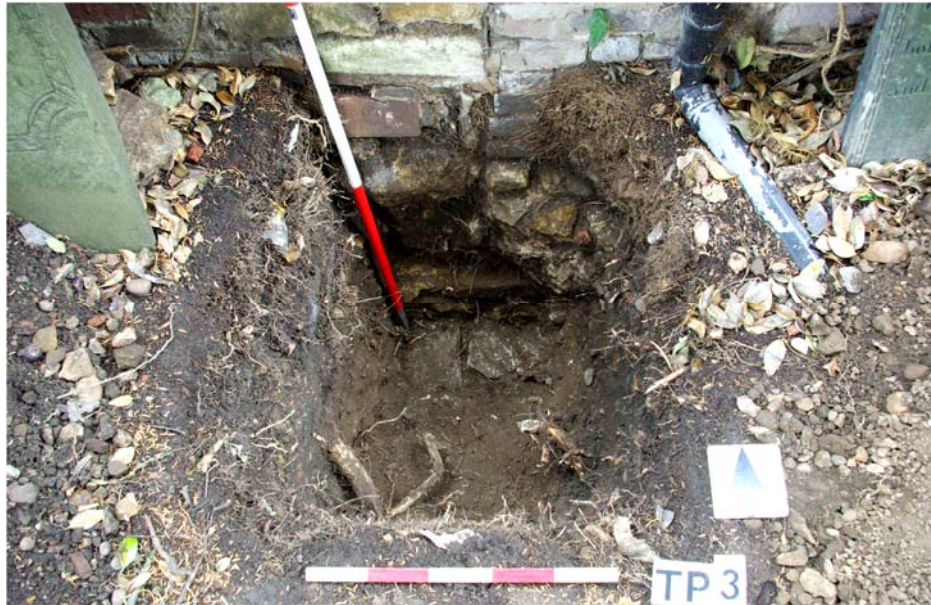
The south facing section of this pit showed that the stone, brick and timber wall (120) extended down almost to the base of the pit and appears to be sitting on a wider limestone plinth (123) which projects outwards by approximately 0.25m. The brick wall of the Samworth Centre has been crudely repaired at its south-west corner and now sits on a large lump of cement and stone which in turn sits upon wall (120). The crude repairs suggest that the walls were repaired after the spoil mound was created as, presumably, the wall (120) was originally exposed. The height of the limestone plinth is just under 0.3m above the church yard path height (see Figure 5) which suggests that well over a metre of the wall is now hidden beneath the spoil mound.

Figure 13 Test pit 3
Looking north. 1m and 0.5m scales

The heavily rebuilt and repaired wall on the north side of Test pit 3 has had a chequered history and may need some further remedial attention if it is to be exposed again. It seems likely that the present mound of earth is not particularly good for it and may be causing problems of damp and pressure against it.

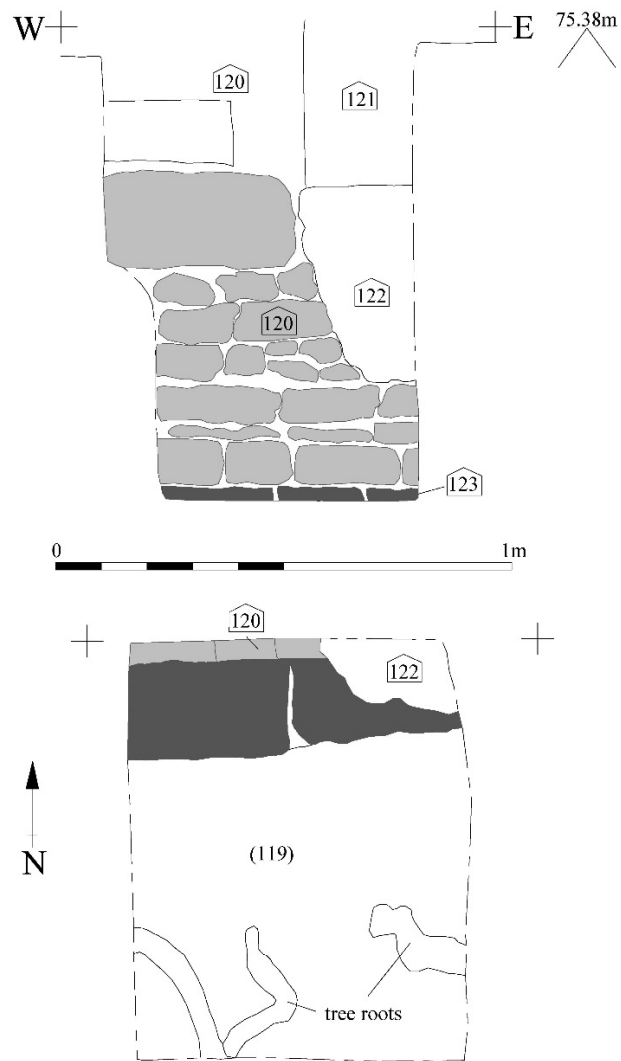
Figure 14 Test pit 3 section and plan

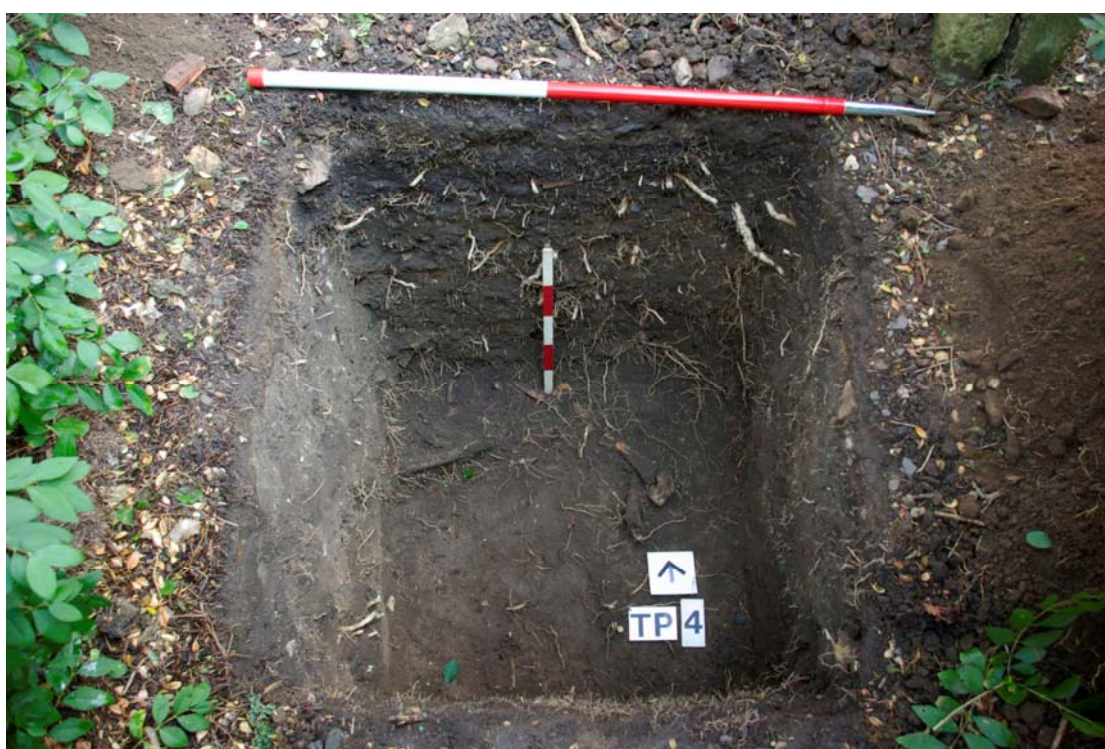
Test pit 4 was placed on the eastern side of the boiler house close to the churchyard path. At this point the ground rises quite steeply from the path towards the wall of the Crown Inn. A 0.2m layer of grey brown silty clay material (116) resembling garden soil was seen at ground level. This was removed to expose a mid-brownish clay silt (117) very similar in nature to the deposit (119) seen in Test pit 3 which was identified as spoil from the boiler house. In Test pit 4 this deposit also contained a number of human bones and many roots from the surrounding trees and shrubs (Fig. 15). At 0.72m below present ground level a slight change in the soil was seen on the southern side of the test pit. This may be the bottom of the spoil mound material and consisted of a pale brown silty clay (118). The top of a possible intact burial was seen at this point so the excavation of this pit was halted.

Figure 15 Test pit 4
Looking north. 1m and 0.5m scales

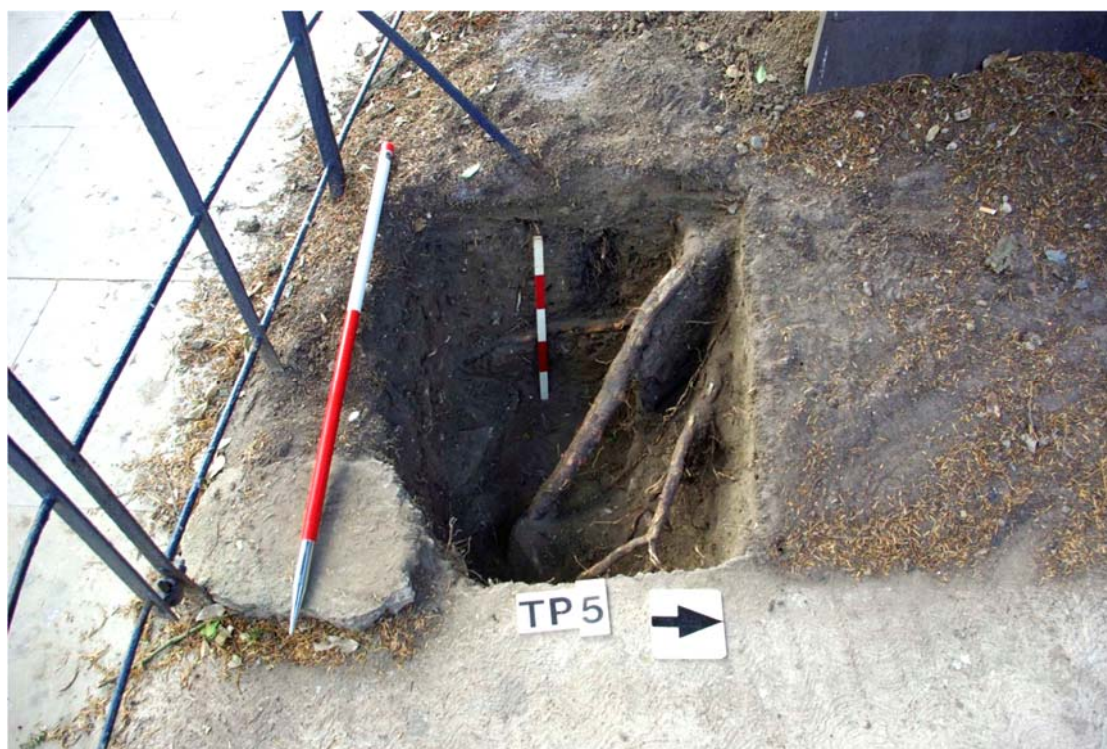
Test pit 5 was located at the corner of the main churchyard path and a path leading northwards to the Samworth Centre. A homogenous and root-filled layer of mid-brown clay silt was excavated to a maximum depth of 0.72m (Fig. 16). Along with 20th century pottery a single sherd of post medieval pottery was observed within the fill. A number of disarticulated human bones were seen close to the surface of the test pit. No apparent changes in the deposit, as seen in Test pit 4, were observed although the presence of some very large tree roots may have disturbed this pit to a greater extent.

Figure 16 Test pit 5
Looking west. 1m and 0.5m scales
