# An Archaeological Watching Brief during

# Improvement Works to the

# Inclined Plane at Foxton, Leicestershire.

ULAS Report Number 2008-143 ©2008

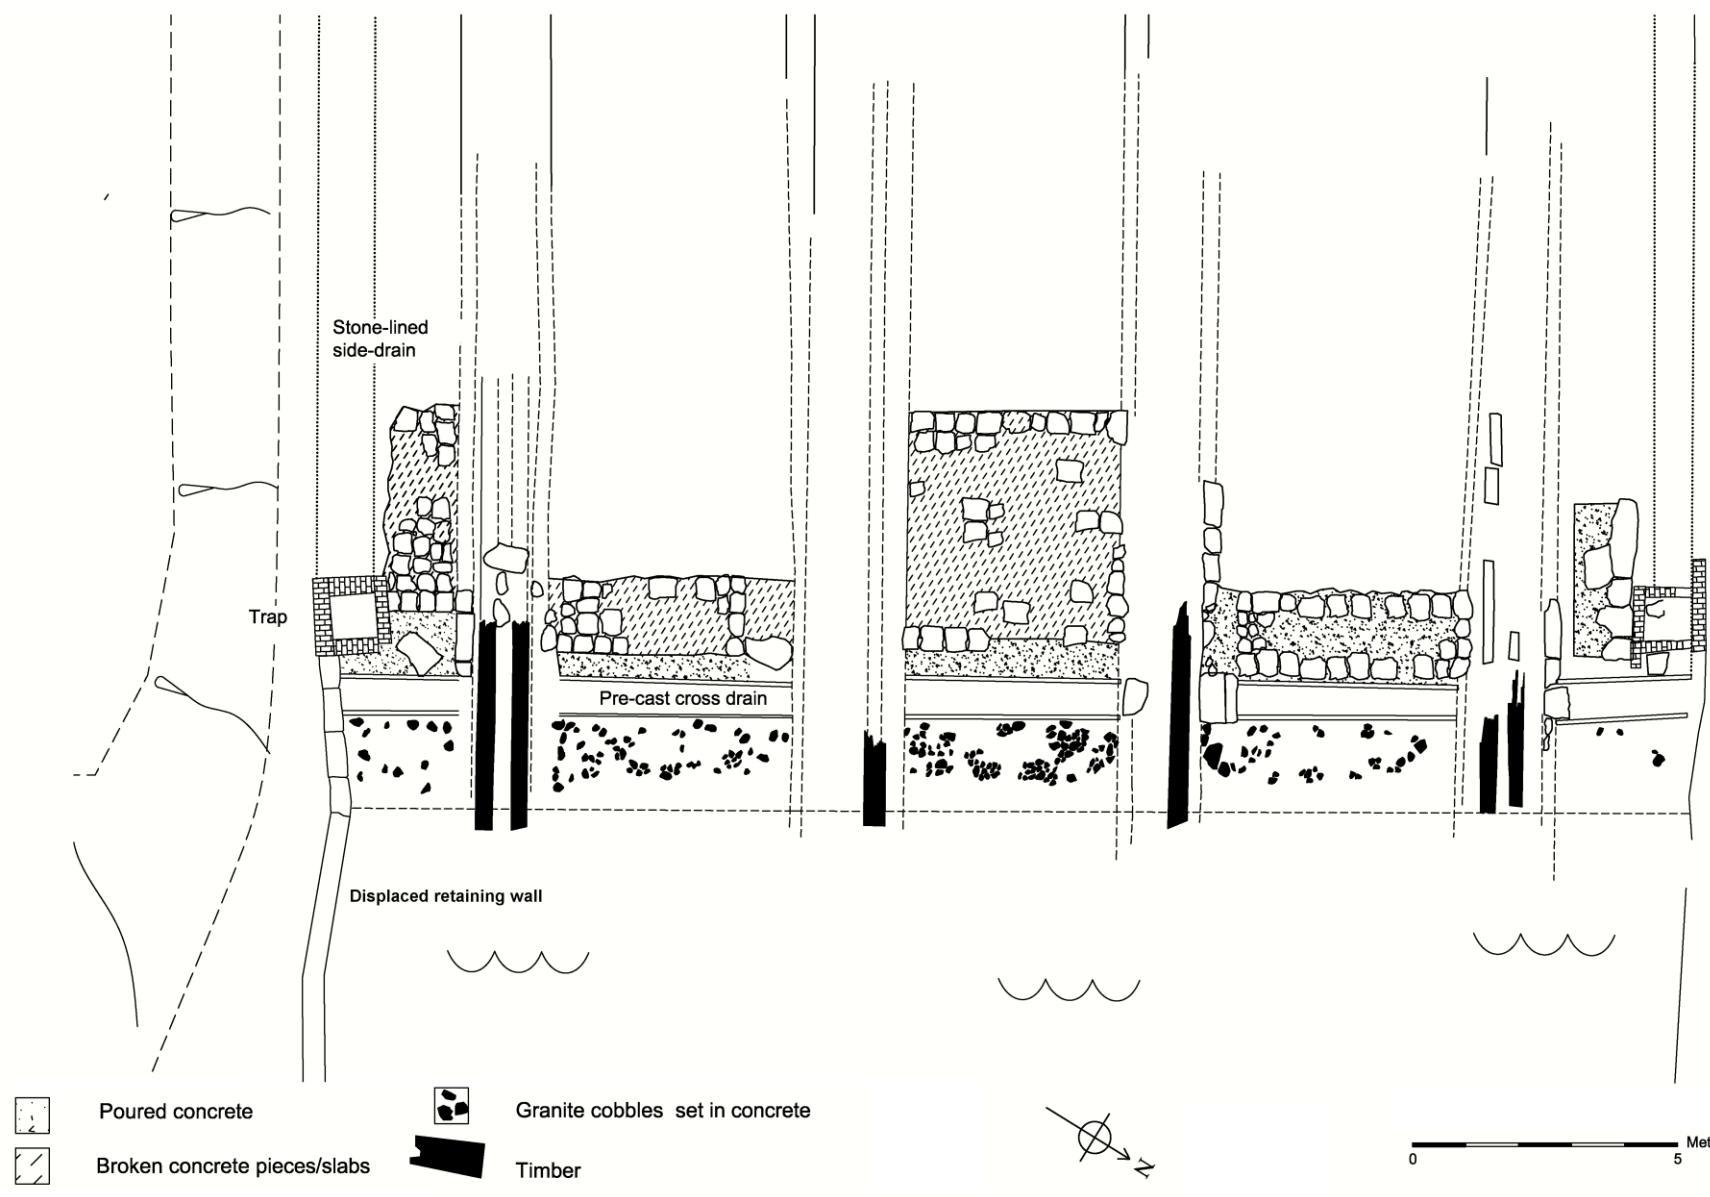
Figure 8: Detailed plan of apron at base of Plane 2

Evidence was uncovered toward the foot of the incline of a substantial apron, as suggested for Plane 1. The apron of Plane 2, having not suffered truncation and having benefited from the protection given by accumulations of silt, was nearly intact and a plan was drawn at 1:50 (reproduced here as Figure 8).

The central element of the apron was a pre-cast cross-drain. This drain, set 1.80m from the normal water level was 25m long overall and connected the two side-drains. The cross-drain comprised three sections around 5m long running between each of the four tracks, and two sections of some 2.5m running outwards to below the side-drains at each end. Each section was approximately 750mm wide and consisted of a concave section between two concrete slabs placed on edge. The drain was not excavated during this phase of work.

Some of the granite coping stones on the left hand basin wall below the trap were missing and the wall was slightly displaced; the missing stones were replaced with loose coping stones recovered in the vicinity during the grading of Plane 1 (Figure 8).

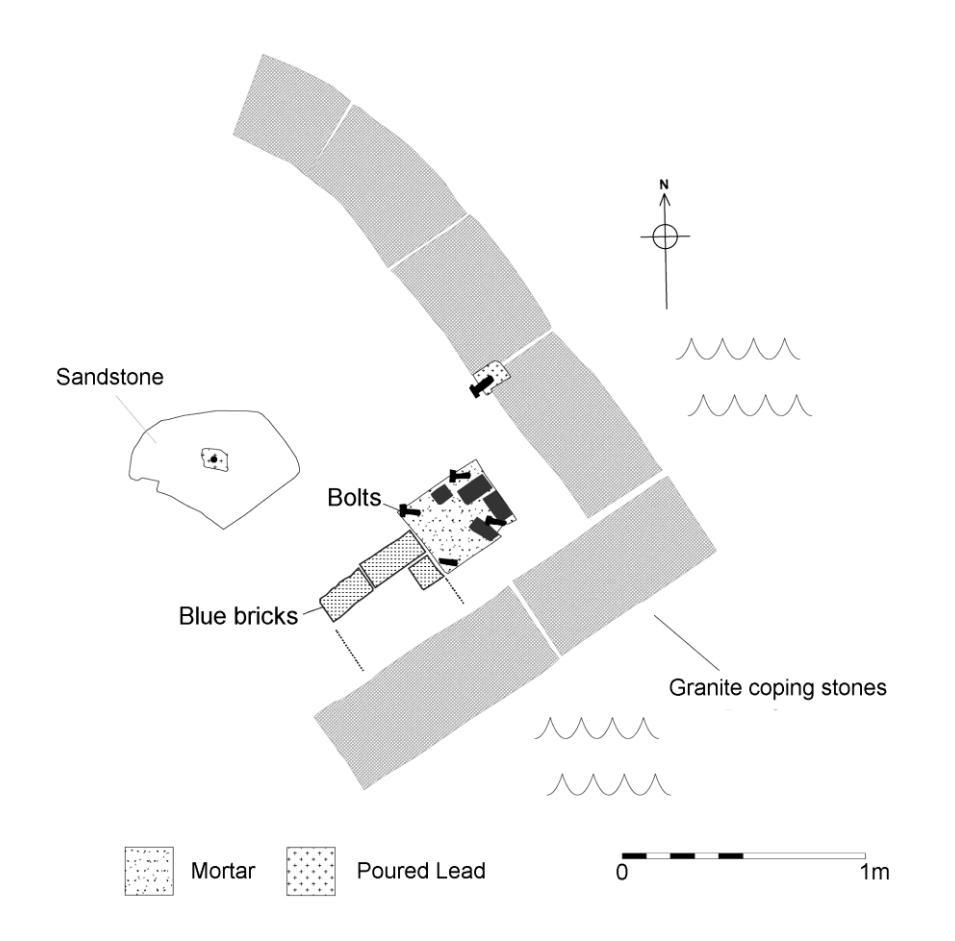
Figure 9: Detailed plan of mounting points on wharf.

In the south-easternmost corner of the dock was a mounting point consisting of four 20mm (3/4inch) anchor bolts some of which retained their nuts, in a rectangle 300mm by 250mm (Figure 9). These bolts were in turn mounted on a brick built footing approximately 400mm by 340mm in size. Early photographs show a hydraulic stand pipe for the portcullis gate in this position (below Figure 10, Figure 11) that was later housed in a part glazed timber building (Figure 20 and Figure 22). A connection was made to the stand-pipe each time the lower gates needed to be raised or lowered (Gardner and Foley 1979, 17). The bolts, therefore, are what remains of the mounting of this mechanism. To the right, *in situ* blue bricks defined a possible chamber, 460mm by 420mm abutting the coping stones, probably forming ducting for the route the hydraulic hoses, also visible in a contemporary photograph (Figure 11).

Adjacent to this mounting point there is an irregular shaped piece of sandstone, with a very smooth, weathered surface. Towards the centre there is what looks like an anchor bolt, sheared off at ground level held in place by

hot poured lead. The bolt itself is 20 mm (3/4 inch) in diameter, while the poured lead is approximately 100 mm by 80 mm in size; hot poured lead is most effective in small areas, in this example, there appears to be too much lead. A second poured lead mounted anchor bolt was mounted between two of the granite coping stones approximately 400 mm to the north of the main mounting point. The anchor bolt was still *in-situ* with the bolt still attached, same size as the previous bolts. Again, this bolt appears to be poorly mounted, a large amount of lead only supported on three sides, one side only being supported by the shale surface of the wharf.

The function of the later two anchor bolts is not clear although it is considered unlikely to have been able to bear any substantial weight before it would have given way and pulled free. It is possible that the mountings relate to the part-glazed timber structure that encloses the hydraulic mechanism (Figure 12). This structure appears to have been added to the dock, as it is not visible in some photographs.

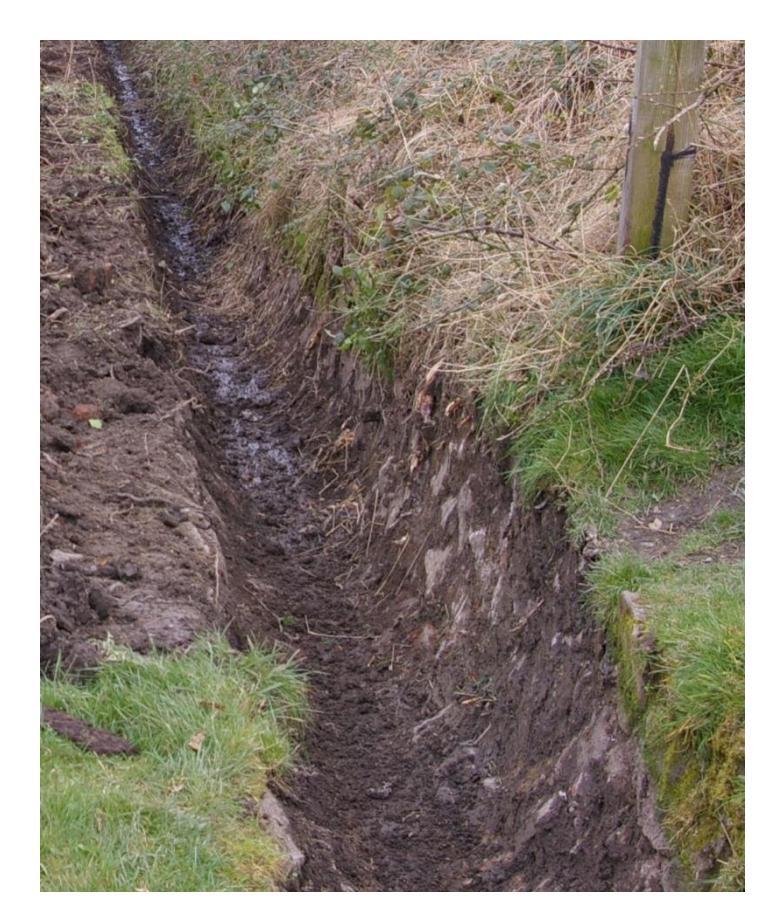
The side-drains had also filled with accumulated humic dark brown soils in which occasional bricks, stone and iron objects were included. The side-drains were in much better condition than was anticipated; granite rubble had been used for the sides with cement pointing and a cement base, and it was decided that as they were so robust that careful machine excavation with a narrow bucket would not cause any damage (Figure 13). A 4 inch glazed ceramic pipe-drain was found concreted into the base of the southern side-drain of Plane 1.

Figure 13: Detail of excavated granite-lined side-drain, Plane 1 (southern).

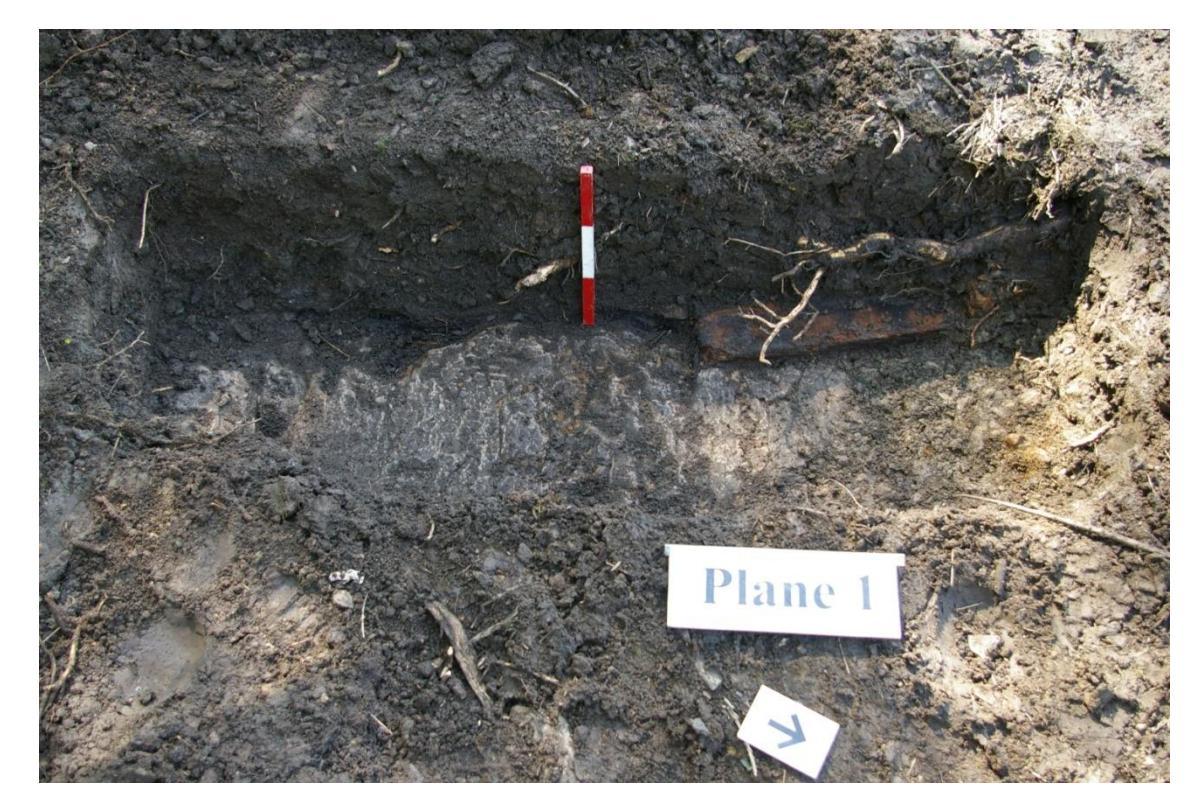
Fragmentary concrete track runners were still largely in-situ on all four lines for the first five to ten metres from the line of the old path. Subsequently the upper runners began to thin and eventually disappeared completely. This occurred on all four runners across Plane 1, and at approximately the same point (Figure 7). Probing along the alignment of the foundations indicated the lower concrete foundations were still *in-situ* but the upper runners themselves were gone. A hand-excavated section across the alignment of the left hand track (Figure 14) confirmed their absence, although the outline of the upper runners was visible on the surface of the exposed

The track runners were absent from much of Plane 1. The original incline surface was exposed during the watching brief as indicated by the stratigraphic change from the soil that had developed over the old surface, and the clays it had been built from. This level was also corroborated by the identification of the wire ropes on the surface of the plane. The absence of the runners may possibly be due to the robbing of the concrete for use as hard-core or aggregate.

Figure 14: Plane 1: hand-excavated section across line of track showing soil accumulation above lower foundation slab and absence of upper runners.

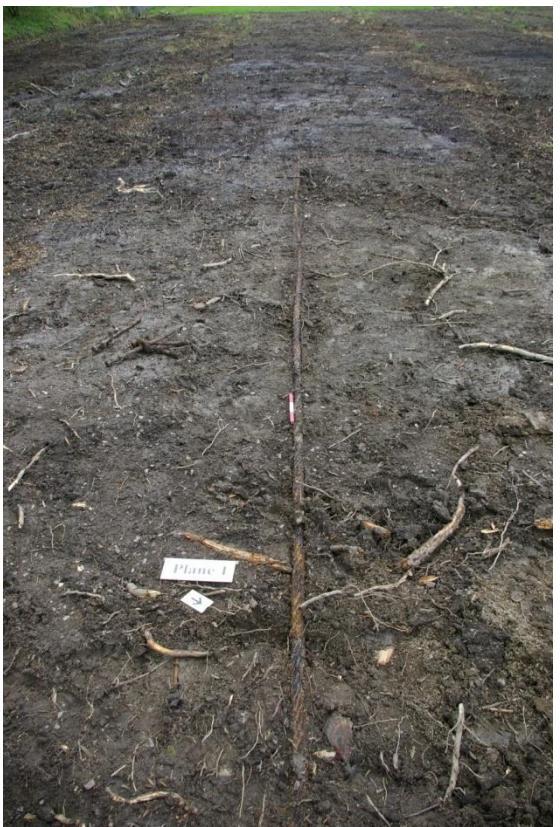
As grading progressed down the incline most of the excavated material consisted of soil accumulations and very little of archaeological significance was exposed. Towards the base of the incline, however, a length of wire rope was uncovered, very close to, if not in its original position; although badly corroded it still measured approximately 50mm (2inches) in diameter.

Figure 16: Rope, Plane 1, possibly near in situ.

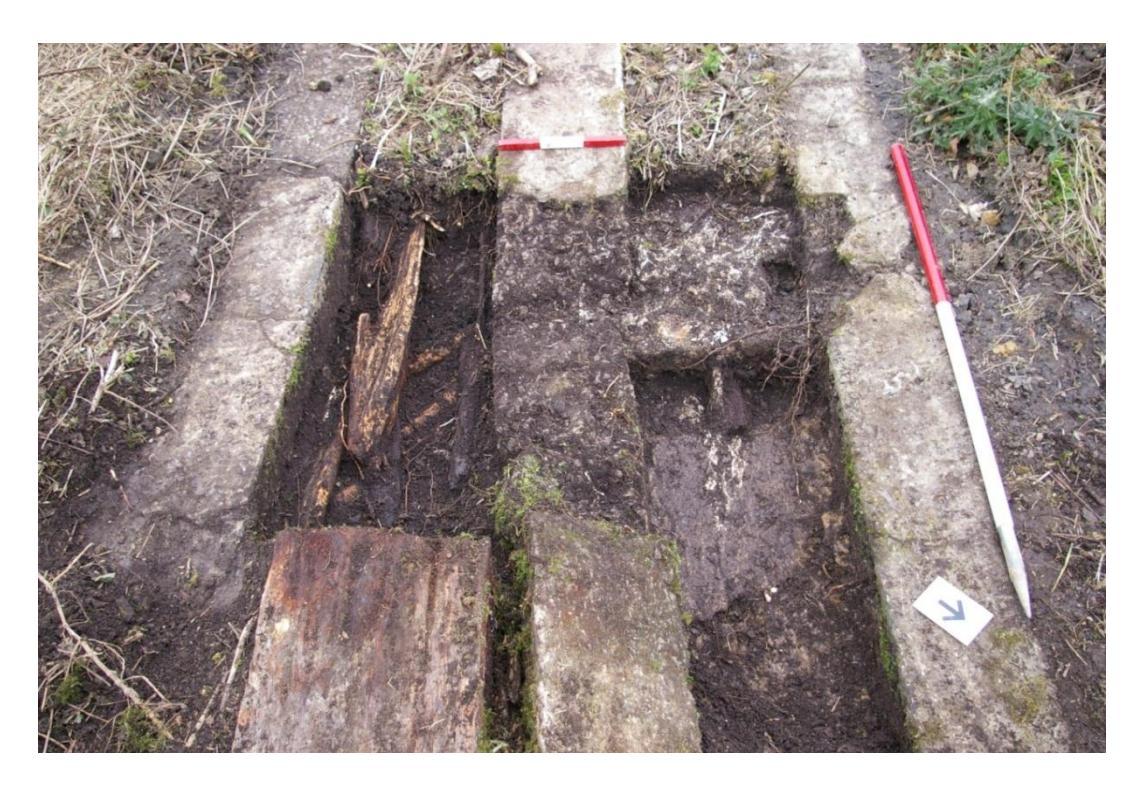
As well as the high level of *in-situ* concrete runners, a large number of the longitudinal timber sleepers were also still present on Plane 2 (Figure 7). A number of the bolts for the original mounting points were still visible in the sleepers; the mounting points consisted of four bolts in a rectangle 120mm by 240mm ( $4\frac{3}{4}$  inch by  $9\frac{1}{2}$  inch), the bolts themselves were 20mm (3/4 inch) in diameter.

Figure 17: Plane 2: hand-excavated section across concrete runners and in-situ timber.

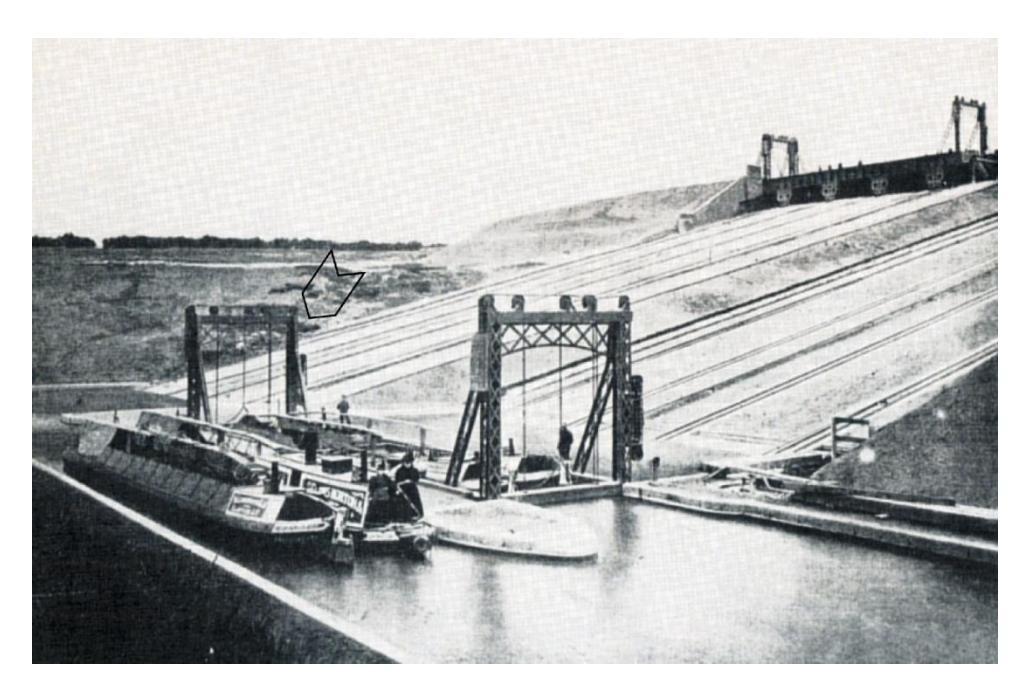
Neither side-drain reached the basin; the northern side-drain had been truncated by the terrace mentioned above. Excavation along the line of this drain partly exposed an *in-situ* structure of blue bricks. The southern side-drain had been buried by slipping of the adjacent bank. In an early photograph, instability in this area is apparent as the southern side-drain is buried in a similar way to that re-excavated. However it is also clear that the last line of tracks is also buried, and the plane cannot be functioning at the time of the photograph (Figure 19). The photograph may pre-date the opening of the planes.

Figure 19: Landslide at rear of Plane 1 has encroached over the drain and first runners. The lack of vegetation suggests this has occurred early in the plane's operation. Little evidence for surfacing above the aprons is visible (after FIPT 1985, 18). This photograph may predate the operation of the planes.

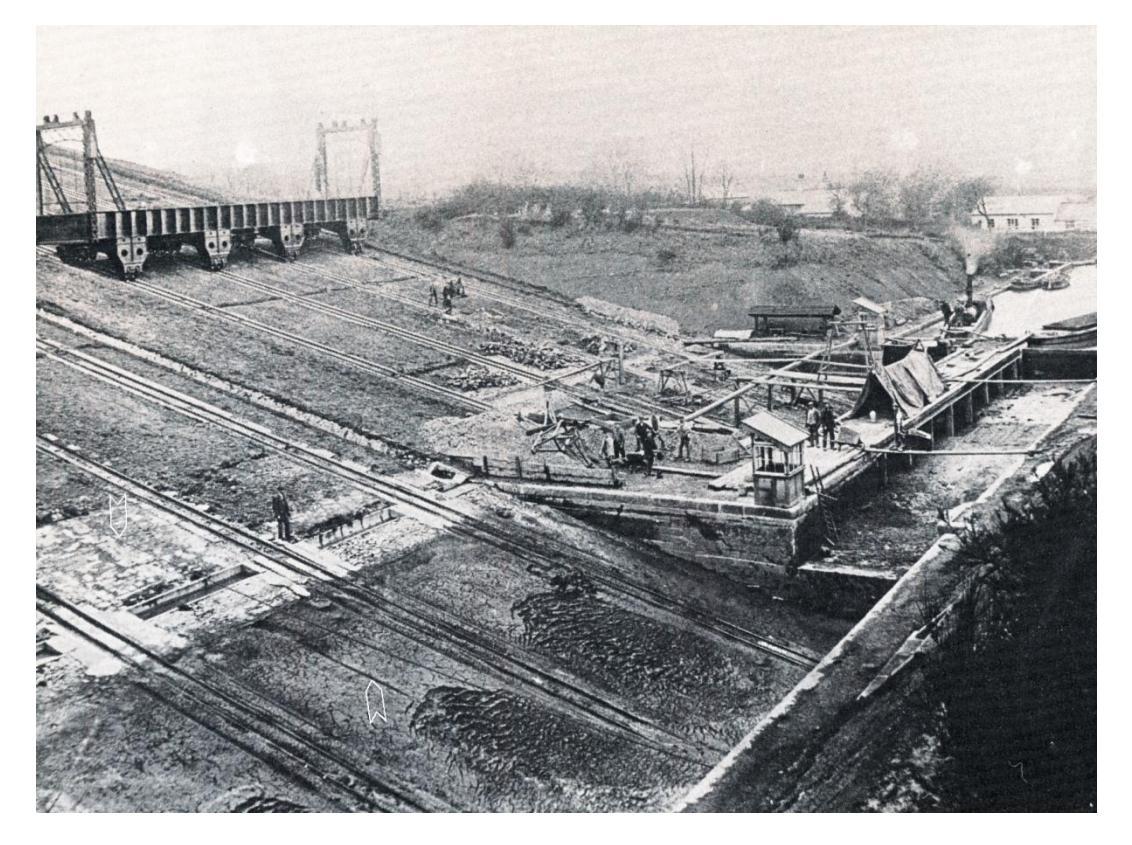
was surfaced in a similar way to Plane 2, and erosion caused by the rope is evident in the photograph, as are remedial surface repairs (Figure 20). The absence of such a surface on Plane 1 now must be due to a lack of preservation either by truncation or robbing. Erosion caused by the wire rope higher up the incline is also evident on other photographs (Figure 21) clearly suggesting that the ropes caused erosion along their whole lengths as the lowest (mid-point) part of the unsupported rope moved with the caisson to which it was attached. Localised surfacing was perhaps carried out in these areas central to each plane.

Figure 20: Maintenance photograph showing the addition of surface materials above the apron on Plane 2, winter 1902/3 (Photo D.Hipwell, after Garder and Foden 1978, 29). Erosion from the balance rope, and probably remedial surfacing to Plane 1 arrowed.

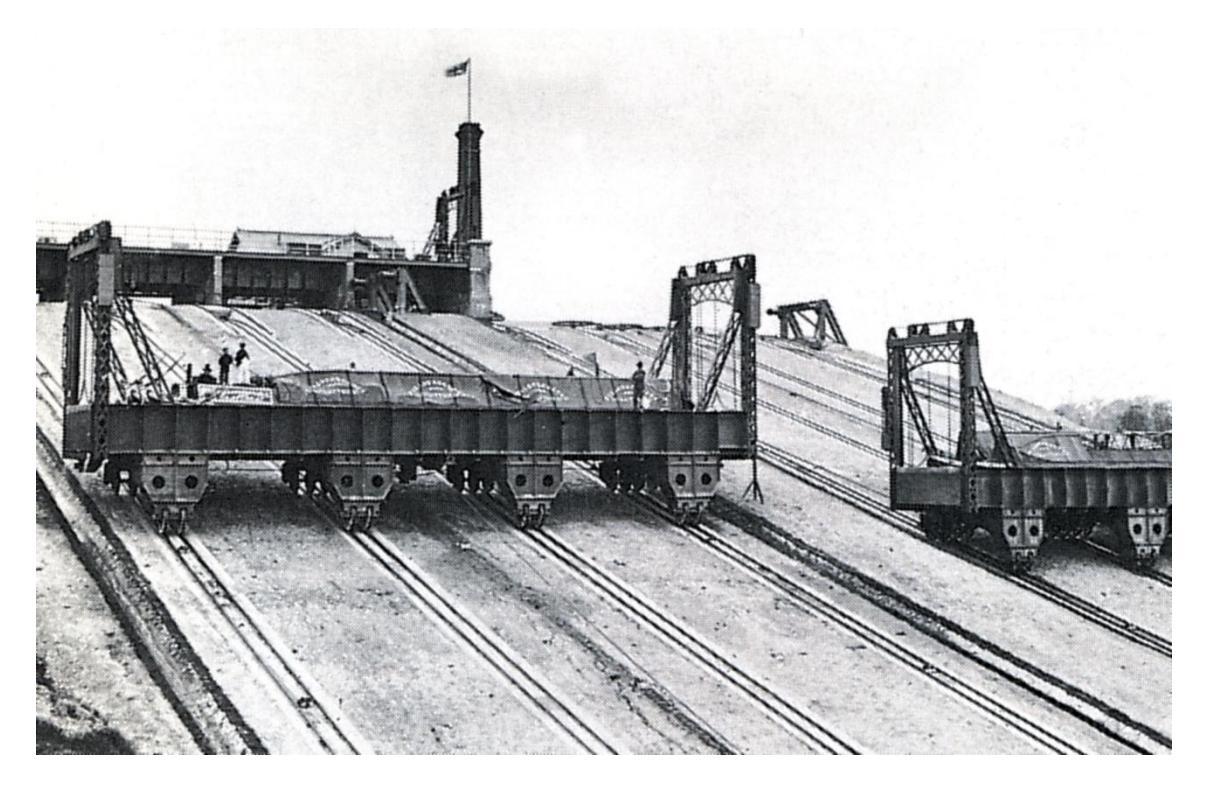
The exact reason for the provision and extension of the surfaces above the cross-drains is not clear, but it seems most probable that it was due to unforeseen erosion caused by the balance and tail ropes. Although no obvious indications of an extended surface was preserved on Plane 1, photographic evidence does suggest that Plane 1

Figure 21: Incline in use, showing localised but extensive erosion caused by balance rope (after Crowe 1994, 36)

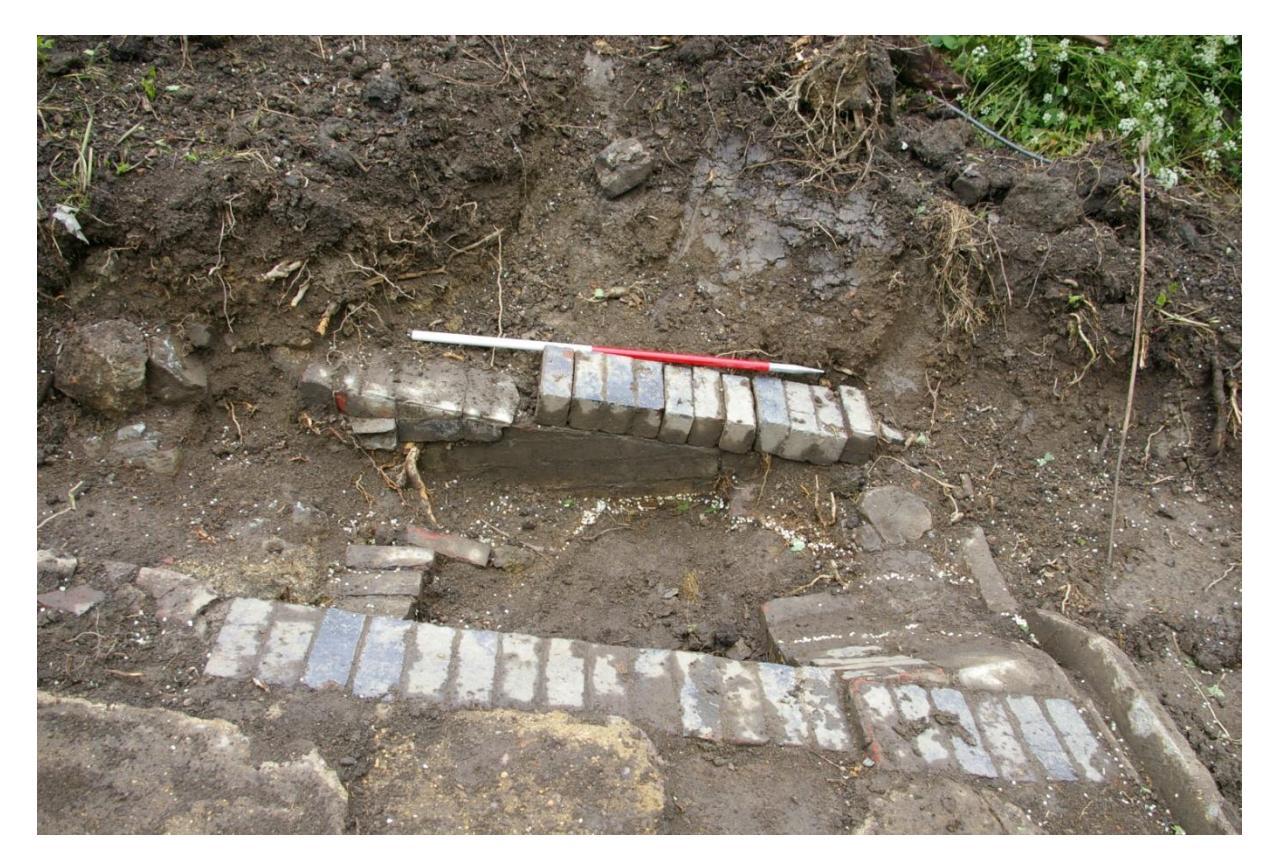
Both side-drains were in good condition, and were found to stop where they abutted small brick and concrete built structures, each 1.4m square and some 4m upslope from the normal water level, just before the cross -drains (Figure 25, Figure 26 and Figure 8). The southernmost trap of Plane 2 was excavated revealing a concrete base, at a depth of around 600mm, although overnight slumping and infilling of the trap from the bank above precluded detailed recording.

Figure 25: Plane 2, southern trap, side-drain above (left) and cross-drain below (right).

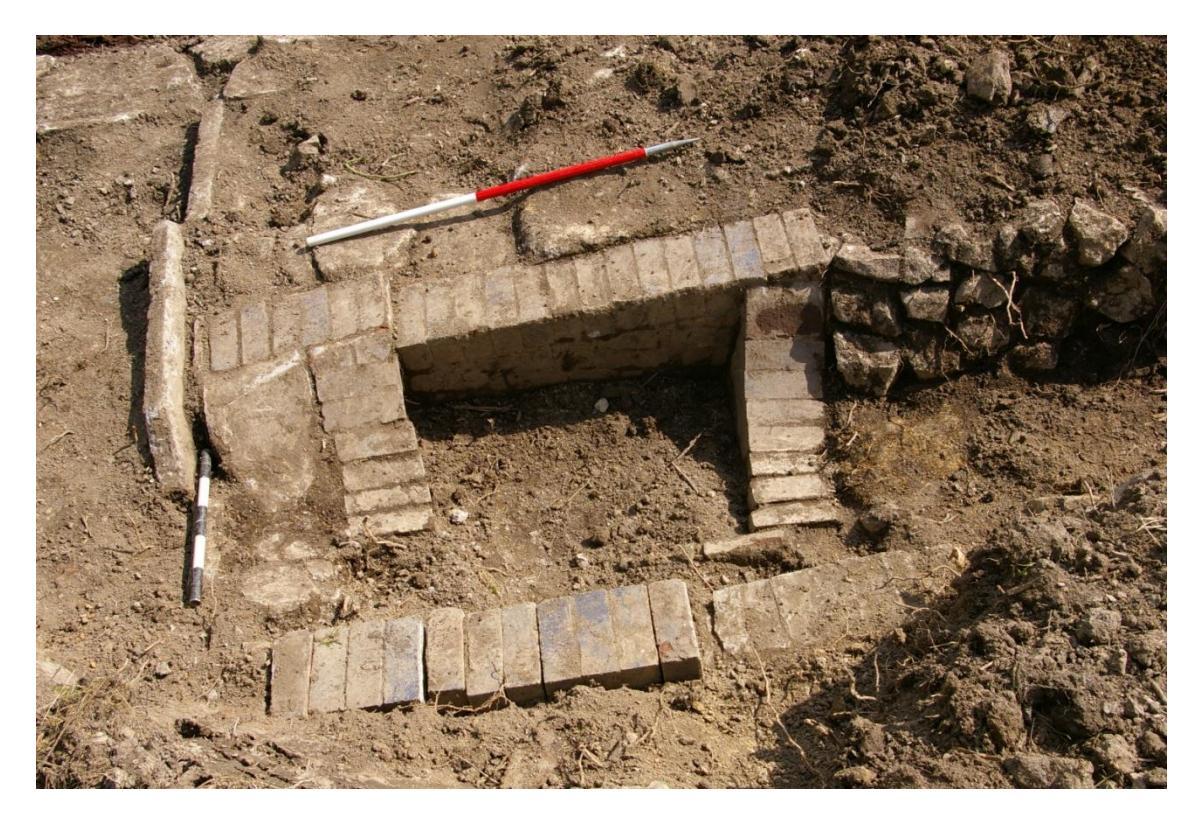
Each trap had a concave profile to upper and lower walls, continuing the form of the side-drains. Little difference in level was apparent between the tops of the two walls (Figure 26) although this was not recorded in detail. The brick structures appear as chambers at the foot of each side-drain, connecting side to cross-drains. It is likely that the blue bricks observed near the apron on Plane 1 came from a similar structure. Each chamber would have served as a form of trap.

Figure 26: Plane 2, northern trap and abutting stone-lined drain above (right) and cross-drain immediately below (left).

As the excavation of the left hand trap had left an unstable vertical face at the foot of the reinstated bank, it was decided to re-grade the bank in order to achieve a slight slope on this face and improve its stability, although examination of the available early photographs suggests this face was intended to be nearly vertical.
