HIDCOTE MANOR GARDEN, GLOUCESTERSHIRE

Archaeological Trial Trenching

for The National Trust

August 2012

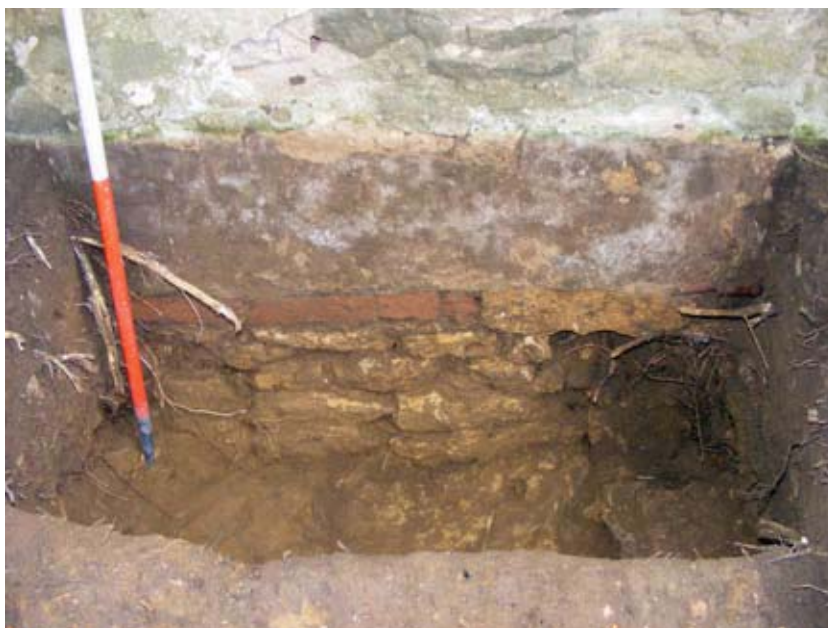
Illus 2

Details of the wall footing and redbrick inclusions within test pit 1

The test pits excavated along the courtyard wall again revealed another interesting feature, suggesting that the ground level may have been considerably lower than the present day level of the flower border, as the rendering seen on the inside face of the courtyard wall continued approximately 300mm below the present ground level. (See Illus 2)

Within test pit 1 further details illustrating the construction of the courtyard wall were revealed as the wall also contained red brick within the fabric. The inclusions of red brick may have been inserted as repairs when the garden building was being constructed, possibly indicating that the wall is of greater antiquity than the garden building or more probable, that the eastern wall was contemporary with the construction of the garden building. (See Illus 2)

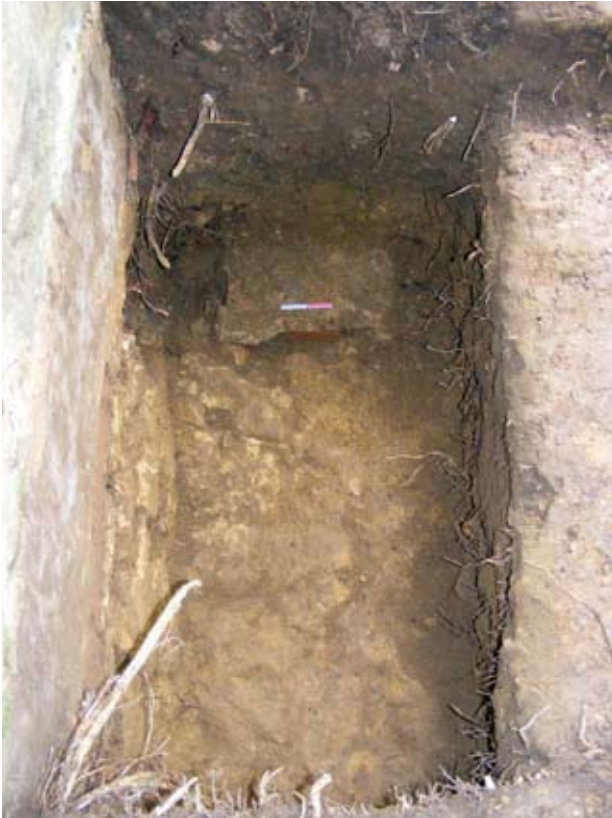
Illus 3

Internal dividing wall, located with in test pit 1

However the excavation of test pit 1 produced the most significant remains seen within the test pits, that of a robbed out brick wall, formerly keyed into the courtyard wall.

The presence of the remaining trace of this brick wall indicates that the previous building was subdivided through the insertion of an internal partition (aligned east west) towards the southern end of the building.

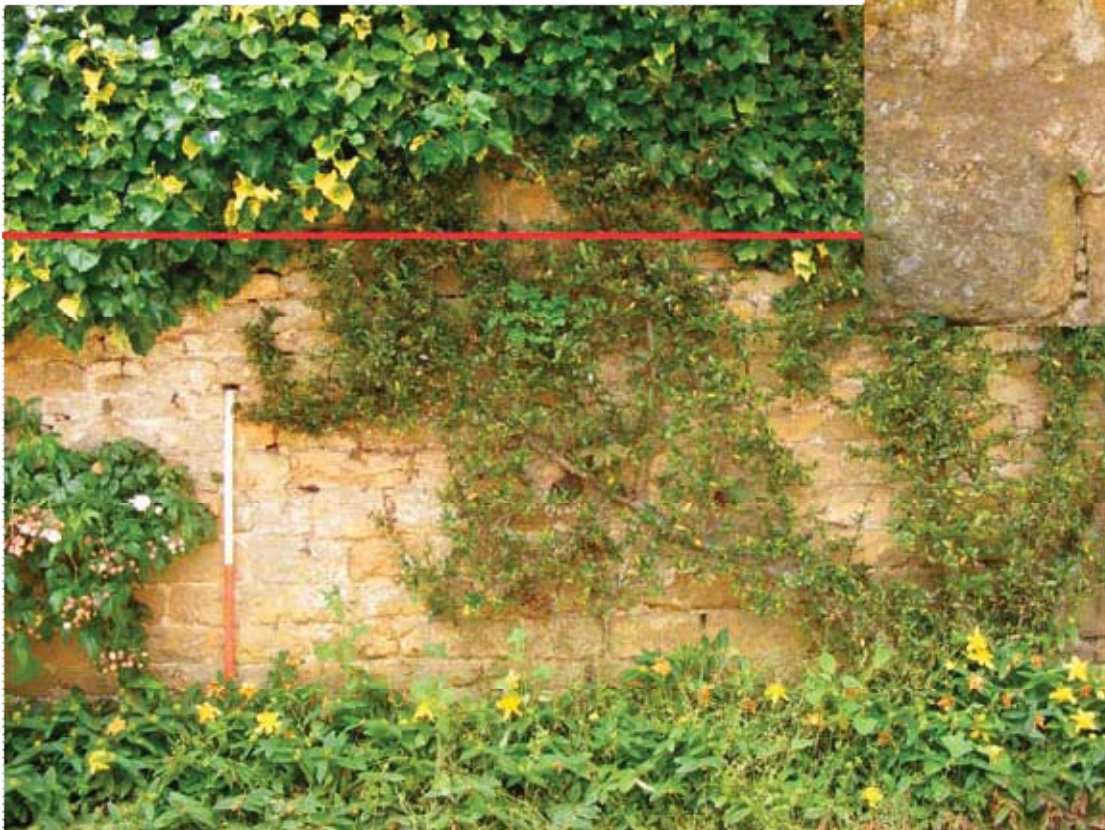
Illus 4

Examination of the external face of the courtyard wall, although greatly obscured by vegetation, shows a distinctive change in the mortar style and stone size approximately 1.00m from the top-down, indicating that the original height of the wall is still evident and the top-most courses were perhaps constructed to increase the height of the courtyard wall after the demolition of the former garden building.

Changes in the construction of the east wall

For example the noticeable change in mortar type and styles on the eastern face of the east wall demonstrate that the original east wall of the garden building has been incorporated into the fabric of the courtyard wall.

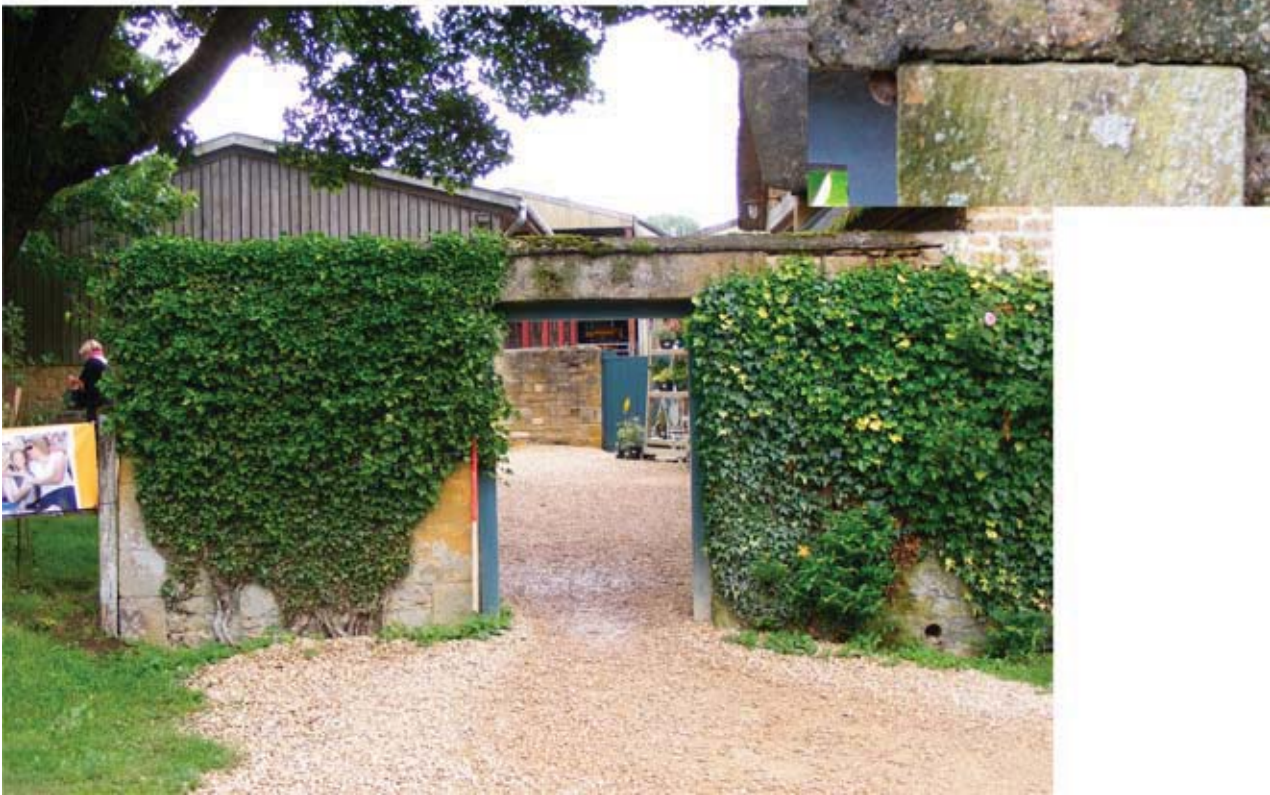
Illus 5

The relative antiquity of the small length of car park wall to the east of the courtyard is brought into question through the inclusion a concrete lintel within the doorway. This maybe a modern repair but further evidence that that the wall is of more recent date is that the wall is not keyed into the adjoining restored barn, but rather butted up to the building, suggesting a later construction date. Furthermore, the overall dimensions of the wall conform oddly to metric measurements.

Carpark wall with insert illustrating the concrete lintel

The inclusion of a concrete lintel in the car park wall implies that this wall, in its present location, is of little historical significance in relation to the Hidcote Manor complex.
