Programme of Archaeological Observation, Investigation and Recording on the Bran Ditch Scheduled Ancient Monument, Cambridgeshire

Prepared for Seearo Group Ltd

V1. 14.01.2015

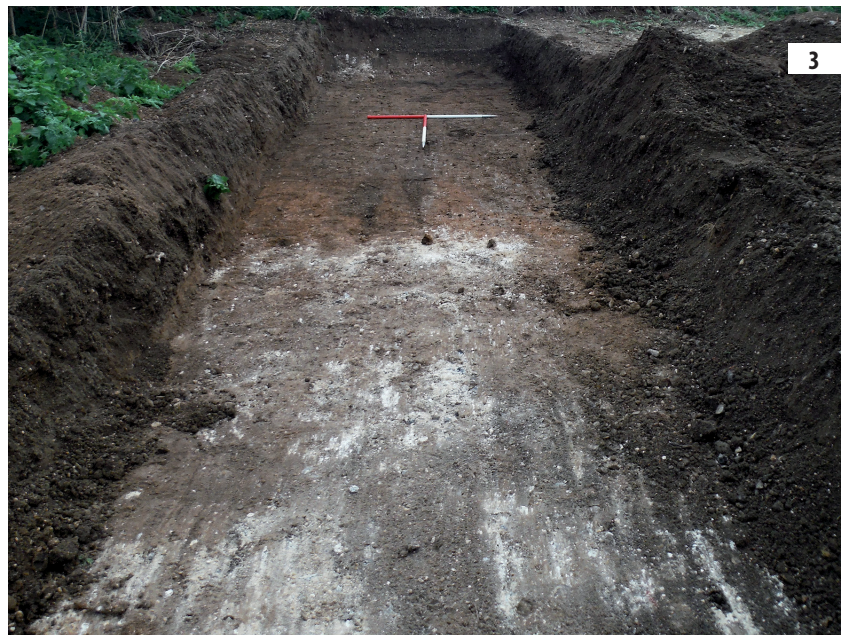
ILLUS 3

Mechanical excavation ceased when the extent of [1006], the Bran Ditch, was exposed, and the area hand-cleaned. The extent of the Bran Ditch was clearly visible in contrast to the surrounding geological deposits of chalk (Illus 3 and 4). It measured approximately 5.92m in width and was aligned NNW-SSE.

NNE facing view of the Bran Ditch

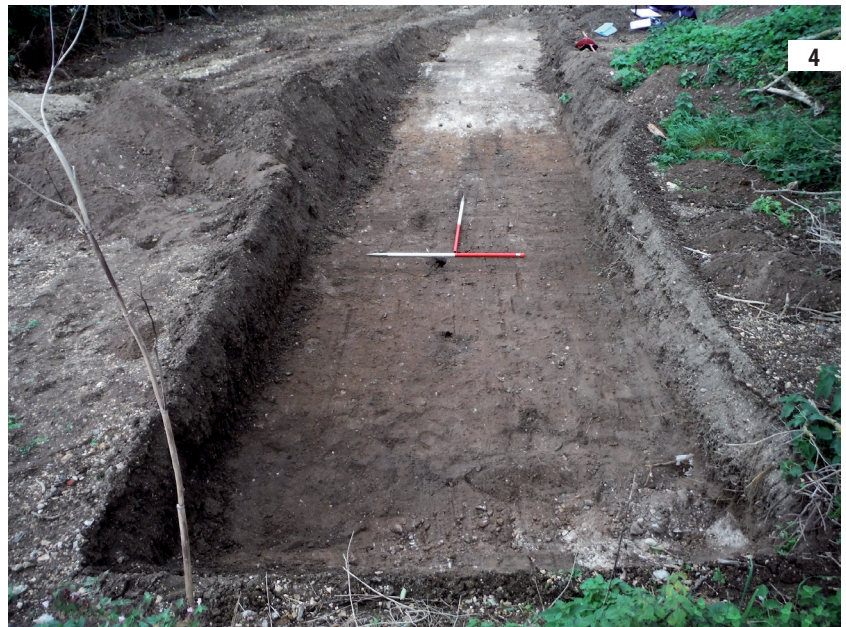
ILLUS 4

SSW facing view of the Bran Ditch

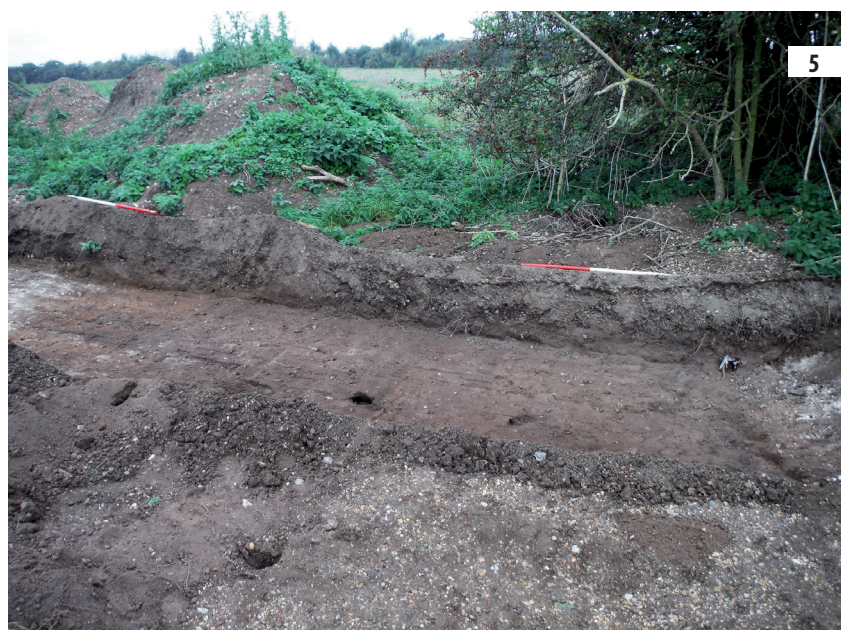
ILLUS 5

SSE facing section of the Bran Ditch

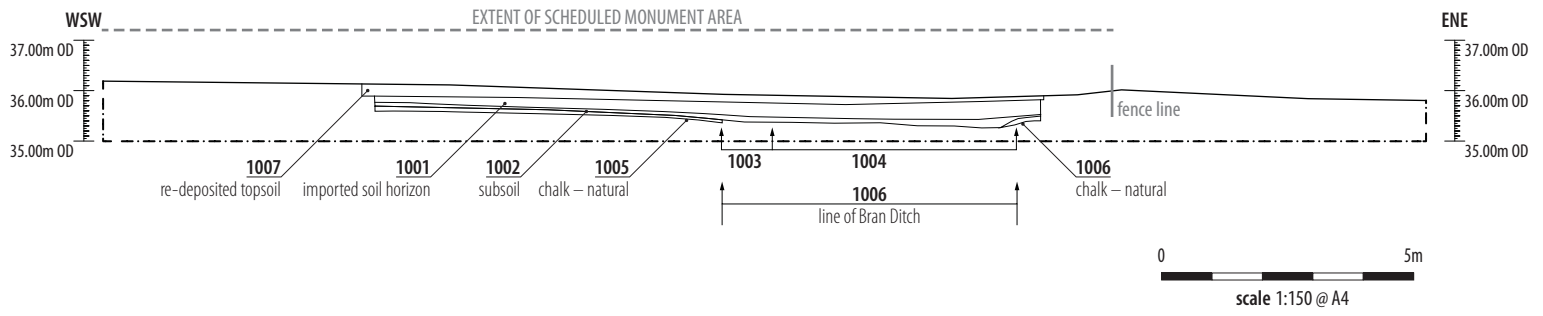
ILLUS 6
Section of evaluation trench

No indication of a large bank or counterscarp bank was observed during the evaluation, although it was visible in the excavated section that the natural chalk deposit (1005) rose at the NNE edge of the ditch line (Illus 6). This may represent part of the former large bank. The lack of evidence for the bank is due to the level of preservation, rather than damage done though the unauthorised works. This area has been subject to agricultural activity and the construction of the A505 and associated layby, flattening the area somewhat and potentially removing any evidence for the bank. This is seen in the profiles through the scheduled area (Illus 7 and 8).
