BADBURY WICK COTTAGES, SWINDON

ARCHAEOLOGICAL WATCHING BRIEF

PLANNING REF. S/10/0842/IH

October 2018

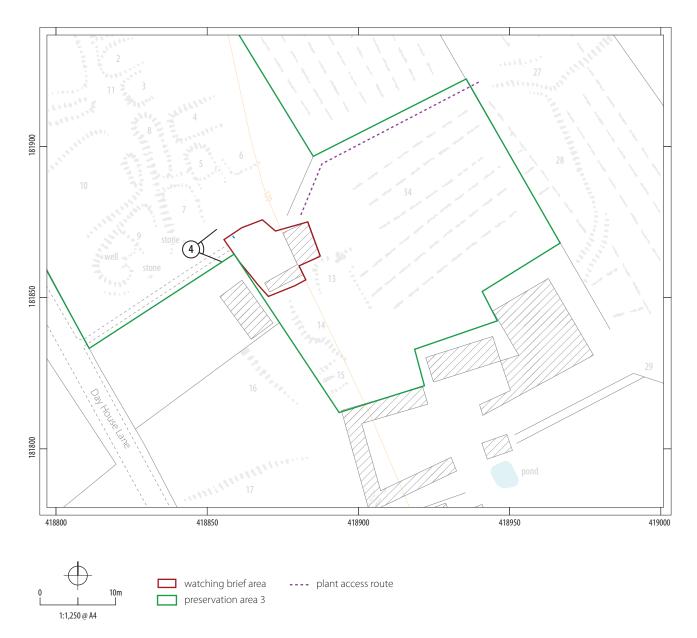
ILLUS 2 Plan of Demolition Site (Preservation Area 3)

Plant movement was restricted to the area indicated in Illus 2.

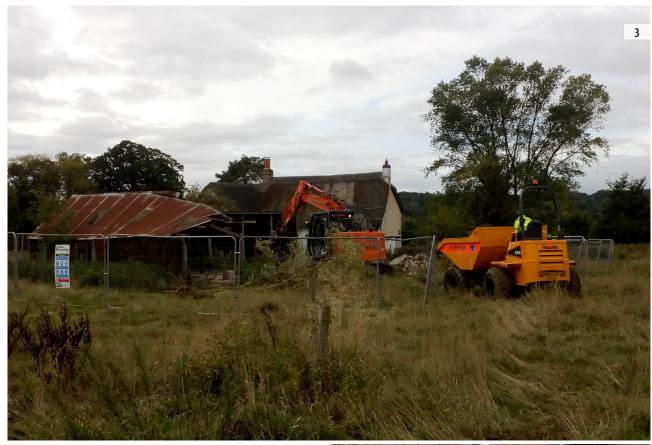
ILLUS 3 East facing shot of demolition works **ILLUS 4** West facing representative section of modern concrete hard standing (0101) and remnants of former courtyard (0102) and (0103)

3.2 19TH / 20TH CENTURY YARD SURFACE (ILLUS 4)

Located in the northern extent of the demolition site were the remains of a courtyard surface. This comprised of a rough assortment of limestone cobbles (0102) (each cobble measured between 0.12–0.32m in length) with an arrangement of unfrogged red brick (0103) (each brick measured between 0.10 x 0.07m). This sat on top of the topsoil (0104) and was in turn sealed by the concrete yard surface (0101).

The underlying topsoil (0104) contained materials related to back yard/horticultural activity, consisting of brick fragments, blue and white china, glass, iron nails, ceramics and ash.

Immediately below the modern concrete hardstanding was the remnant of a former yard surface constructed of cobbles and brick. The surface immediately predates the laying of the concrete and a date for its construction in the late 19th / early 20th century seems likely. Following the removal of this deposit, a former topsoil was

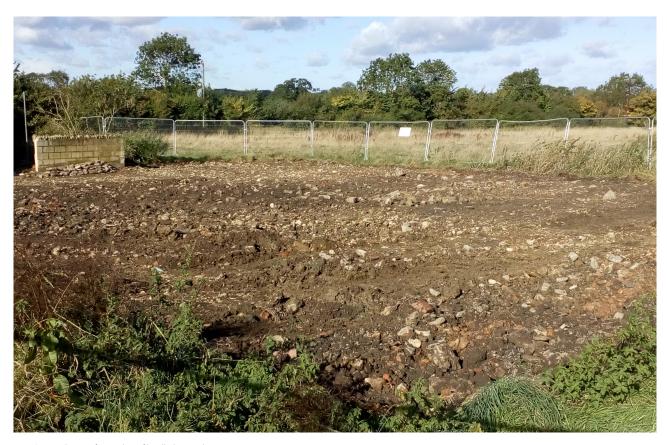
ILLUS 5 North-west facing shot of levelled ground

5 CONCLUSION (ILLUS 5)

No features, deposits or materials pre-dating the 19th century were observed during the project. Adequate monitoring was in place to ensure that any archaeological remains present on the site were not impacted by the demolition works.
