**An Archaeological Evaluation at the
former Neal's Scrap Yard, Gilesgate,
Durham.**

ARS Ltd Report No. 2011/49
June 2011

An Archaeological Evaluation at the former Neal's Scrap Yard, Gilesgate, Durham.

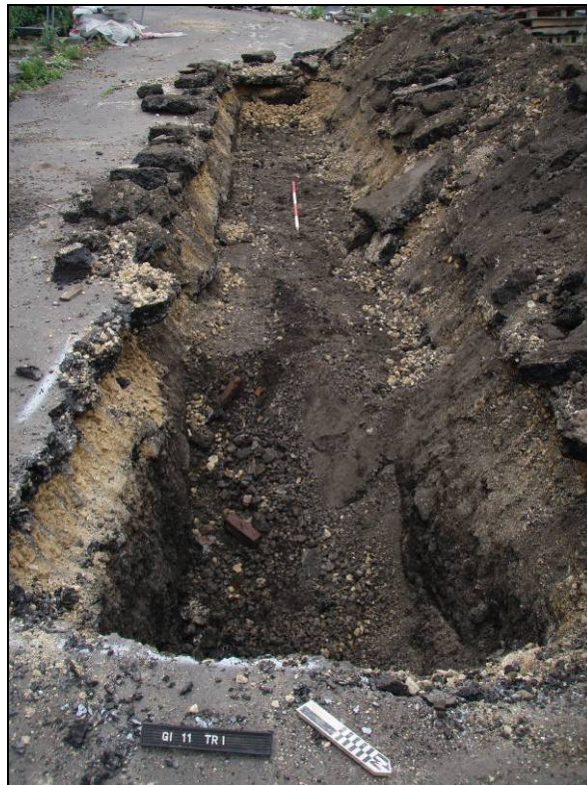
- 6.1 Trench 1 measured 10m in length by 2m in width. A breaker was required in order to penetrate the tarmac layer (001) which constituted the stratigraphically latest layer of the trench. The tarmac layer (001) was a maximum of 0.18m deep. Directly underlying the tarmac (001) was a layer of hardcore (002) which had a depth of 0.3m. A previous road surface (003) underlay the hardcore layer (002) and consisted of a coarse tarmac with a depth of 0.20m. A shallow second hardcore layer (004) underlay the former road surface layer (003) and had a depth of 0.1m. Directly underlying the second hardcore layer (004) was a layer of made ground/ landfill (005). The landfill contained modern plastics, as well as electrical wiring, metal and glass. The depth of this layer could not be determined as it

extended beyond the depth of excavation. Due to the unstable nature of the material, and the confined space to work in, it was not possible to excavate the trench to any great depth, therefore in order to evaluate the landfill deposit, the layer was removed in the northeast corner of the trench to a depth of 3m. Diesel contamination was present in the landfill (004) layer of this trench. There were no features of archaeological or historical significance found in this trench.

Figure 3: Trench 1 showing landfill deposit, and test depth in northeast corner.

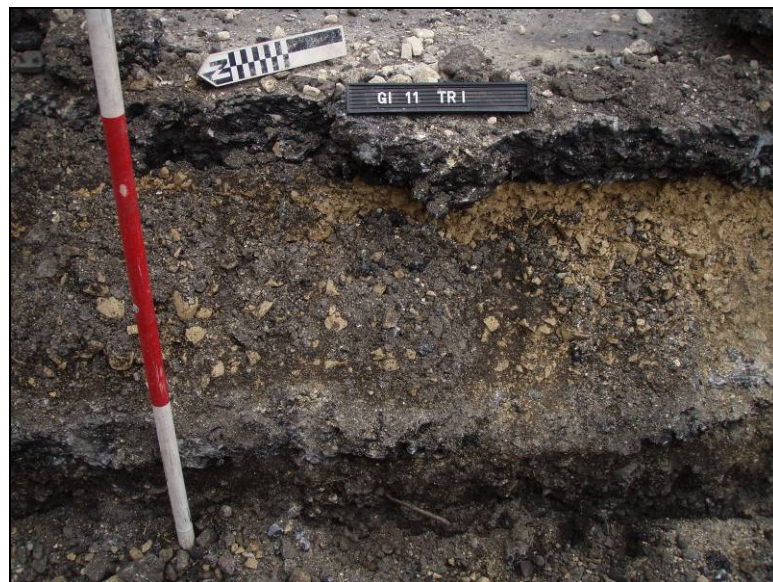
Figure 4: North facing section of Trench 1 showing two levels of hardcore and tarmac.

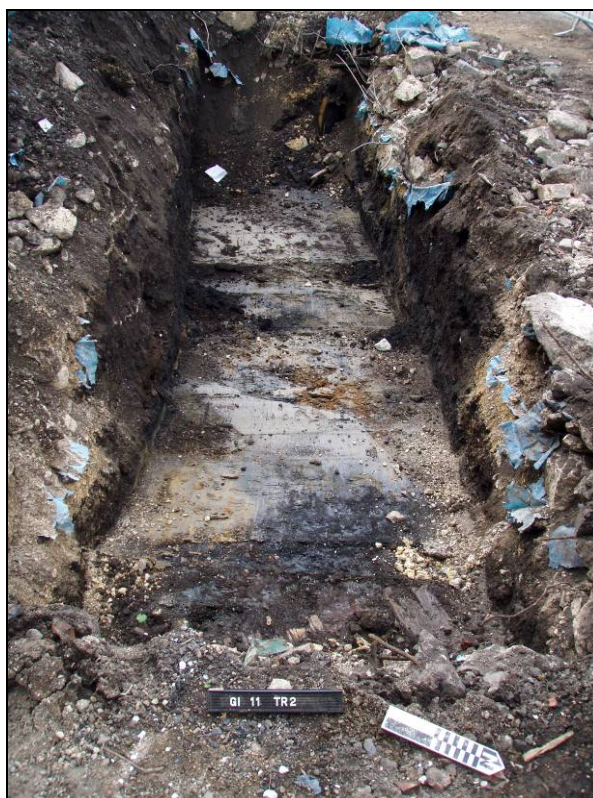
- 6.2. Trench 2 measured 10m in length by 2m in width. A layer of broken tarmac and rubble (006) covered this trench to a depth of 0.20m. Directly underlying the rubble (006) was a layer of hardcore (007), which existed to a depth of 0.80m in the northeast end of the trench, and 0.10m in the south west. Directly underlying the hardcore was a layer of made ground/ landfill (008), as in Trench 1. This landfill layer was considerably shallower in Trench 2 than in Trench 1, with depths between 0.2m and 0.6m deep, suggesting that this area was the top of the slope which declines to the north. The landfill (008) in this trench had heavy diesel contamination throughout. There were no features of archaeological or historical significance found in this trench.

Figure 5: Trench 2 Showing landfill deposit.

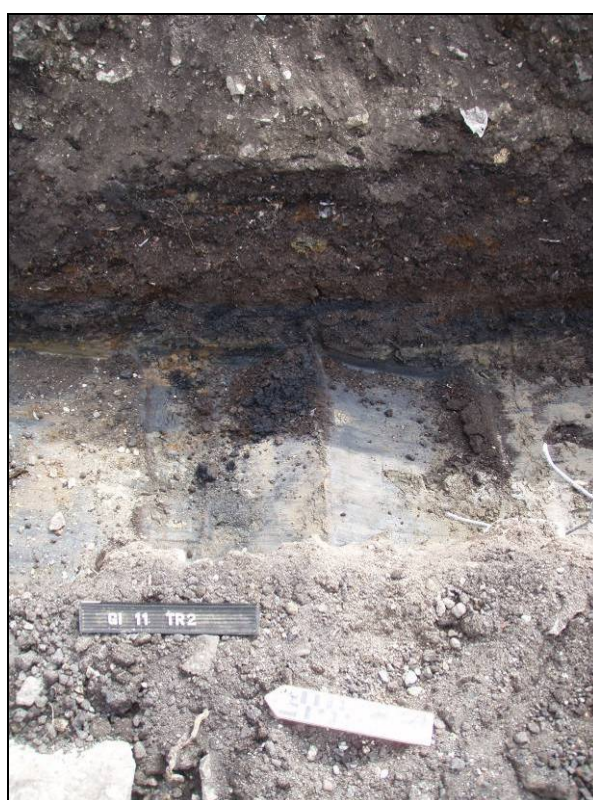
Figure 6: Trench 2 North facing section showing landfill deposit over clay.
