## St. Giles Church, Matlock Watching Brief Report

**ARS Ltd Report 2006/29**

August 2006

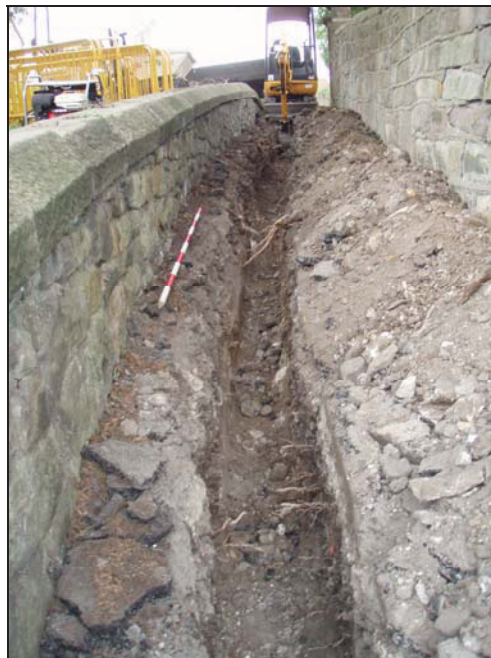
Fig. 3 General view of the cable trench looking west.  
Scale: 2m

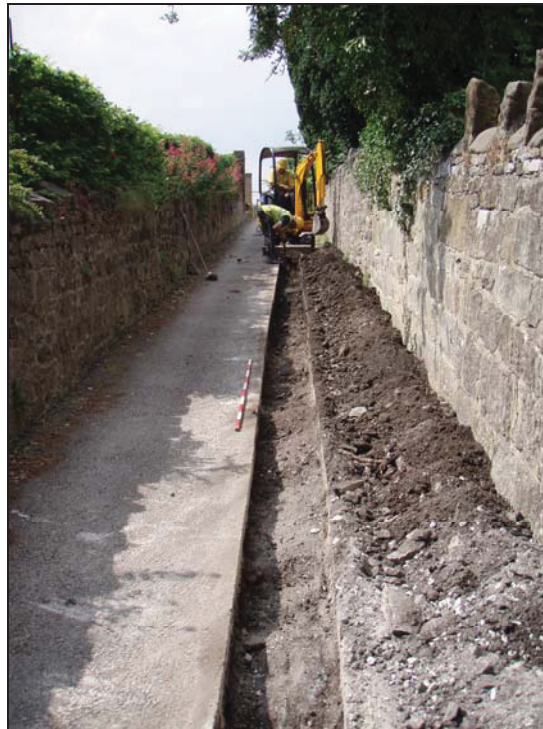
Fig. 4 Trench under excavation in driveway to graveyard  
Photograph taken looking west. Scale: 2m

- 5.3 The only feature identified (001) was located beneath the sunken tarmac driveway leading to the graveyard (Figs 2 & 4). This consisted of a linear arrangement of placed sandstone blocks, the largest of which measured 0.46m in length, 0.22m in width and 0.19m in depth (Figs 5 & 6). To the west of these stones was an area of levelled ground (005) (Fig. 7) which consisted of a dark brown (10YR 3/2) deposit containing small pieces of coal, brick and Victorian pottery. This was a relatively shallow deposit (0.08m) and overlay another deposit of lime mortar to a depth of 0.09m (006). This layer rested upon the natural limestone bedrock and was again found to contain small pieces of brick and Victorian pottery. The feature had a width of 6.95m and was bounded to the rear by the natural limestone bedrock which rose close to the Tarmac surface. The feature can best be interpreted as the remains of a structure of uncertain date but probably dating to the Victorian period in view of the nature of the pottery and the presence of coal.

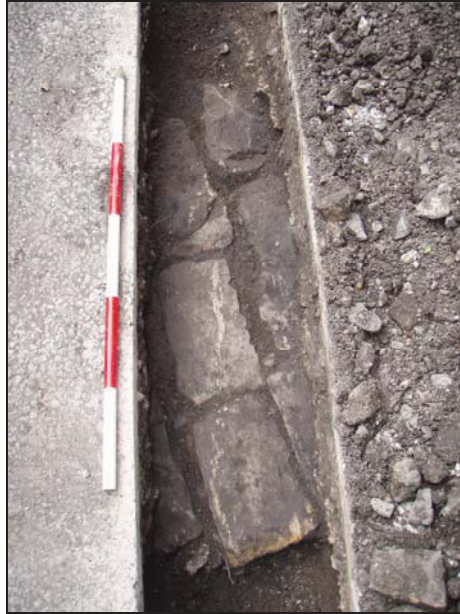
Fig. 5 Linear feature of placed sandstone blocks. Vertical shot.  
Scale: 1m

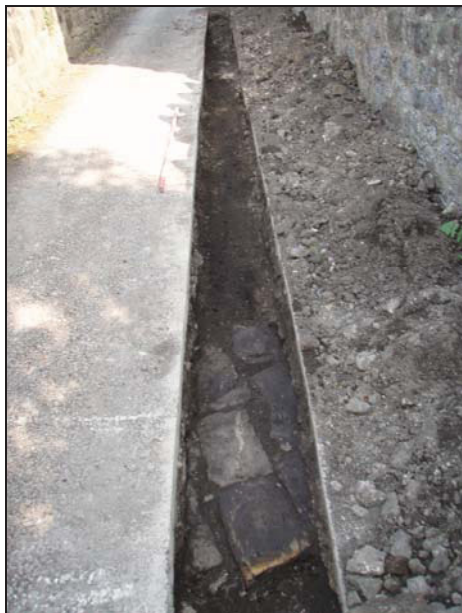
Fig. 7 Feature (001) looking west.  
Scale: 2m
