'FAIRVIEW' **Carmen Street, Gt.Chesterford**

HN450

Archaeological Monitoring Report

April 2004

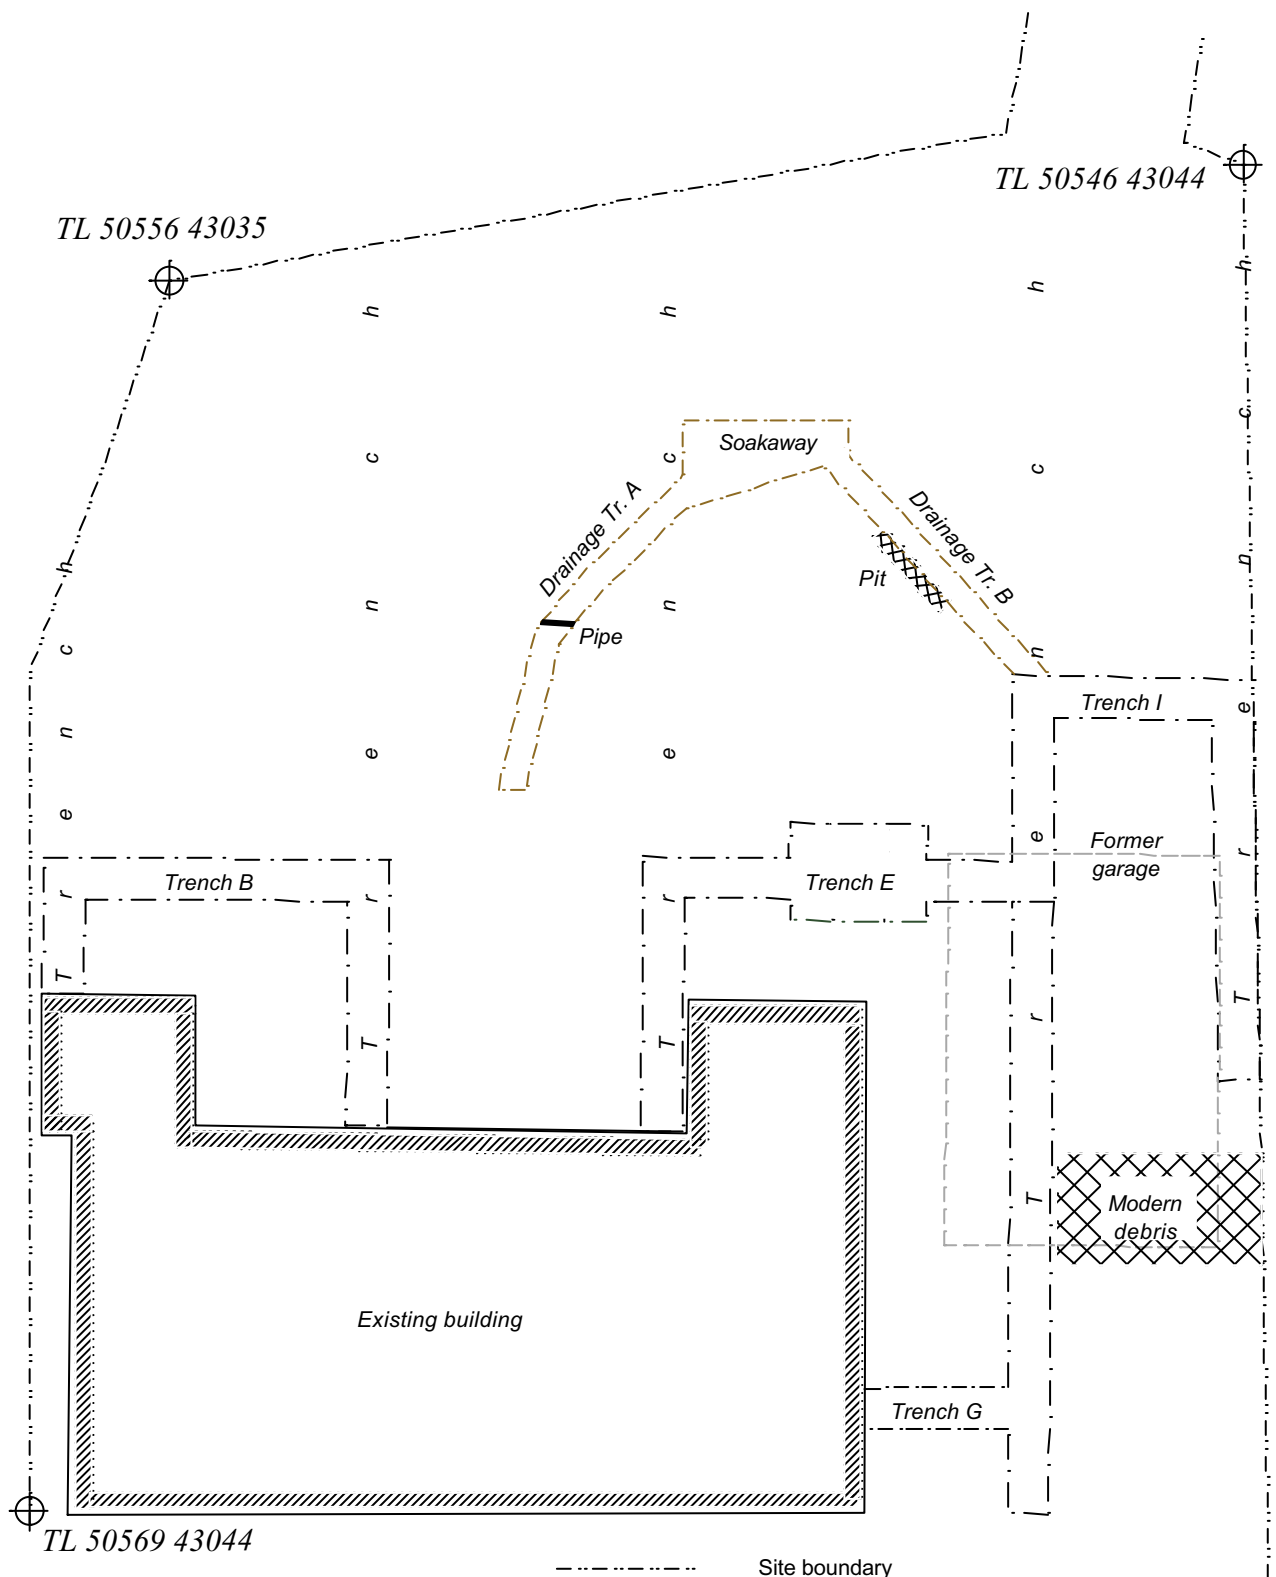
Figure 2

2.7 The footings trenches were excavated using a tracked mini-digger fitted with a 450mm toothless bucket (Fig.2).

2.15 The drainage trenches were excavated using a mini-digger fitted with a 350mm toothed bucket (Fig.2).

Site layout

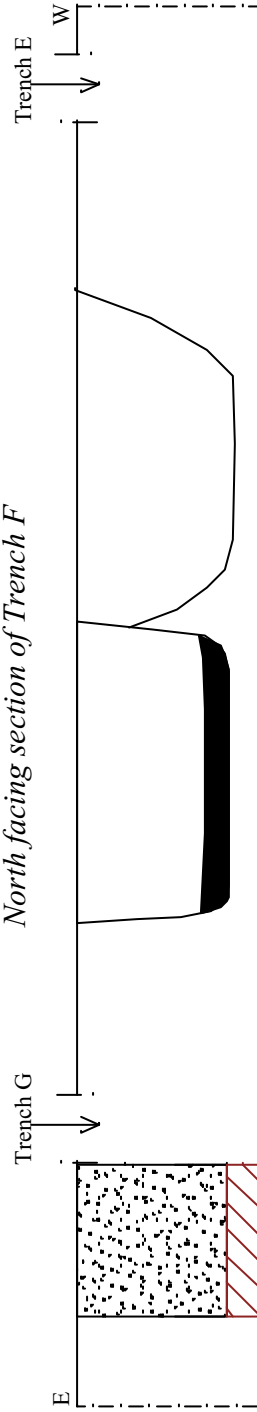
North facing section of Trench F

2.12 A number of possible pits were revealed in Trench F, most of which were filled with a dark reddish brown sandy clay (Fig.3). One, however had a mid-brown sandy-silty clay fill and another contained mixed material over a dark, charcoal-rich fill. No artefacts or ecofacts were found in these features.
