Great St. Mary's Church, Sawbridgeworth, Hertfordshire

HN1178

Report No. 919

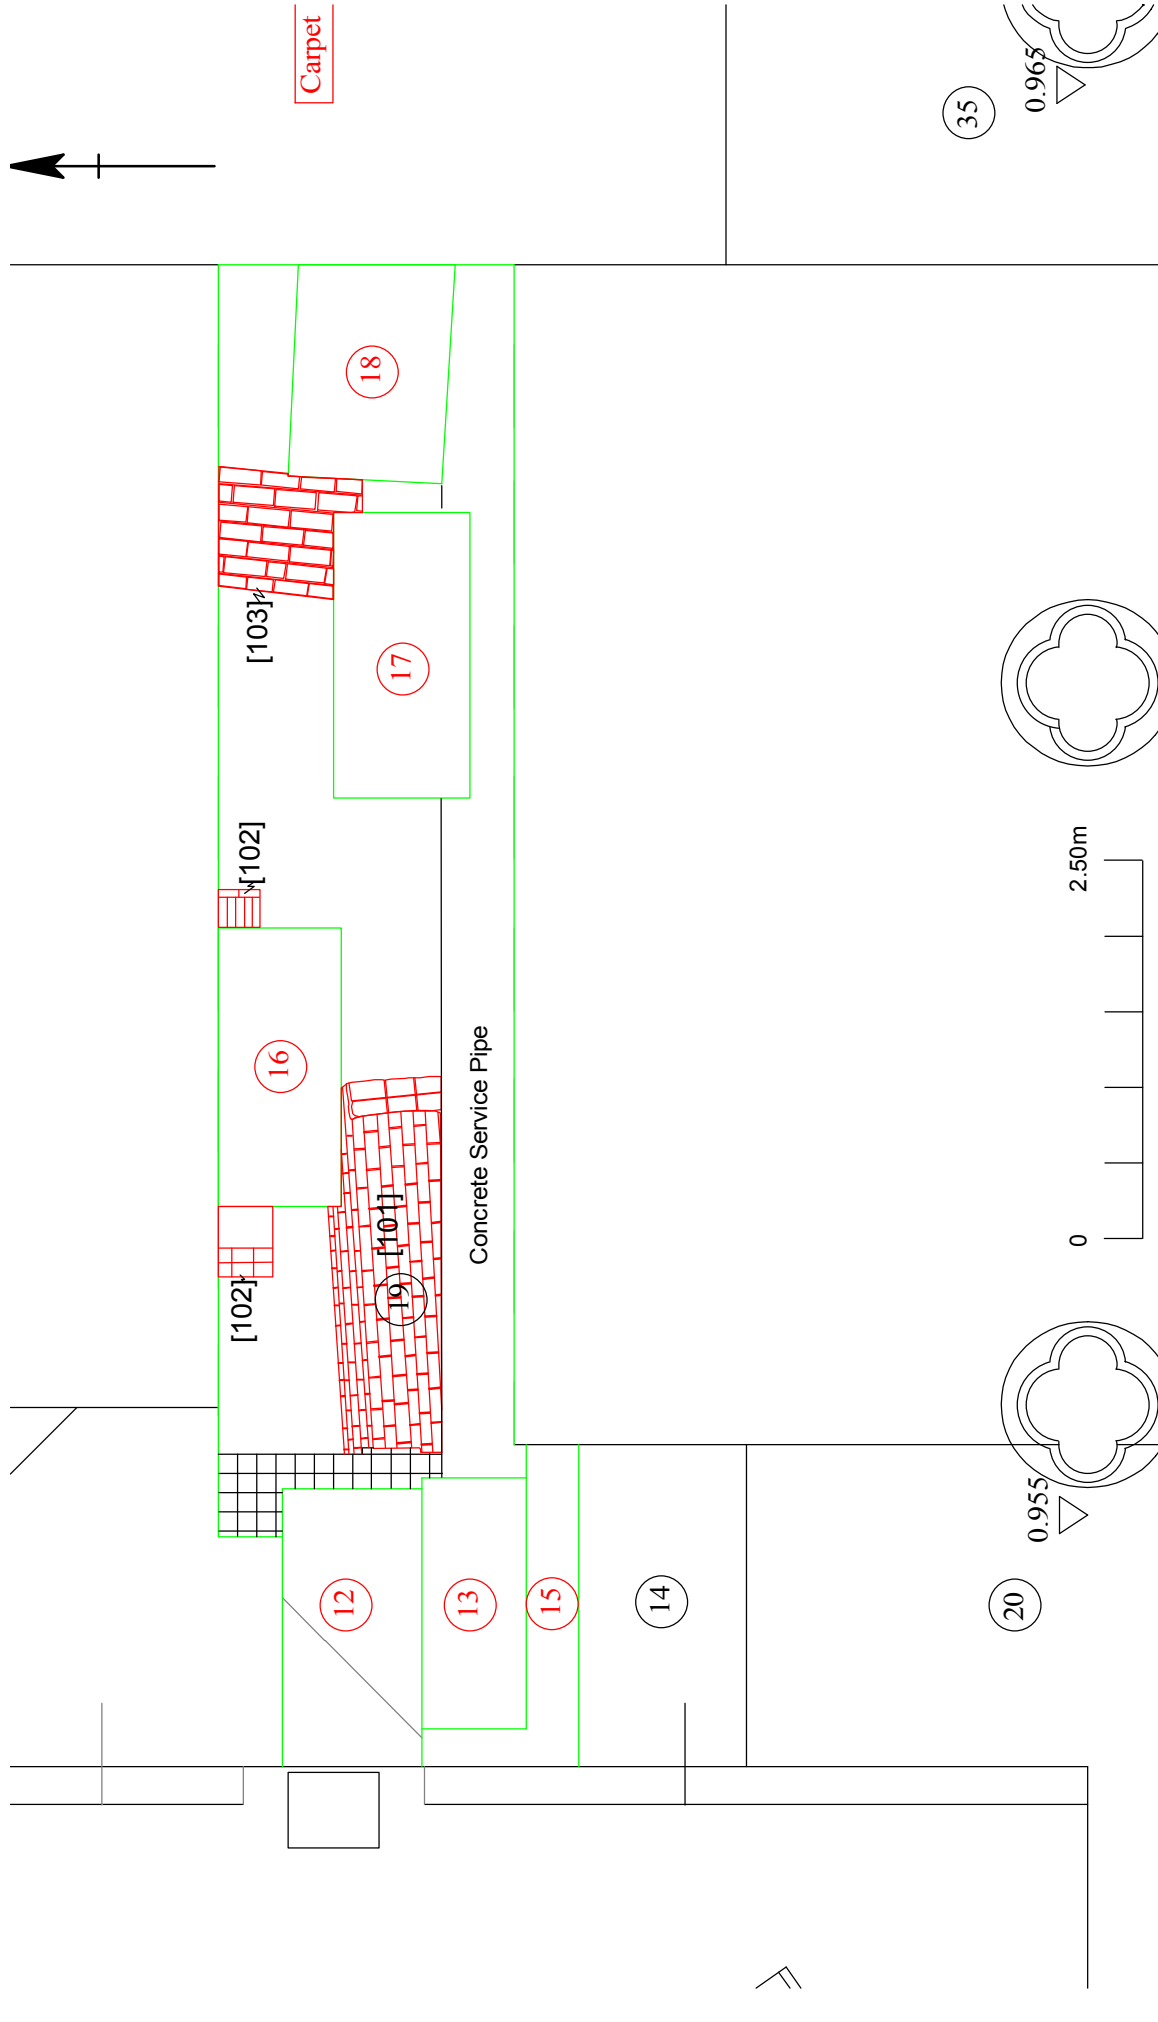
Plan of Archaeology

The groundworks for the present project were located in the centre of the nave. This work exposed the roofs of two probable brick built burial vaults dating to the mid 19th century or earlier, and a 20th century brick structure of unknown purpose.

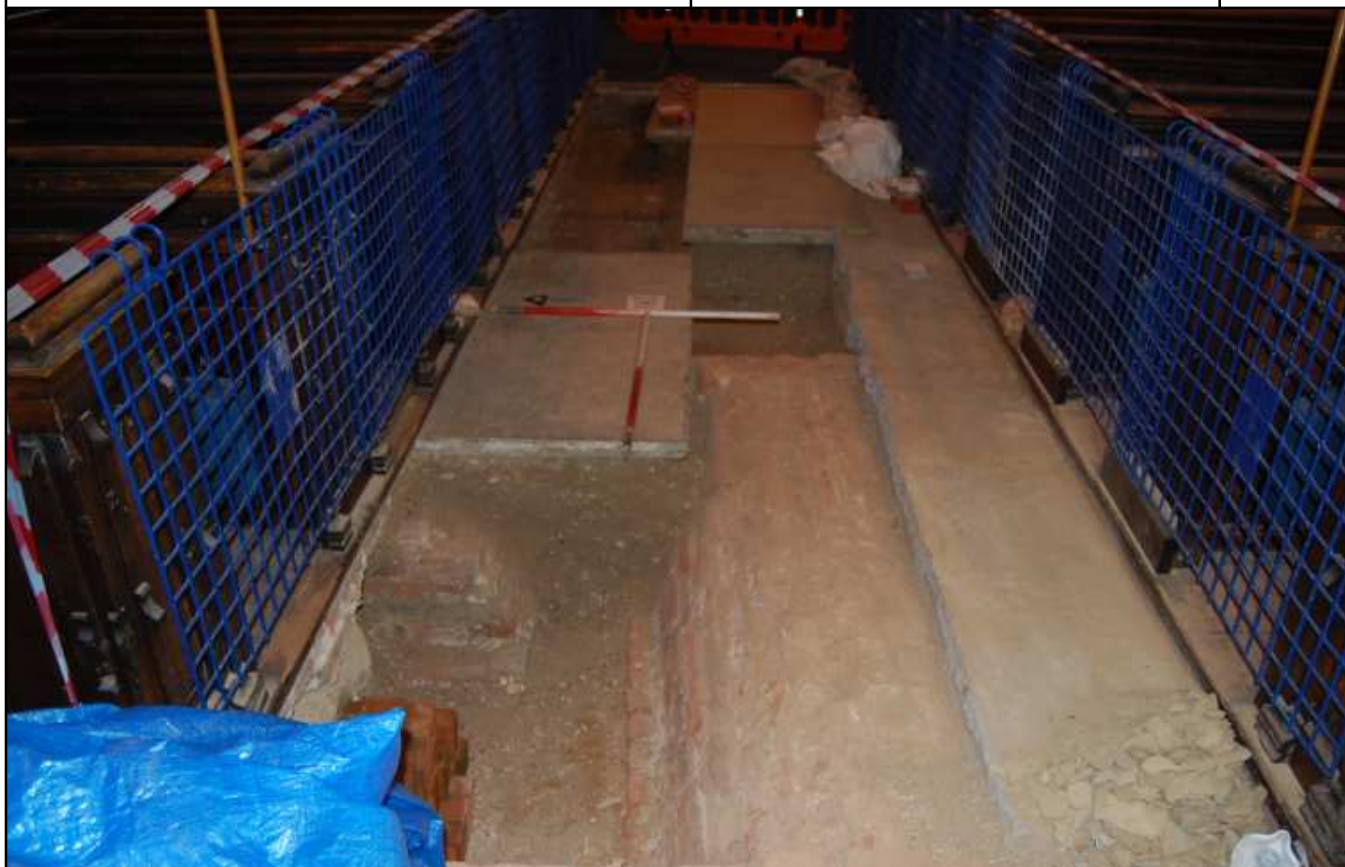
Plate 1: Vaults [102] and [101] looking east

Three brick structures were revealed in this area. Structure [101], was encountered in the southwest corner of the trench and was orientated east – west, along the nave. It was built of handmade red bricks, bonded with lime mortar and had a curving roof. Its exposed area measured 2.50m in length, 0.80 in width and 0.15m in depth (Figure 3, Plate1). The structure has been interpreted as a burial vault of mid 19th century or earlier date.

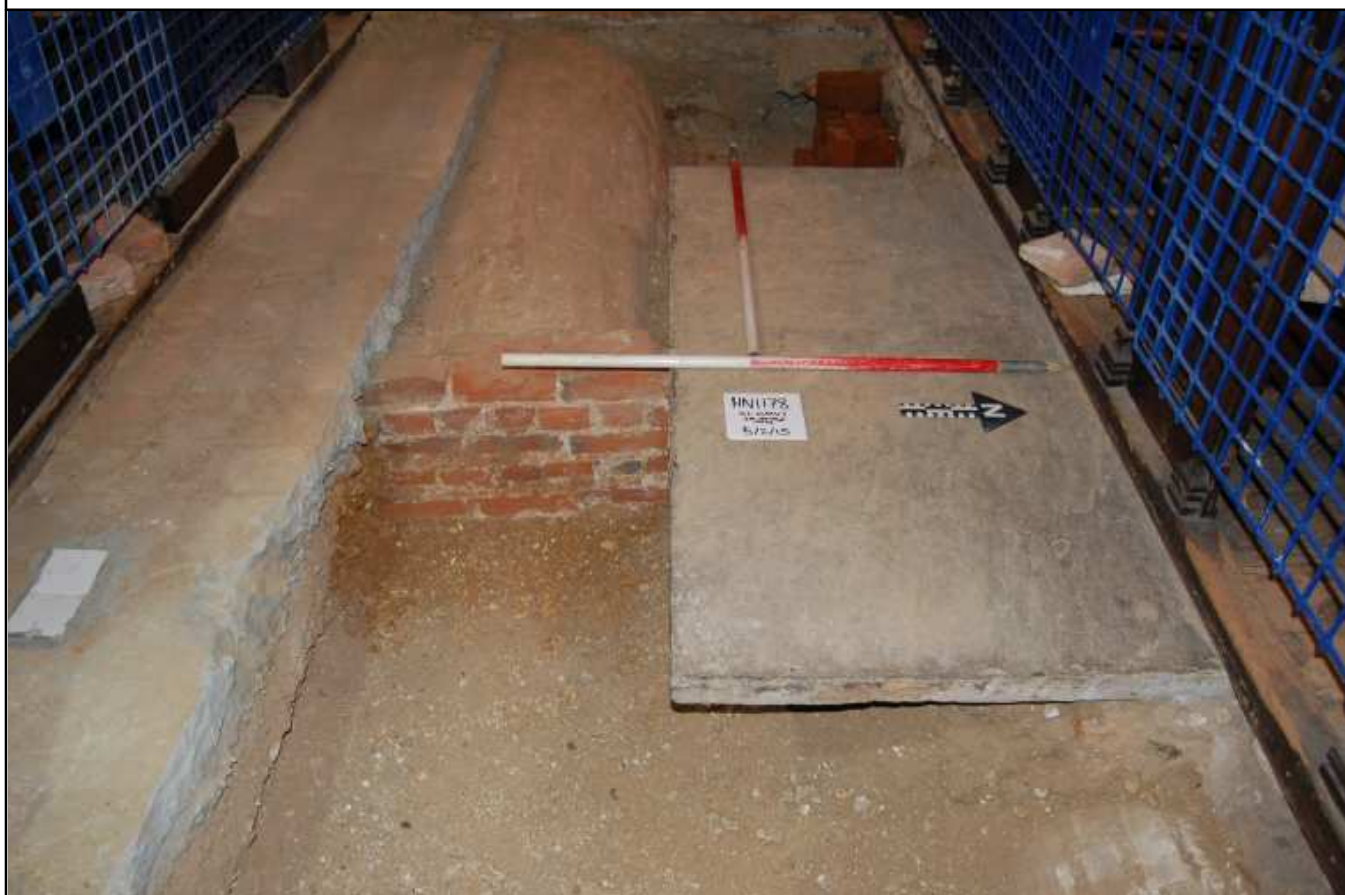
Plate 2: Vaults [101] and [102] looking west

Structure [102] was located on the northern side of the aisle, to the north of [101], and lay below ledger stone 16 (Figure 3, Plate 2). It was also aligned east – west and constructed of red handmade bricks bonded with lime mortar. Its exposed area measured 2.5m in length, 0.40m in width and 0.20m in depth. No lettering was visible on the ledger stone.

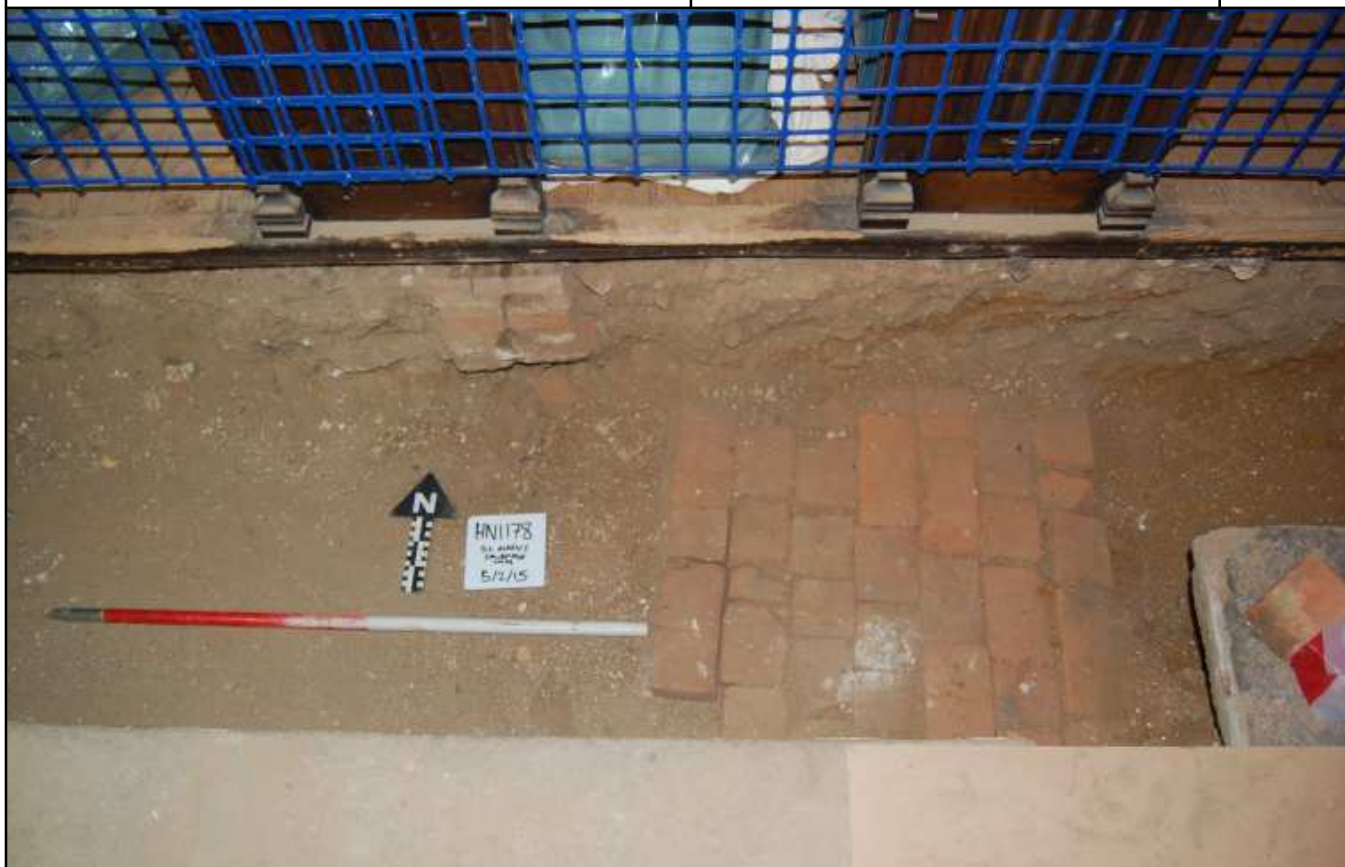
Plate 3: Brick structure [103] looking north

Structure [103] was located towards the eastern end of the aisle, to the east of [102] and was orientated north - south (Figure 3, Plate 3). Its exposed area measured 0.75m in length, 0.80m in width and 0.12m in depth. It was constructed of red machine manufactured bricks, which had been broken to fit. The bricks, which were laid at least two courses high and bonded with a dry lime mortar, may have been reused or reclaimed for this purpose. This structure was apparently of later date than the postulated burial vaults to the east, although it's purpose is unknown.

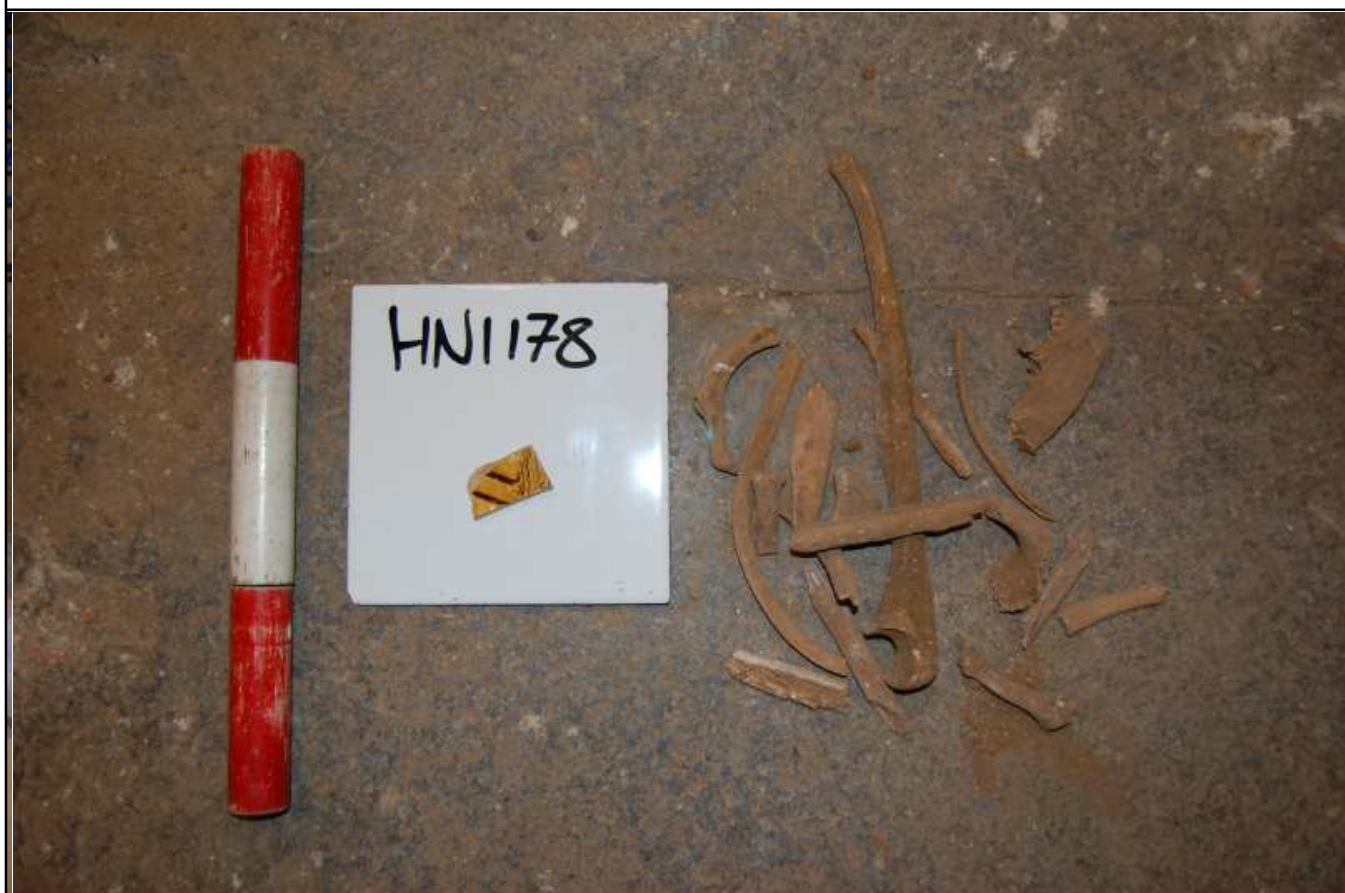
Plate 4: Disarticulated bone and pottery sherd

Finds collected during the course of the present project comprised seventeen disarticulated human bone fragments and a sherd of slip-trailed pottery of probable 18th century date (Plate 4). With the agreement of the vicar, these were all reburied in the trench after the work was complete.

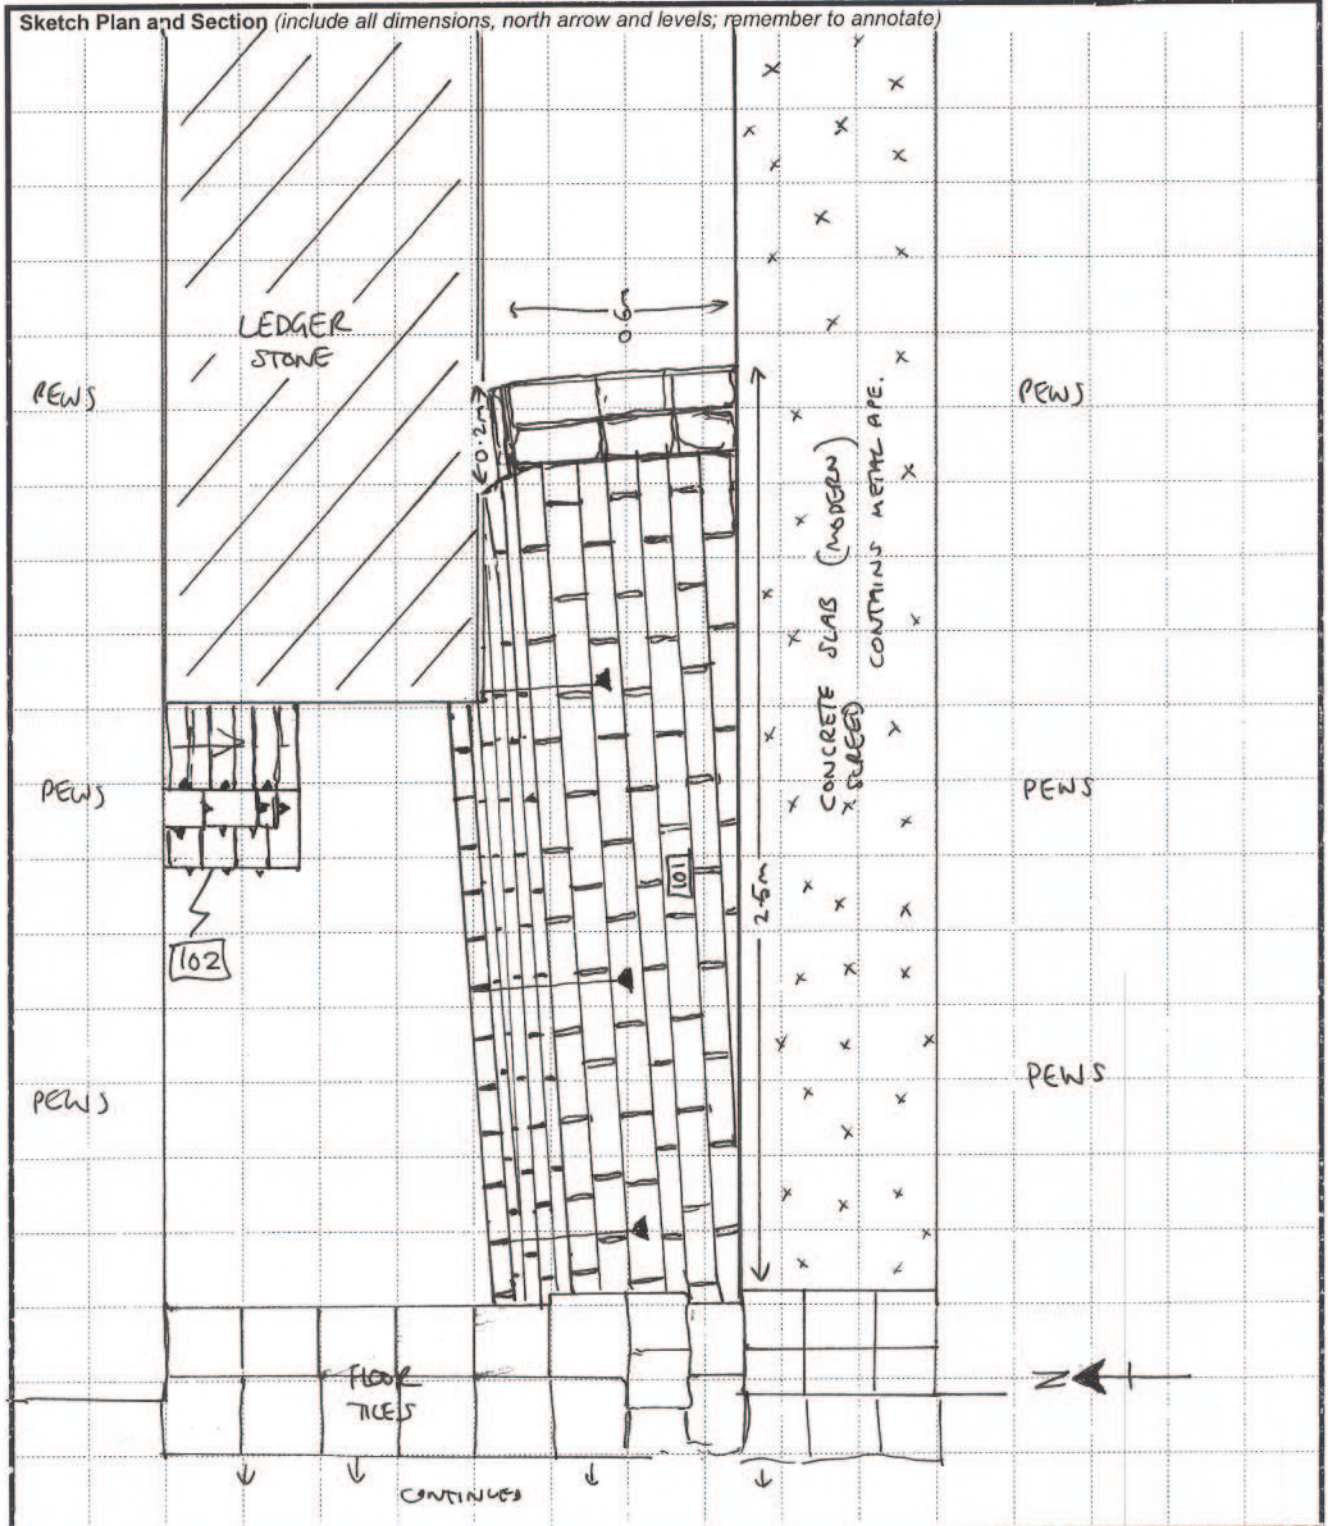
SITE CODE YN 1178	Site Name Sawbridgeworth Ch. St. Mary's Church	Sub-division NAVE	CONTEXT [101]
----------------------	--	----------------------	------------------

Discussion and interpretation	BRICK BUILT VAULT [101] (EXPOSED DIMENSIONS:- 2.5m		
	long by 0.5m wide).		
Scale	1:20		
Signature	DAJ		
Date	8/1/15		
Checked	✓		
Sheet	2	of	3
