GADEBRIDGE PARK, Hemel Hempstead, Hertfordshire

HN1351

Report No. 1093

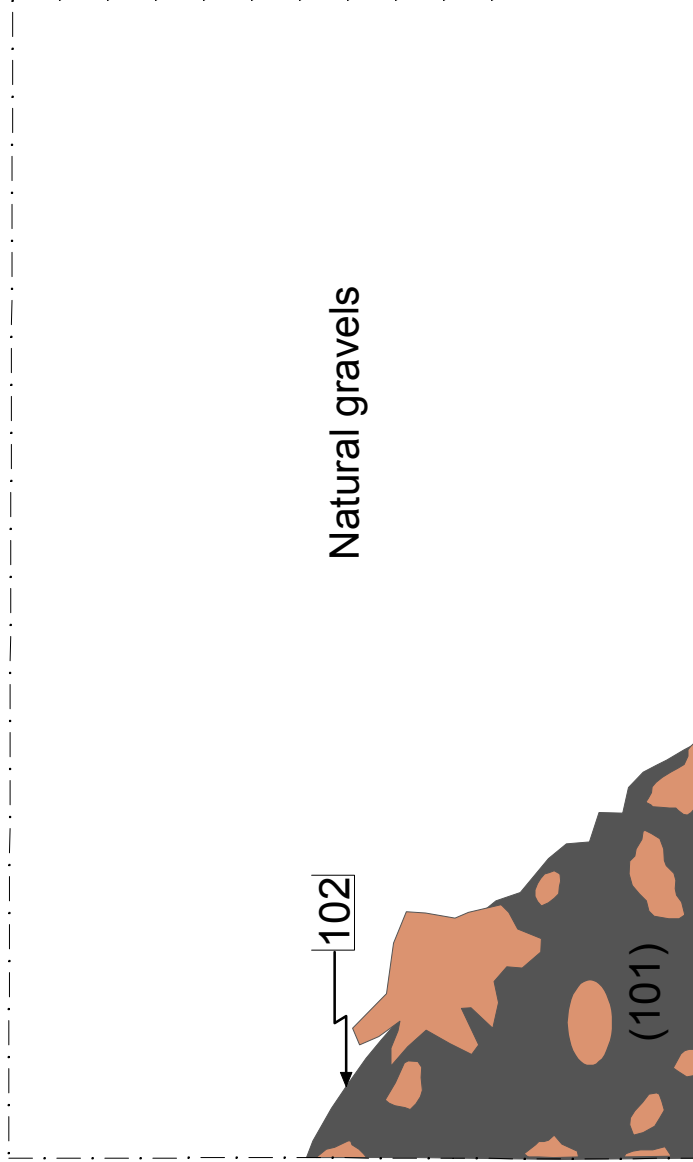
Plan of water tank trench

Feature [102], was observed cutting the natural gravels in the south-western corner of the trench and measured over 2.5m in length, over 2.2m in width and 1m in depth (Figure 3). It was very irregular in shape and in profile. The fill, (101), consisted of dark grey and black sticky silty clay containing frequent rotting wood fragments and pockets of natural gravels. No finds were recovered from the fill to date the feature, which has been interpreted as a possible tree bole.

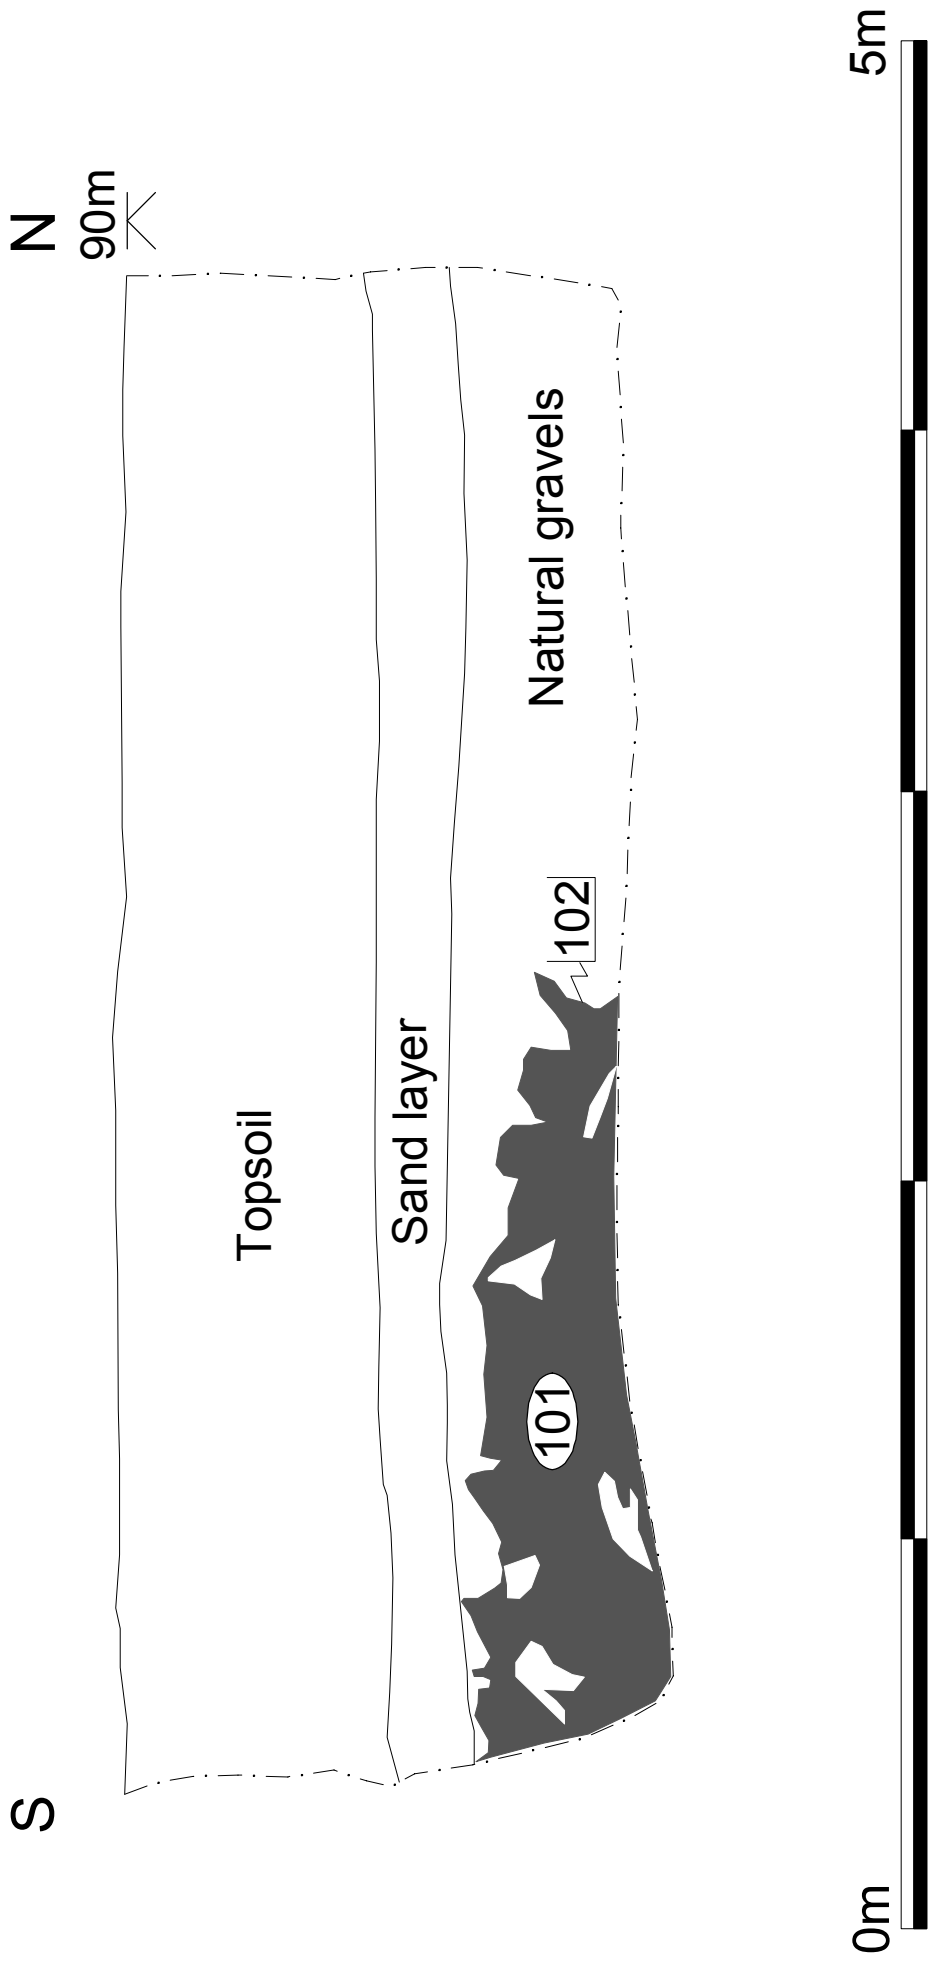
Section of E facing baulk of water tank trench

A single feature was revealed in the water storage tank trench. However, the irregularity of the cut and the presence of wood within the fill indicates that it is likely that this feature represents a tree bole.

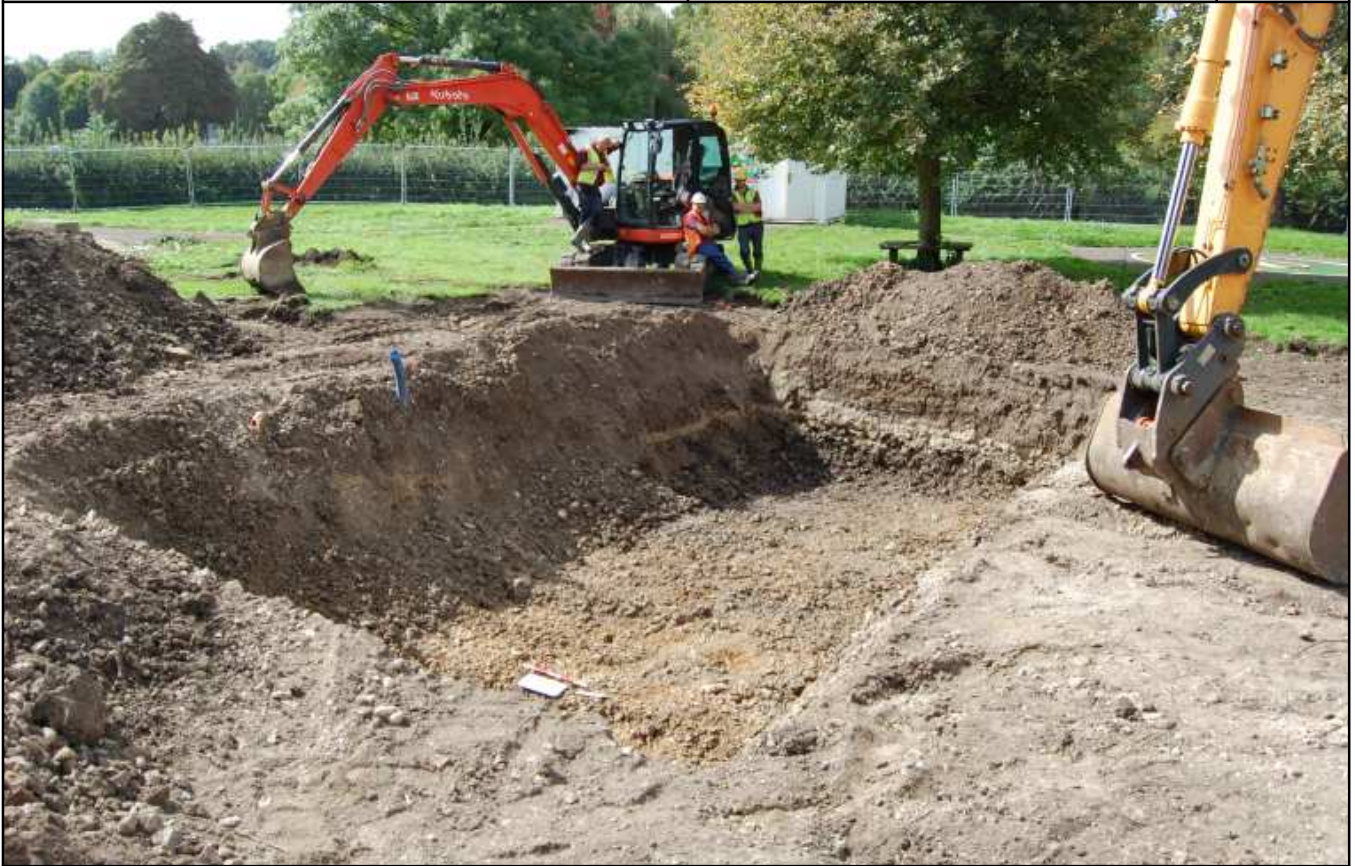
The first phase of works involved monitoring the excavation of the water tank trench, immediately to the west of the splash park. This measured 7m in length by 4m in width and was excavated to a depth of c.1.3m (Figure 2). The exposed stratigraphy consisted of dark greyish brown, friable sandy silty clay topsoil, 0.7m in depth, above a layer of friable white sand with gravel, c.0.2m in depth. The natural substrate was reached at a depth of approximately 0.9m below the present ground level and consisted of mid/light orange brown sands and gravels (Plates 1-4).

Plate 1: Water tank trench, looking SW

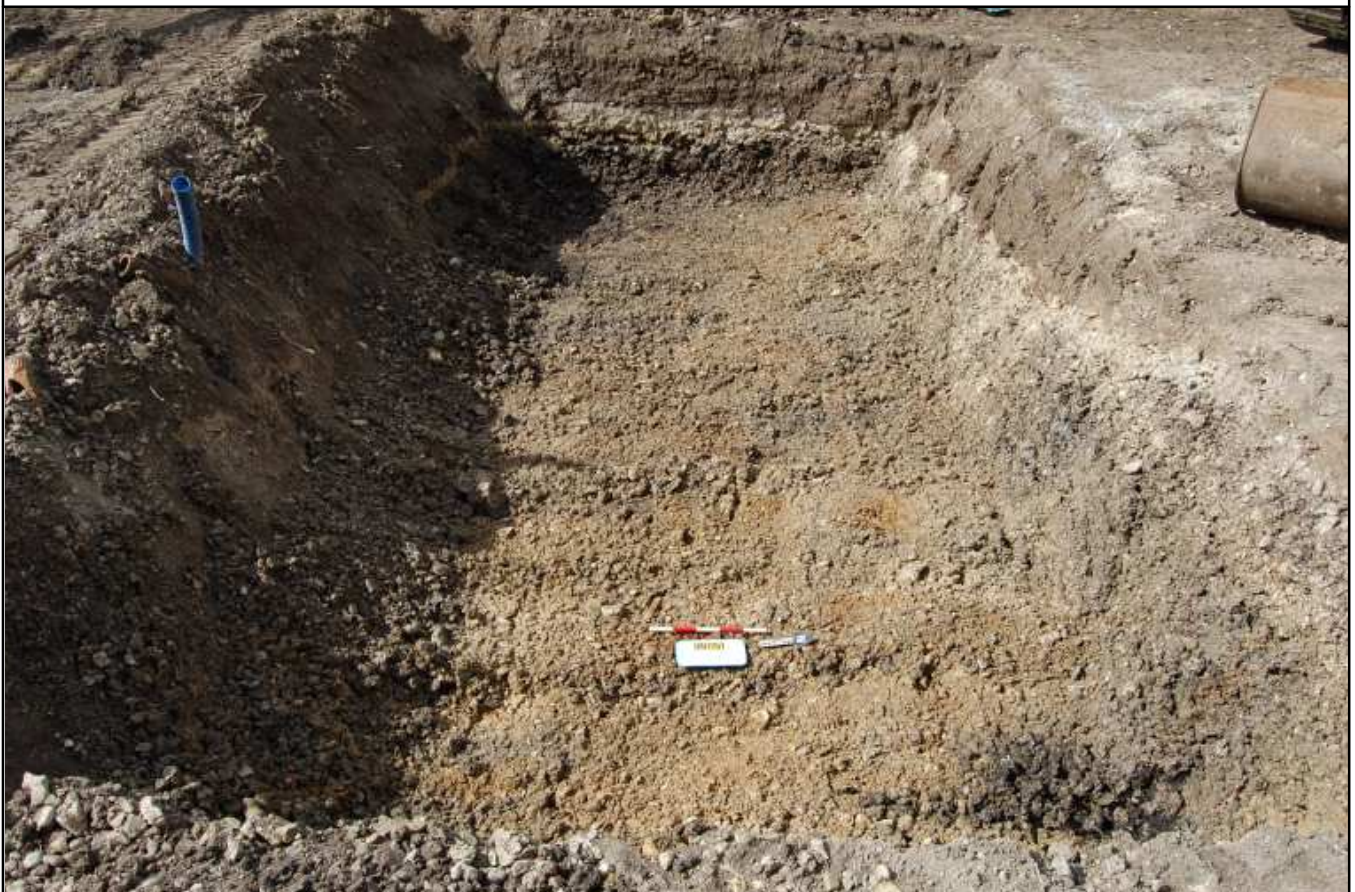
Plate 2: Water tank trench, looking W

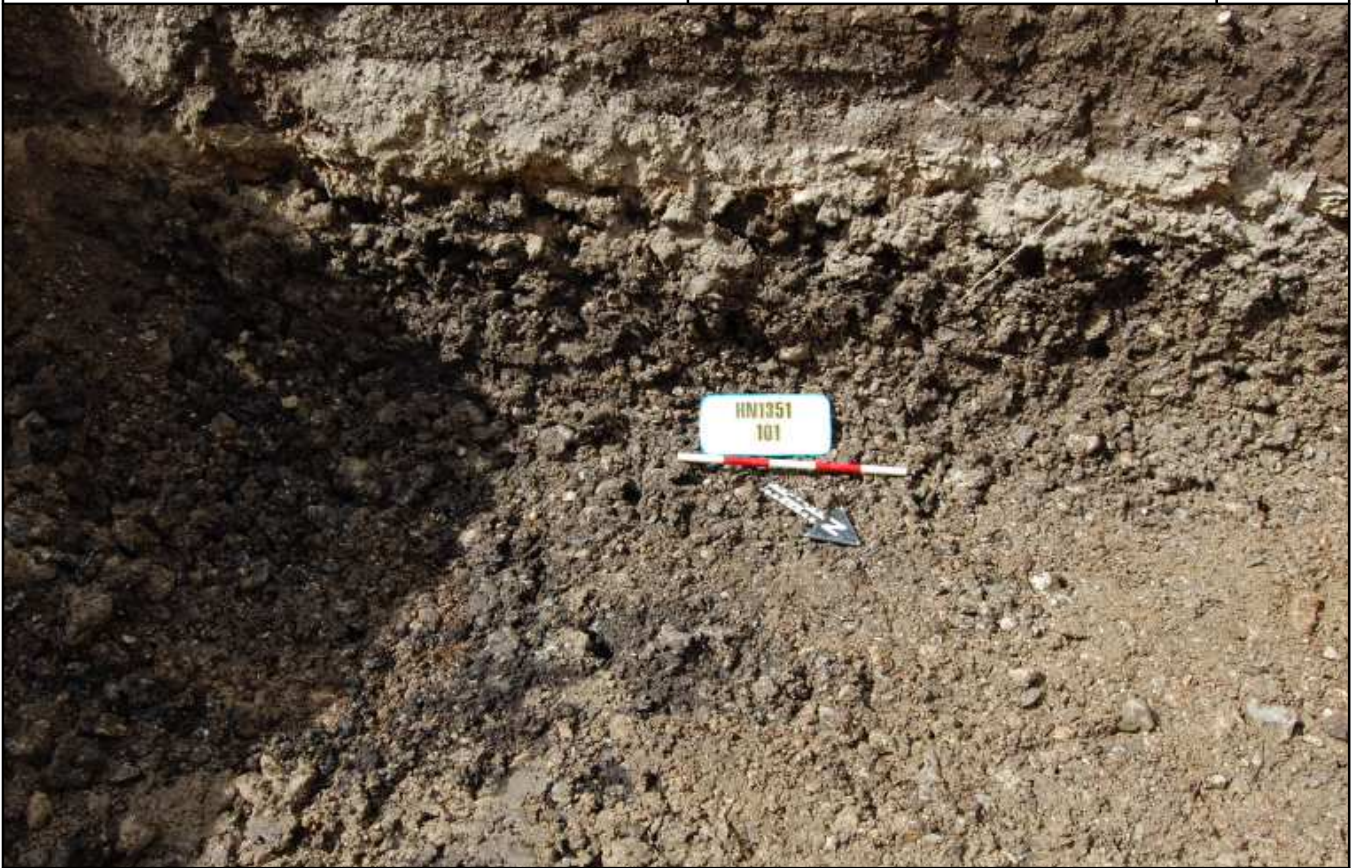
Plate 3: Possible tree bole [101], looking SW

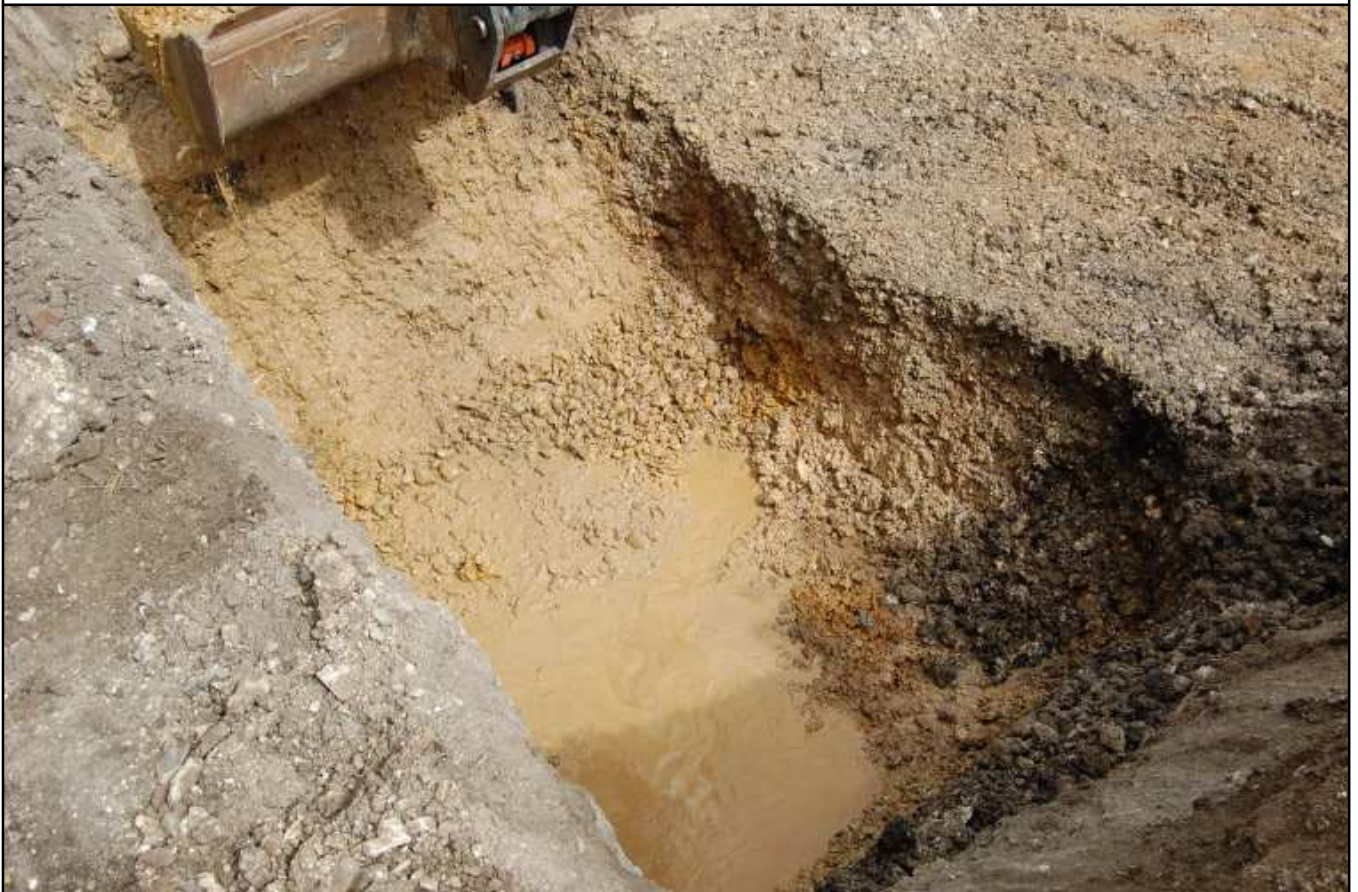
Plate 4: Working shot showing natural gravels, looking NE

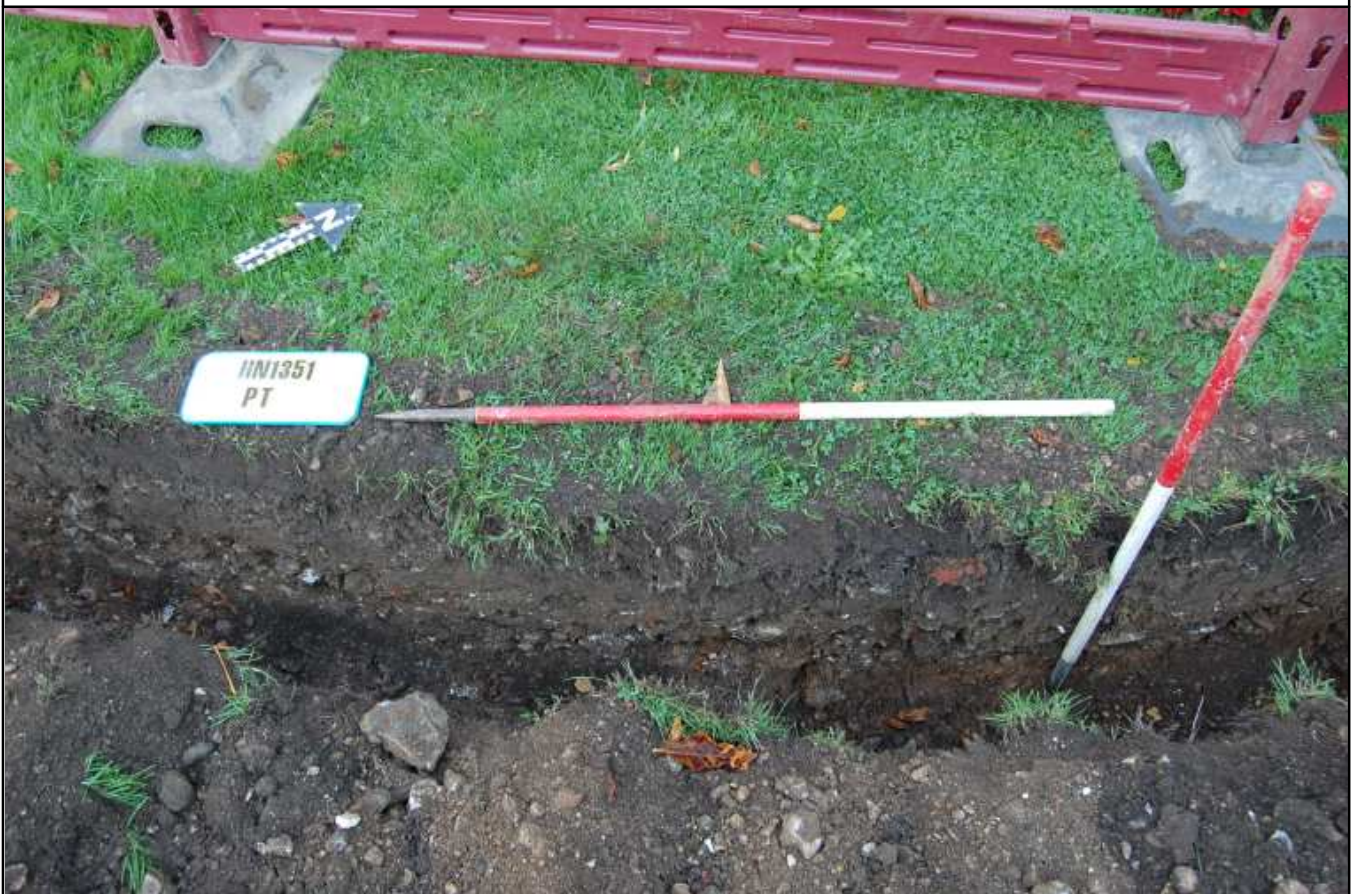
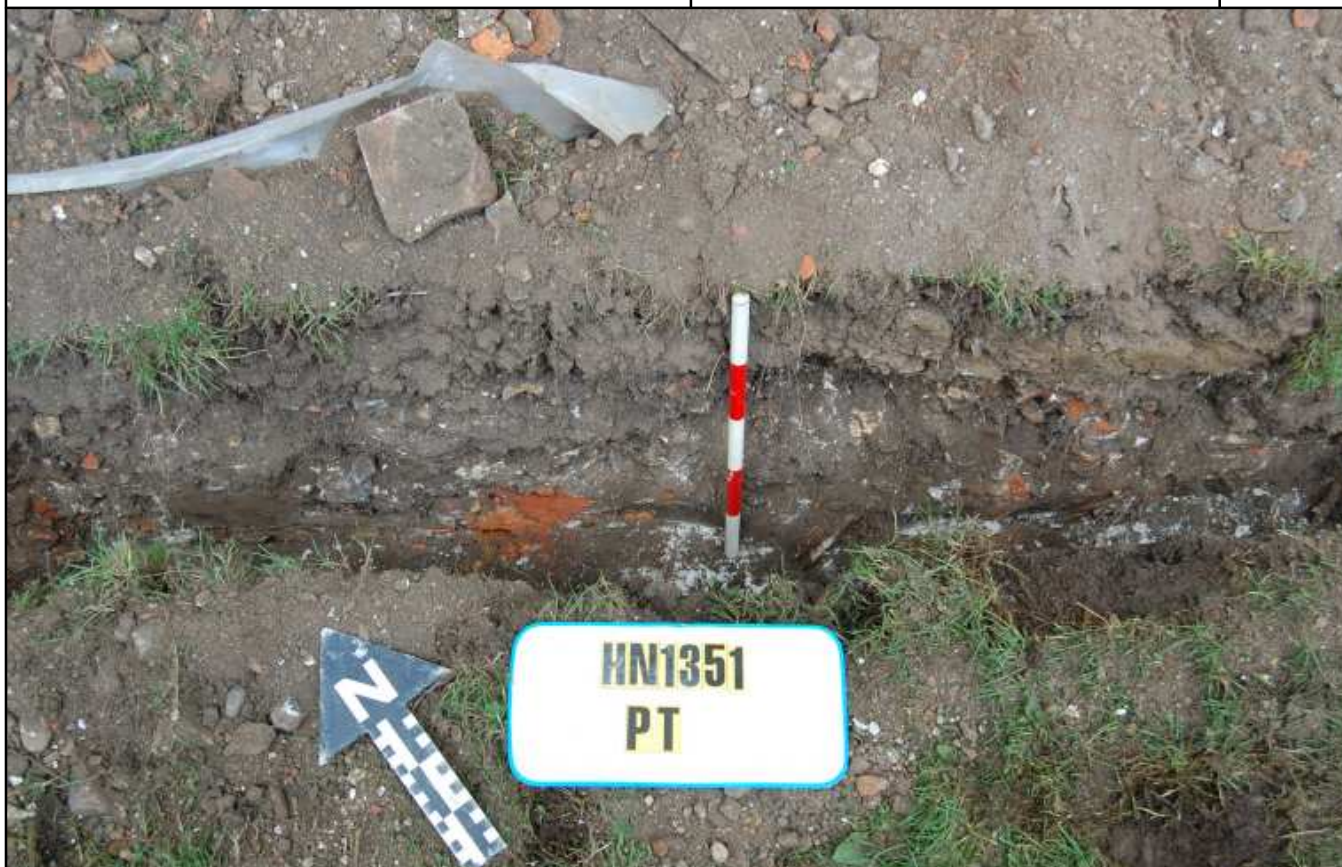
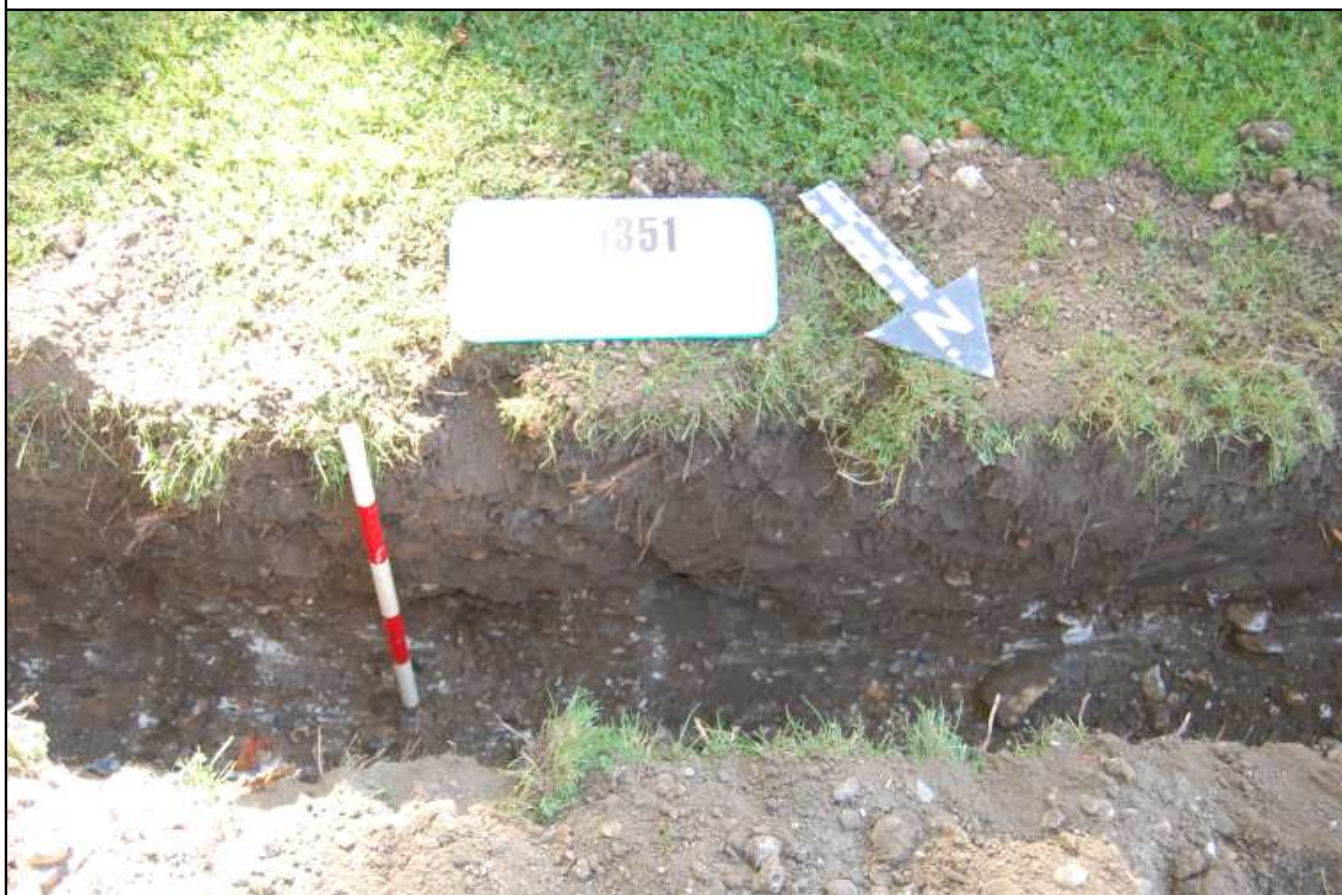
The exposed stratigraphy consisted of dark greyish brown friable sandy silty clay topsoil, c.0.45m in depth, over mid yellowish brown friable sandy silt clay subsoil, over 0.15m in depth, which contained chalk and late post-medieval brick fragments (Plates 10-12). These were noted, but not collected. The natural substrate was not reached at any point during the excavation of the trench.

Plate 10: Electrical service trench stratigraphy, looking NW

Plate 11: Electrical service trench stratigraphy, looking NE

Plate 12: Electrical service trench stratigraphy, looking SW

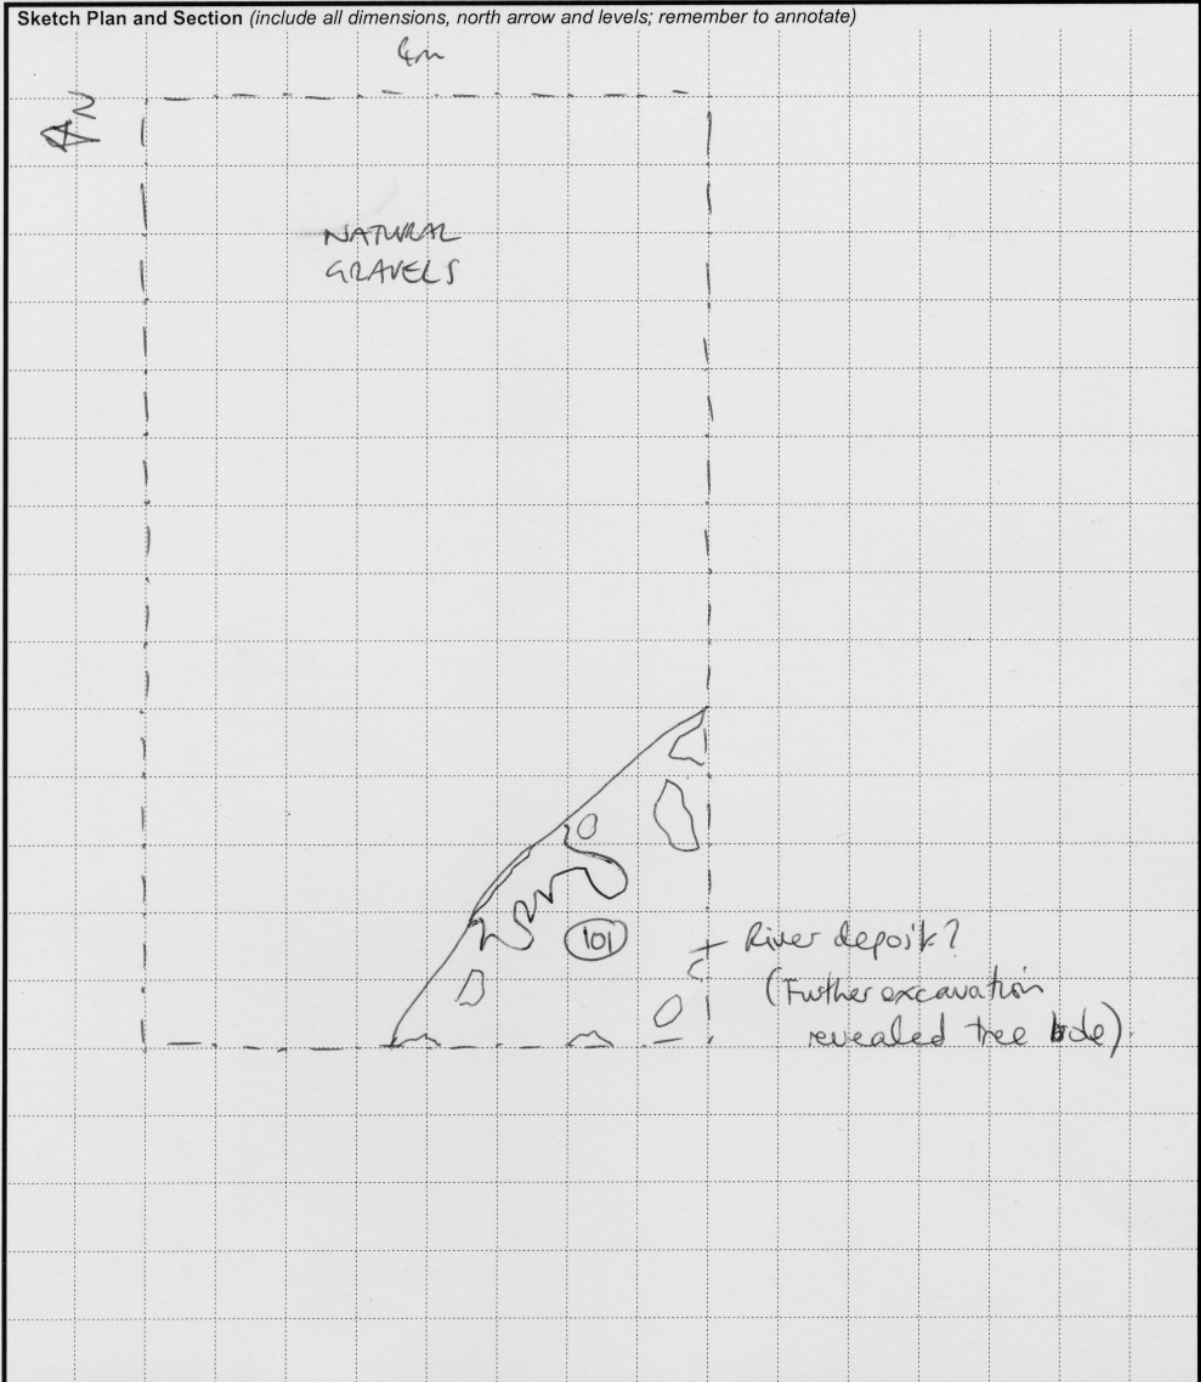
Discussion and interpretation					
Blank Trench. Tree bole revealed in SW corner.					
				Scale	1:50
				Signature	GAJ
				Date	6/8/17
	Sheet	1	of		Checked

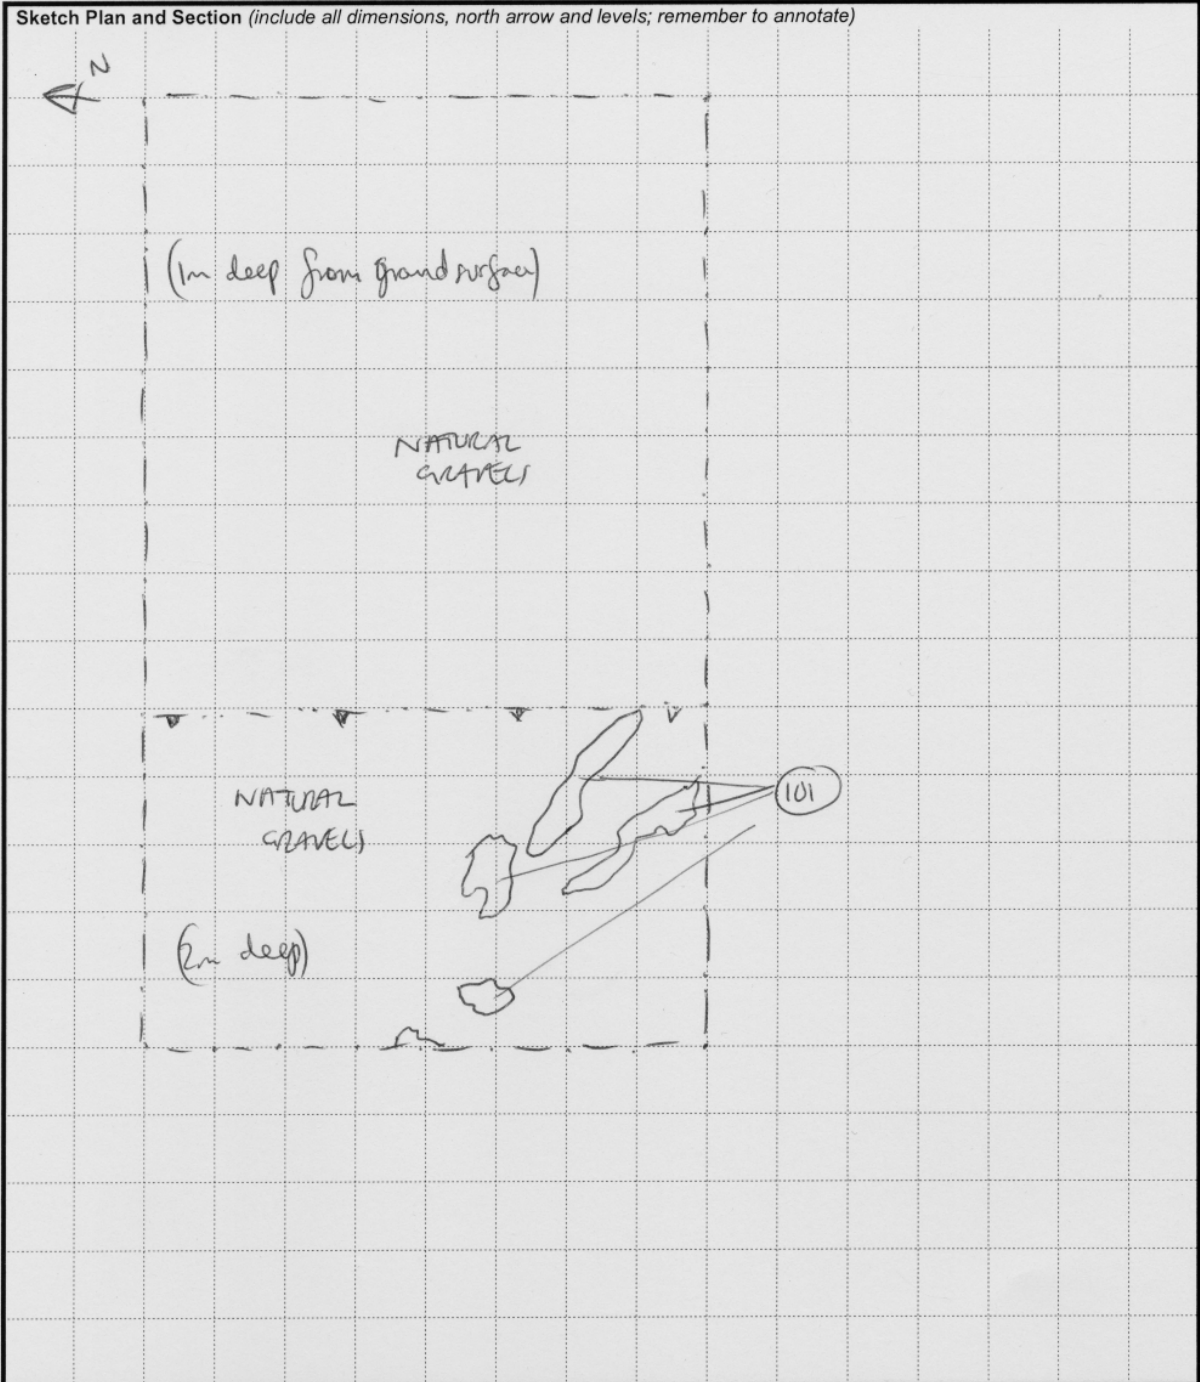
Discussion and interpretation	
sondage excavated revealing 'river deposit' to be a tree hole - very irregular and lots of rooting stains.	
Scale	1:50
Signature	GAJ
Date	6/8/17
Sheet	of
Checked

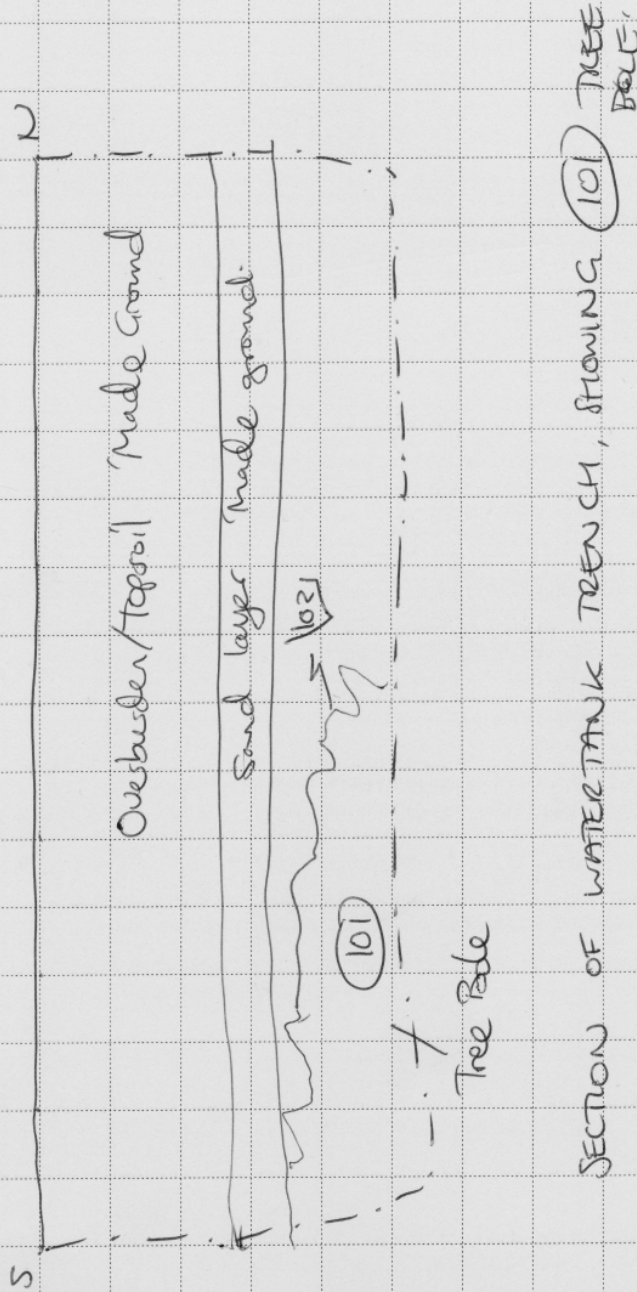
SECTION OF WATER TANK TRENCH, SHOWING 101 TREE BOLE.

Section of E facing Bank in Water Tank Trench. Showing naturally derived feature 101, most probably a tree bole.
