ARCHAEOLOGICAL
SERVICES
DURHAM UNIVERSITY

North Bondgate Car Park
Bishop Auckland
County Durham

archaeological monitoring

report 3476
June 2014

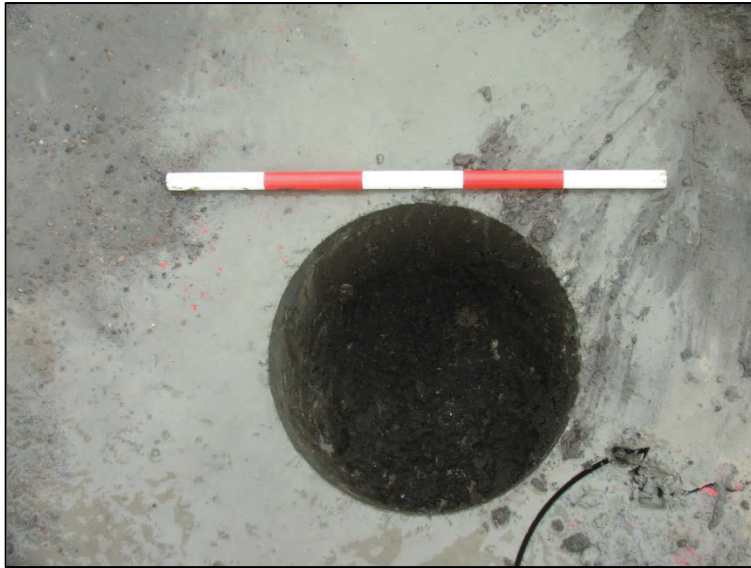
Figure 3: Borehole 1,
looking North

- 5.2 Borehole 1 was in the northern, concreted, part of the site and reached a depth of 0.35m. A deposit of grey-brown silty clay [4] was revealed beneath the concrete [1].

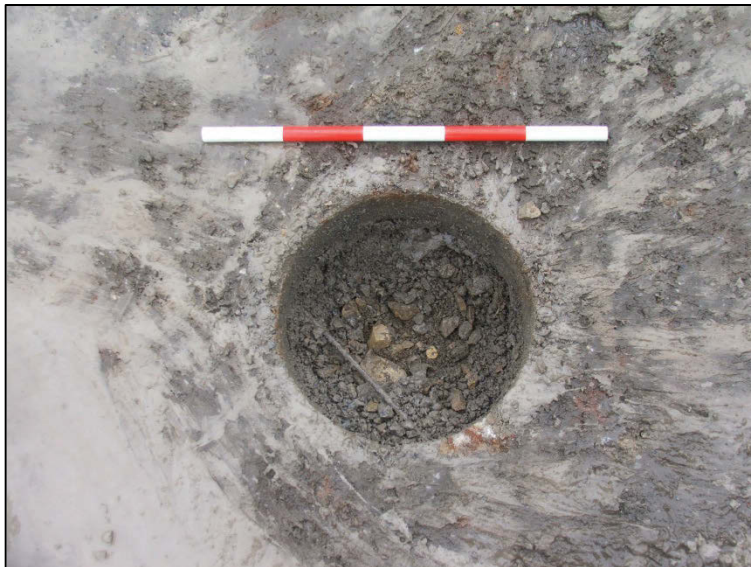
Figure 4: Borehole 2,
looking North

- 5.3 Borehole 2 was in the north-east corner of the concreted part of the site and reached a depth of 0.25m. A deposit of modern hardcore and rubble [3] was revealed beneath the concrete [1].

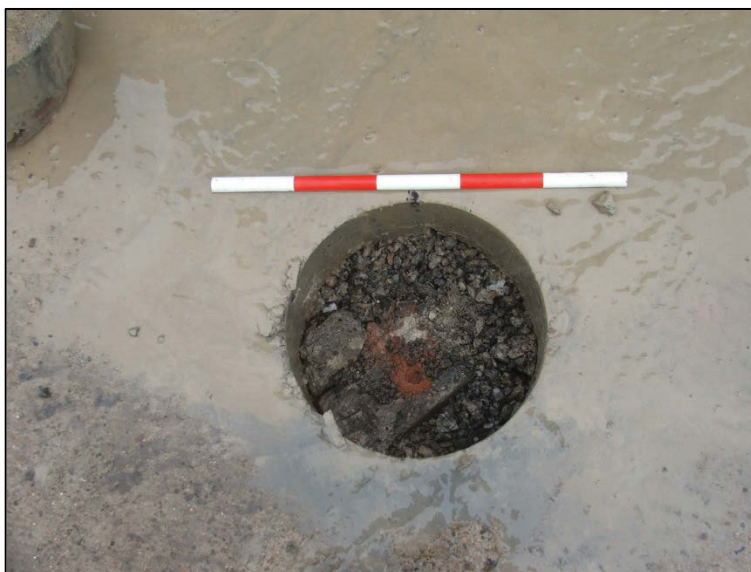
Figure 5: Borehole 3,
looking North

- 5.4 Borehole 3 was in the south-east corner of the concreted part of the site and reached a depth of 0.15m. A deposit of modern hardcore and rubble [3] was revealed beneath the concrete [1].

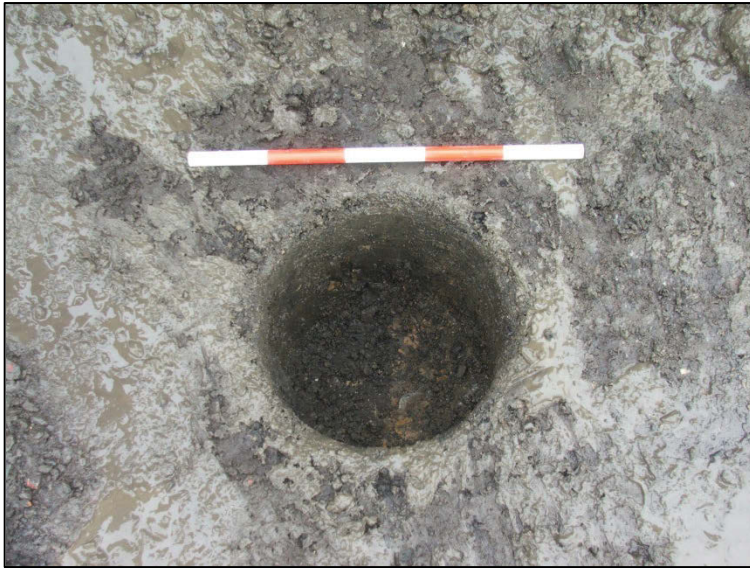
Figure 6: Borehole 4,
looking North

- 5.5 Borehole 4 was in the south of the tarmacked part of the site and reached a depth of 0.45m. A deposit of grey brown silty clay [4] and a yellow sandy clay [5] were revealed beneath the tarmac [2]. The edge between these two deposits suggested a cut feature.

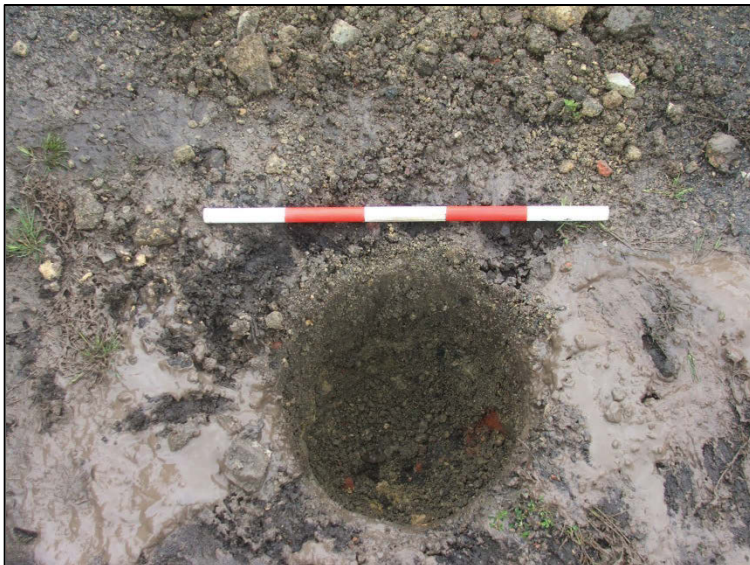
Figure 7: Borehole 5,
looking North

- 5.6 Borehole 5 was in the north-western part of the site and reached a depth of 0.45m. A deposit of modern hardcore and rubble [3] was revealed beneath the tarmac [3].
